Module 3 Charge Readout Status

Stephen Greenberg
Feb 1, 2023

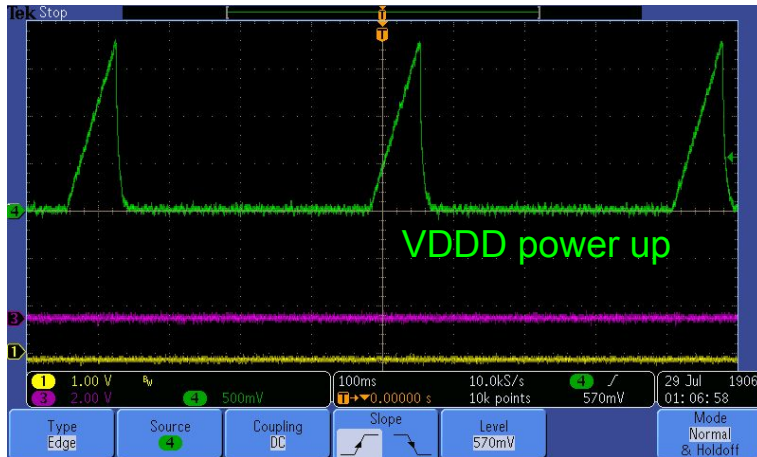
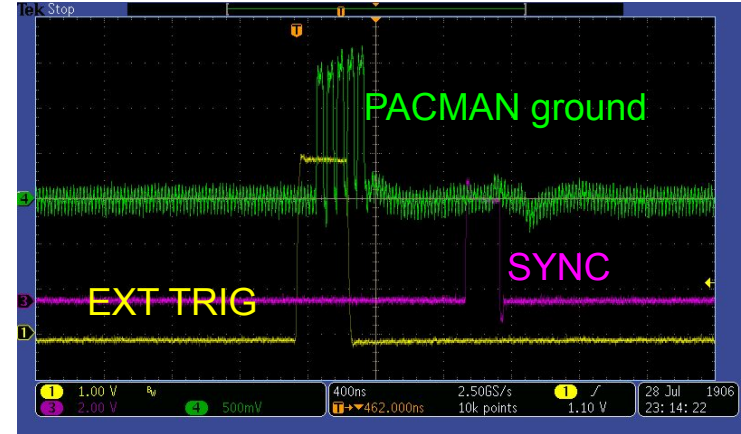
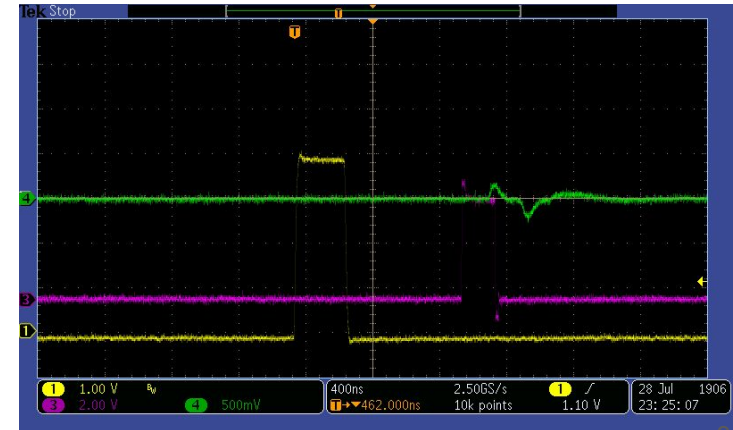
PACMAN Power Instability

- Observed instability in PACMAN ground supplied to tiles with sync/external trigger pulses
- Coupling of sync line directly to pacman receivers
- VDDD power up for all tiles trips regulator

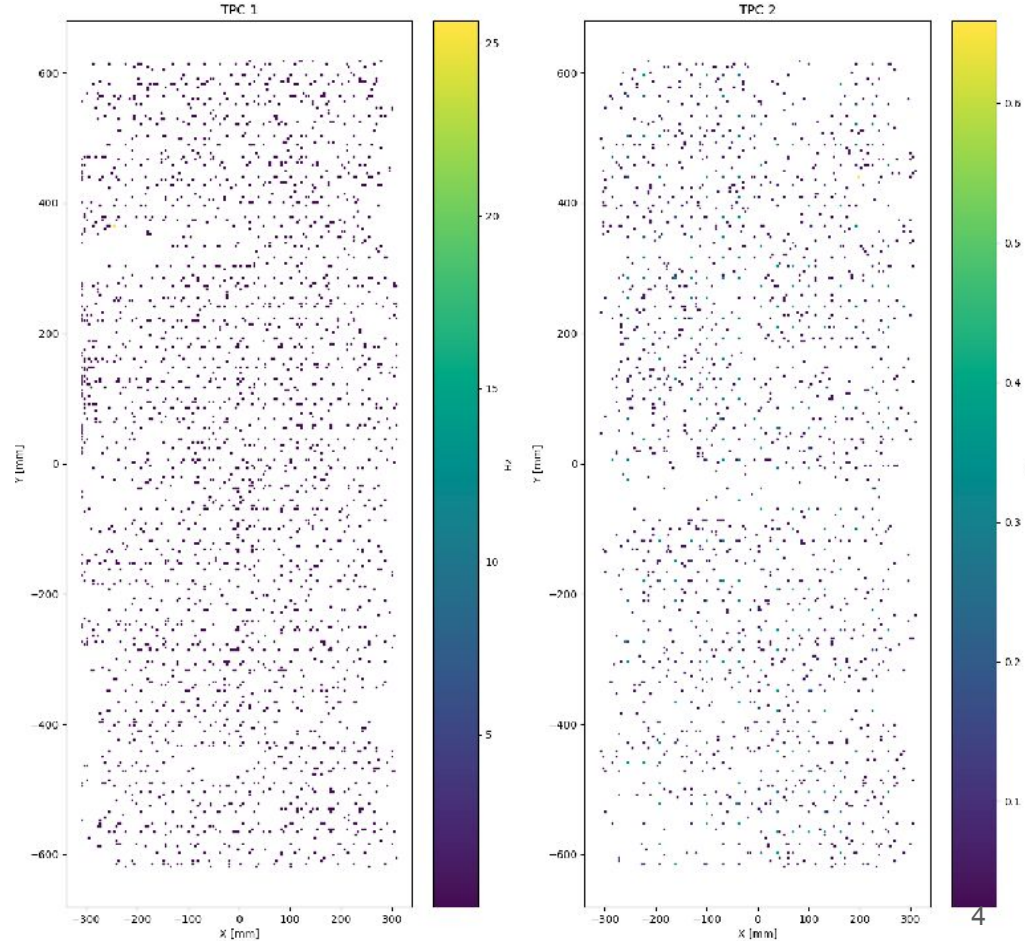
Configuration/Noise Issues

- UART test mode enabled on bringup for some ASICs
 - Results in continuous stream of identical packets
 - Issues configuring chips and others around it
 - Solved: writing configuration to disable upon bringup on all channels
- Channel 37 noisy channel
 - Analog-digital crosstalk on channel near UARTs
