Measurements on APAs 14 and 15 September 30th to October 4th, 2024 Pre-Cold Test

Matthew Wright
UNIVERSITY OF MANCHESTER

Pip Hamilton IMPERIAL

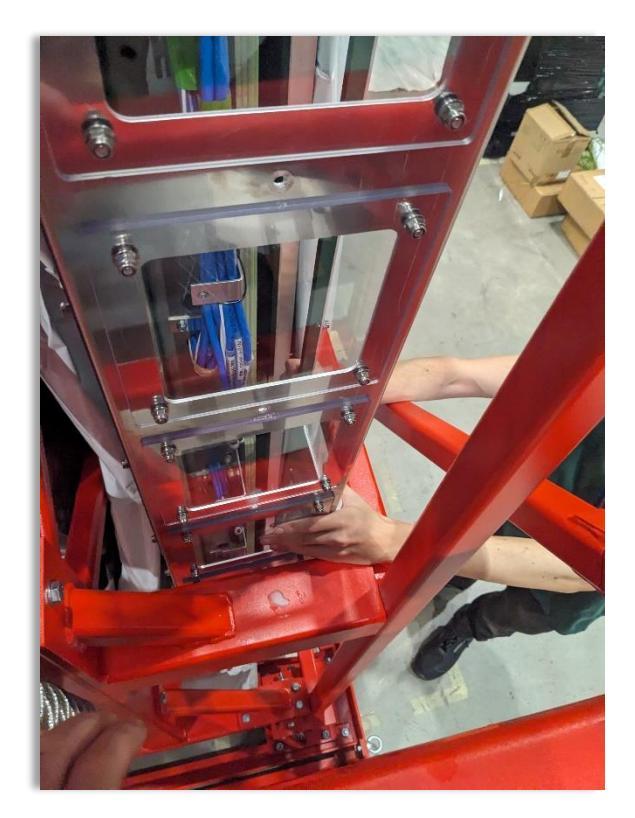
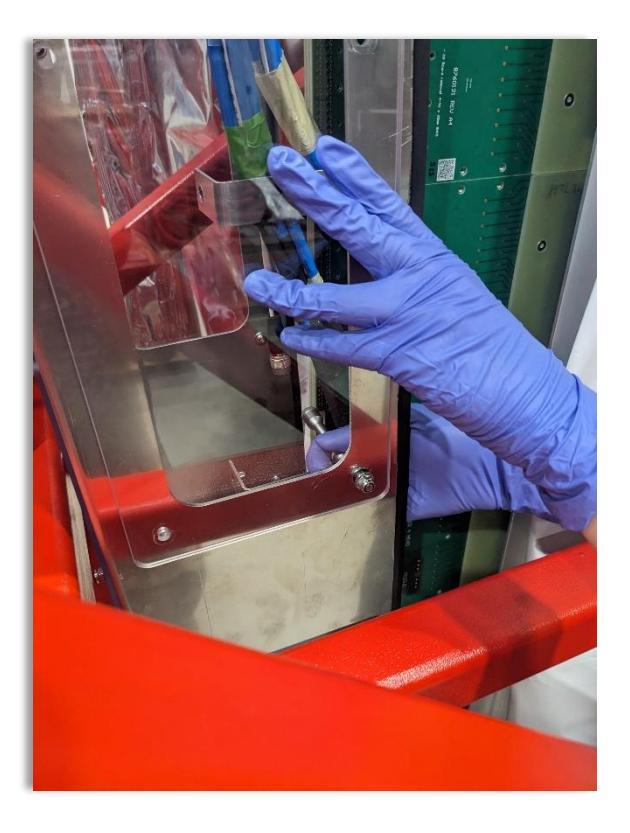
Once free, the headguard can be removed. To do this, it must be lifted vertically up out of the ASF. In this instance this was not possible due to the interference with the ASF structure of the nuts used to fix the Perspex windows onto the Headguard. We therefore needed to remove these nuts before being able to extract it. This would have been avoided if the nuts had been located on the inside of the headguard and the lowprofile button screw to which they are connected, located on the outside. After consulting with Rob Chapple (designer) at Manchester, it seems that the screws were indeed assembled the wrong way around. This must be communicated to the Daresbury technicians before future shipments are made.

Nuts retaining Perspex windows on Headguard should be assembled on the inside with the connecting button screws on the outside. This will allow Headguard to clear ASF structures when being removed from APA/ASF.

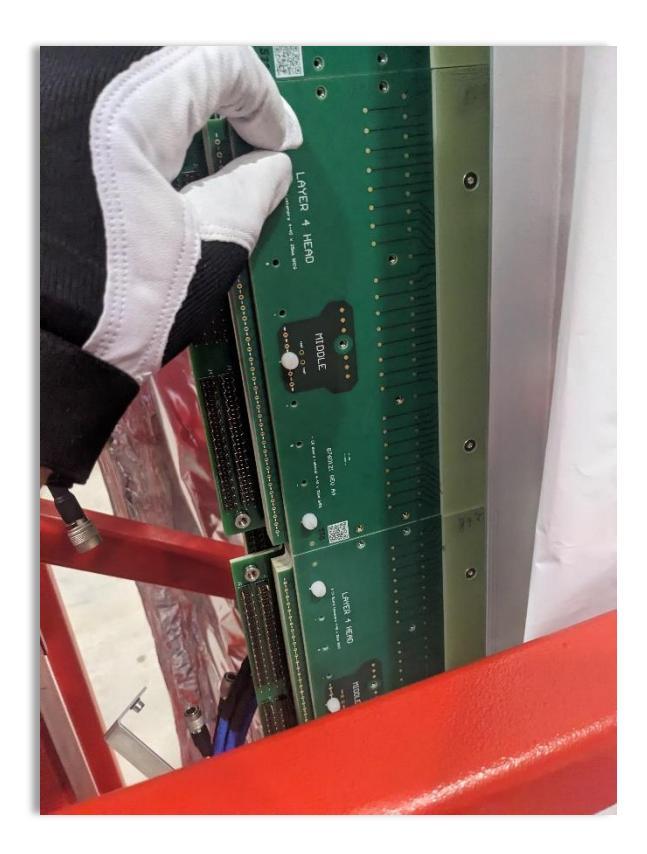
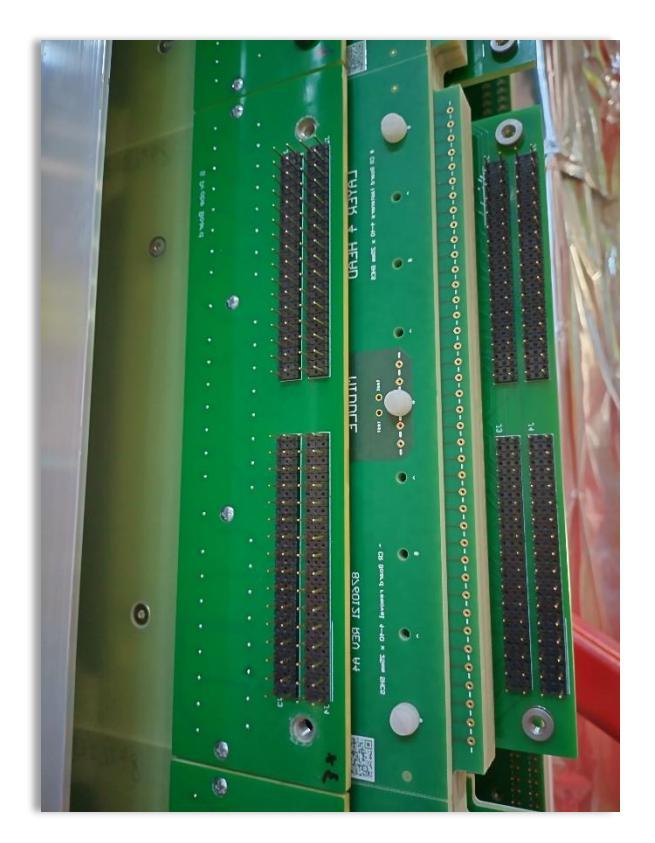
G Probe Board fixing holes were counterbore instead of countersink. This is not consistent with the design drawings of these boards, and made tightening of the attachment screws a little more difficult than usual. This was due to excessive friction between the flat underside of the screw heads and the counterbore profile.

Another problem encountered was the occasional decoupling of the broach nuts from the Probe Boards. The broach nuts allow the flex cable connector to be easily attached and disconnected from the Probe Board using the captive thumb screws on the flex cable head. A number of these broaching nuts were pulled out of their sockets as the flex cable head was unscrewed and detached from the probe boards.

Attaching of X probe boards to inner face of APA proved relatively simple, but attaching G Probe Boards using the traditional screws was extremely difficult due to access and line of sight issues.

Need to replace the G boards completely and supply additional X and G Probe Boards (minimum of 20 of each flavour required).

Need dedicated nylon screws for G Probe Board attachment.

The press-fit Broach nuts on Probe Boards need the addition of an appropriate epoxy to increase the binding strength to the FR4.

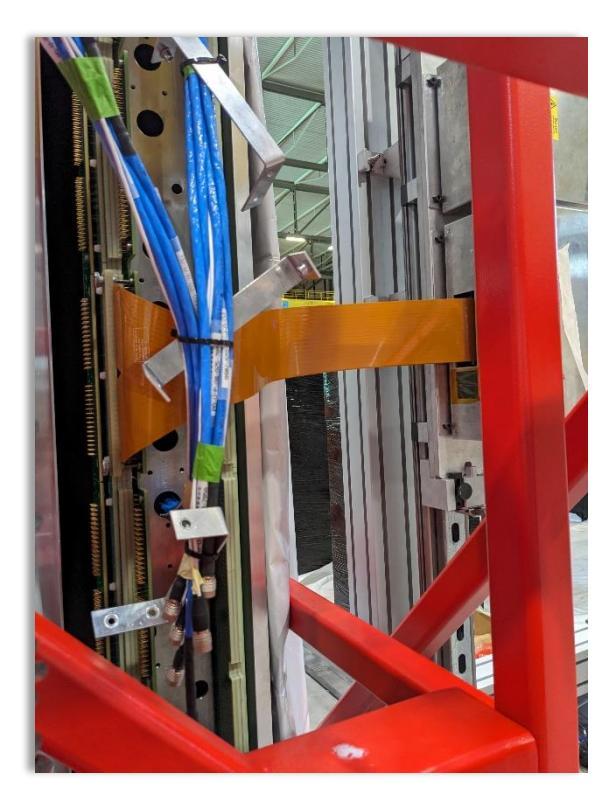
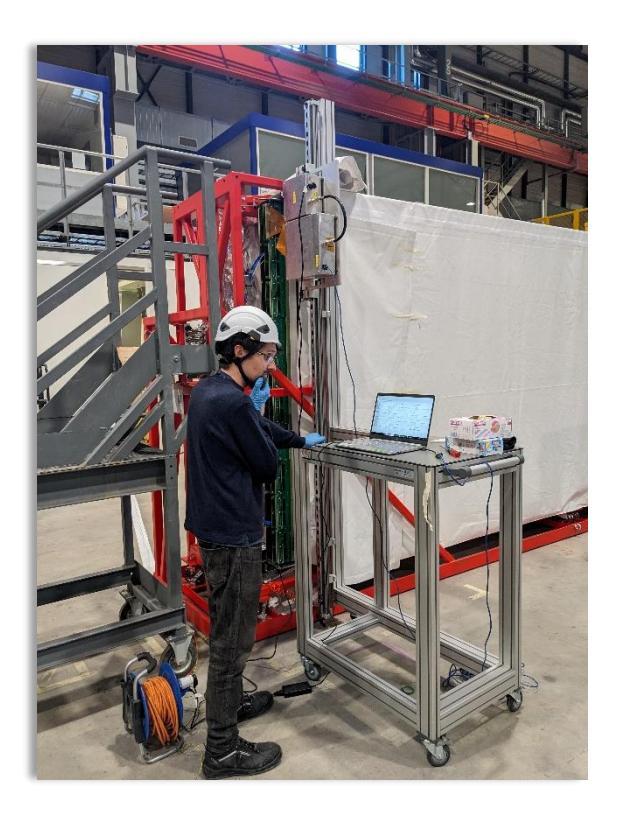
A loss of communication between the analogue board and one of the relay boards did halt proceedings for approximately an hour during measurements on Side B of APA 14. This recovered and measurements were completed, but this highlights the fragility and temperamental nature of the DWA systems. Efforts to establish the cause of this and other related issues have now been given priority.

Easily portable steps/platform (1m high) would be useful when attempting to reach the high points of the APAs. The heavy-duty platform used was inappropriate for this work. Need a dedicated power extension lead. Need a dedicated multimeter for continuity checks (grounding). Need braided grounding straps with bolted connections to grounding points. Longer flex cable (additional 10-20cm) might be useful. Need a dedicated and stable DWA unit for CERN activities (applicable to all sites). At least 2 flex cables should be available (1 spare). Spare fuses for PDB AC input required. Spare surface mount fuses required for regulators in PDB. Access to soldering equipment may be required.

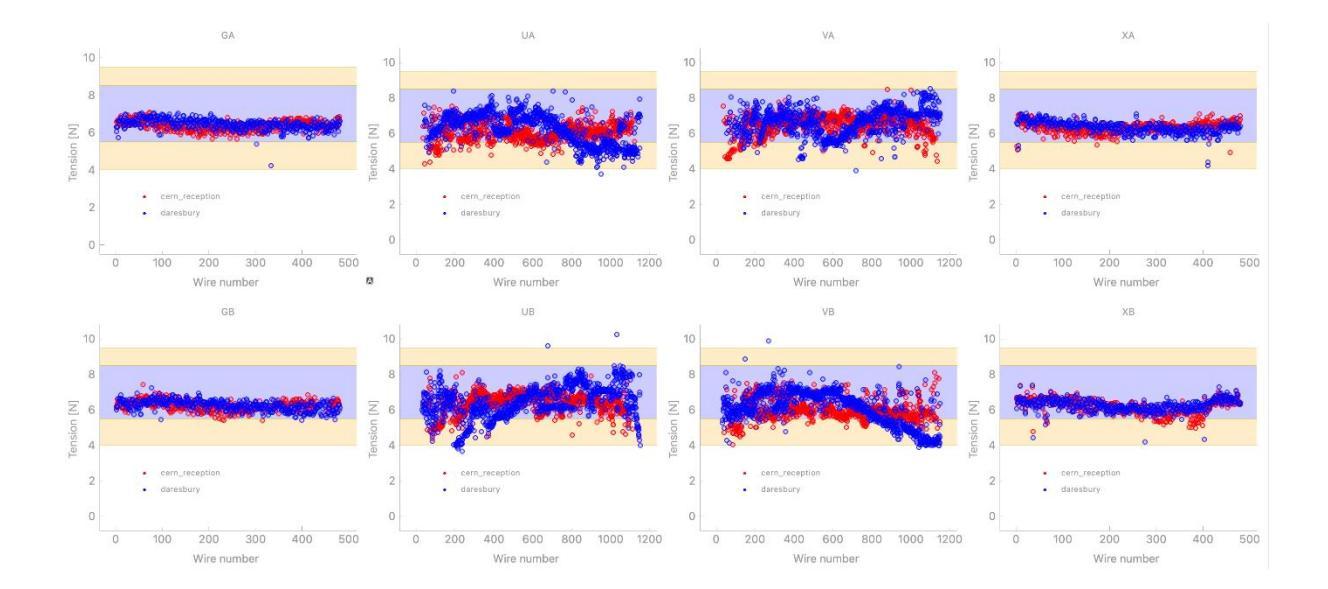
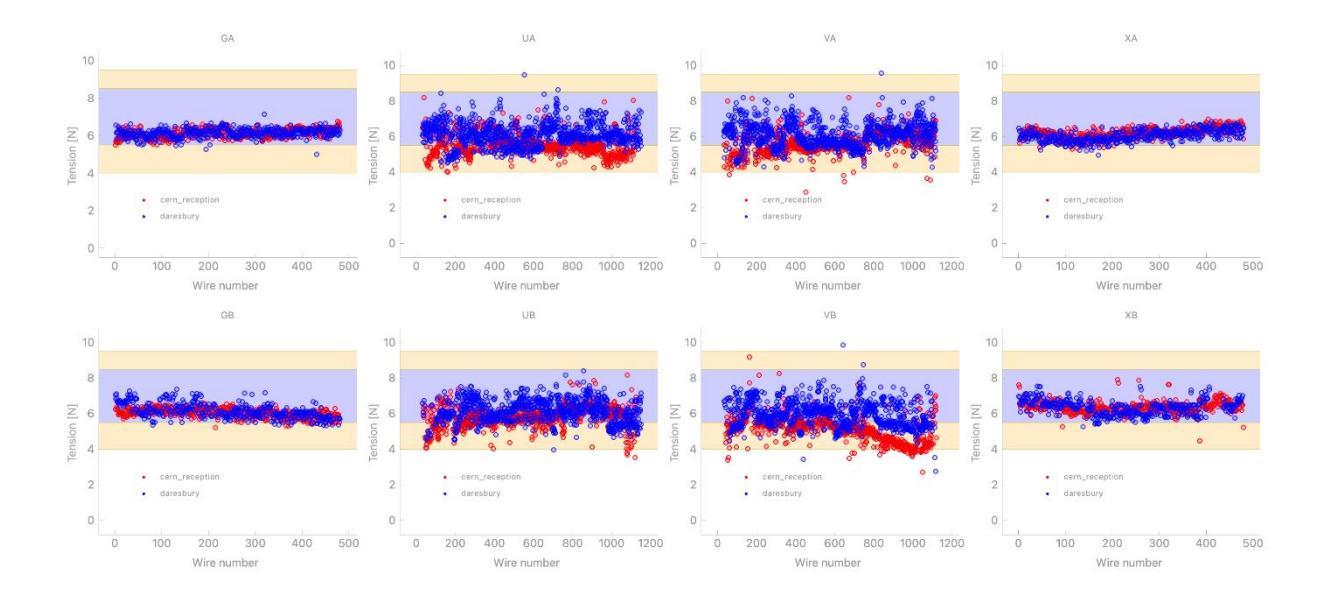
Pre- and Post-shipping Data Compared

G and X layer tension data well matched to across the two measurements.

Sinusoidal-like variation observed in UA layer and VB layer tension data seen in preshipping data appears to have been suppressed in the post-shipping data. This may suggest the different mechanism of APA support in the ASF has altered the wire tensions in these layers (APA 'straightened out'??)

There appears to be a drop in tension on U and V layers, most notably in UA and VB layers. Again, this could be indicative of the differences between the APA support mechanisms pre-and post-shipping. This is not necessarily suggestive of a change associated with transportation.

To be sure of consistency between pre- and post-shipping measurements, all future DWA tests should be performed while APAs in ASFs.

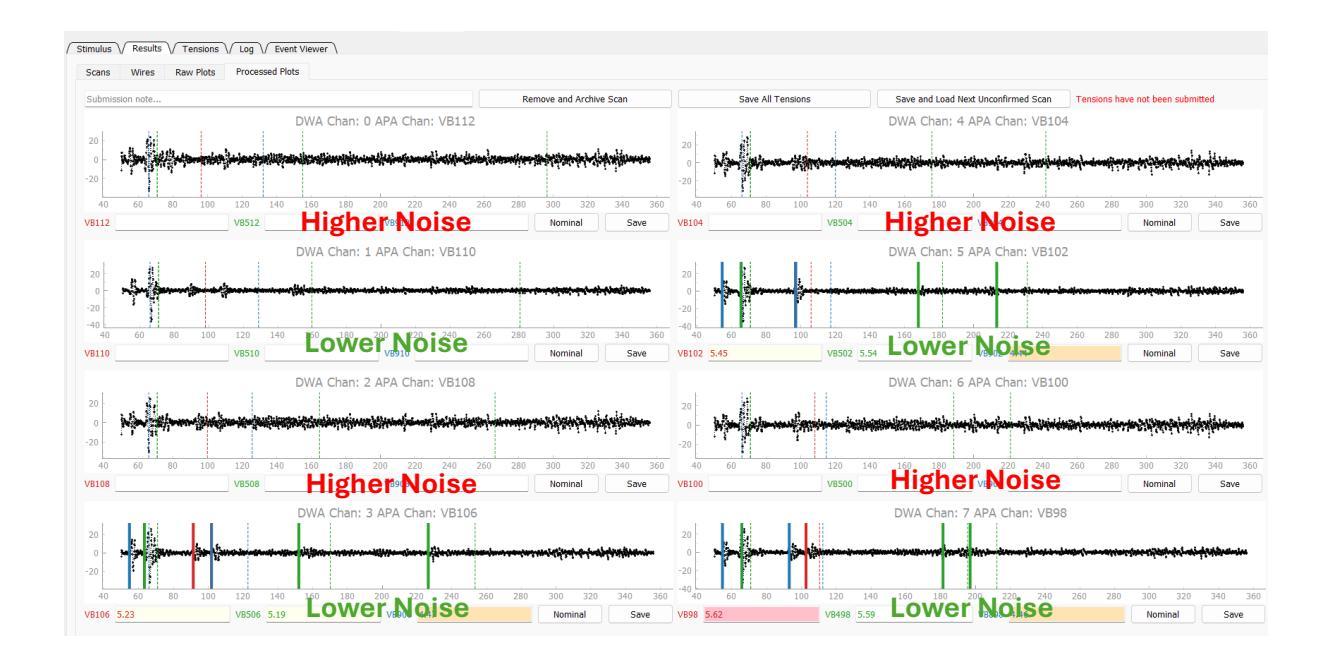
Data from APA 15 (CERN)

Examining data from measurements at CERN revealed a repeated pattern of noise in certain datasets. This noise dramatically impacts the resolution of sense current resonances in these data.

This pattern is repeated regardless of layer, Headboard or scan groups. Its source is therefore associated with the DWA and, more particularly, with the Analogue board (independent of which Relay Board is being activated for the scan).

The magnitude of the raw signal was noted to be significantly higher for traces showing the higher noise levels.

Technical review of DWA boards to ensure any potential sources of noise are minimised. Already underway and to be supported by Electronics Engineers at RAL.

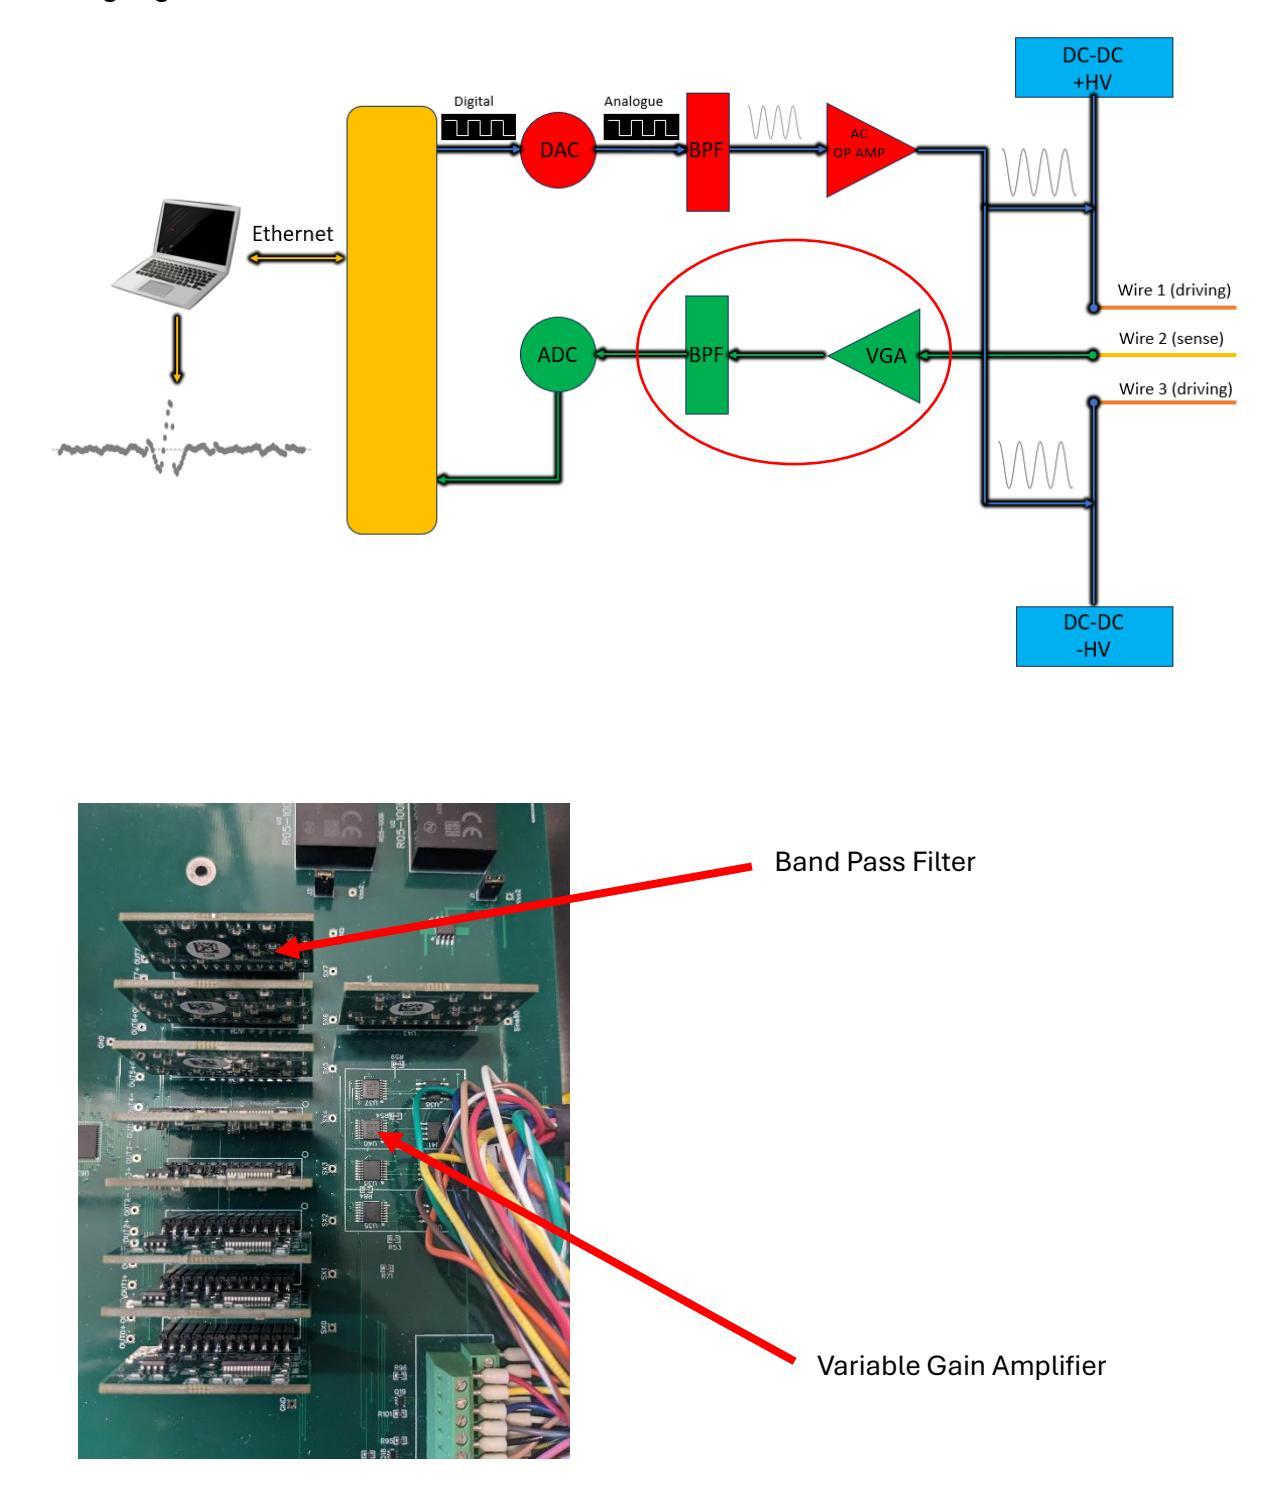
Signal from each wire pass through a VGA and then onto a Band Pass Filter before being digitised and returned to the FPGA.

Outputs of the VGAs were sampled. These showed significantly higher gain for channels showing the higher noise.

These VGAs are programmable digital gain amplifiers. It is likely that the gain is controlled by the FPGA and is set in the uploaded firmware.

To understand the reasons for the differences in the gains of these amplifiers, or to establish if these have been modified at some point, we are sending a report to Nathan Felt and John Oliver. It will likely be necessary that we modify the firmware by adjusting the pre-amp gains and study their influence on the signal-noise ratio.
