# Status of PID detectors at BigRIPS

H. Sato, Detector team, RNC

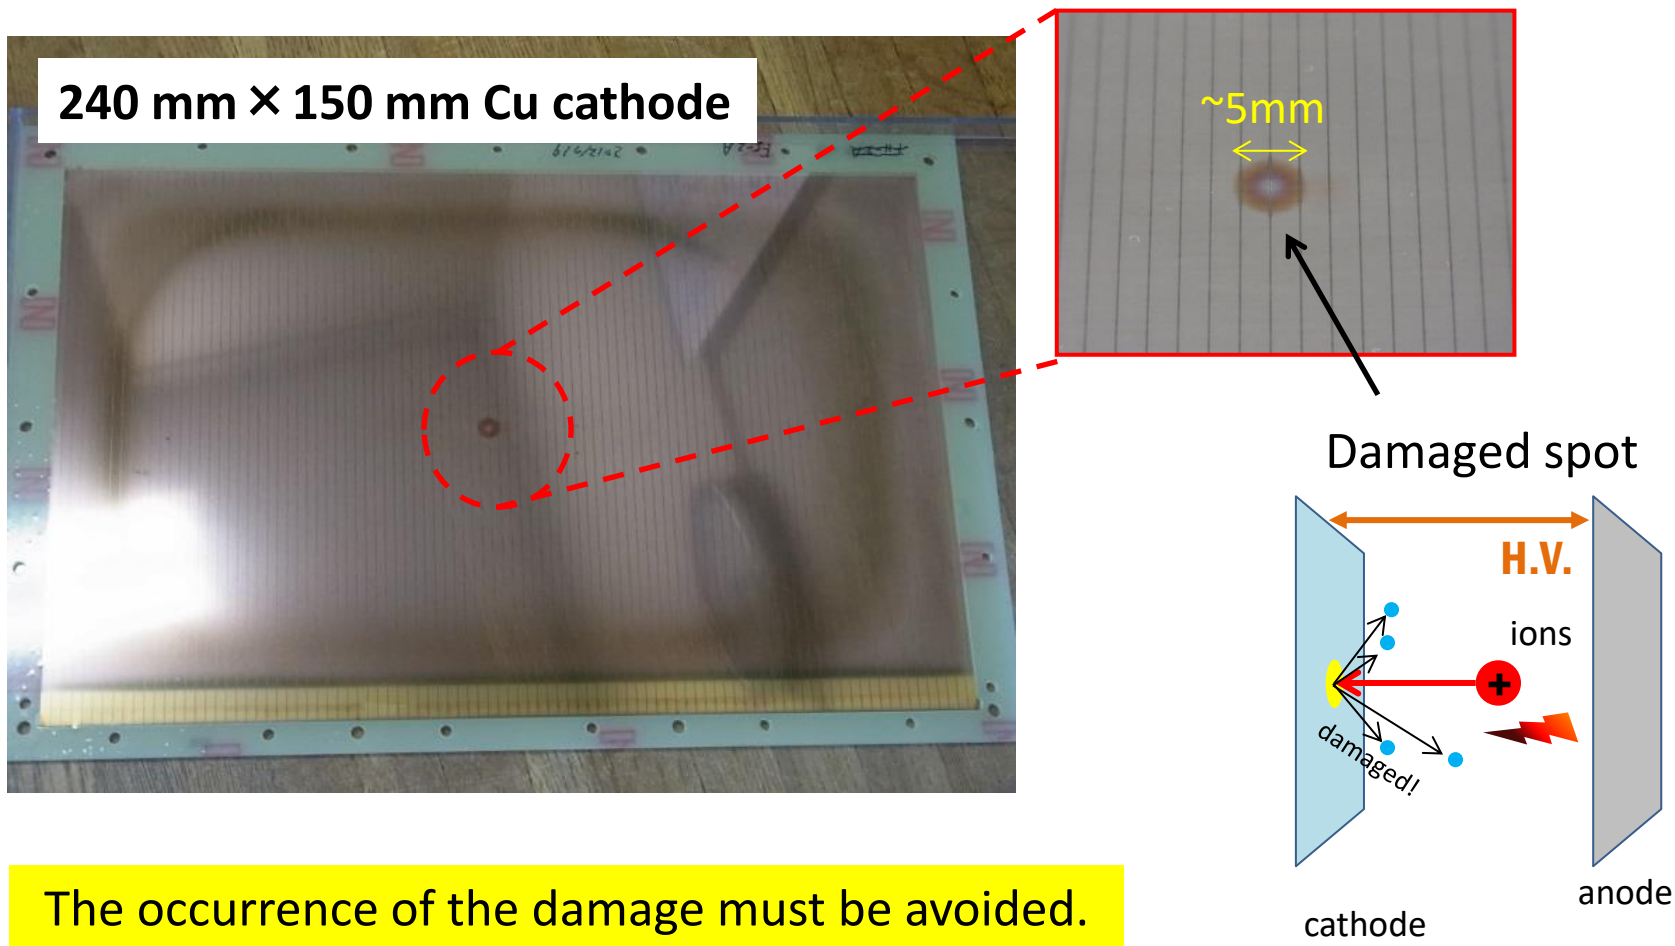
# 1. Damage due to discharge

Electrical discharge sometimes occur with several tens of kHz of beams.

Trip of H.V. modules frequently happens.

Damage on the cathode electrodes can be seen.

Au, Al, Cu → **Ag**

Empirically, silver electrode is more tolerant to the discharge than the others.

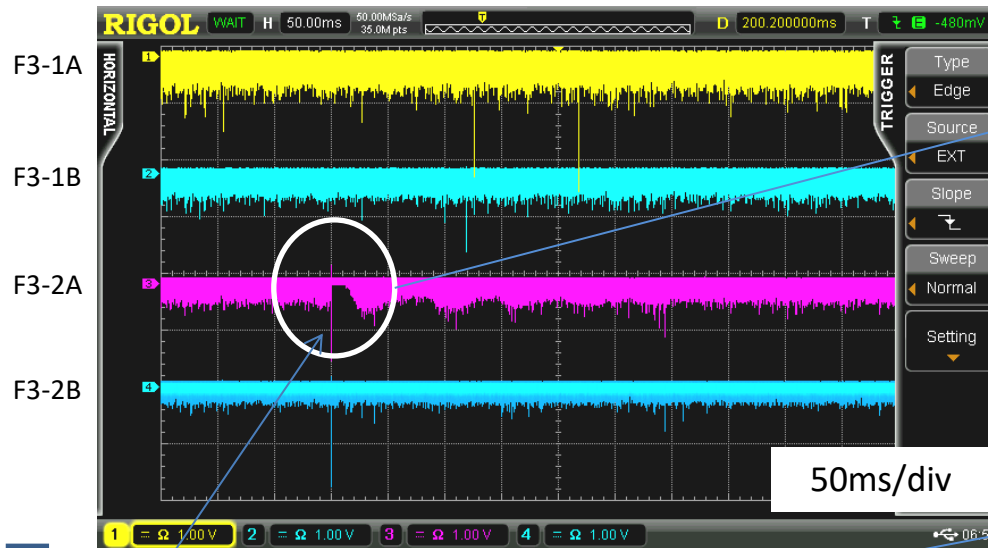
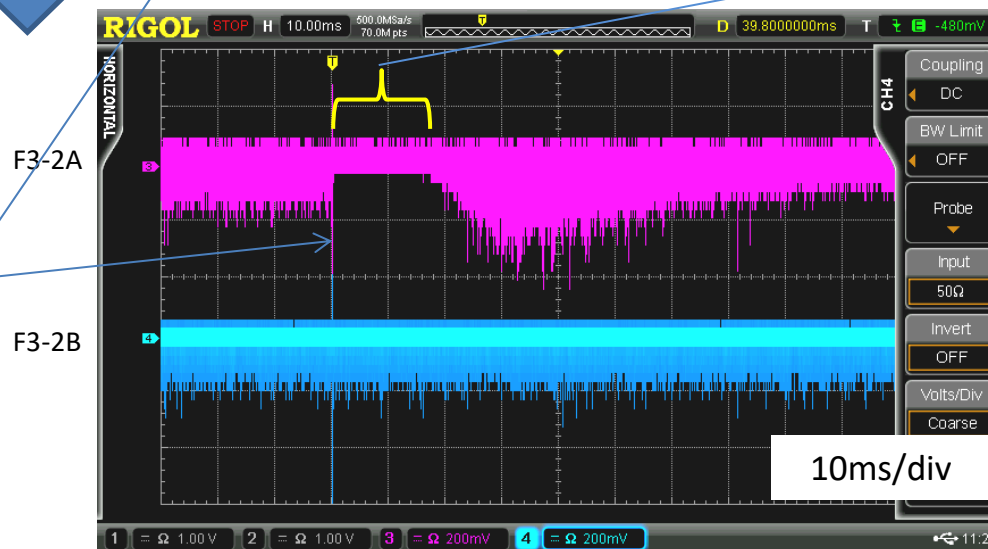
We increased the bias voltage of F3-2A up to 750V @1MHz beam, and a discharge happened on F3-2A.

The anti-discharge unit was operated.

Bias voltage was shutdown and recover.

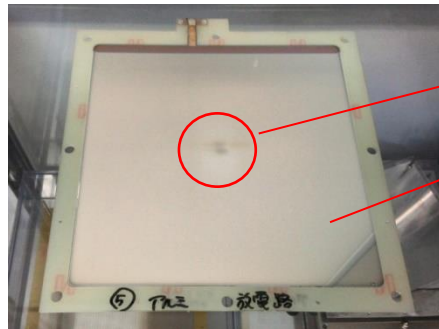
- Damage on the **anode** appears because the lifetime of the cathode becomes longer by using the anti-discharge unit.
- ✓ The ADU cannot stop the electrons which are running to the anode.
- ✓ We prepared the anodes which have thicker Ag layer (50nm → 100nm).
- ✓ We will test them on the beamline.

Same kind of damages are seen in the case of Ag.

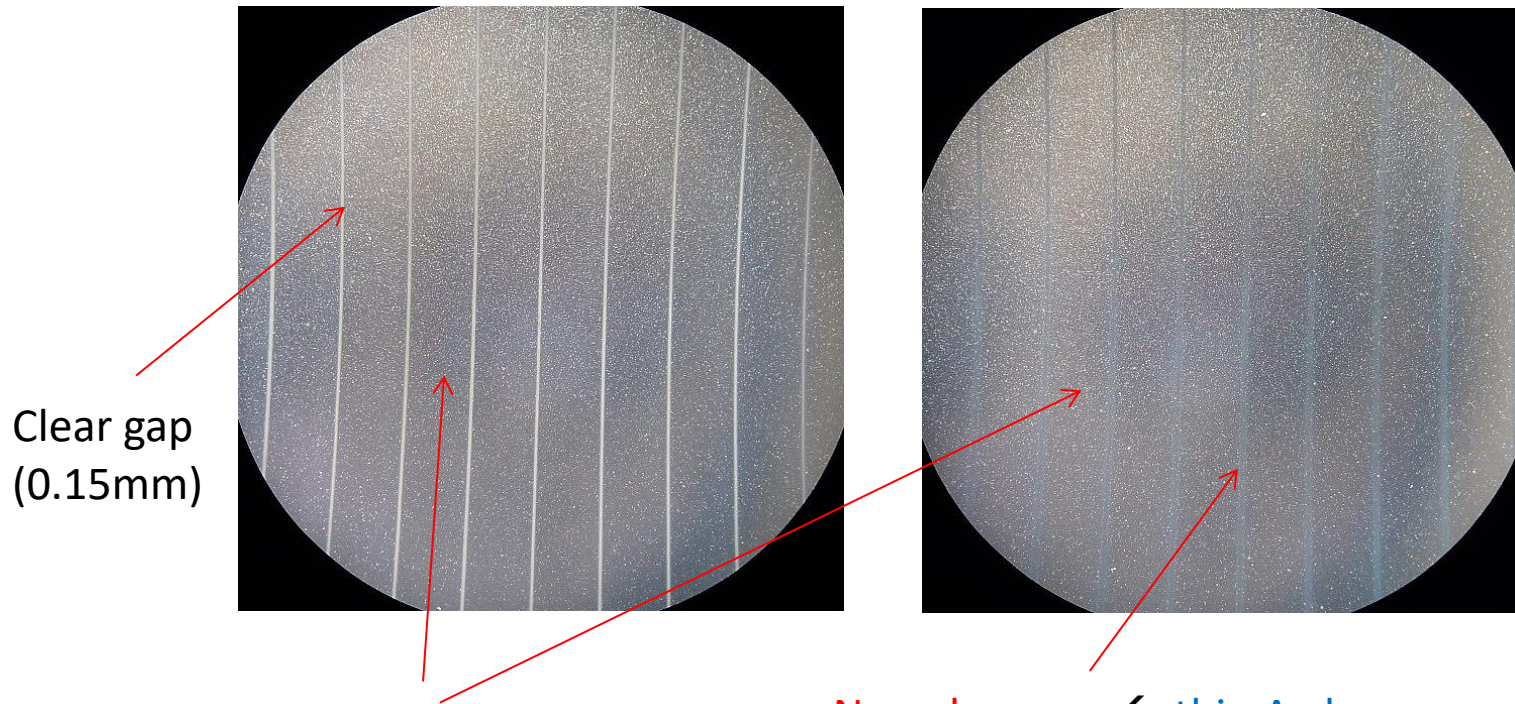
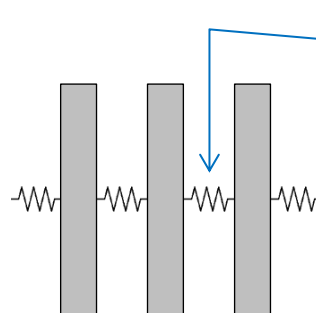
Sometimes, non-clear strip gaps are seen after depositing Ag.

Non-clear gap ← thin Ag layer

Each strips are connected !

Such electrode cannot be used !

Non-clear strip gaps comes from the imperfect contact between the mylar film and the mask wire.

- Add the spring to apply more tension to the mask wire.

- Silicon rubber is put on the mylar film.

Production yield: ~50% → 100%!

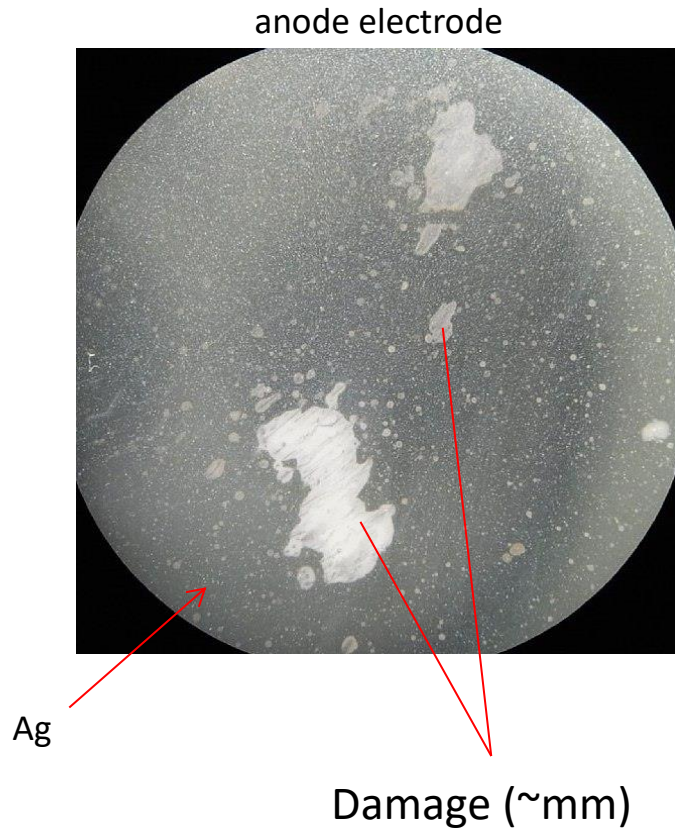
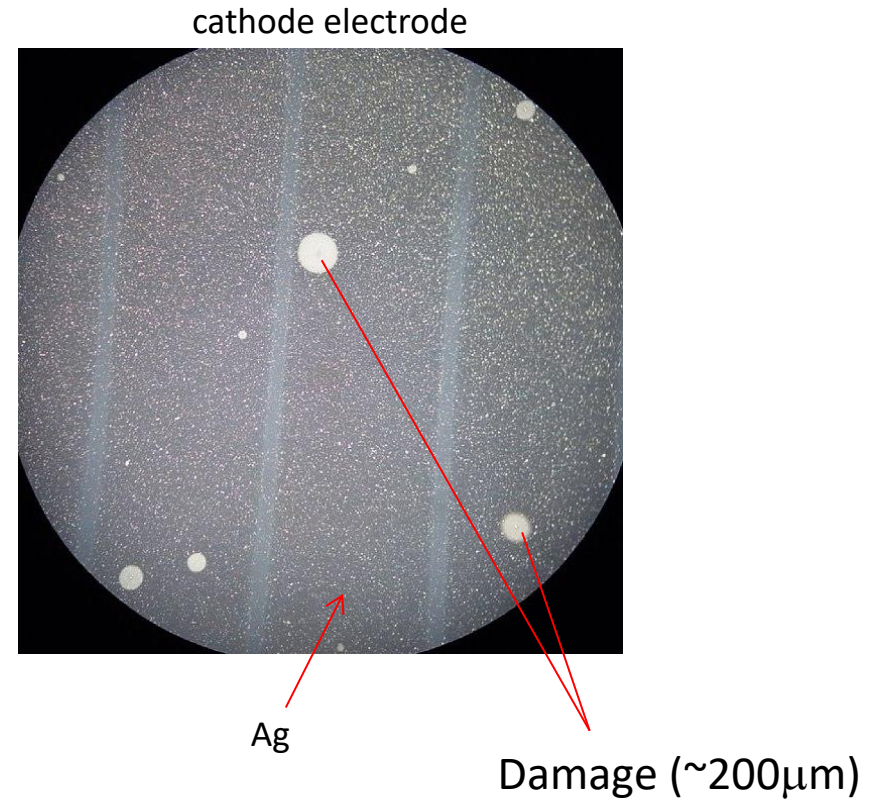
After depositing Ag on the mylar film, sometimes damages (colored arer of the Ag) has been seen.

- ✓ Sometimes, they appear immediately after finishing the deposition.
- ✓ Sometimes, they appear several days after.

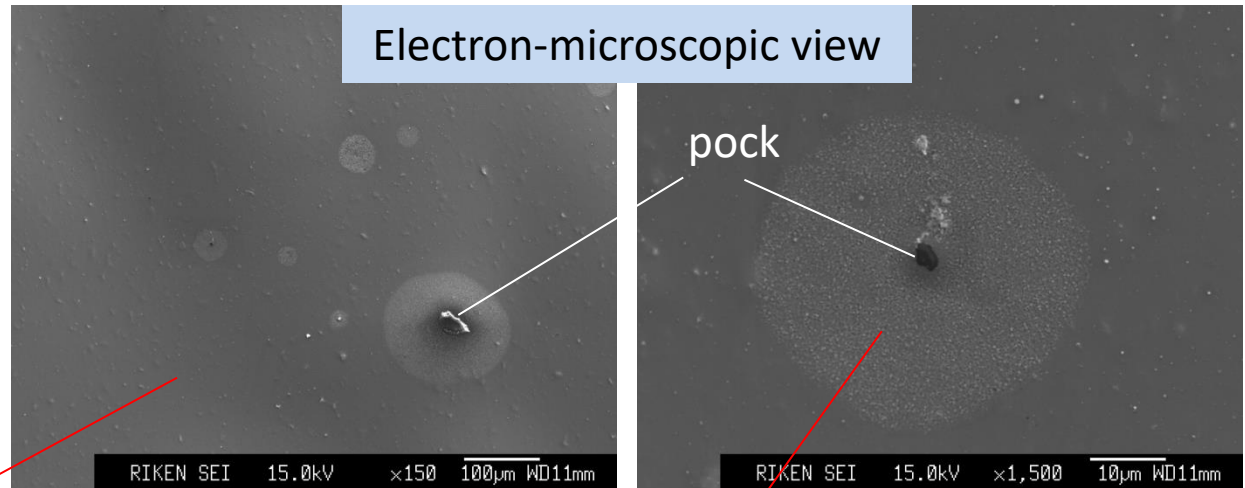
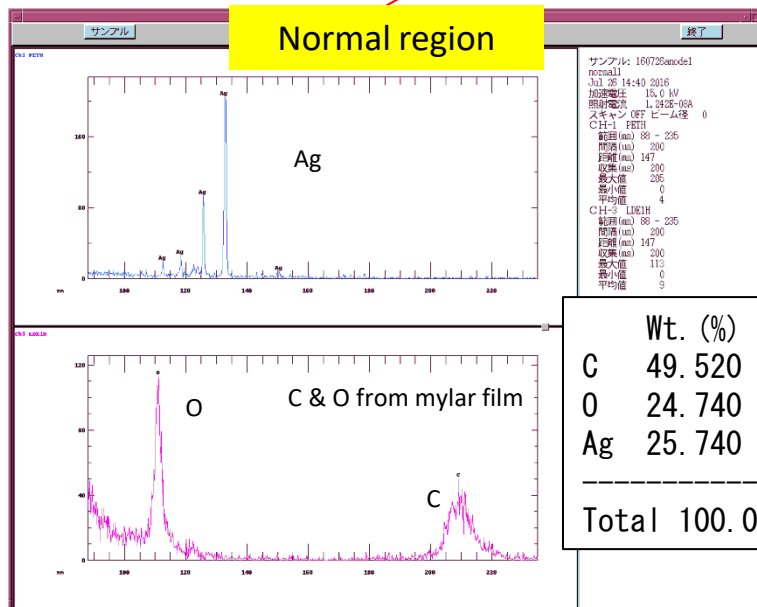
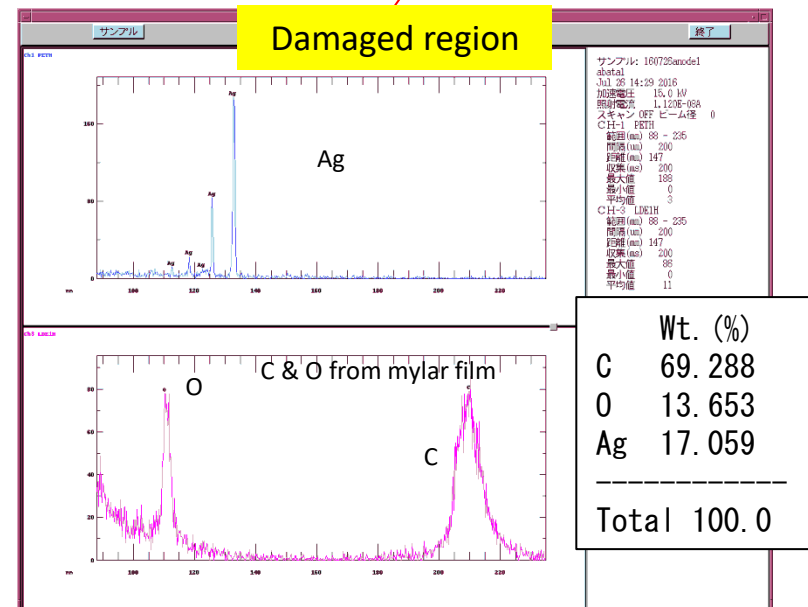
The component analysis of the damaged area was done by using Electron Probe Micro Analyzer.

There are no contaminants in the damaged area.  
We consider that the reason of the damage is due to the wet on the film.
