# Laser Incidents and Lessons Learned at DOE Labs since 2014

11<sup>th</sup> Annual DOE Laser Safety Officer Workshop  
Fermilab National Accelerator Laboratory

**Joanna Casson**

September 27, 2016

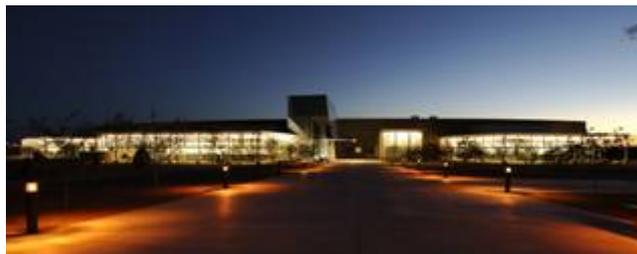
# Sandia National Laboratories – ABQ

- **Alignment of 800 nm laser**
- **800 nm laser light doubled to 400 nm**
- **Worker wearing LPE for 800 nm only**
- **LPE that covered 400 nm and 800 nm available in lab**
- **Alignment involved a vertical beam**
- **Beam block was present, but beam exceeded height of beam block**
- **When beam went vertical, worker experienced a flash in his eye**

- **Worker secured the scene and reported the incident to lab owner**
- **Determined that LPE was inadequate**
- **Reported to management**
- **Worker taken to SNL medical facilities**
- **No injury detected**
- **DLSO determined that the worker was exposed to laser light above the MPE**

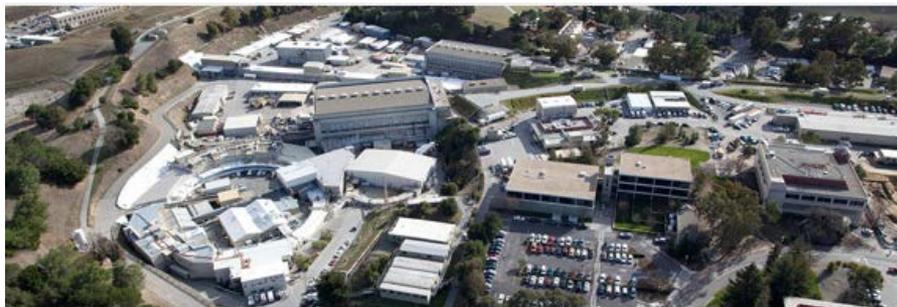
# SLAC National Accelerator Laboratory

- **Alignment with Class 3R laser**
- **Associated Class 4 laser was turned off**
- **Worker open a laser safety shutter without authorization**
- **Shutter was labeled “Laser Safety Device – Do Not Remove or Modify without SLSO Approval**
- **Approval must given before opening the shutter**
- **Opening the shutter tripped an interlock fault and an alarm sounded**
- **Following procedure, the laser system was secured by the SLSO**

- **SLSO inspected the Laser Safety System**
- **Found the latched fault**
- **SLSO asked the worker about the shutter fault**
- **Worker stated he needed to have the open shutter to do the alignment with the Class 3R laser**
- **Worker did not think the shutter impacted safety**
- **Since the Class 4 laser was in “off” mode and shutters upstream prevented the laser from reaching the worker, there was no immediate safety hazard in that room**
- **If the Class 4 laser was on, then it could have exposed personnel to laser light above the MPE**

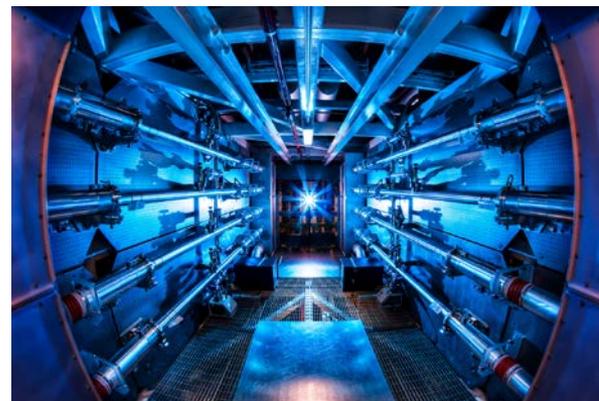
# Lawrence Livermore National Laboratory – NIF

- **VISAR safety gate valve improperly LOTO in open position**
- **Work paused**
- **LOTO properly applied**
- **No workers exposed to laser light**

- **No policy defining when to use Energy Isolation Procedure**
- **Workers did not recall LOTO training**
- **Indicator slide was not clearly visible due to black background and limited lighting environment**

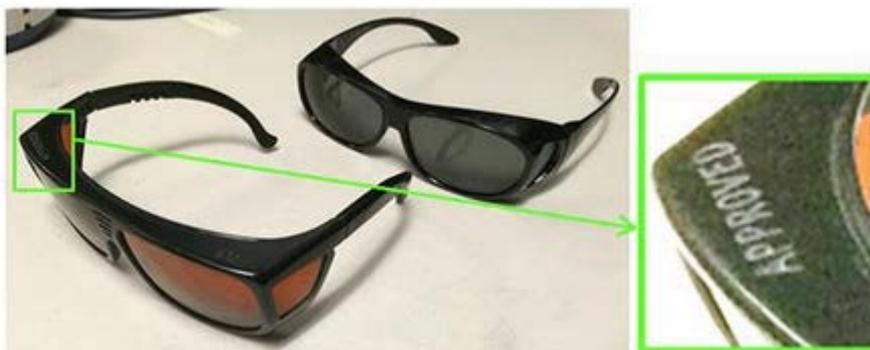
# LLNL – Jupiter Laser Facility

- Room was dark
- Visiting graduate student donned eyewear before laser was turned on
- Student picked up what he thought was LPE
- Saw a spot of green light for about 2 seconds
- Later while working on a computer, noticed that the computer screen was gray when it is normally orange
- Left the room
- Realized he was wearing a coworker's personal sunglasses

- **Notified other workers and reported the incident**
- **Seen by Occupational Medicine**
- **No injury detected**

- **Signs posted indicating personal sunglasses should be kept away from LPE**
- **Personal reflective items must be securely stowed while working in target areas**

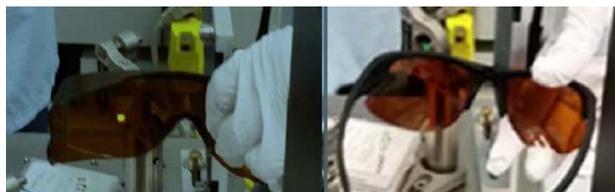
# Lawrence Livermore National Laboratory

- **Worker aligning a pulsed green laser (527 nm)**
- **Laser light reflected off a semiconductor wafer toward LPE**
- **Worker saw bright flashes across upper part of eyewear**
- **Worker reported incident**
- **Eye exam revealed no injury**

- **Eyewear and similar eyewear with the YAG/KTP filter fluoresced when struck by a green laser beam.**
- **Other eyewear filters produced a dull spot**

- Practice good beam control during alignments
- Reduce laser output energy/power to as low as practical to perform the alignment.
- Do not move optics into or out of the beam path with laser(s) on.
- Ensure downstream beam is blocked while performing course adjustments.
- When using viewing cards, direct them down toward the table and not upward.
- Use cameras when possible to free up your hands.

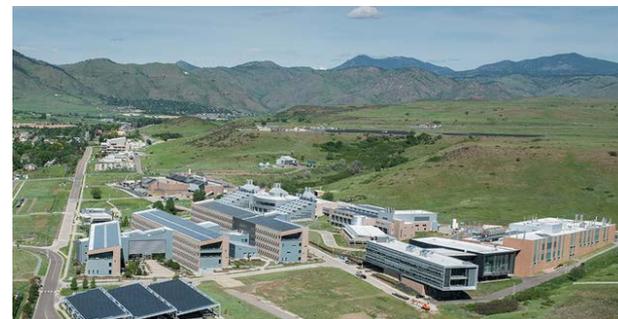
# National Renewable Energy Laboratory

- Worker aligning a Class 4 Ti-Sapphire (2.5W, 60 fs, 1kHz)
- Worker lowered his eyewear to better see the laser beam
- Turned his head and saw a flash of light
- Continued working
- Later that evening noticed a blind spot in right eye

- Reported the incident to line management
- Evaluated by Occupational Health
- Confirmed injury to right eye

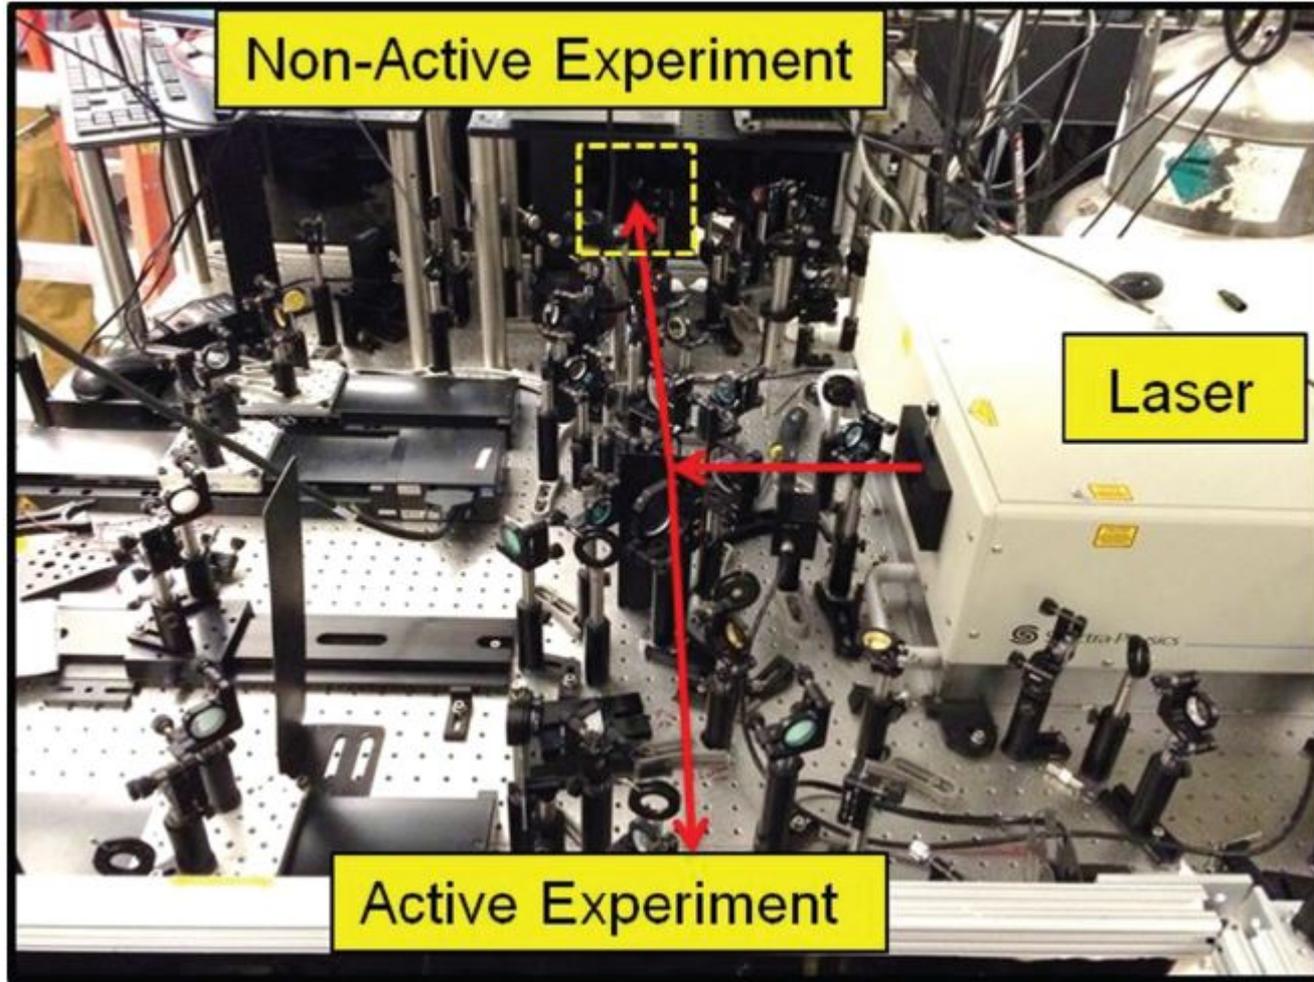
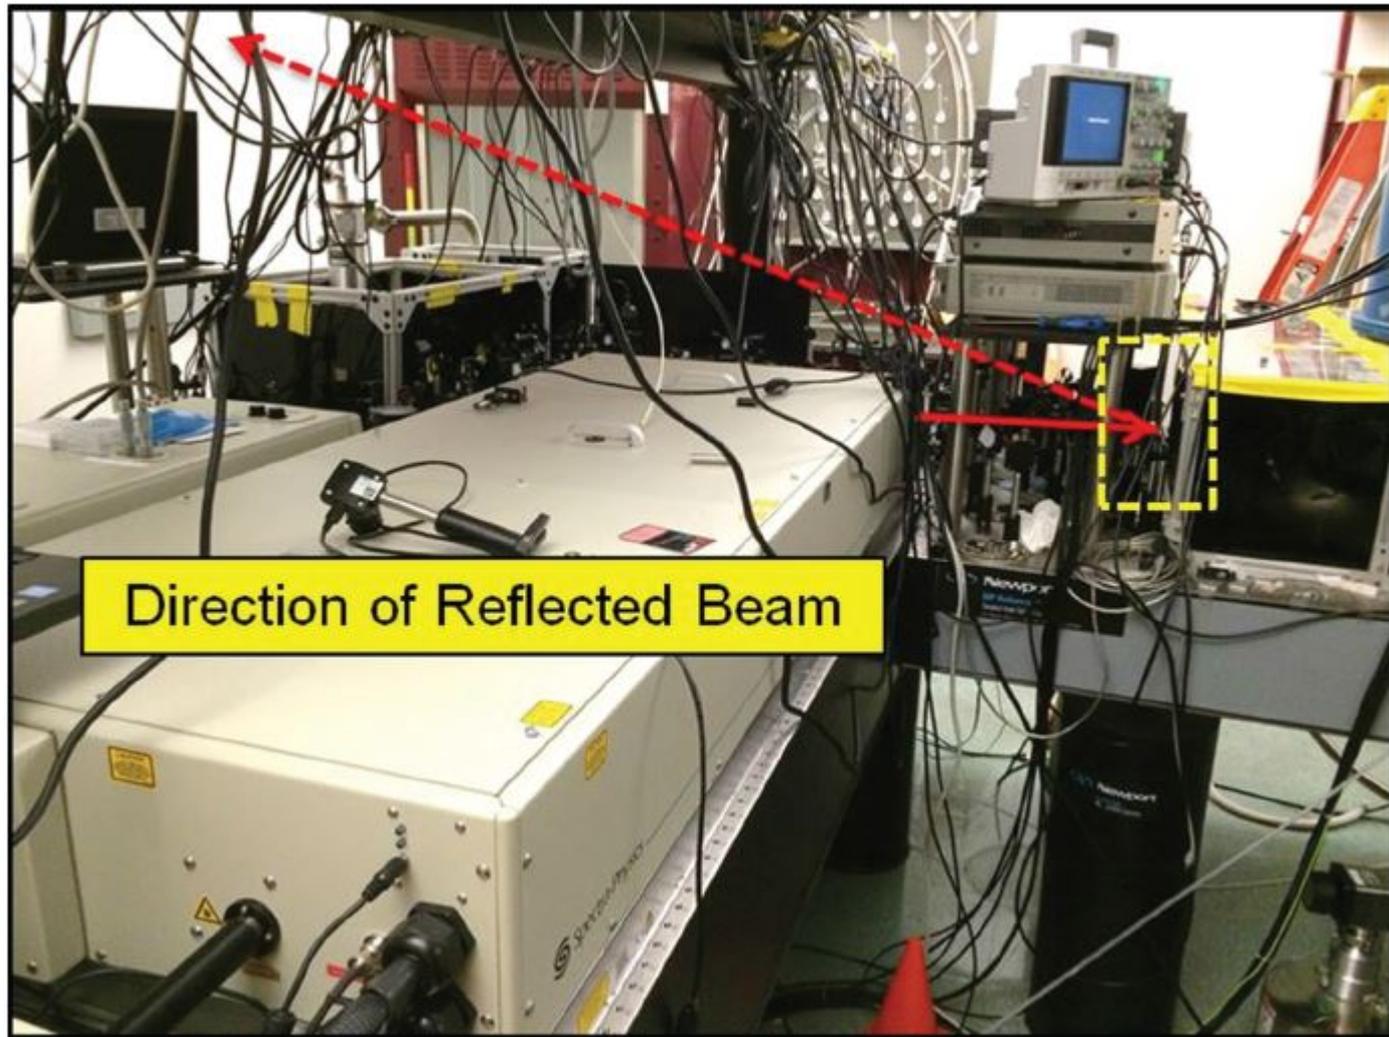
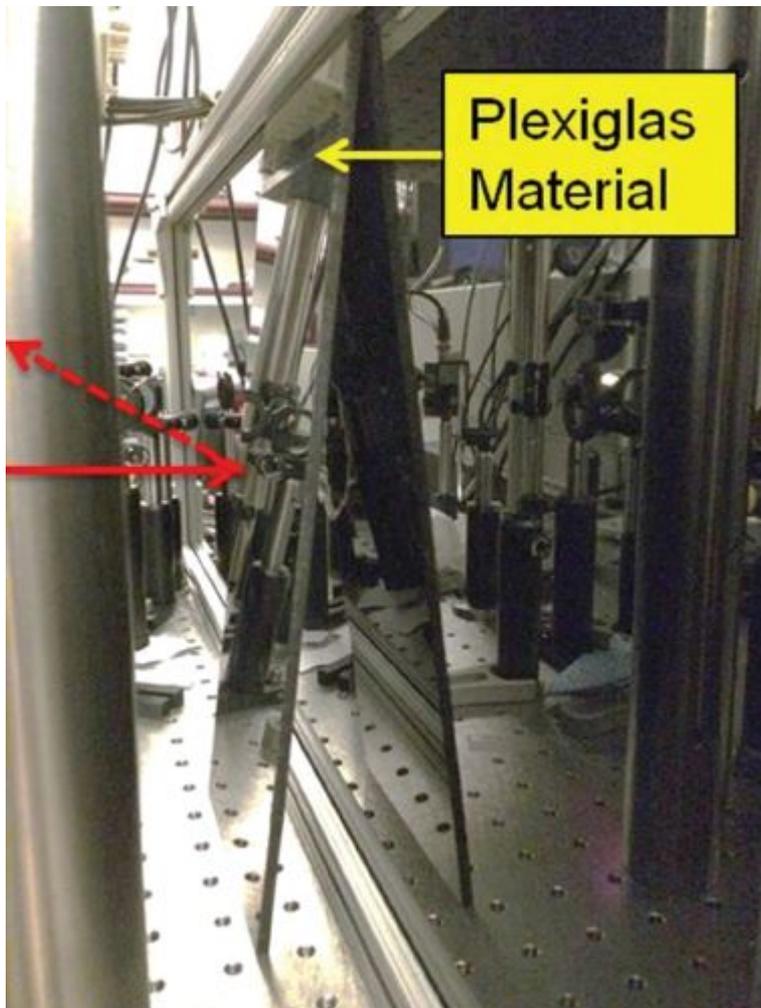
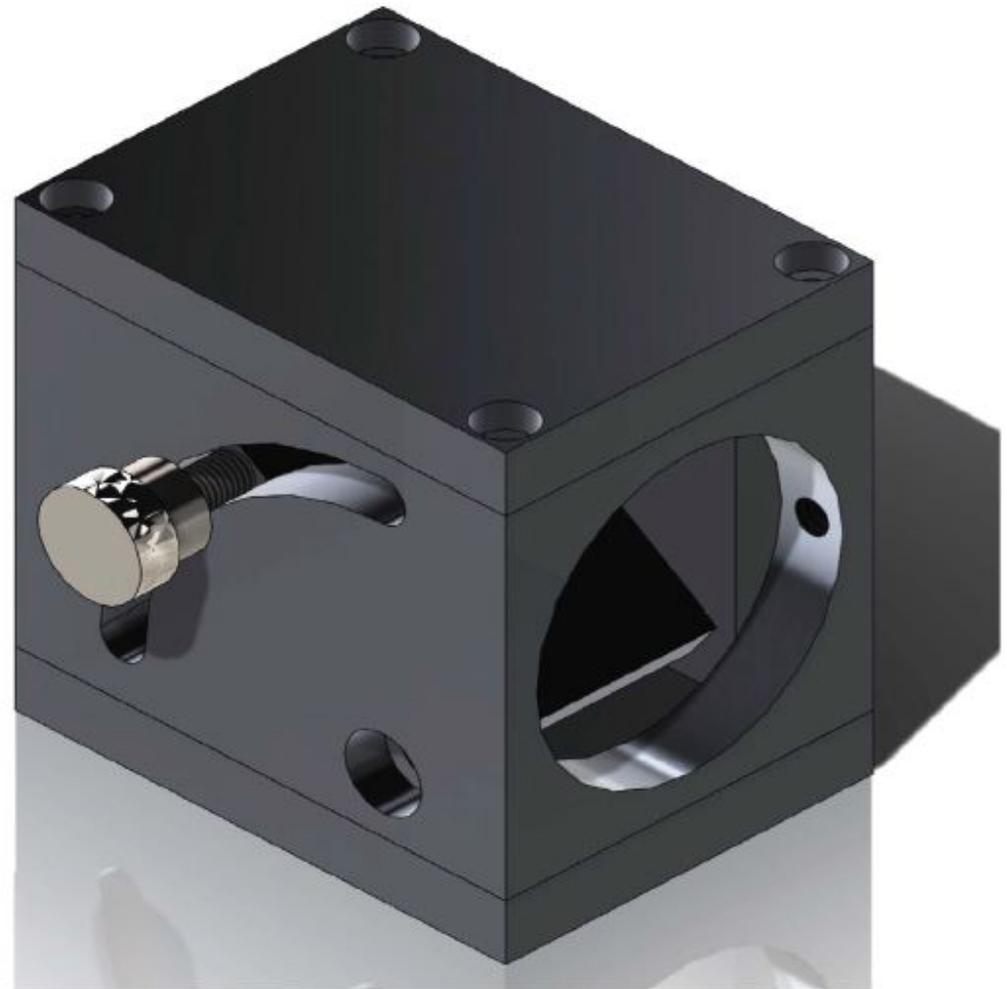
# Sandia National Laboratories – ABQ

- **LANL worker at CINT core facility in ABQ**
- **Worker aligning a Class 4 pulsed Ti-Sapphire laser**
- **Laser beam was split for two separate experiments**
- **Only one experiment was active**
- **Worker stepped onto a step ladder to read a micrometer inside the laser enclosure**
- **Lifted his eyewear to read the micrometer and saw a flash of light**
- **Used infrared viewer to locate the stray reflection from the other experiment**
- **Reflection from an angled opaque material used as a beam stop**
- **Later worker noticed a blurry spot in his vision**

- Evaluated by ophthalmologist
- Small spot of inflammation found

- **Insufficient communication between users**
- **Second beam active when not in use**
- **Inappropriate material for beam block**
- **Stray reflections not blocked**
- **Insufficient lighting for reading micrometer**
- **Worker removed LPE**

- **Assess suitability of beam control devices currently used**
- **Improve communication between laser users on multiple systems in same laser lab**
- **Communicate special activities, e.g. laser alignment, “dark” measurements**
- **Use team meetings, email lists, white boards for communication**
- **Laser operator responsible for terminating unused beams and blocking stray reflections**
- **Use appropriate beam control devices (nonreflective, properly placed)**
- **Provide additional lighting for low visibility tasks**
- **Do not remove LPE**
