NuMI Status

Jim Hylan / AD Target Systems Dept.

NoVA Collaboration Meeting

October 23, 2015

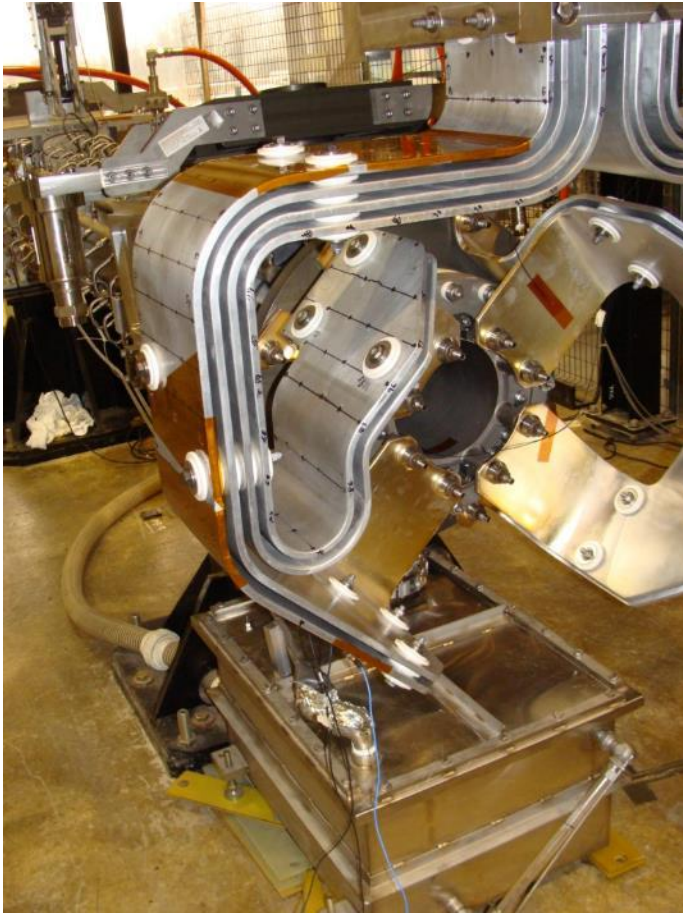
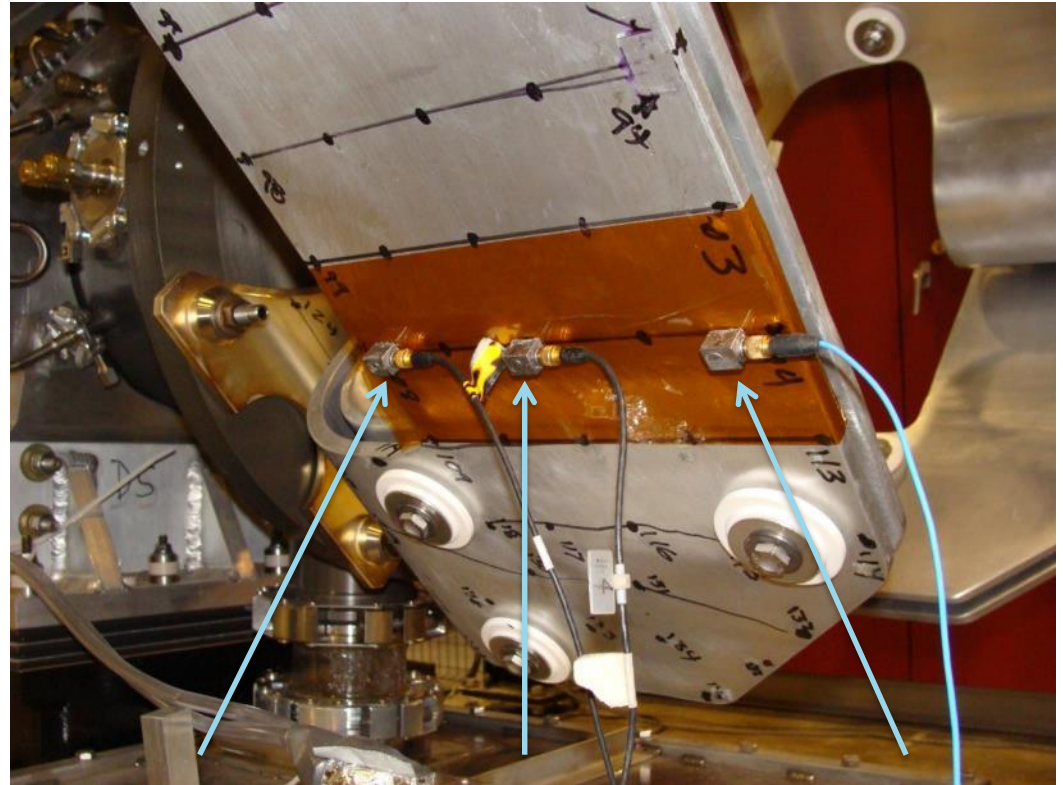
Horn strip-line vibration measurements

PH1-04 style strip-line has larger motion,
longer ring-down than PH1-03 style

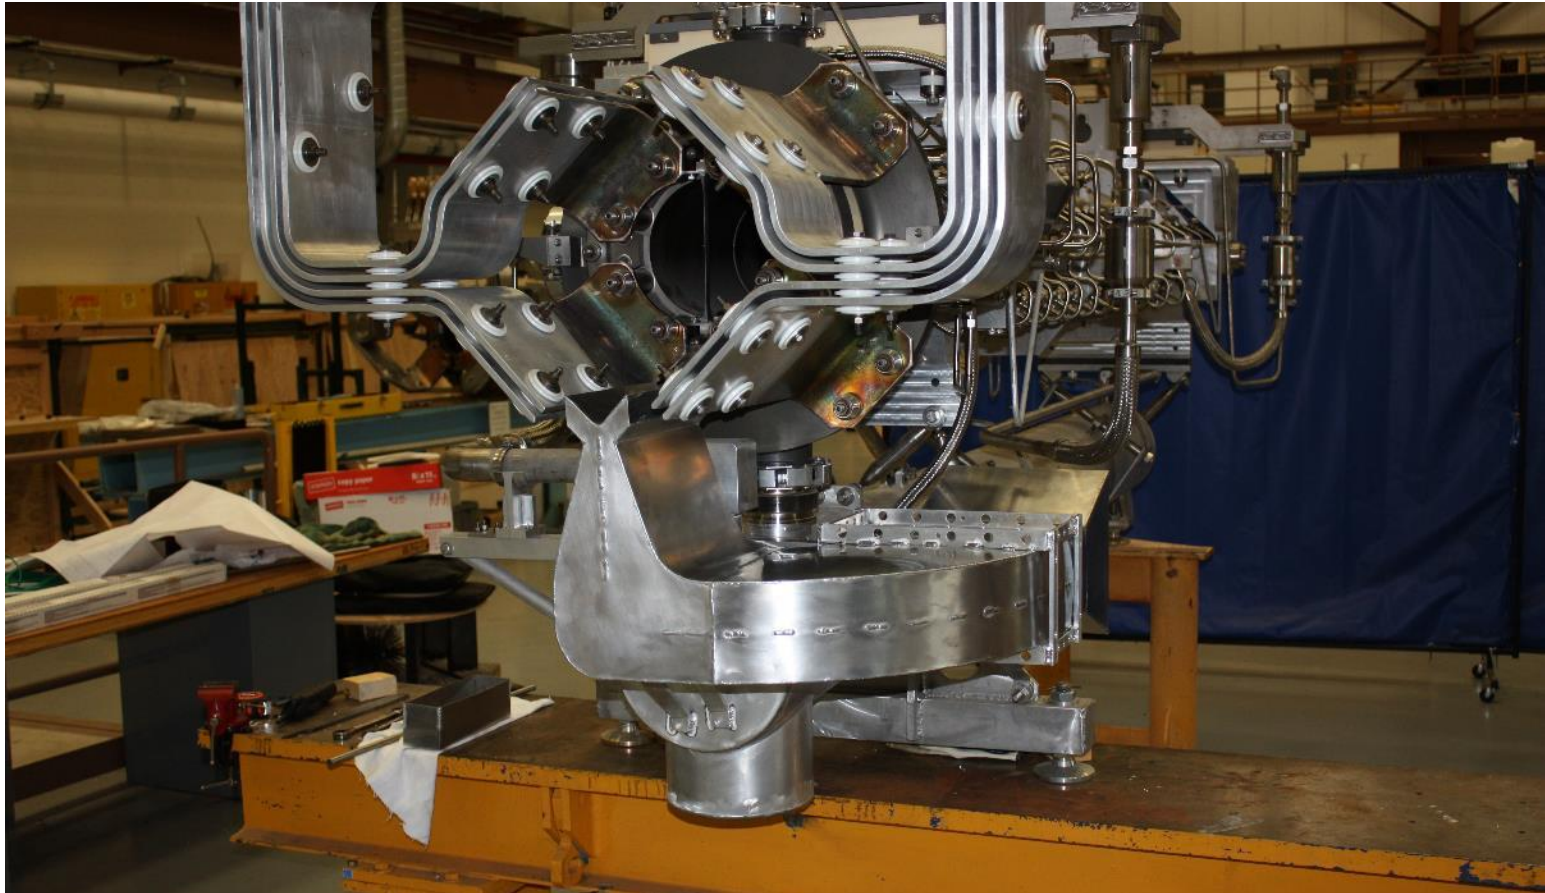
PH1-03 Modifications for higher beam power

- Air duct added (wind tunnel result)
- Al cross-hair replaced with Be
- Water cooling of DS flange added
- Bdot coils removed

- Based on modifications, wind tunnel tests, vibration tests:
 - *PRELIMINARY: May have some safety factor for 50 million pulses at 200 kA current and 700 kW beam power*
- Work is on-going, will be finalizing analysis this fall

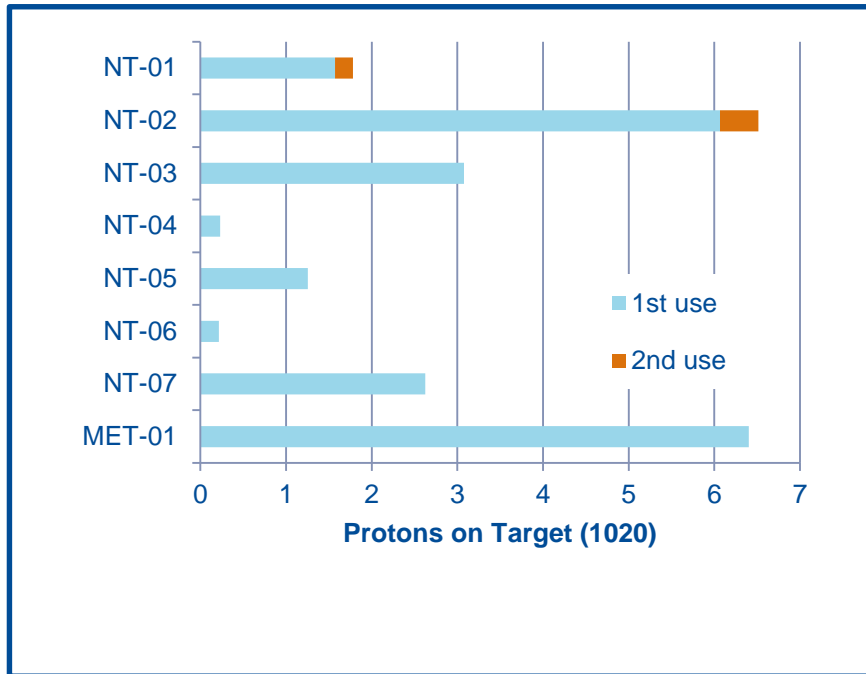
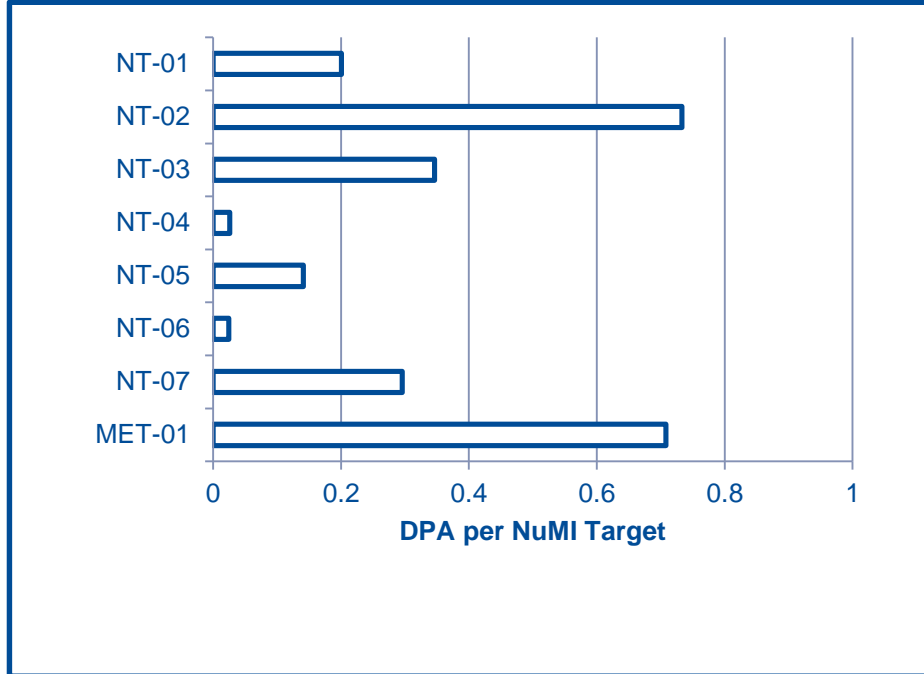
Target status: MET-01 is two years old

- MET-01 Exhibits No Sign of Neutrino Yield Degradation
- For Graphite, Significant Changes in Material Properties With $DPA > 1$

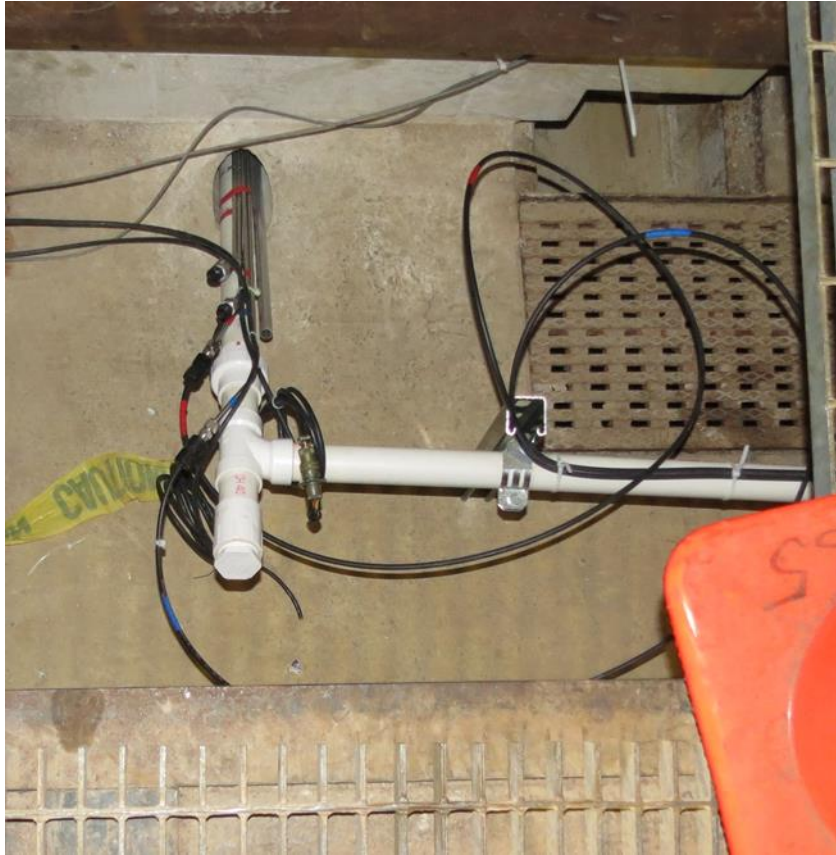
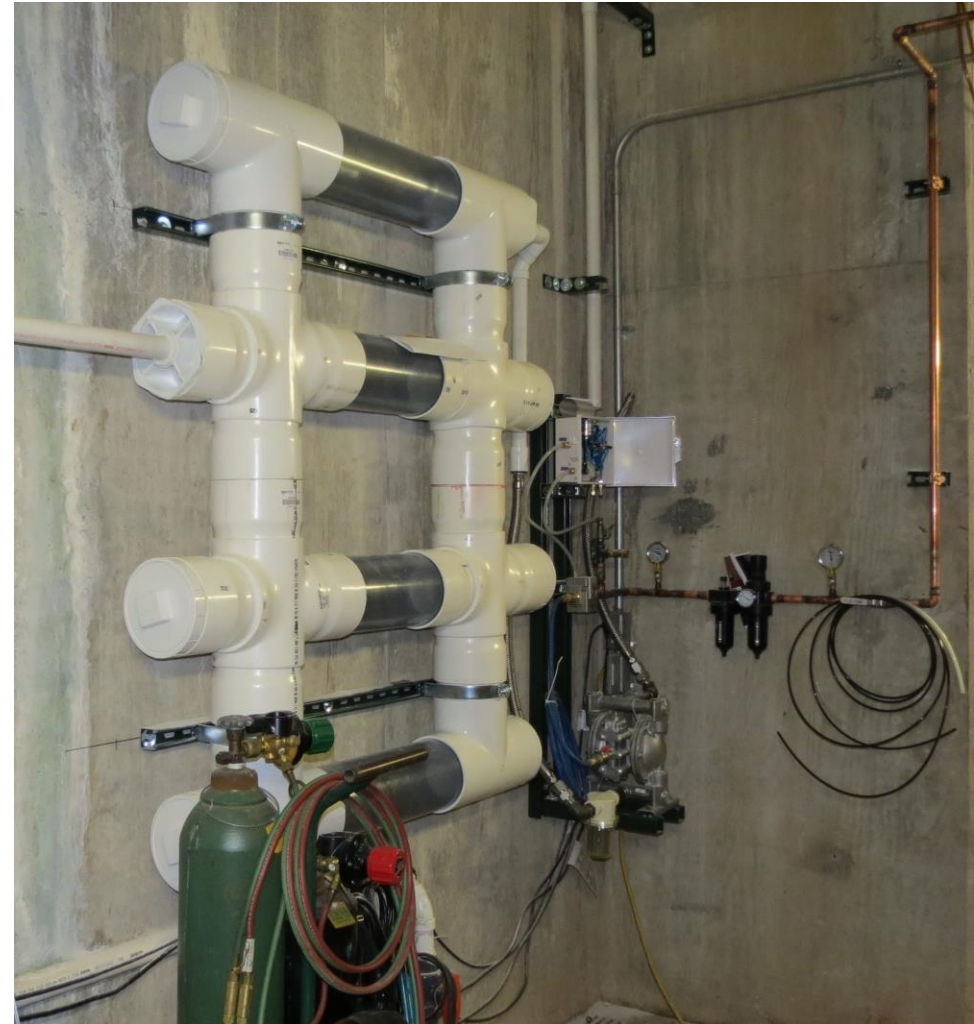
New sump pump system for cored hole

Sucks water from drain
through sediment settlement system
with pneumatic diaphragm pump.

Pump can be turned off remotely for vinegar injection.

- PH1-03 was tested, modified, and installed in place of failed horn PH1-04
- Target+baffle removed to allow beam scan of horn, then re-installed
- Profile monitors PM114, PM117, PMTGTL replaced
 - *PMTGT, used for normal beam monitoring, was NOT replaced*
- Leaking cooling coil in target pile air recirculation system replaced
- Dehumidifiers were refurbished, as done every shutdown
- Shielding at muon alcove 2 was upgraded
- New instrumentation added for air & water, aiding radiation containment
- Hole cored 11 feet to target hall under-drain, sump pump installed
- System installed to remotely inject vinegar into under-drain
 - doing weekly remote injection of 100 gal 12% vinegar to combat calcification

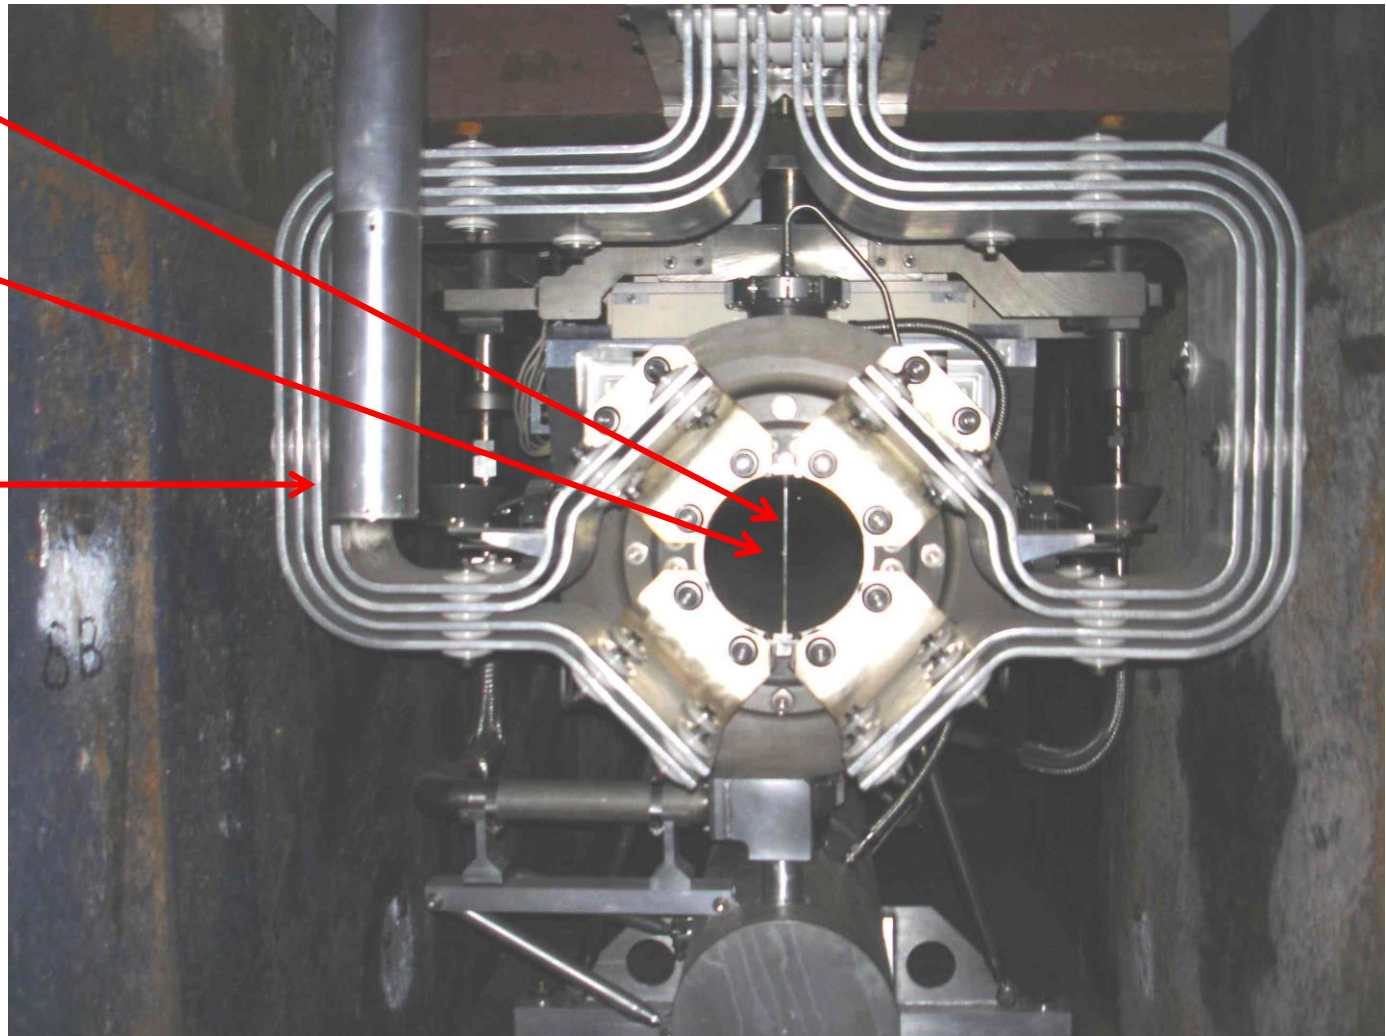
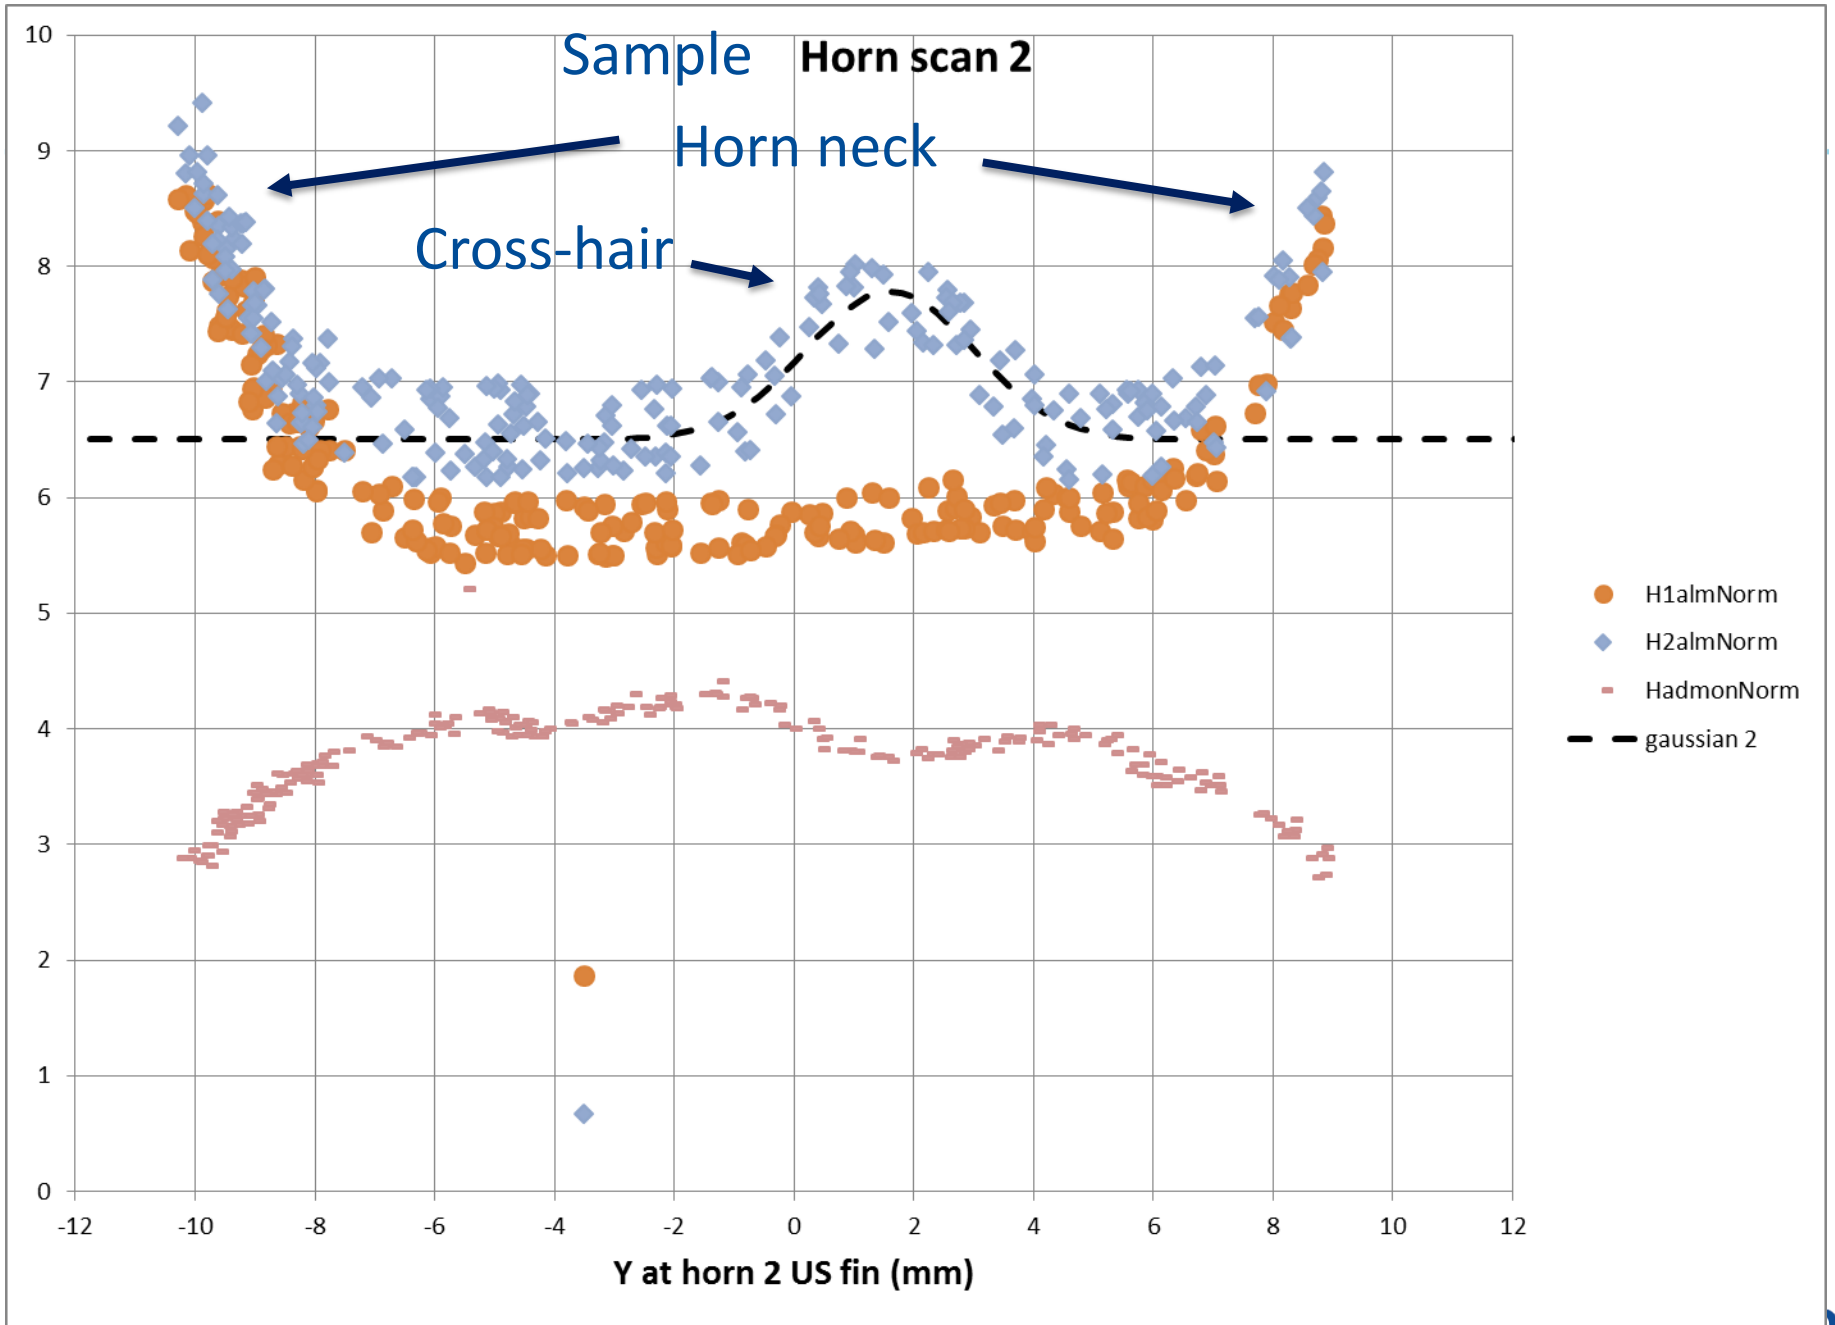
Horn cross-hair

Fin for beam
horz. alignment

Nub for beam
vert. align

Beam loss mon.
to detect beam
scatter from fin

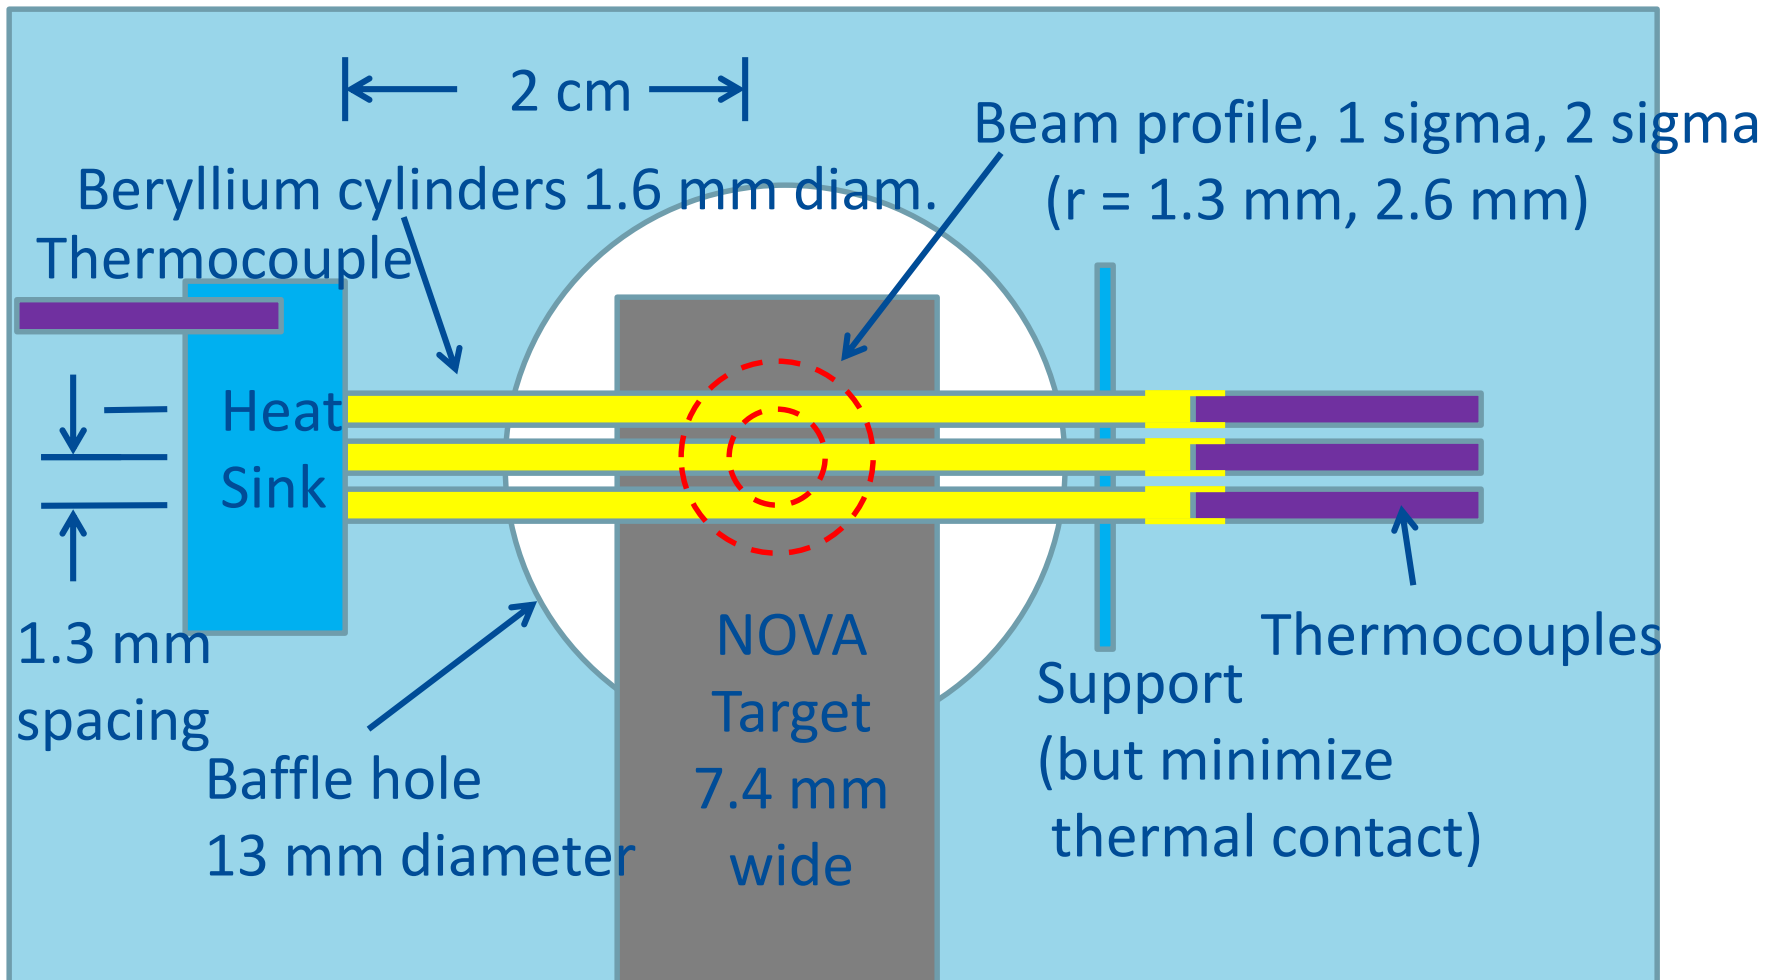
Concept of Target Vertical Position Thermometer

(not to scale; note baffle drawn behind target, although it is actually in front)
