# **35 Ton Run 2**

## **Operation and Experiences**

Fritz Schwartz

October 26, 2016

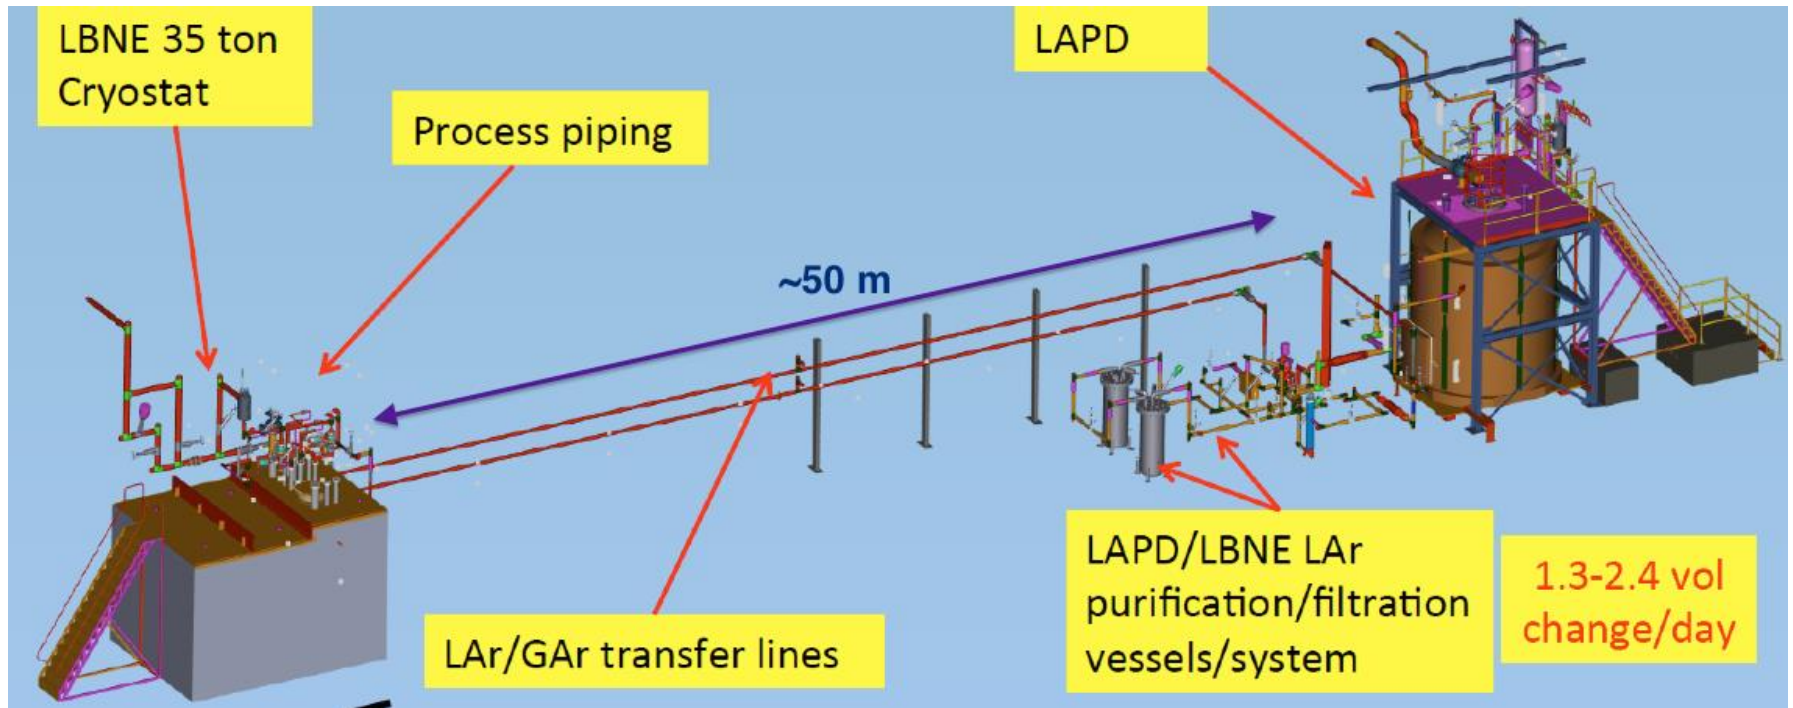
# Cryogenic System Overview

- System as installed in PC4 facility

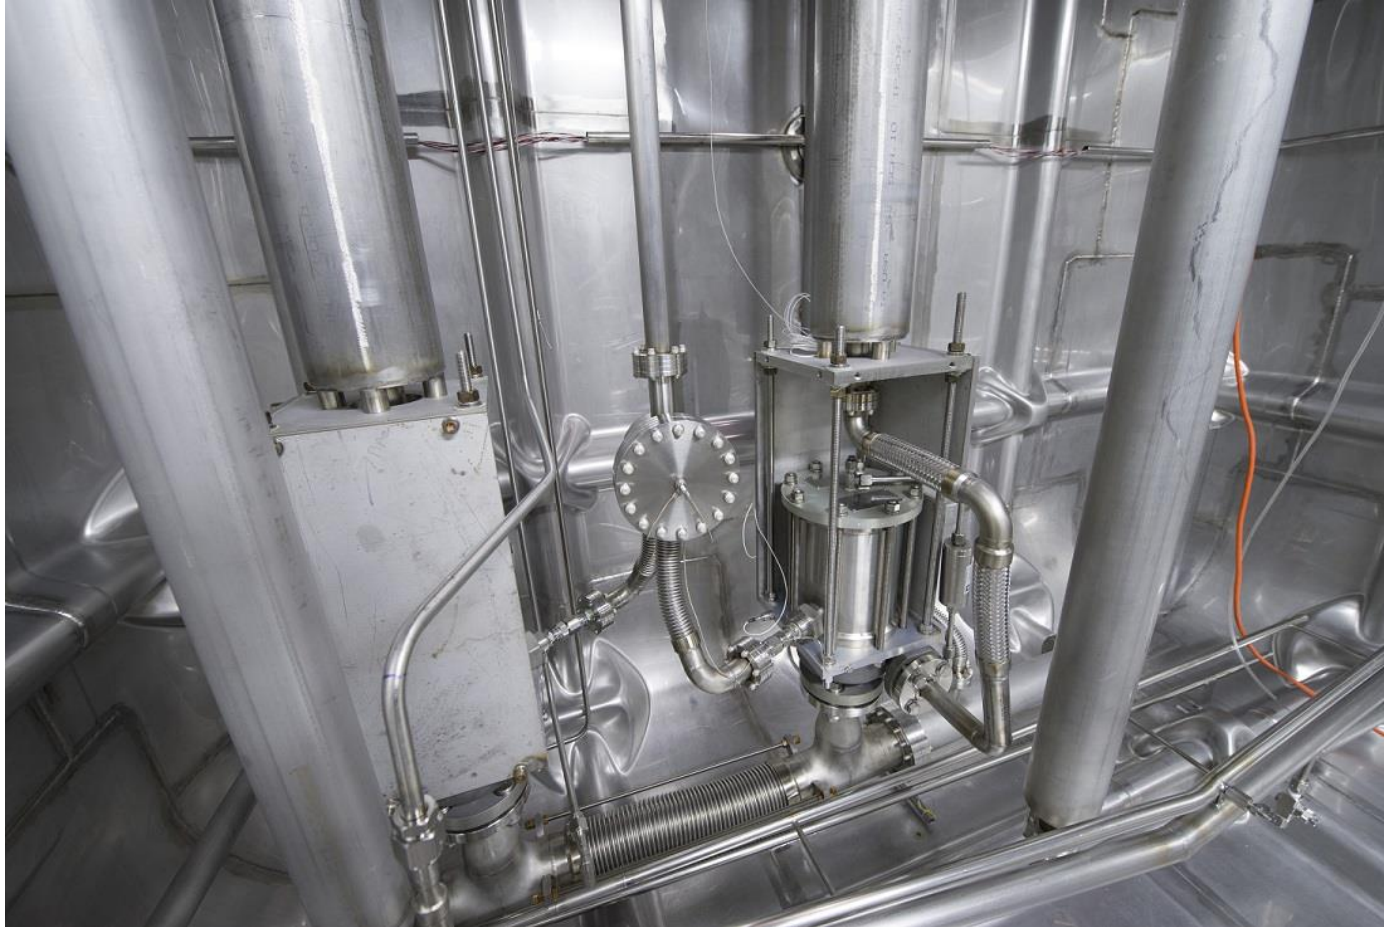
# Liquid Argon Pumps

- ACD submersible AC32 pumps

- With 35T cryostat completely filled, the submersible pumps were seized up and blowing fuses
- Pumps were rebuilt after Run 1, suspected that they were not tested prior to trying to operate them now
- Controls group bypassed fast acting fuses with disconnect fuses and installed simple ON/OFF switch to bump motor several times (momentarily ON, 1 minute OFF)
- The pump finally broke free after 12 repetitions
- Restored original wiring once pumps were freed

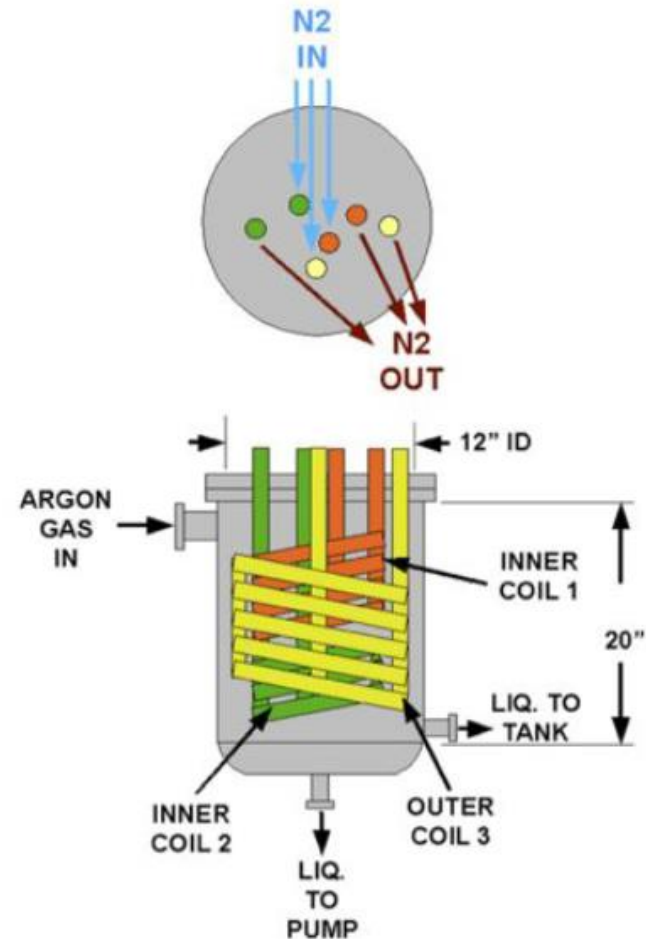
# Condenser Design

- Coiled tubing circulating liquid nitrogen
- Seamless tubing with connections outside vessel to decrease possibility of leak into cryostat argon
- Control valves regulate the flow to each coil depending upon heat load

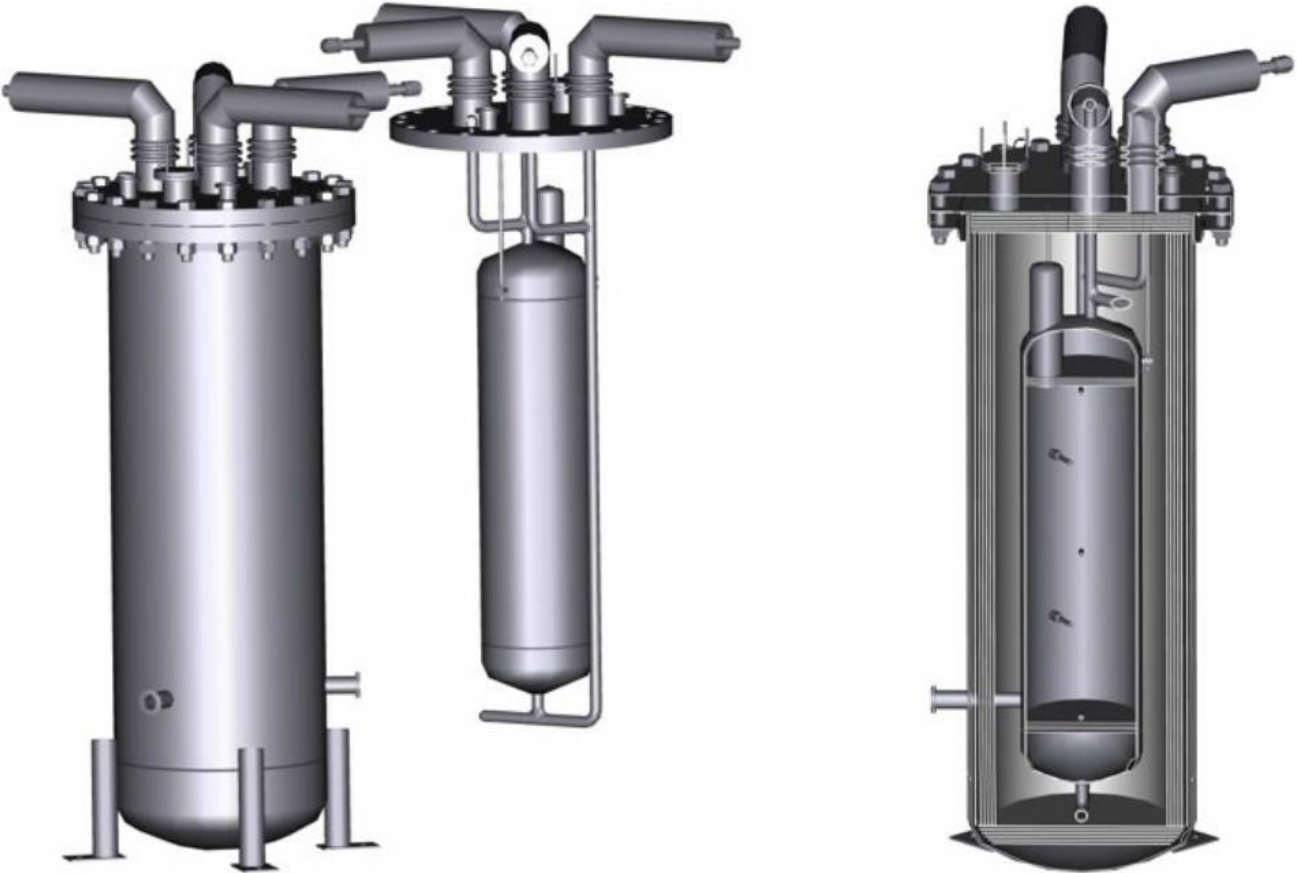
# Water & Oxygen Filter Design

- Water filter
  - ~80 liters 4A porous sphere molecular sieve
  - Regenerated using heated argon gas, followed by evacuation
  - Upstream of oxygen filter because oxygen filter also removes water
- Oxygen filter
  - ~80 liters of copper catalyst
  - A thin layer of copper on a high surface area alumina substrate
  - Regenerated using a heated mixture of hydrogen/argon gas which removes oxygen from the copper to form water, followed by evacuation
  - Capacity at LAr temperature is approximately 0.5g O<sub>2</sub> per kg of filter material
- Particulates
  - Sintered metal filters, large surface areas
  - Used to protect other equipment from debris

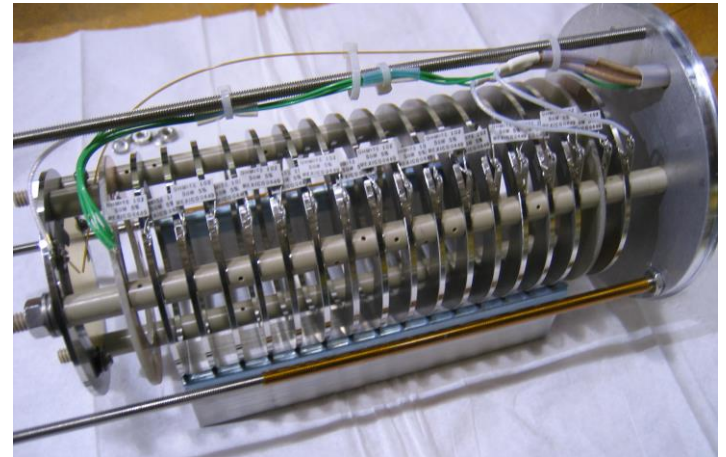
# Purity Monitoring

- Commercial/Laboratory Gas Analyzers
  - Nitrogen
  - Oxygen (3 with multiple ranges)
  - Water (Rough dew point and higher precision)
- Purity Monitor
  - Creates an electron drift using xenon flash lamp and photo cathode
  - In-line and cryostat installations

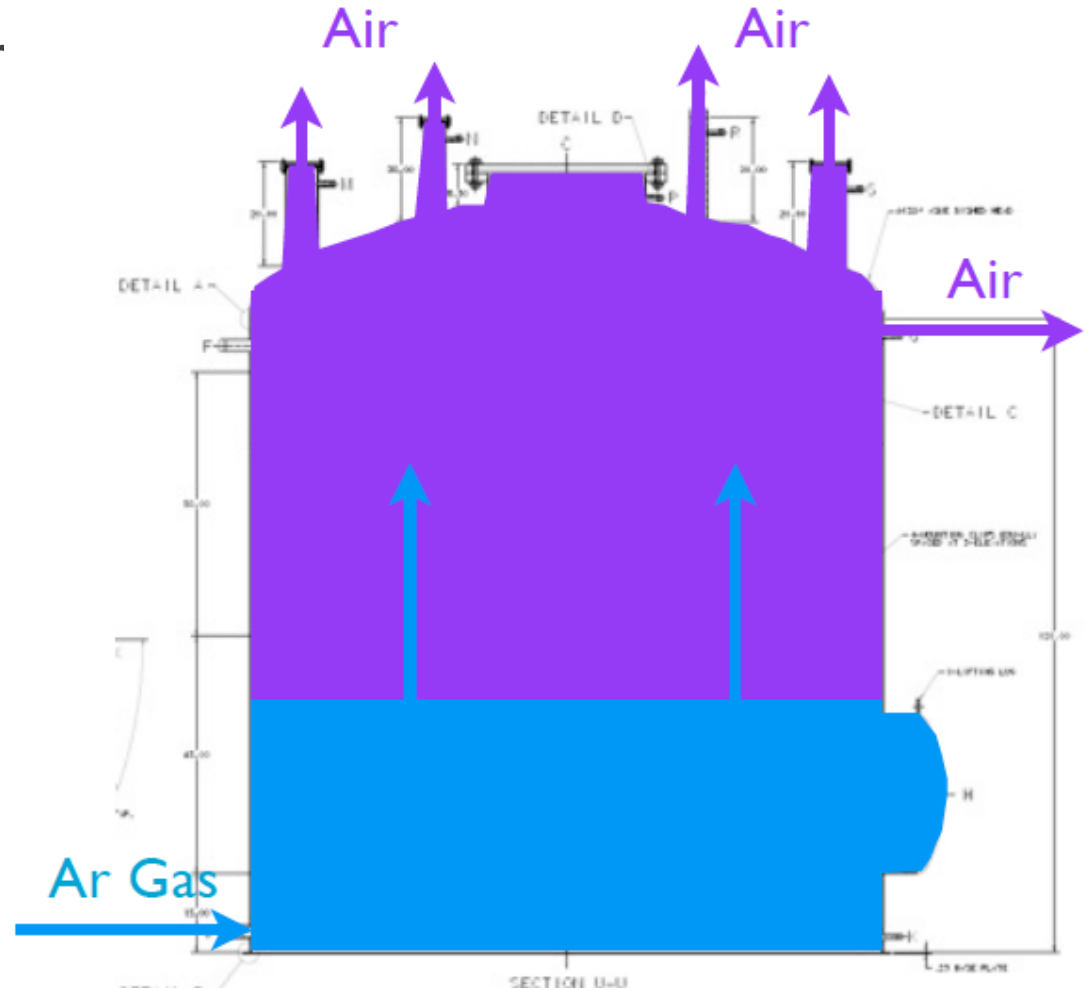
# 35T Piston Purge & Recirculation

- Using higher density of argon to push out other gases from bottom to top
- Vertical velocity of 1.2 meters per hour determined best to reduce mixing

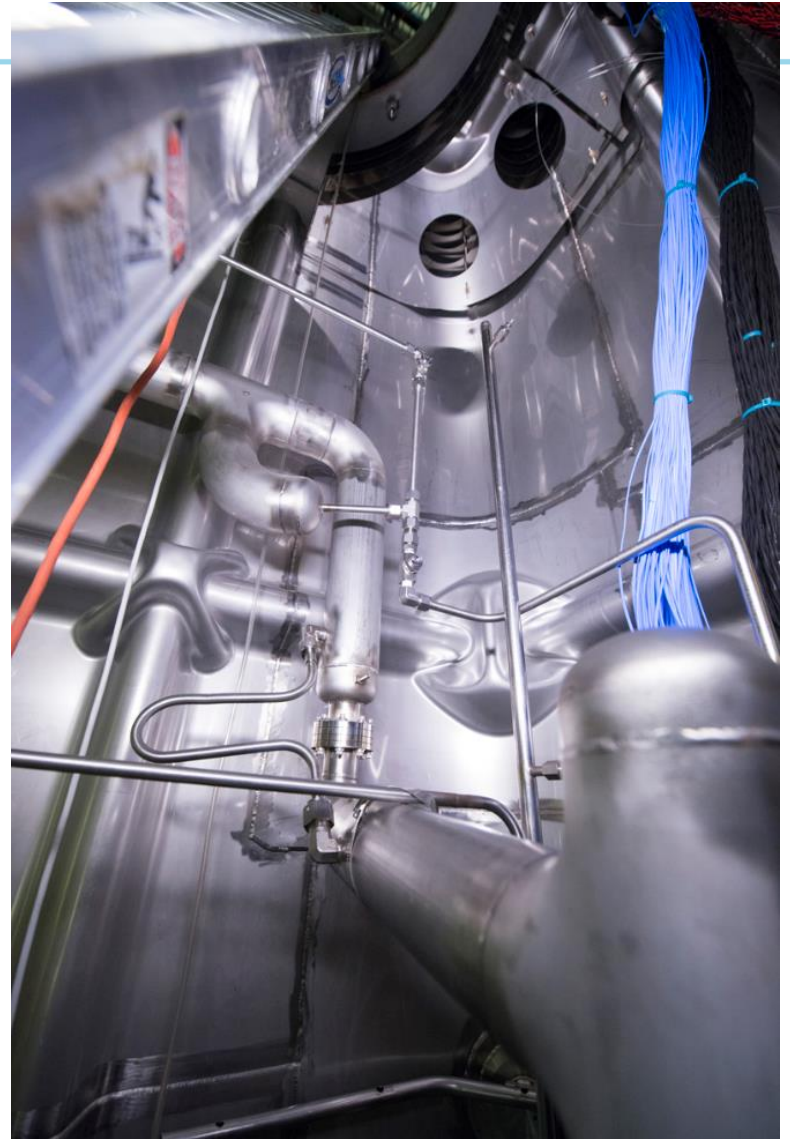
# Cooldown Sprayers

- Mix liquid and gas argon
- Additional nozzles provide necessary momentum to circulate flow around volume of cryostat
- Design rate of 10K/hr supplied by cryostat manufacturer

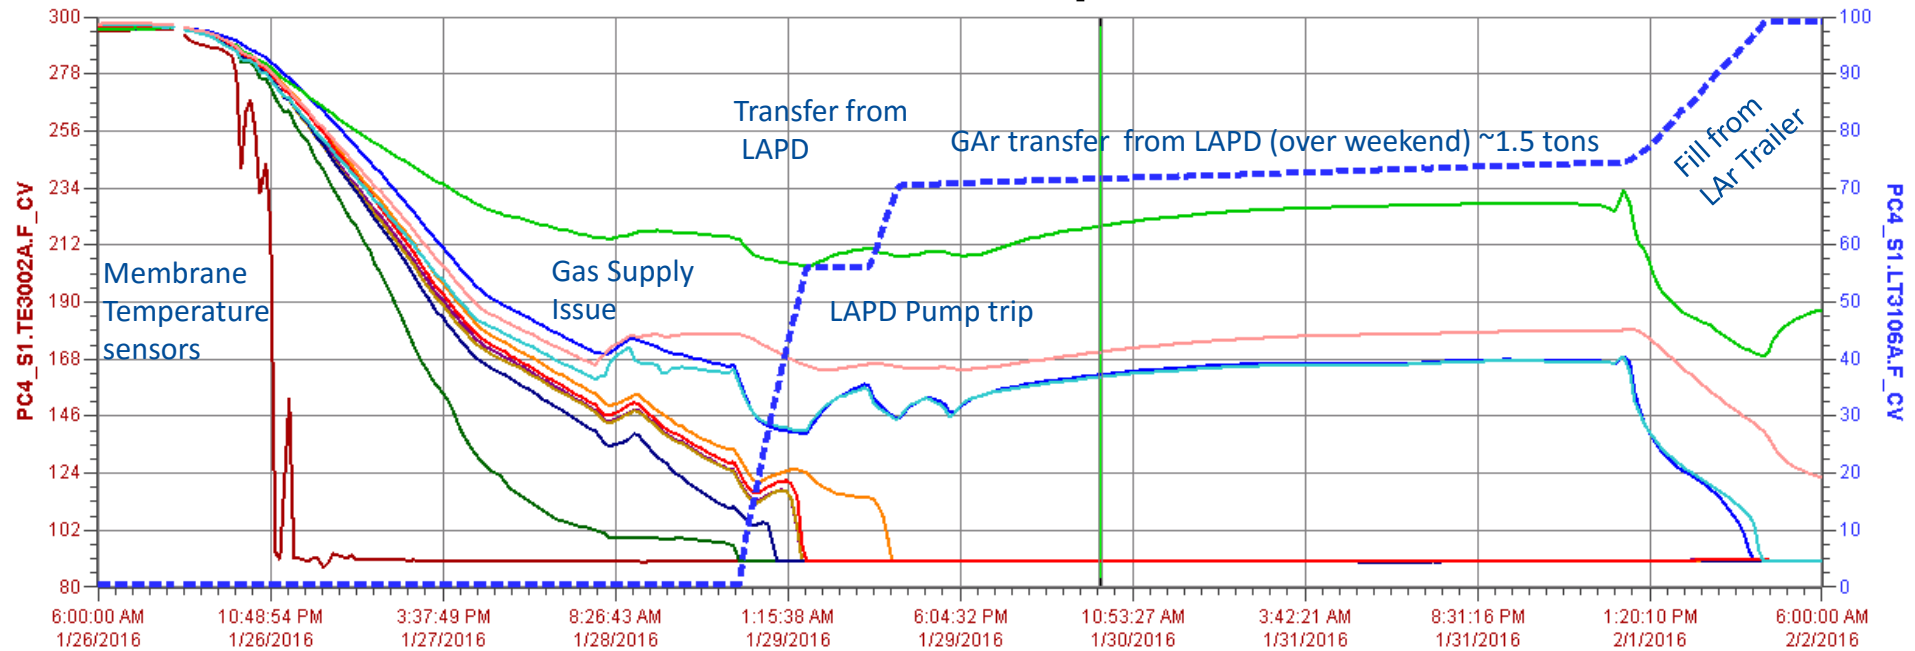
# Cooldown and Fill of 35T

Membrane RTDs and LAr Level during Cooldown&Fill

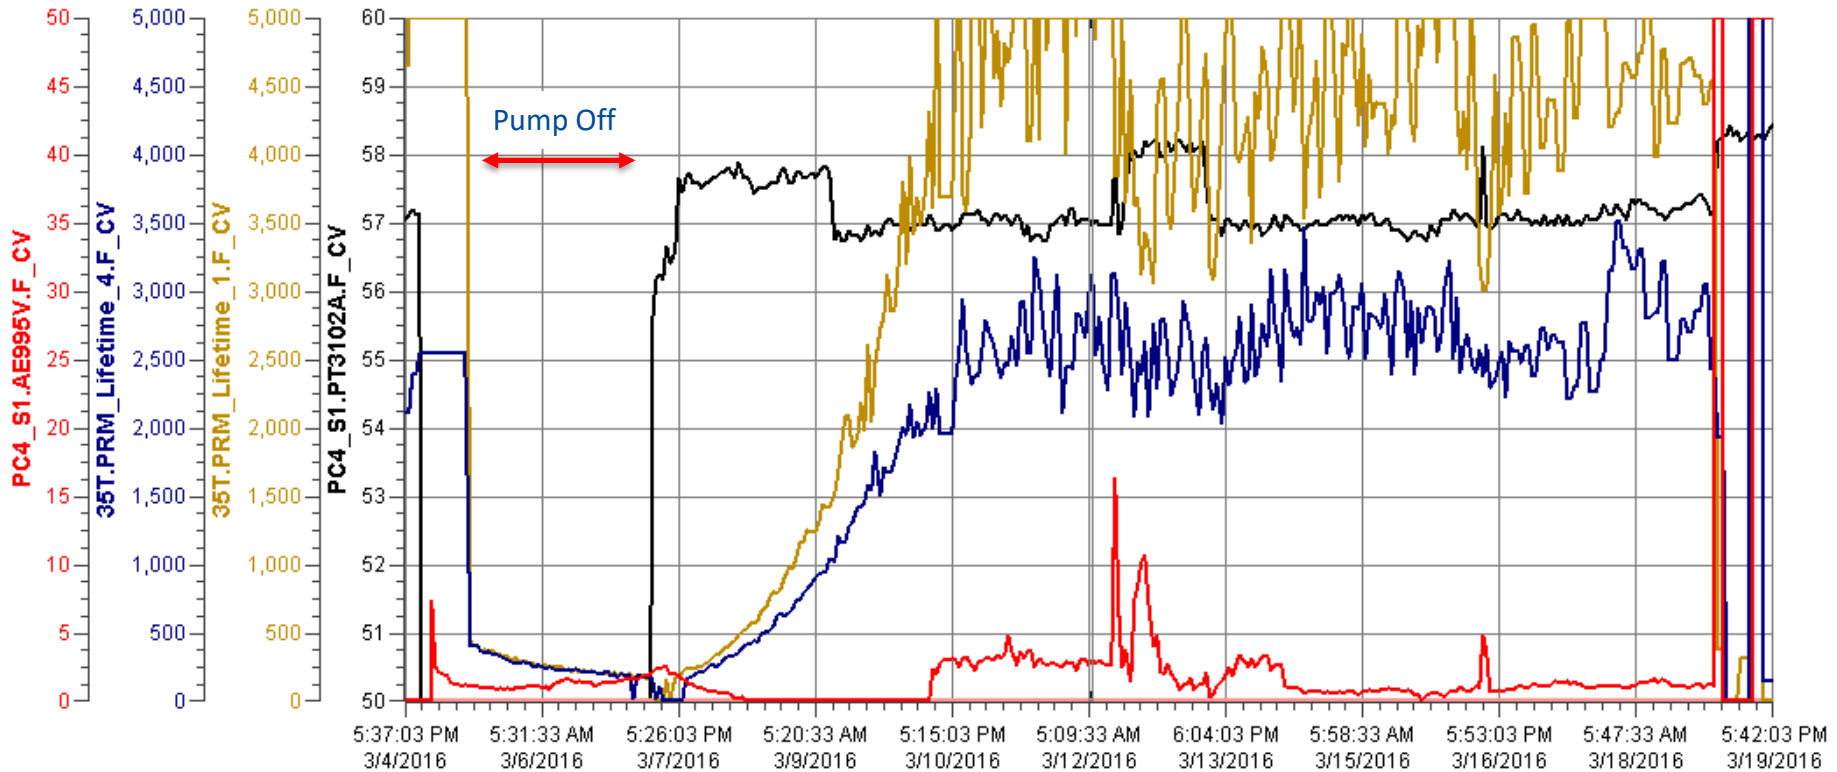
# Power Outage

- The power outage provided an opportunity to identify purity gradients within the liquid

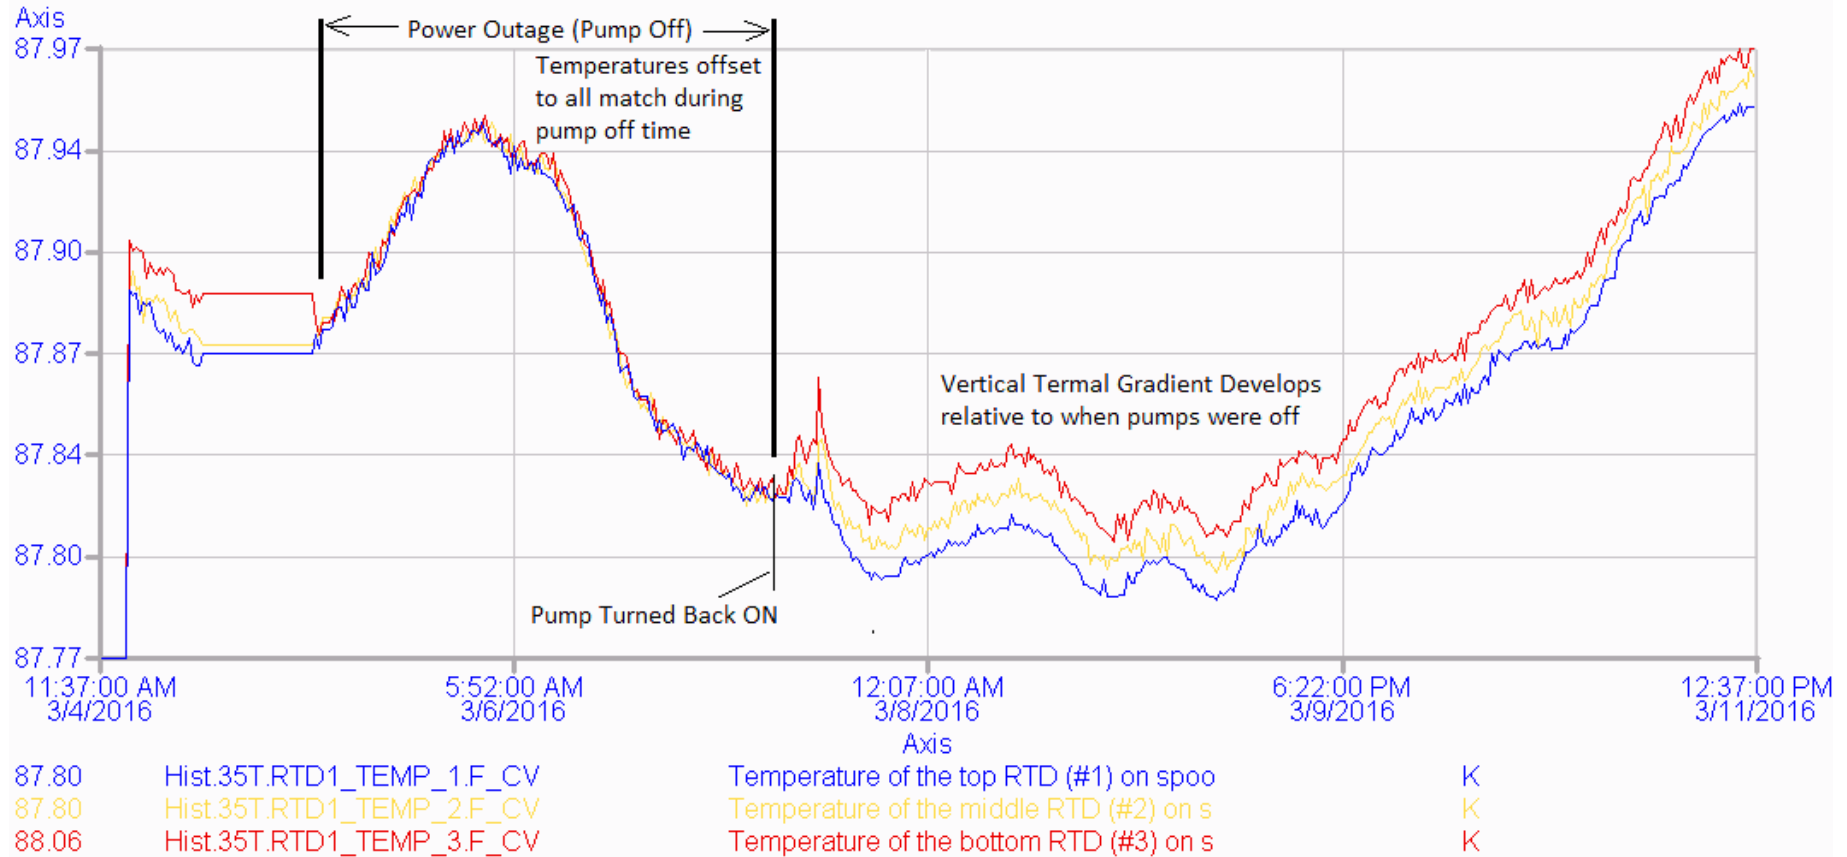
# Power Outage

- Small thermal gradients were also noticed

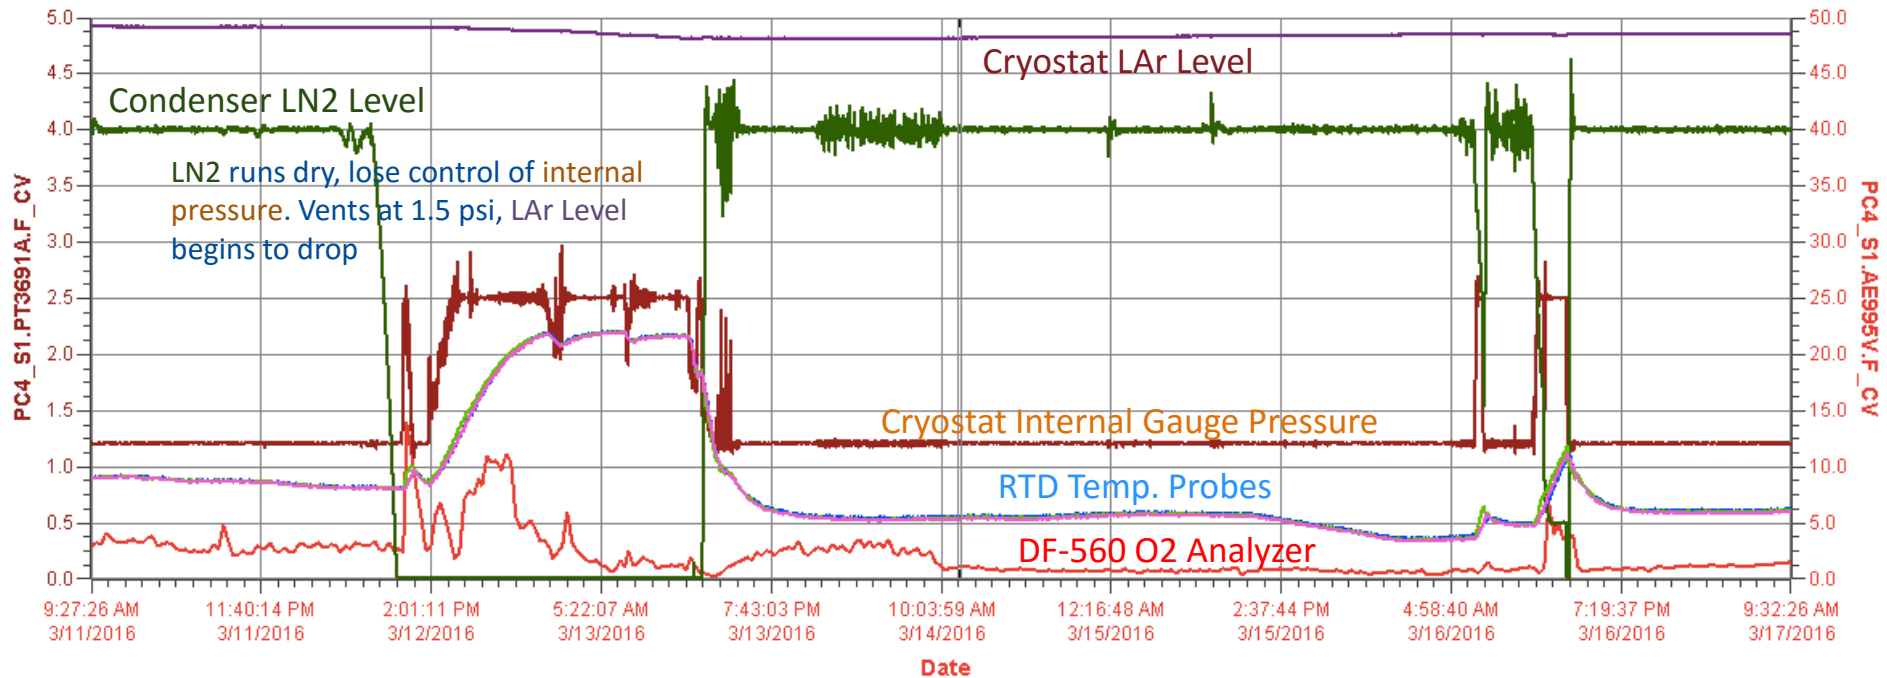
# Loss of LN2 Cooling

- Loose valve plug on LN2 supply line

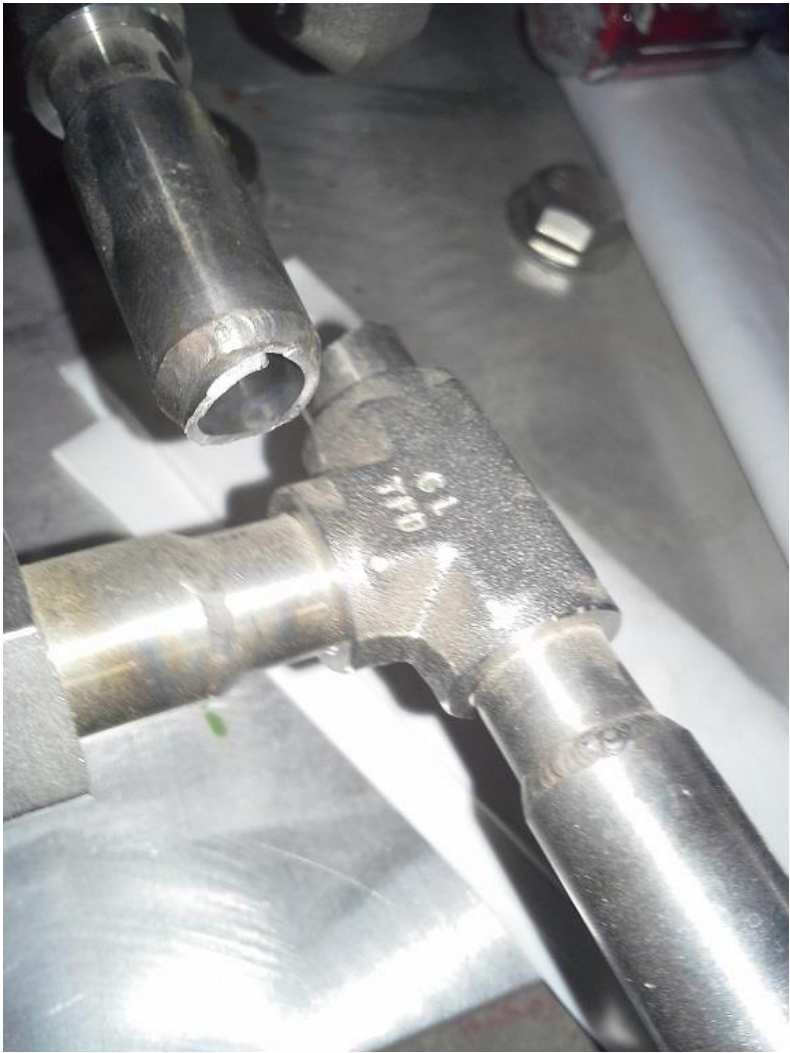
# Vapor Pump Failure

- Gas analyzers sampling from ullage space
- Filters saturate, see response from analyzers within 20 minutes
- Complete loss within 30 minutes...ending the run

- A panel was formed to investigate the failure of the pump
- Conclusion was that design was done to acceptable codes and standards, also considering the short expected runtime
- Panel suggested that analyzers be installed at locations where contamination can be caught prior to entering cryostat
- Location is likely to be at liquid return line to cryostat where nitrogen (or oxygen) analyzer can be utilized
- Upon detection of impurities, controls need to isolate cryostats – total shutdown mode
