Study of vacuum RF Breakdown in 805MHz pillbox cavity in strong magnetic field

Alexey Kochemirovskiy
The University of Chicago

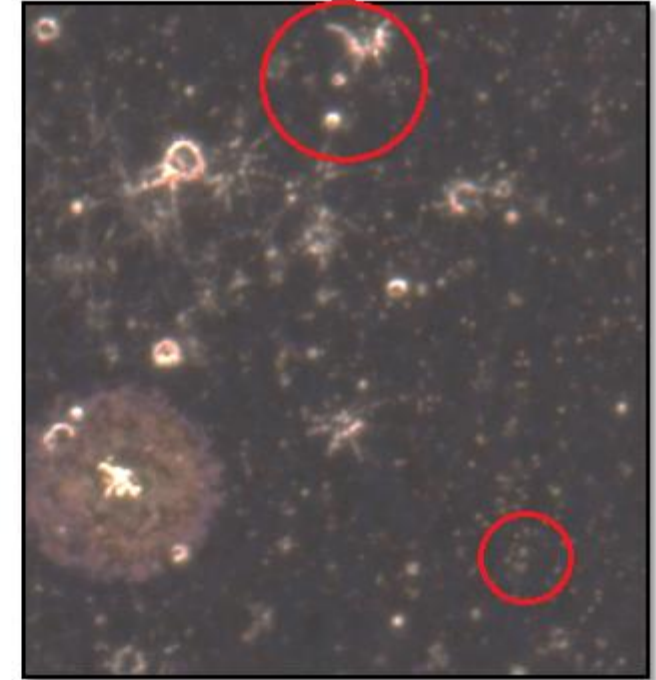
No new damage sites observed
Some splashing traces disappeared

After

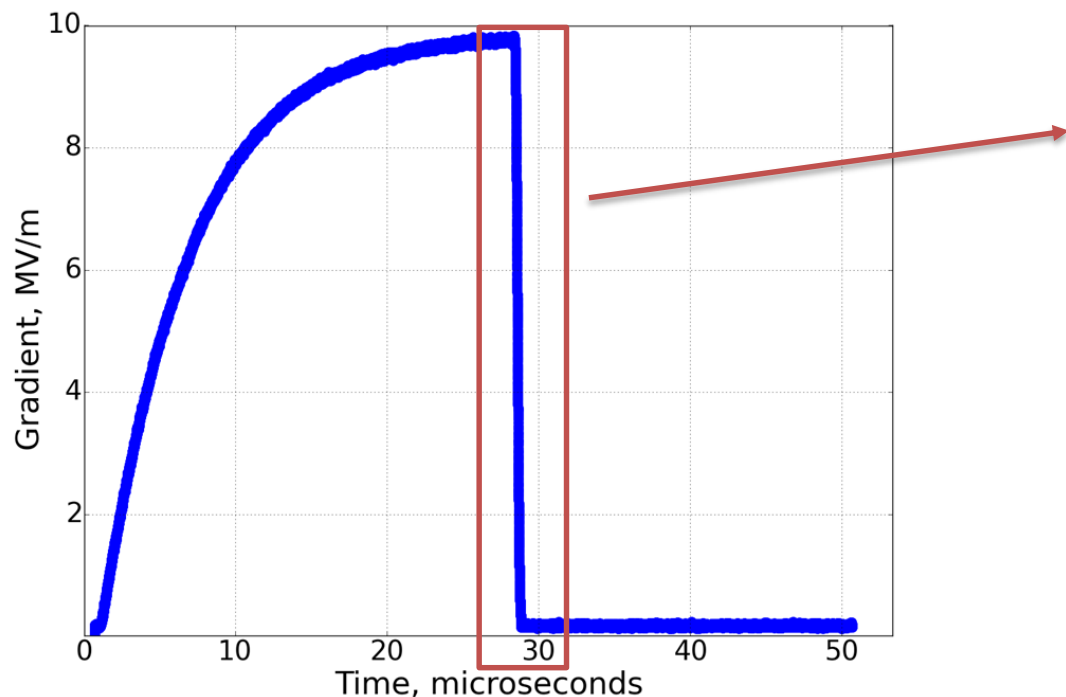
Envelope of pickup signal during breakdown event
