Construction of the Phase 1 Upgrade of the CMS Pixel Detector

Maral Alyari
on behalf of CMS Collaboration

DPF 2017

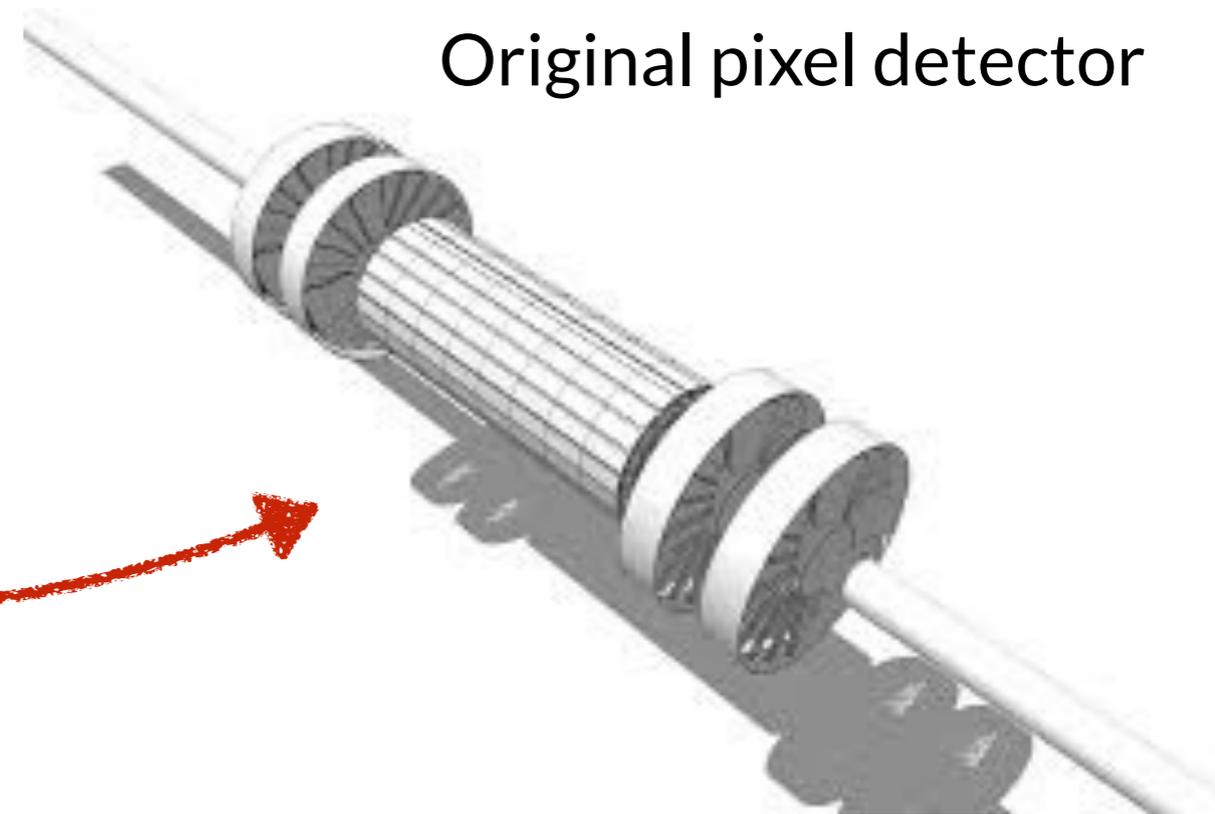
Original pixel detector

- The original pixel tracker of the Compact Muon Solenoid (CMS) experiment is:
 - The innermost CMS sub-detector (closest to the collision point)
 - Used for reconstruction of the tracks and vertices of charged particles

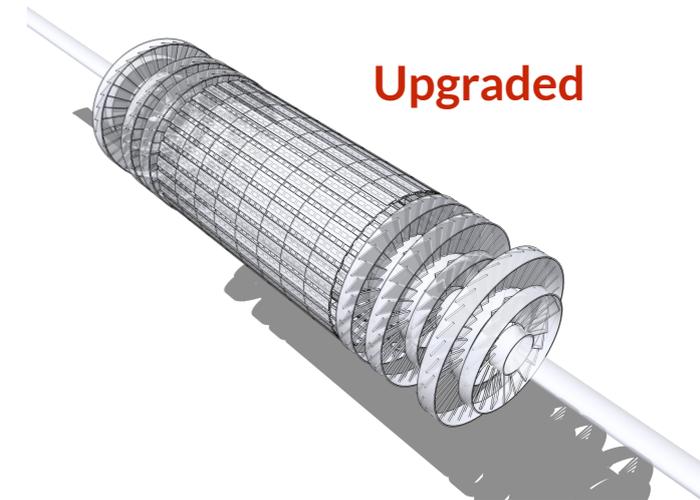
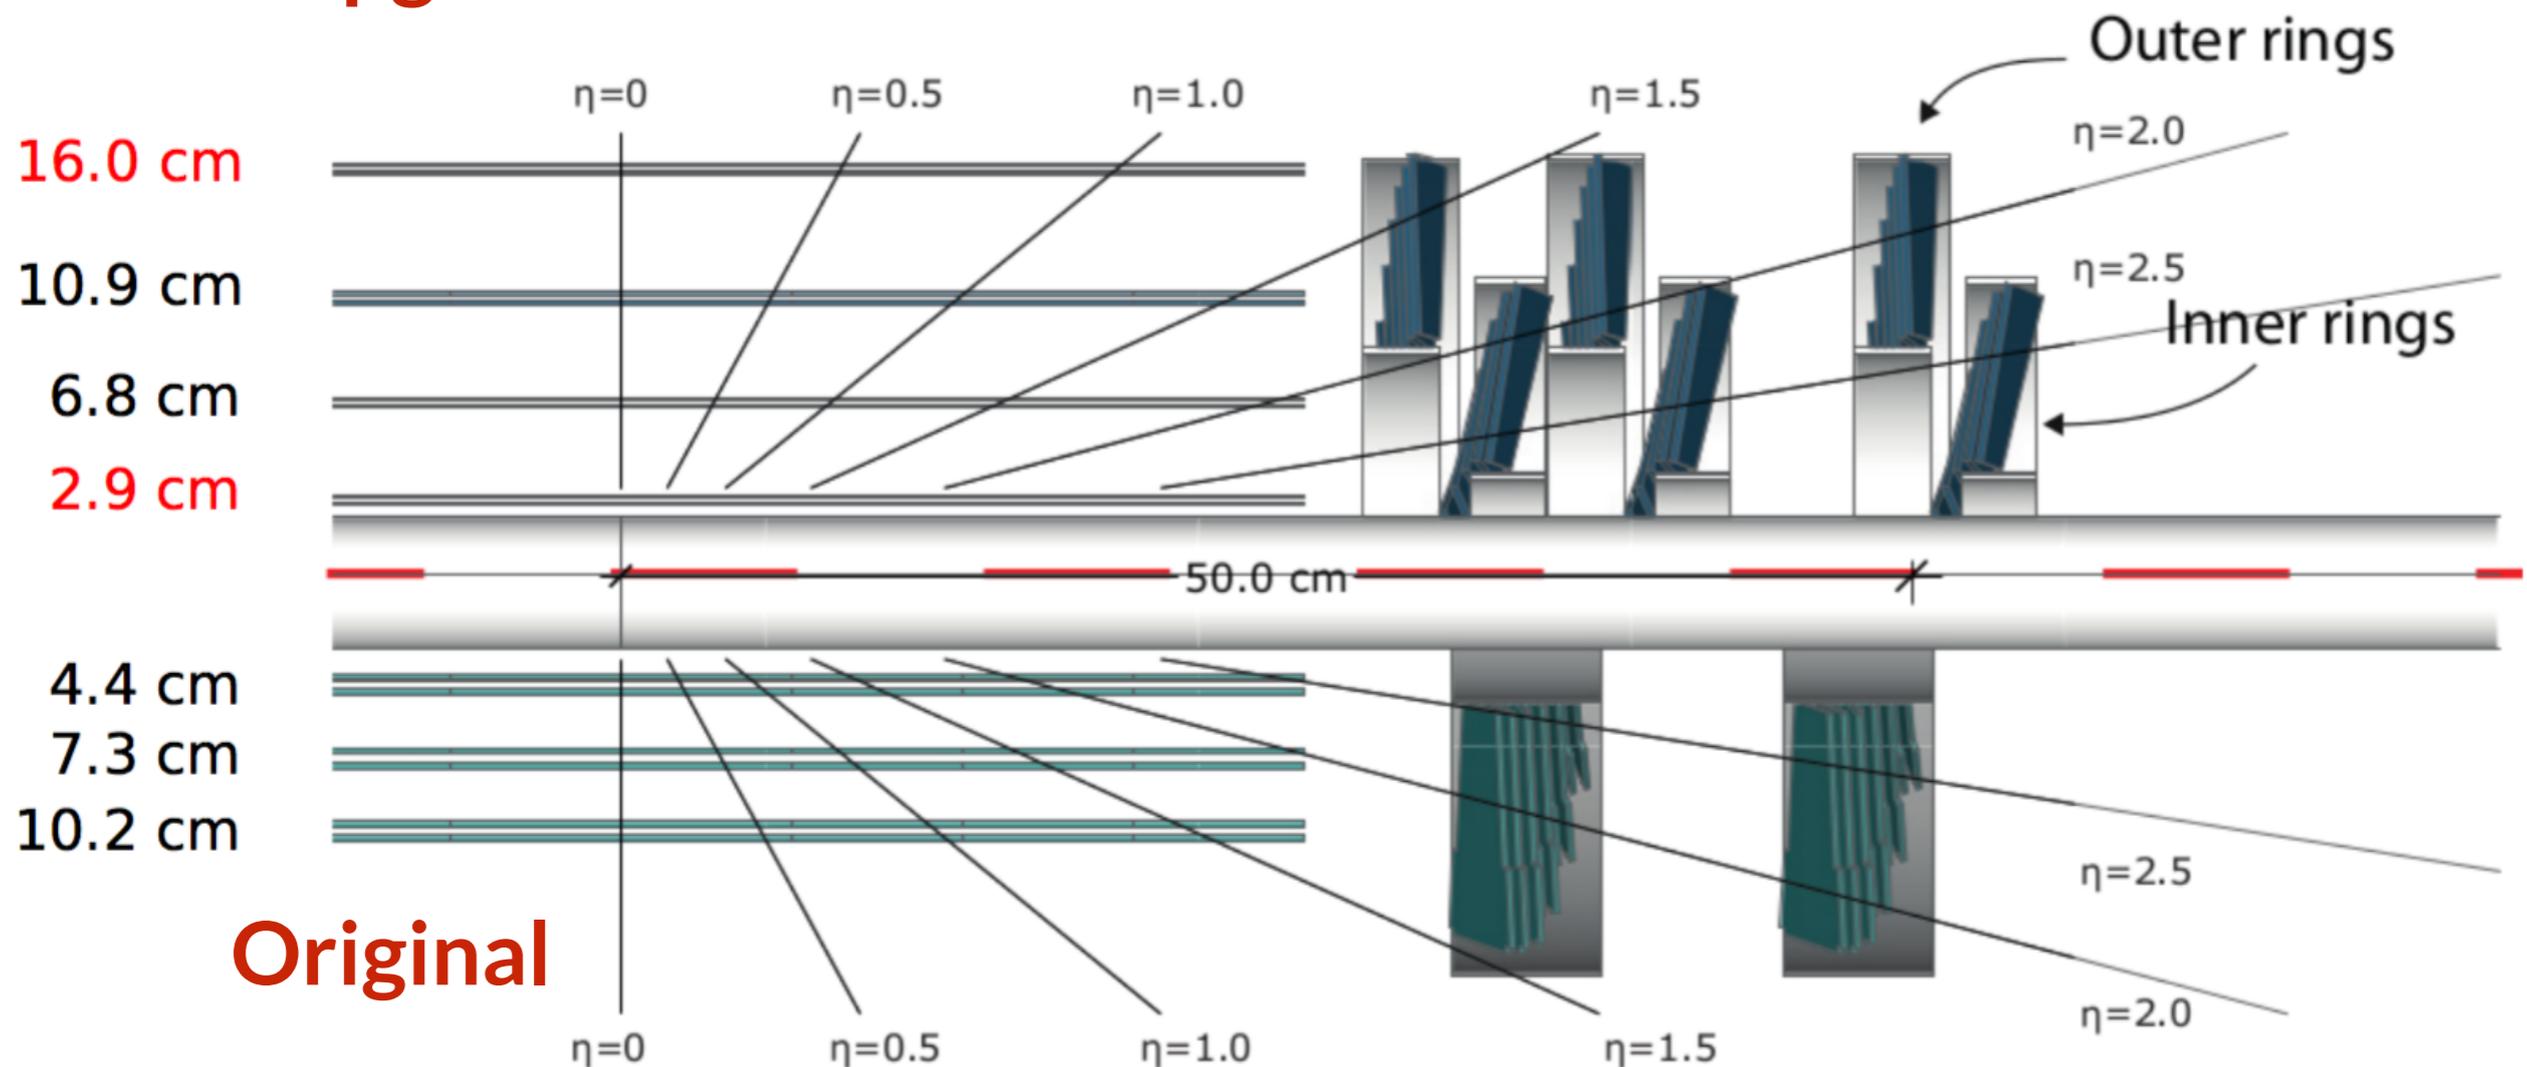
Upgraded Pixel Tracker Layout

- One additional barrel layer and forward disk
- Inner most layer moved closer to the interaction point
- Outer most layer moved further from the interaction point

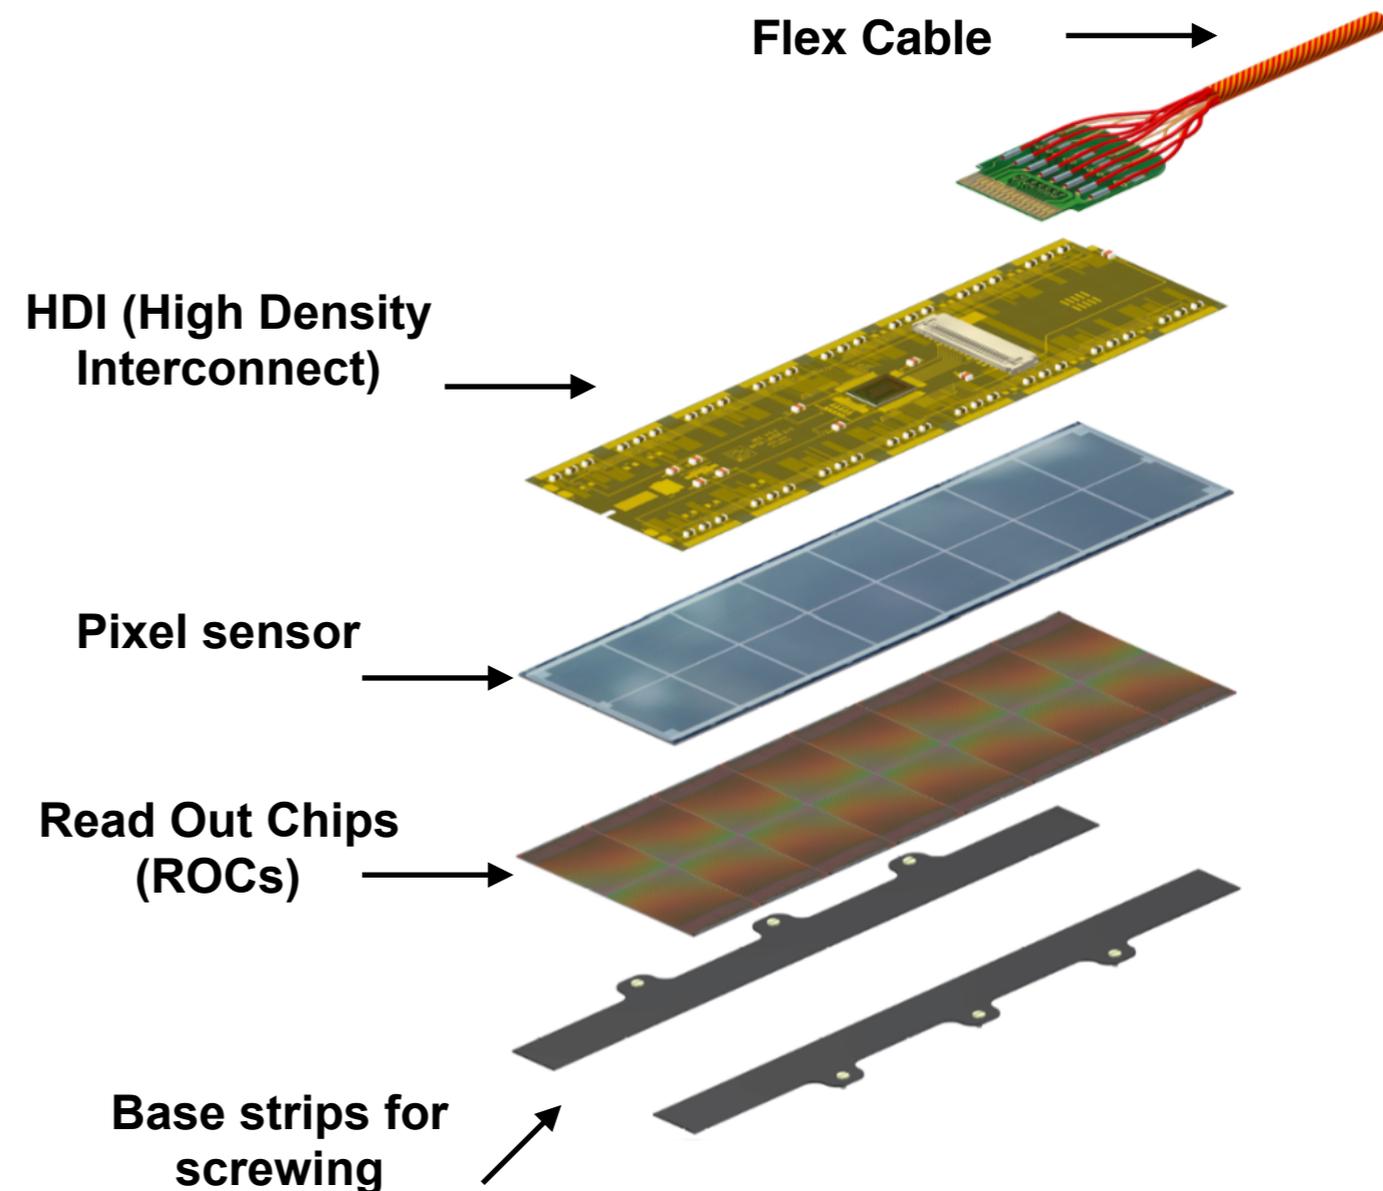
New Sensor Modules and Readout Chips

- Upgraded sensor and module design:
 - 285 μm thick n⁺-in-n silicon sensors (same as original)
 - 100x150 μm^2 pixel size (same as original)
 - Only one sensor geometry through entire pixel detector
 - 2 × 8 readout chips (ROCs) per module
- New faster digital ROCs are used
 - 40 MHz analog -> 160 Mbit/s digital
- Module readout bandwidth increased by a factor of 8
 - 40 Mbit/s -> 320 Mbit/s

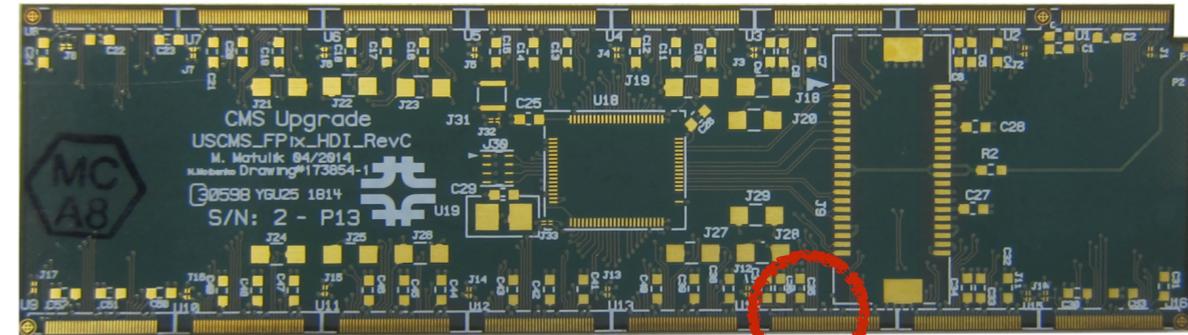
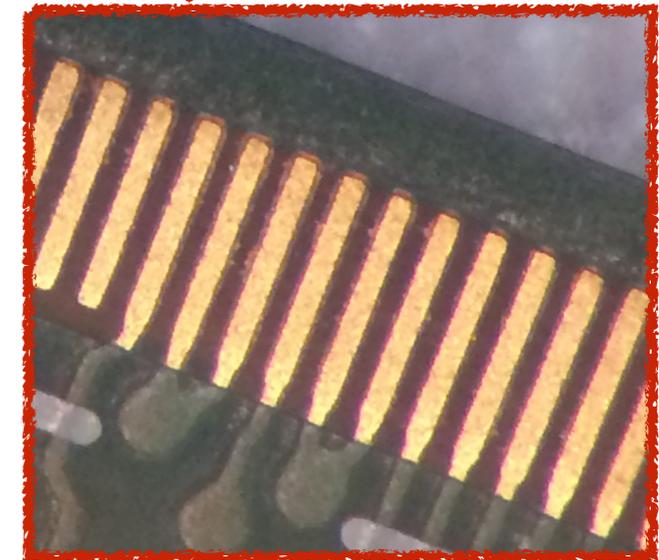
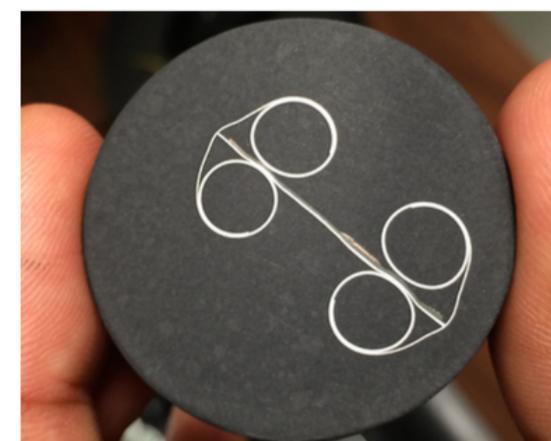
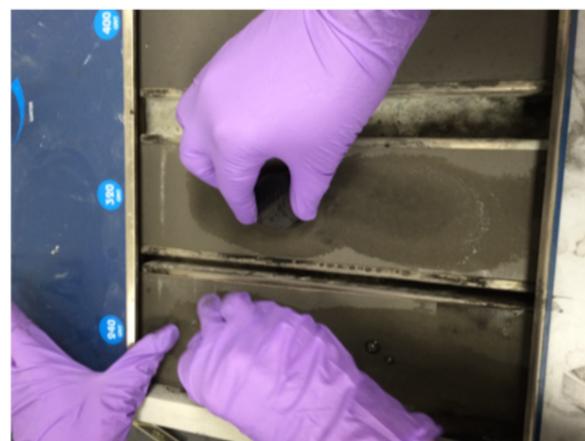
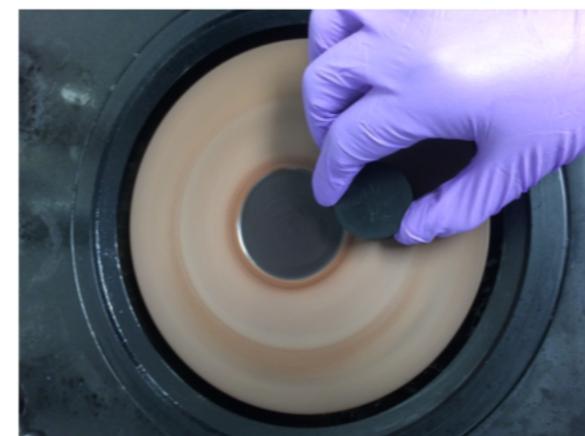
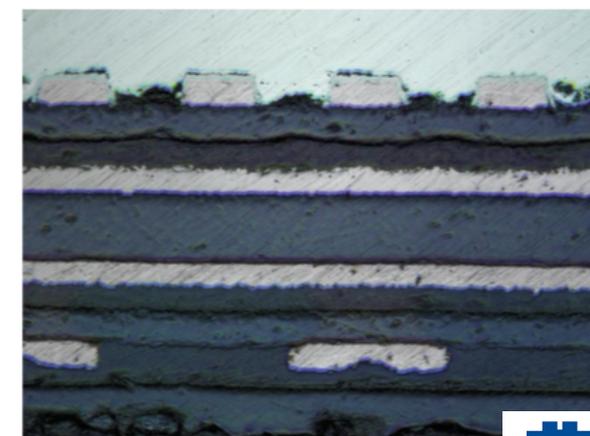
High Density Interconnects Challenges

- Problems encountered:
 - Wire bonding difficulties due to the insufficient thickness of Copper under the wire-bonding pads
 - High voltage breakdowns
 - Yield issues
- Solutions:
 - Improving visual inspections
 - Making thickness measurements on the thicknesses of layers on selective high density interconnects from each batch
 - Preventing high voltage breakdowns by improving the backing of the HDIs besides adding an additional layer of Kapton.
 - Making more batches, improving fabrication process (vendor)

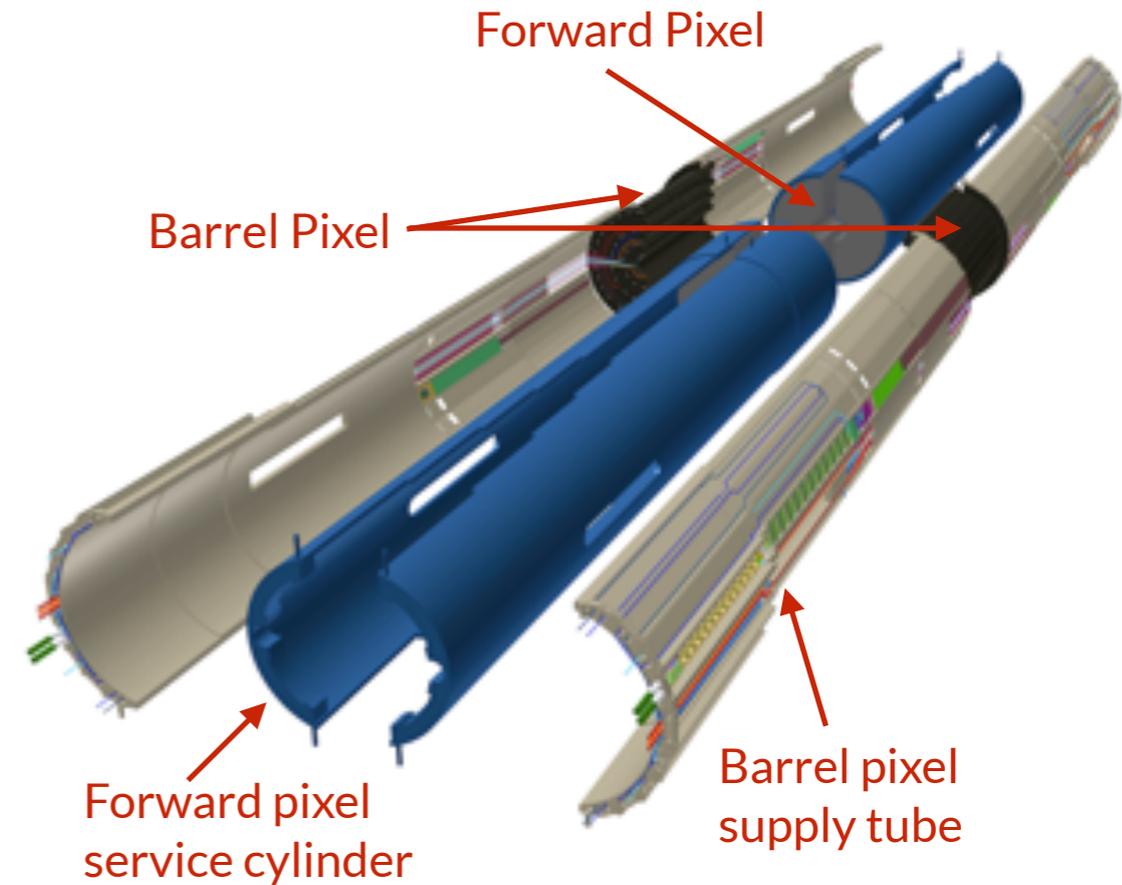
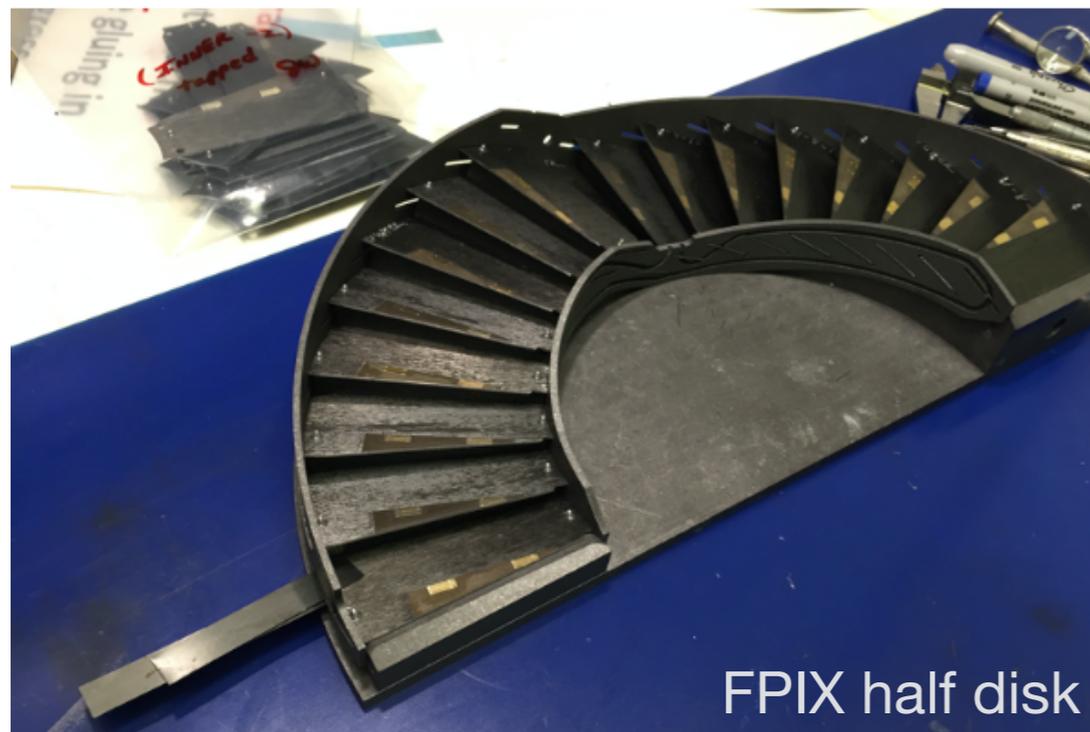
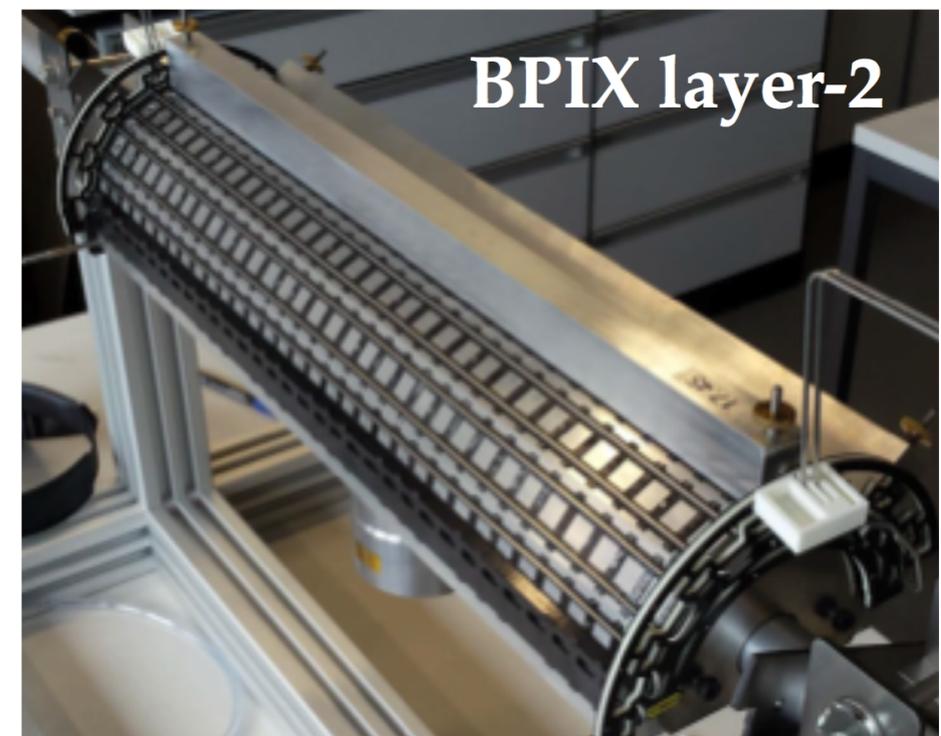
Mechanics

- Light weight Carbon Fiber structure supports services and cooling tubes
- Barrel pixel modules are installed on Carbon Fiber plates
- Forward pixel modules are installed on Thermal Pyrolytic Graphite (TPG) blades encapsulated with Carbon Fiber and glued to Graphite rings

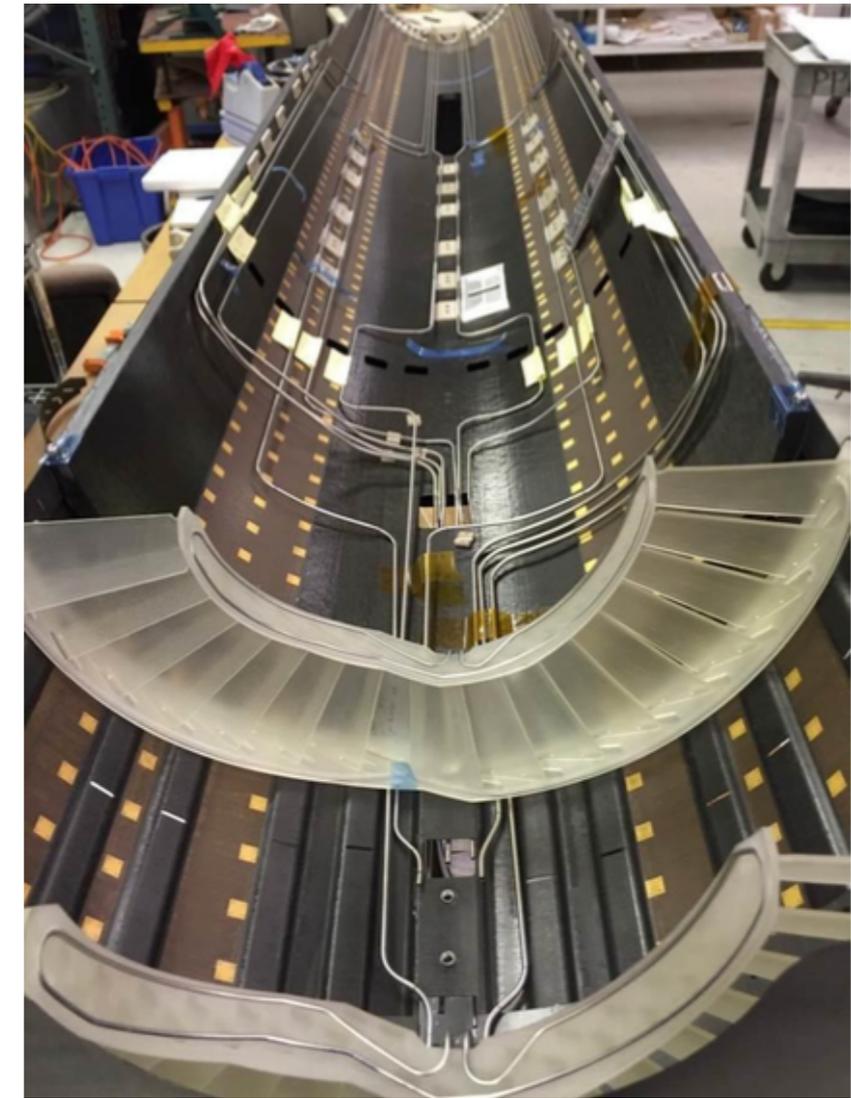
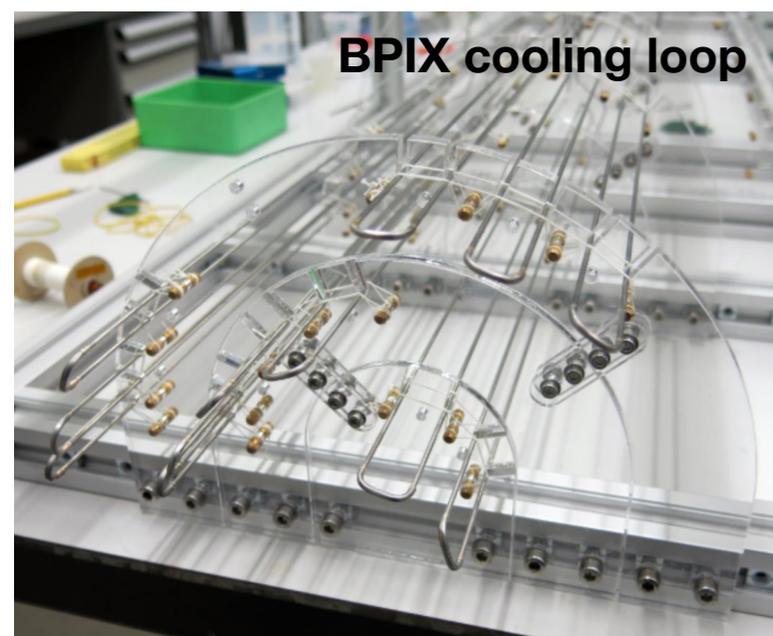
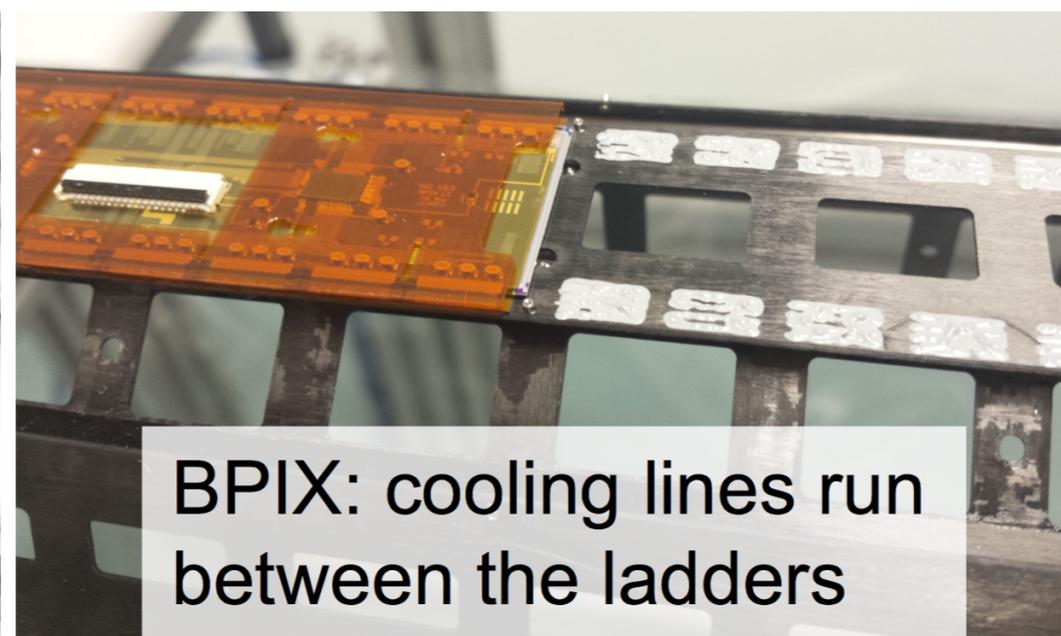
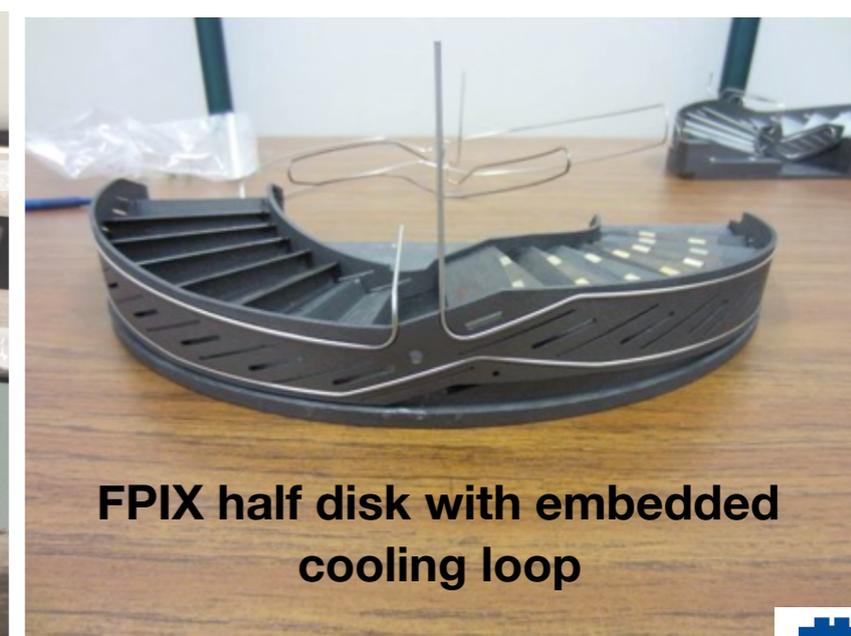
Cooling

- Mono-phase C_6F_{14} is replaced with Two-phase CO_2
 - More effective heat removal through latent heat
 - Thinner cooling tubes (≤ 0.5 of original tubes)
 - Tube wall thickness: 50-100 μm
 - Benefitting from high thermal conductivity of Carbon Fiber/Graphite/Thermal Pyrolytic Graphite
 - Operating point 20 bars at $-20^\circ C$

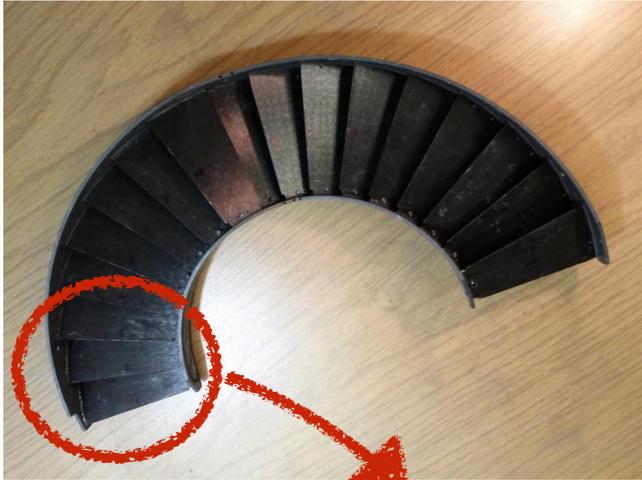
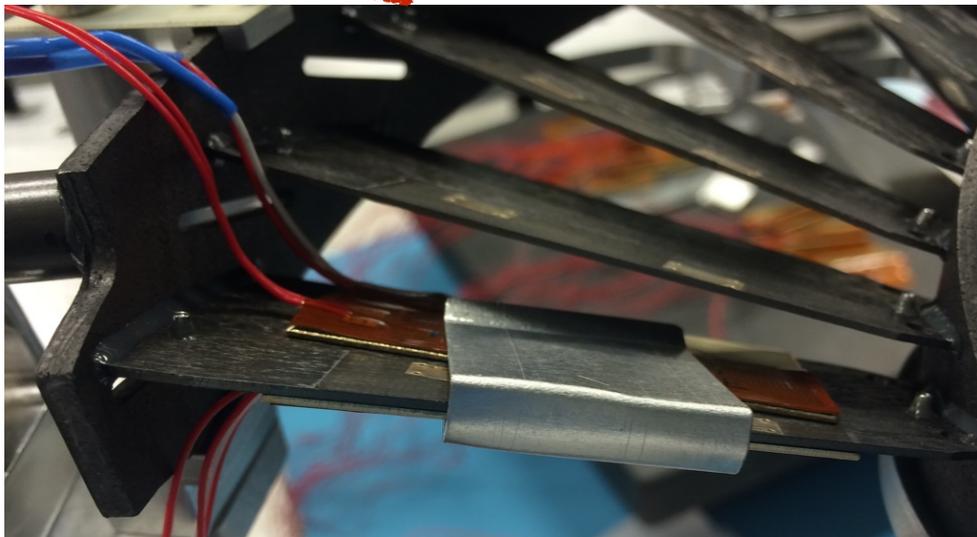
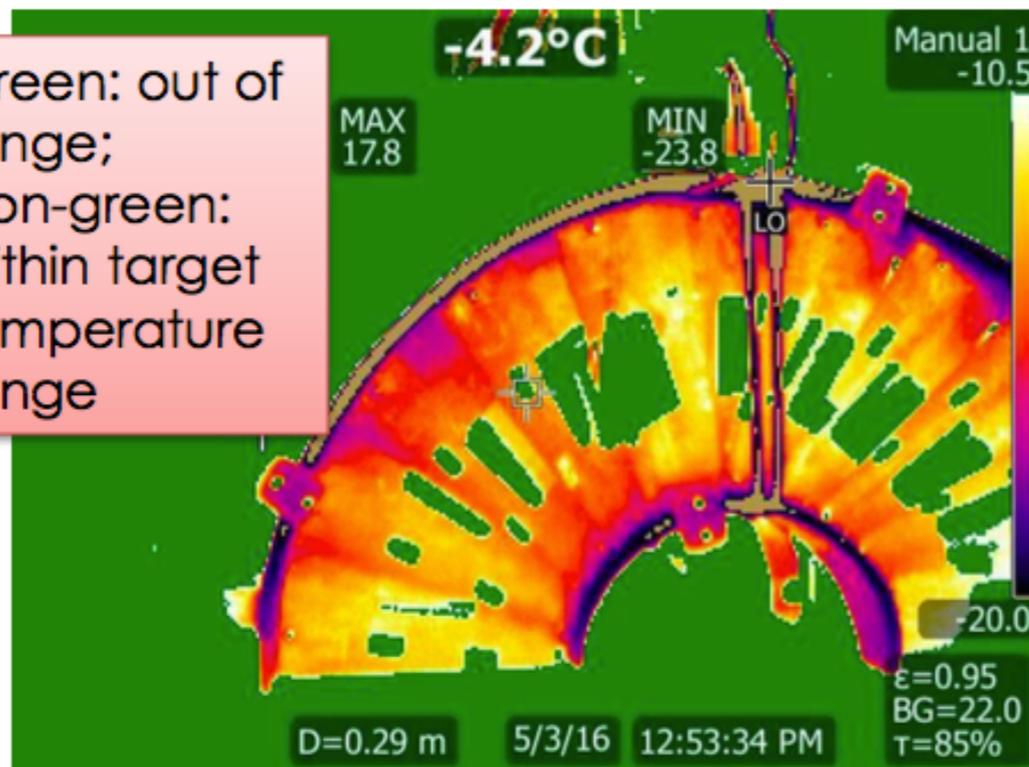
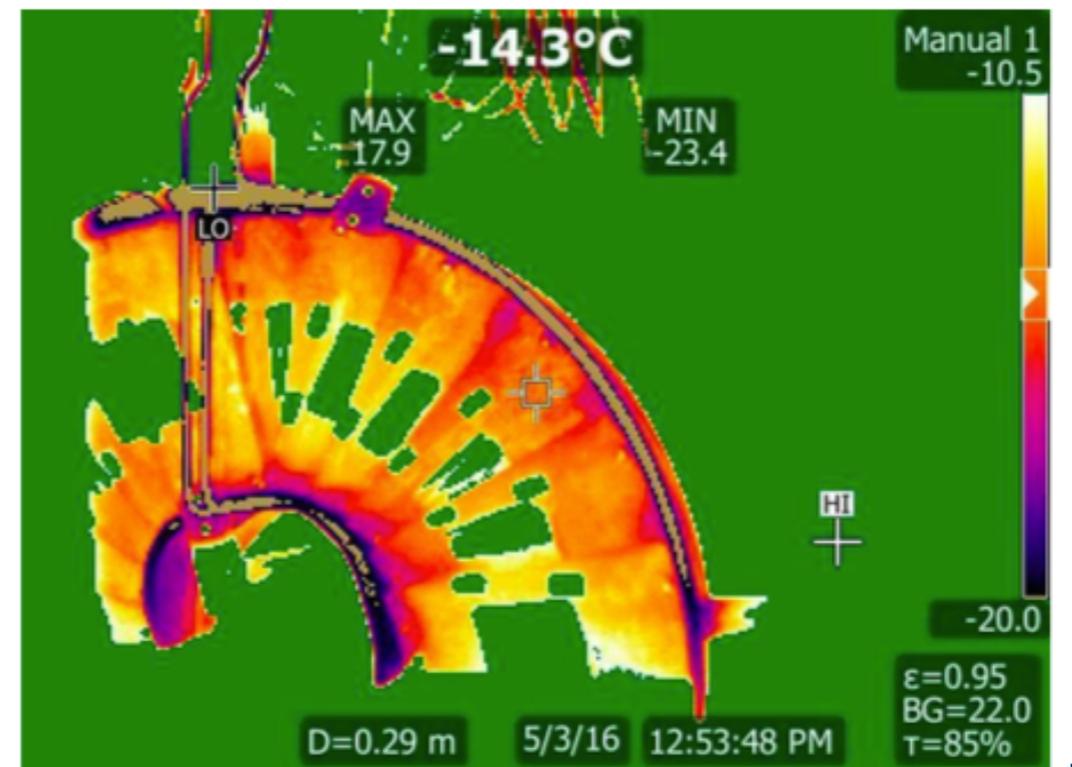
Cooling Performance

- Forward pixel blade-ring joint is critical
 - Tight control of tolerances and of assembly technique is necessary
- Half disk thermal tests are done:
 - Mimicked the full end of life heat load on each blade (3Watts/module)
 - Made thermal measurements using an infrared camera
 - Achieved $\Delta T_{\text{module-coolant}} < 10^{\circ}\text{C}$

Green: out of range;
Non-green:
within target
temperature
range

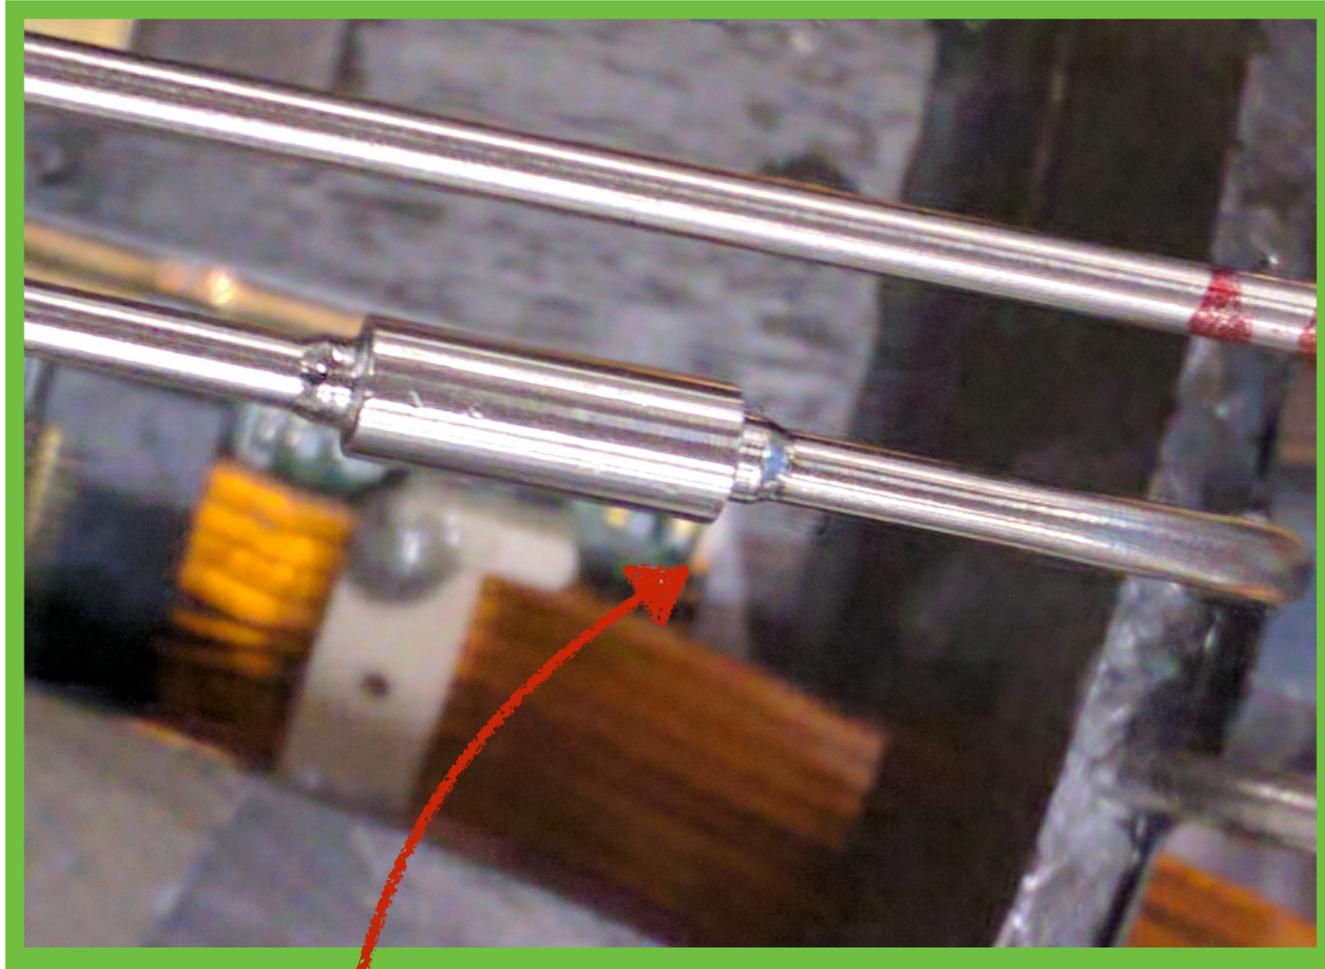
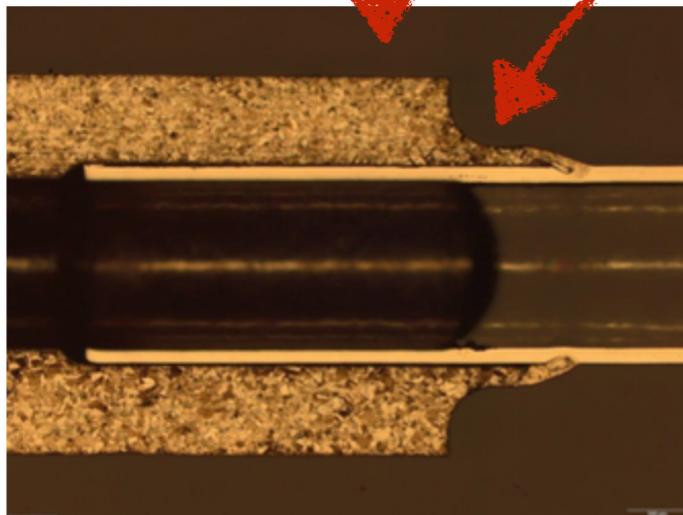
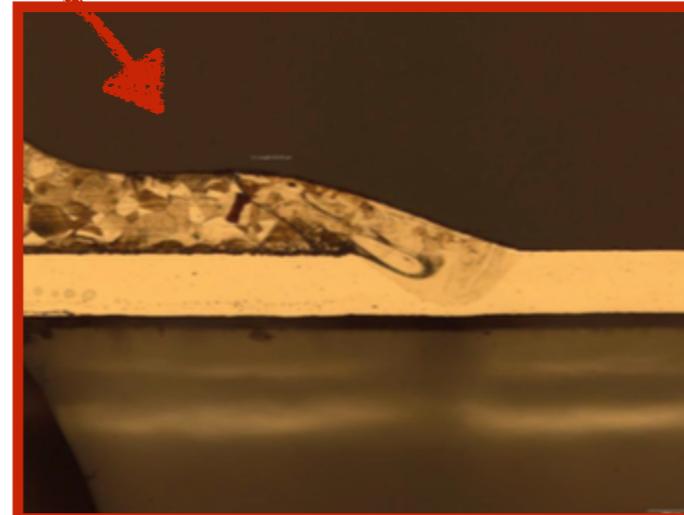
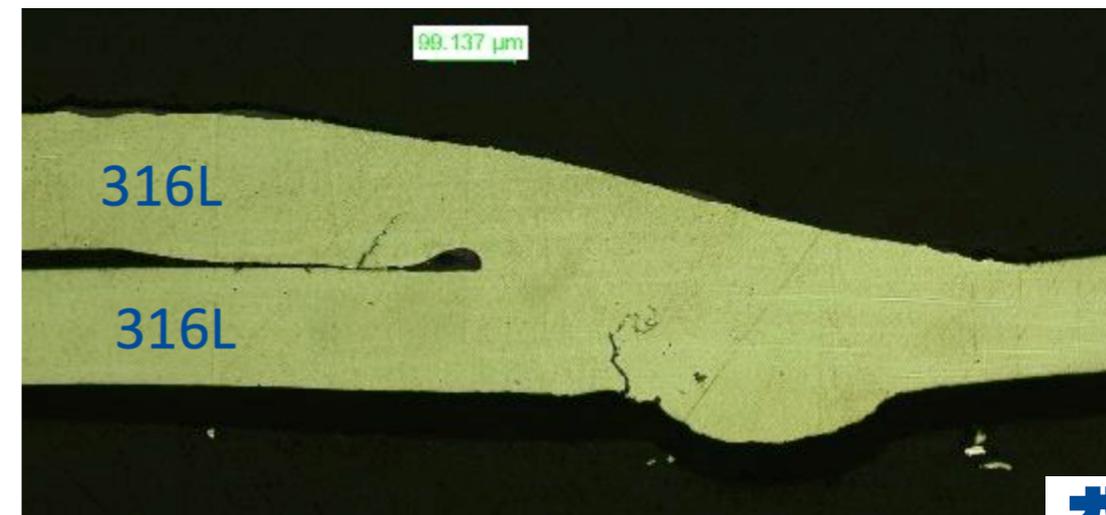
Welding Challenges

- Welds were needed on each forward pixel CO₂ cooling loop
- Problem encountered:
 - Concerns over hot cracking were raised and it was decided to micrograph welds and investigate
- Lesson learned:
 - Material composition plays a role in final microstructure and cracking susceptibility
 - The weld pool mixture of ultra high purity 304L Stainless Steel + 316L Stainless Steel lowers susceptibility to cracking (refer to Stephanie Timpone's talk at FTDM 2016 for more details)

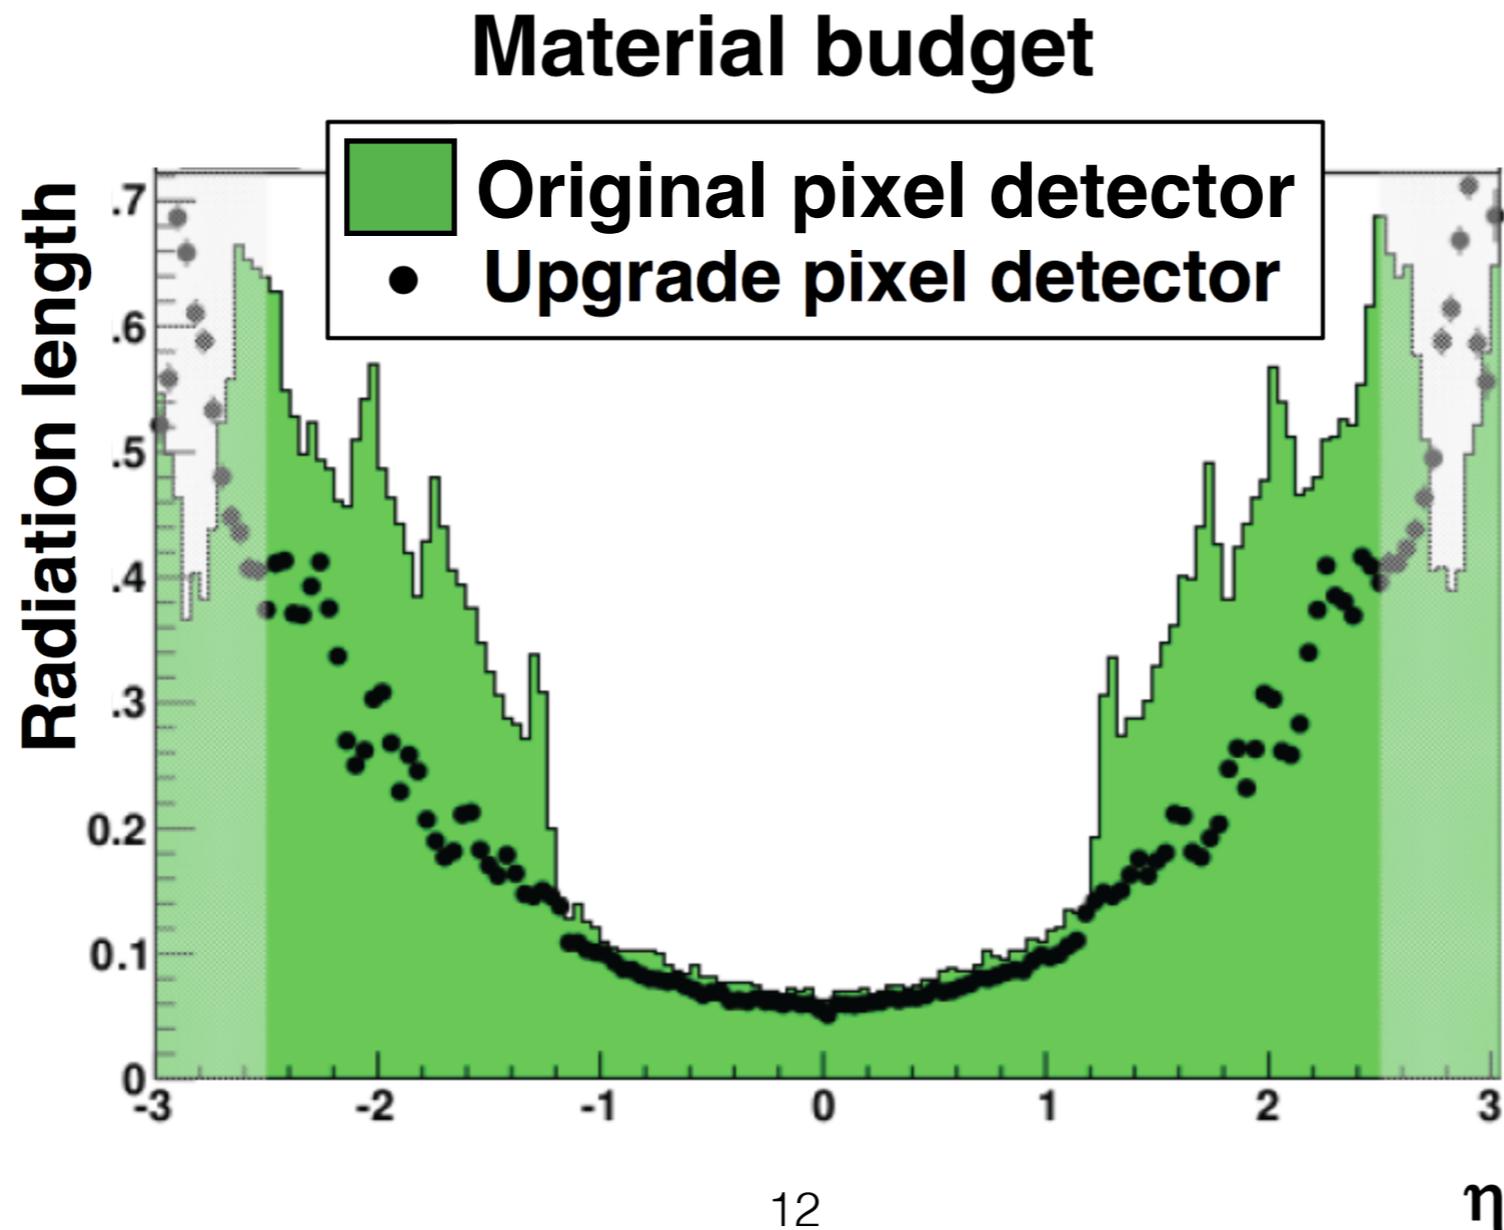
Pixel Tracker Material Budget

- Reduced material budget:
 - Choice of lighter material
 - More efficient cooling system
 - Moving service electronics further away from the interaction point
 - Adopting the powering scheme

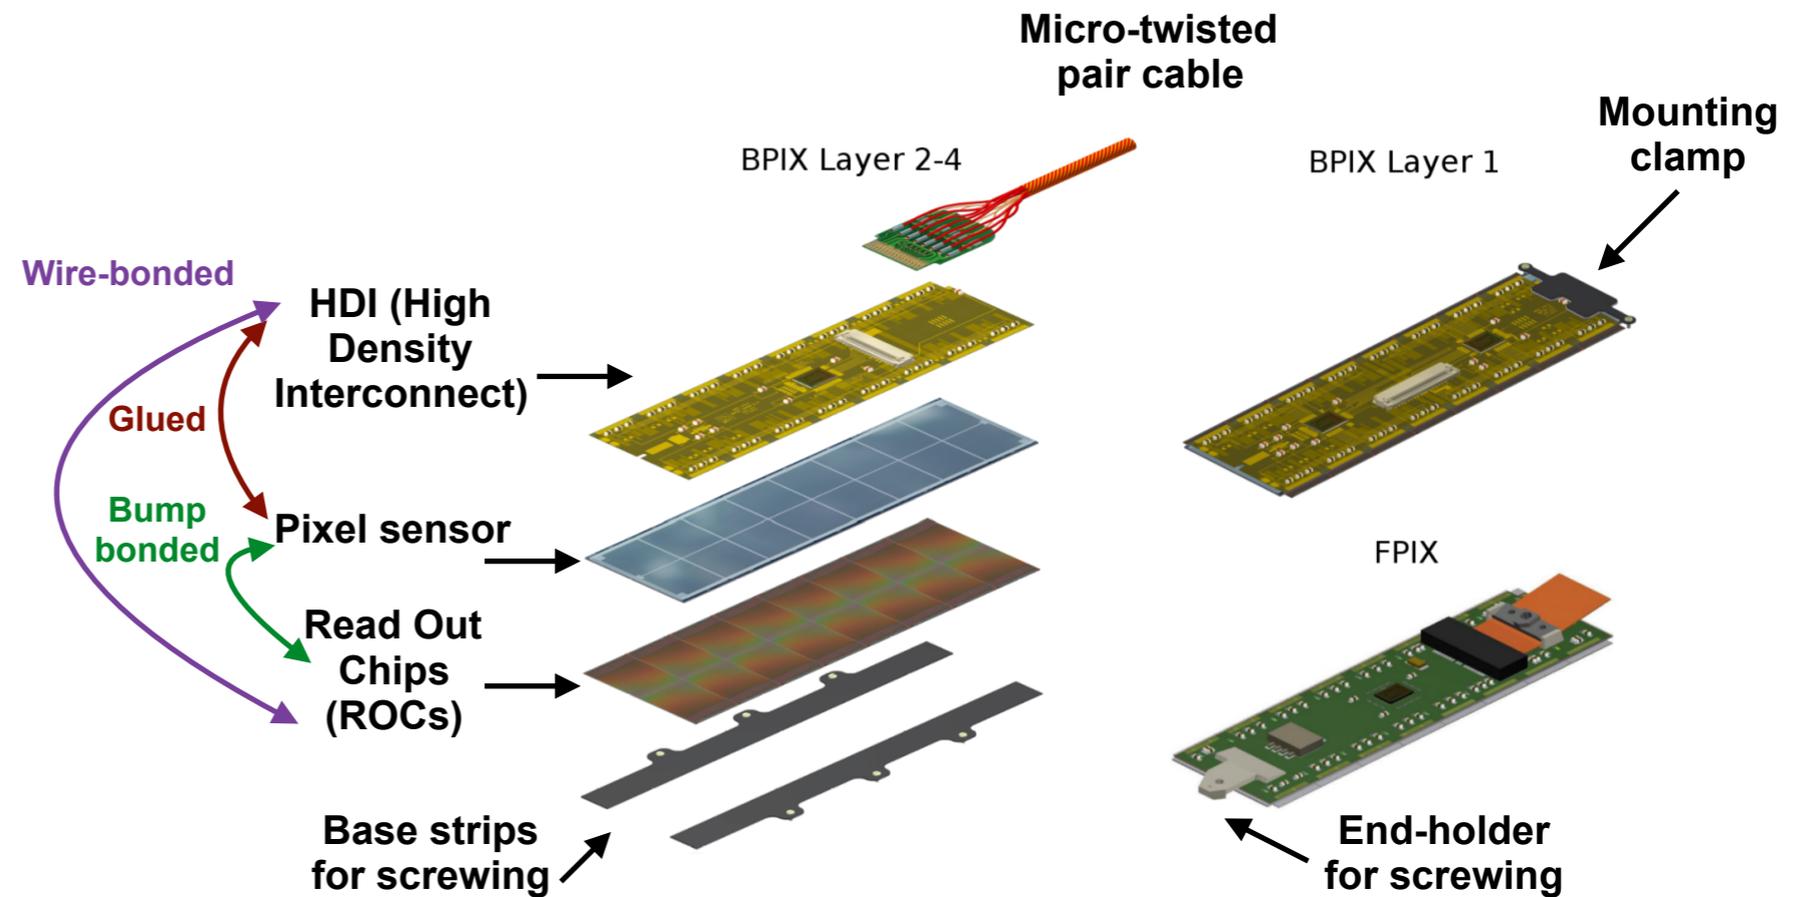
New Sensor Modules

- New readout chips are used:
 - Layer 1 requires dedicated chip to meet data transmission needs
- The readout data is merged in a single output stream by the Token Bit Manager chip (TBM)
 - Aggregates and formats the data
 - Sends it to the detector back-end with a rate of 320 Mbit/s (parallel readout)
 - 1 single data stream per module in FPIX and BPIX Layer-3/L4 (1 "TBM8" chip)
 - 2 data streams per module in BPIX L2 (1 "TBM9" chip)
 - 4 data streams per module in BPIX L1 (2 "TBM10" chips)
