Construction of the Phase 1 Upgrade of the CMS Pixel Detector

Maral Alyari
on behalf of CMS Collaboration

DPF 2017

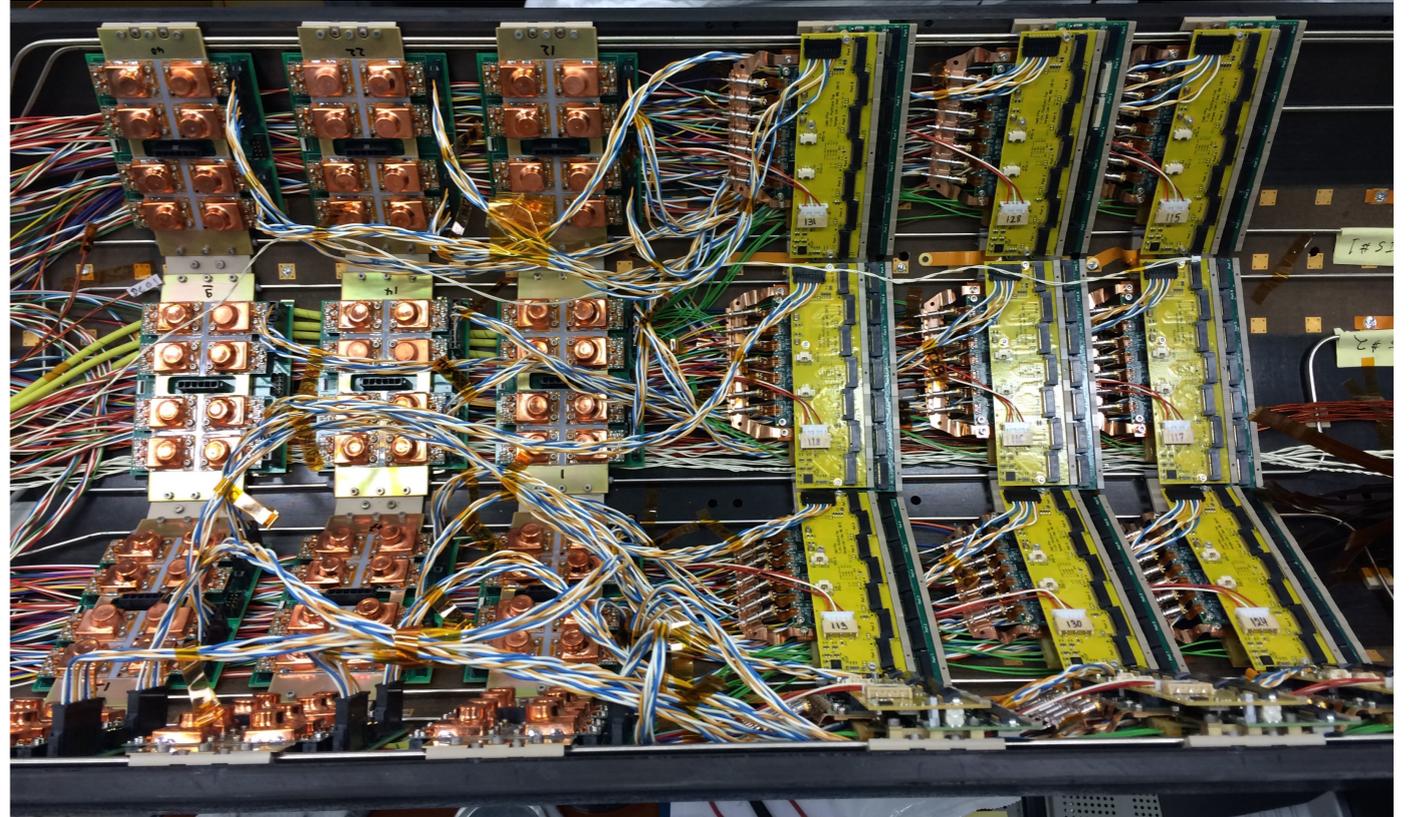
Forward pixel half cylinder DC-DC converters

- A factor of 1.9 more channels in upgraded pixel detector
- Avoided replacing power supply cables:
 - Adopted powering scheme with DC-DC converters
 - Trading high current / low voltage in the power cables for high voltage and low current
 - Reduces the power losses in the cables.
 - Power supplies deliver 10 V to the detector
 - 10 V input is converted to to 2.4/3.3V (analog/digital)

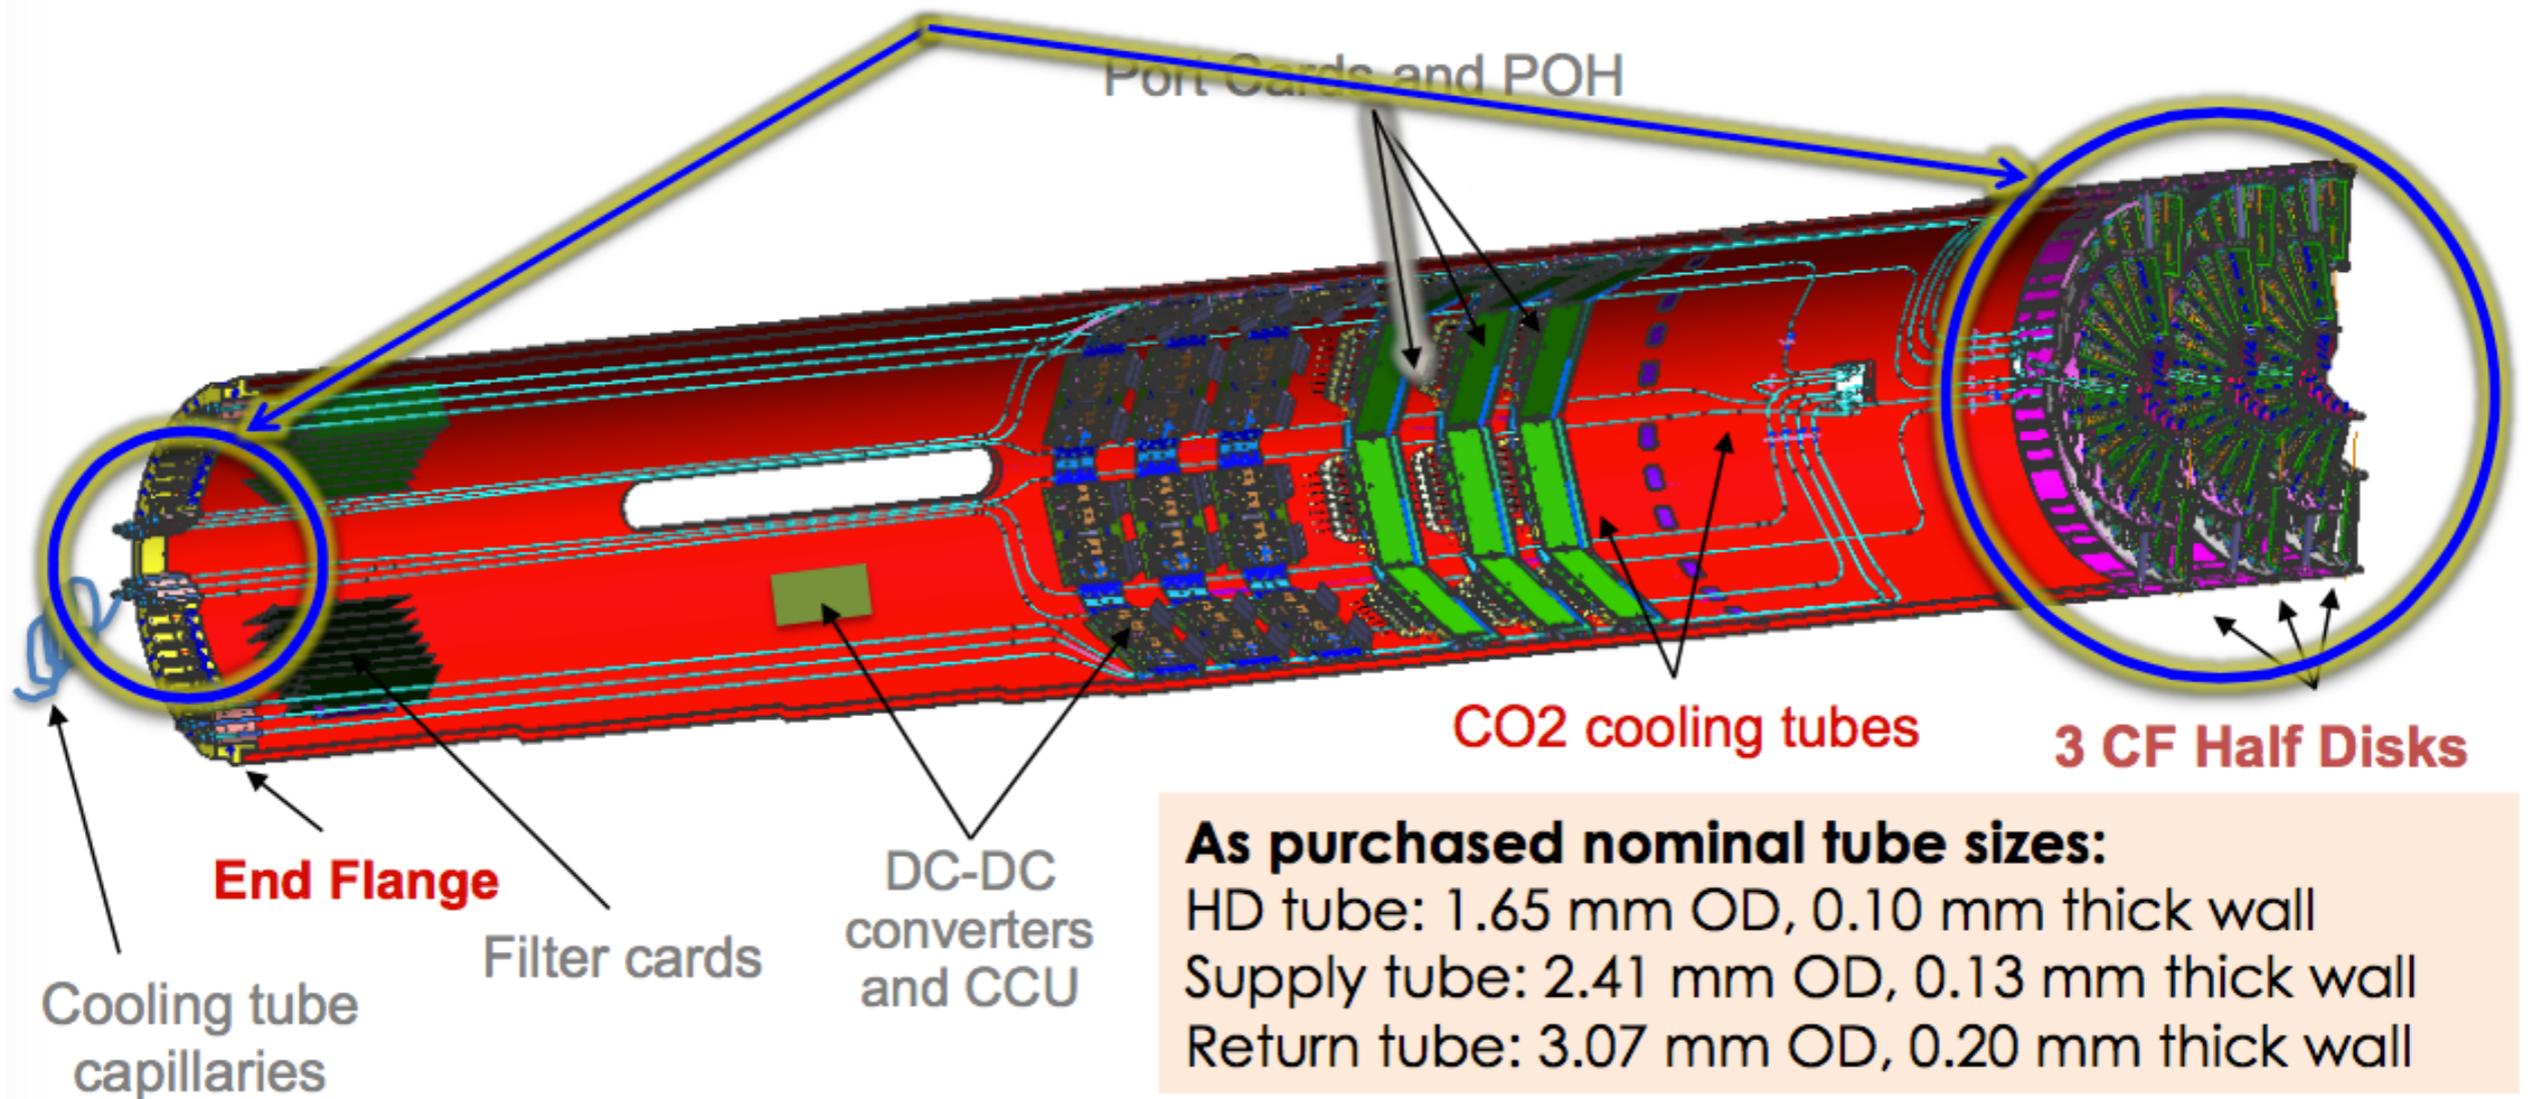
Forward Pixel Cooling Tubes

6 stainless steel CO₂ cooling loops/HC (supply-HD-return)

- 8 Welds per loop (2 on supply tube, 4 on HD tube, 2 on return tube)
- 48welds/HC,192 welds in FPIX

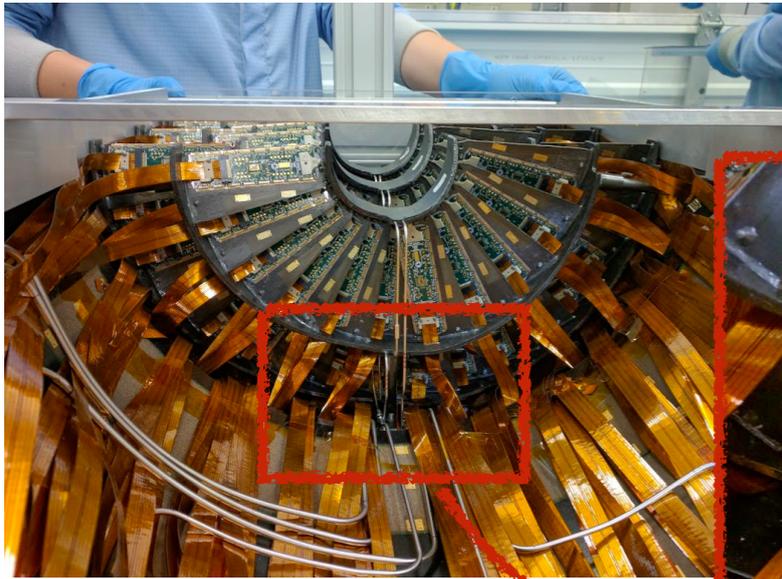
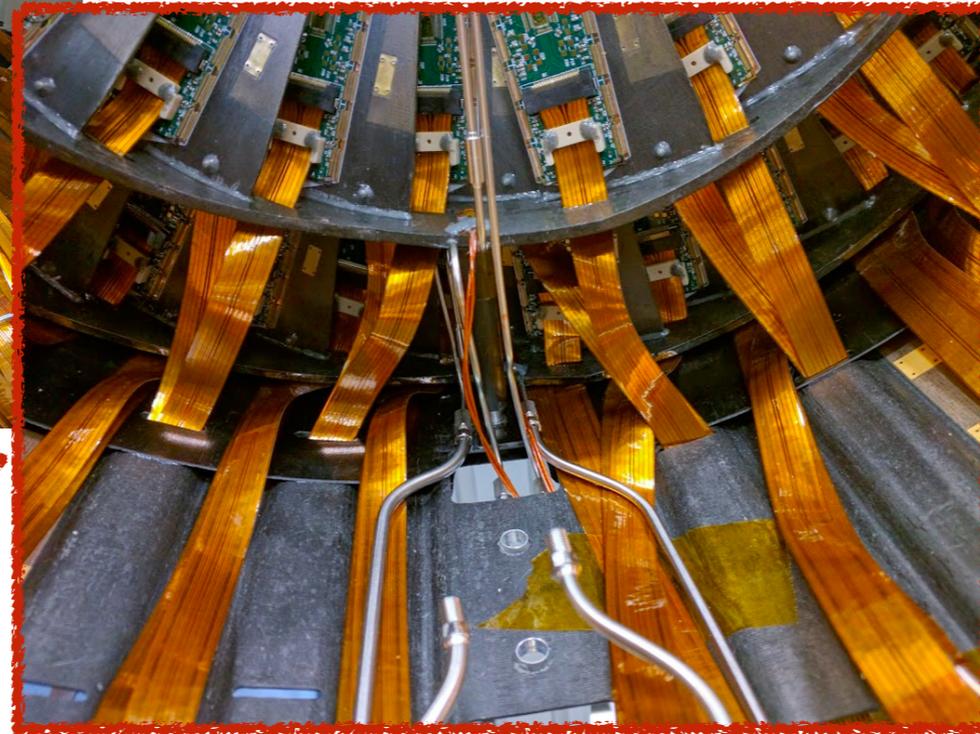
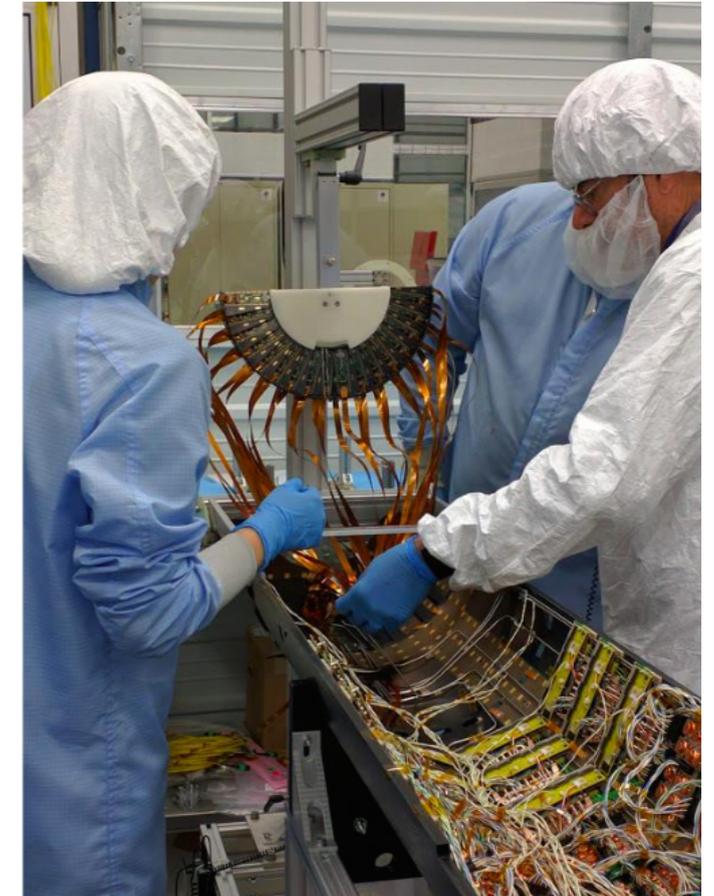
Aluminum Flex Cables

- FPIX Cylinders with disks were assembled and tested at Fermilab, then disassembled and shipped separately to CERN for reassembly and retest
 - Motivation for separate shipping of disks was to reduce risk – minimization of forces on disks (same procedure as for original FPIX)
- Problem encountered:
 - Trace breakage at port card end of module flex cables, induced by handling
- Lessons learned:
 - Aluminum flex cables are more delicate than expected
 - A specifically designed cable end cover would've been more protective compared to an ad-hoc tape-based protection
 - Minimizing the assembling, disassembling and re-assembling process during shipment

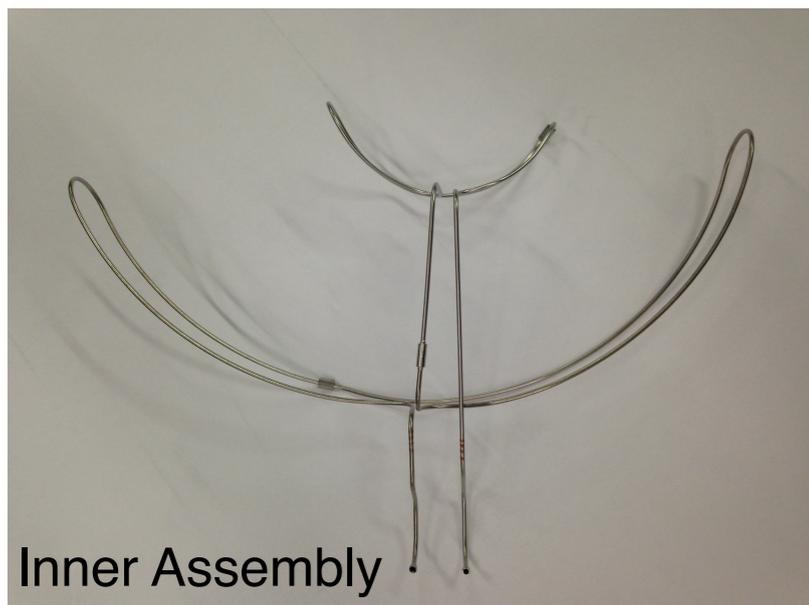
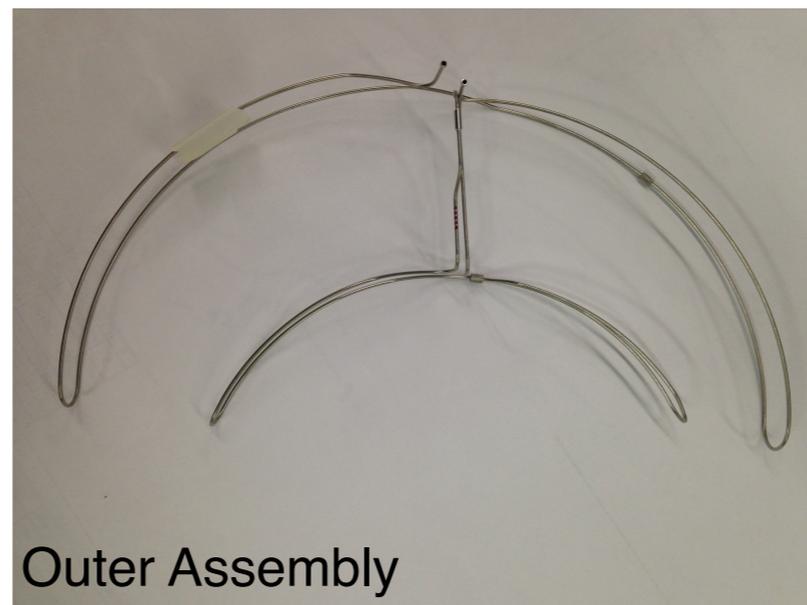
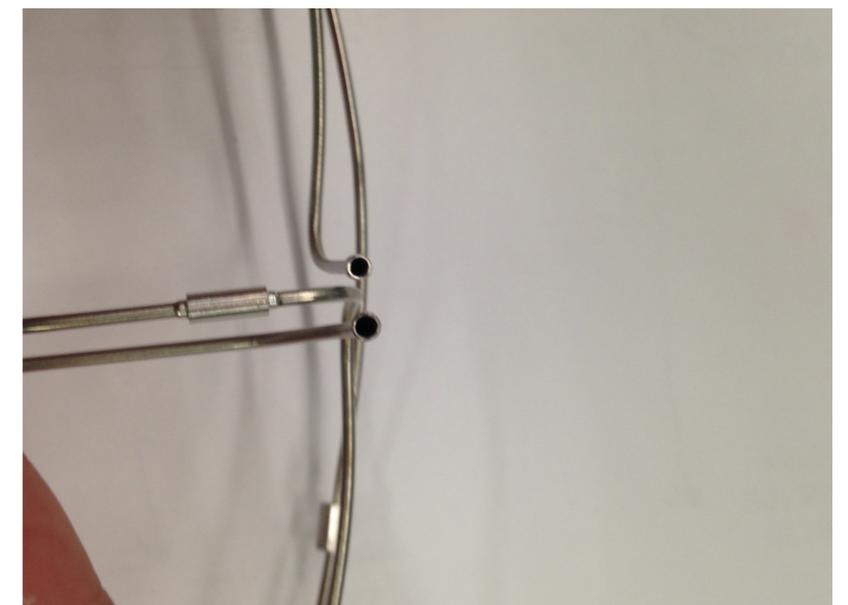
Forward Pixel Cooling Loop QA/QC

Each cooling loop as final qualification before committing the loop to the detector (both HC and HD):

- Upon completion, parts are cleaned and visual inspected.
- After an initial pressure test, each loop undergoes 10 cycles from liquid Nitrogen to room temperature.
- Upon completion, each loop is brought gradually up to 2280 PSI (157 bars) in 5 steps and leak checked in a water bath. Once reached 2280 PSI (157 bars), the loop is held at this pressure for one hour.
- This is followed by 24hr leak test at 1600 PSI (110 bars) with the loop still in the water bath. Leak tightness is checked both visually and by pressure decay measurement with a gauge.
- Helium leak checking is faster and more precise than leak-down test or looking for bubbles, but can not replace high pressure test

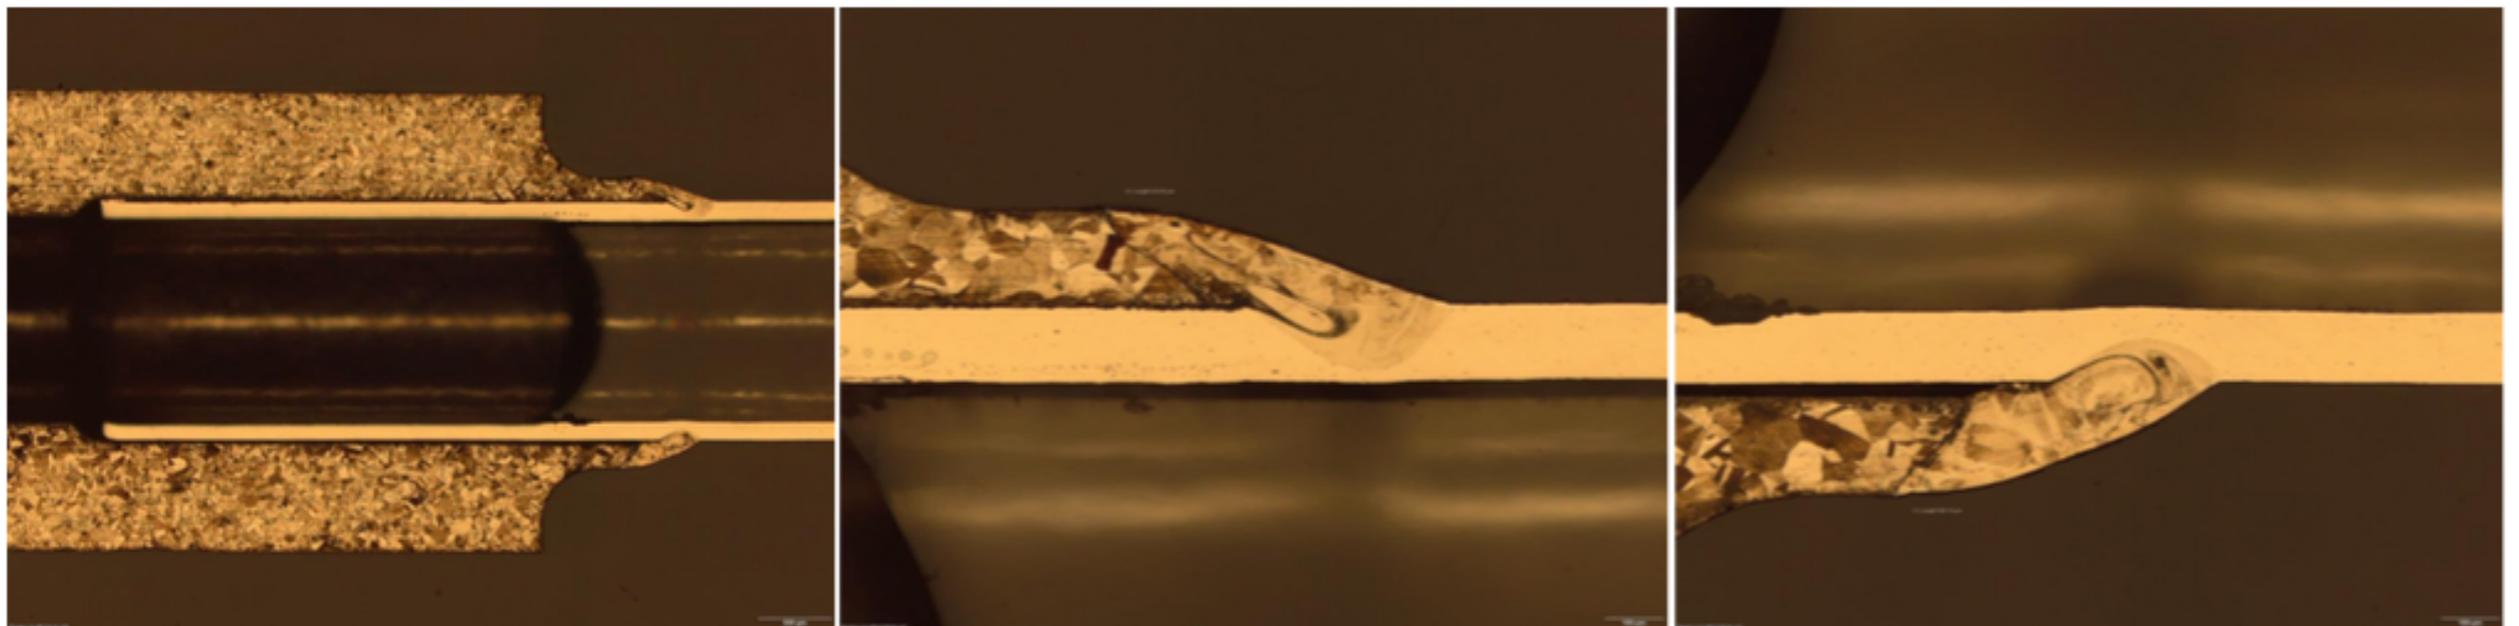
Welding Batch Validation

One complete sample loop for each welding batch is extensively tested in order to validate the welding process for each weld fabrication batch (both HC and HD loops).

- A total of 200 cool-down/warm-up cycles from liquid Nitrogen temperature to room temperature.
- Pressure test at 2280 PSI (157 bars) for 1 hour and leak test at 1600 PSI (110 bars) for 24 hours.
- All welds of the sample loop will then be potted, ground and polished, and inspected for defects under a microscope both before and after etching.
