Production of the CADS spoke cavities and ancillaries, and lessons learned

Feisi He

On behalf of colleagues in IHEP SRF group
Institute of High Energy Physics (IHEP)

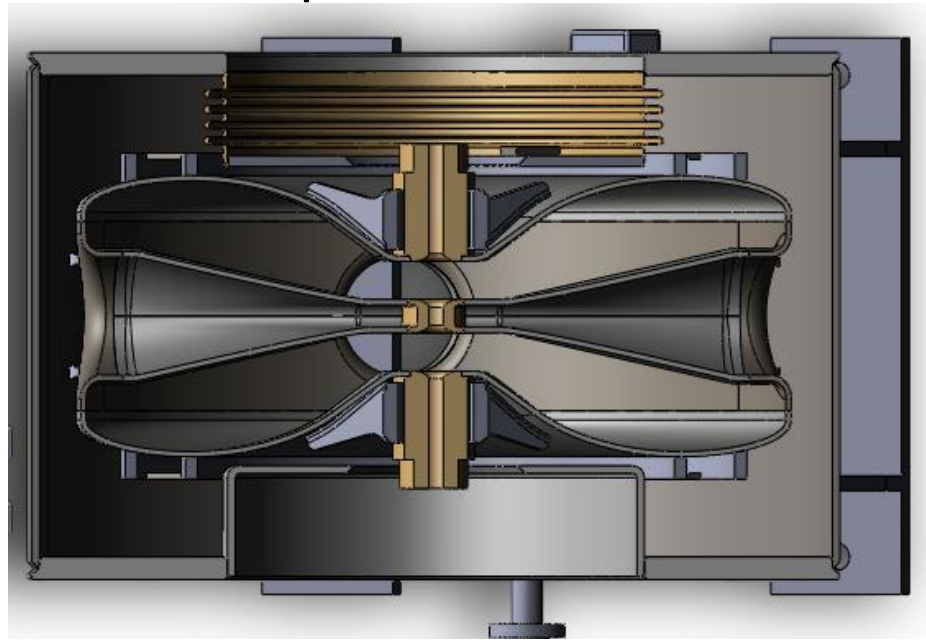
Spoke012 cavity

14 cavities in 2 CM. Beam commissioned with 2mA CW proton from 3.2MeV to 10MeV

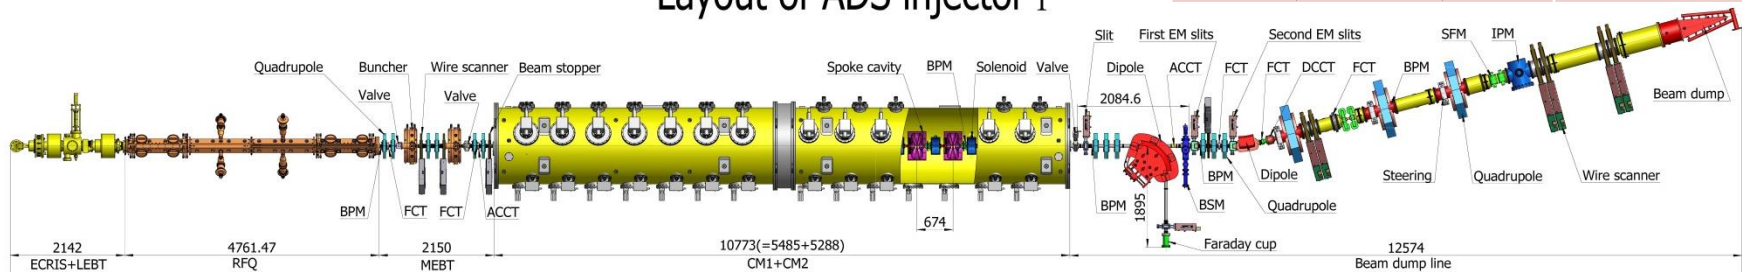
Layout of ADS injector I

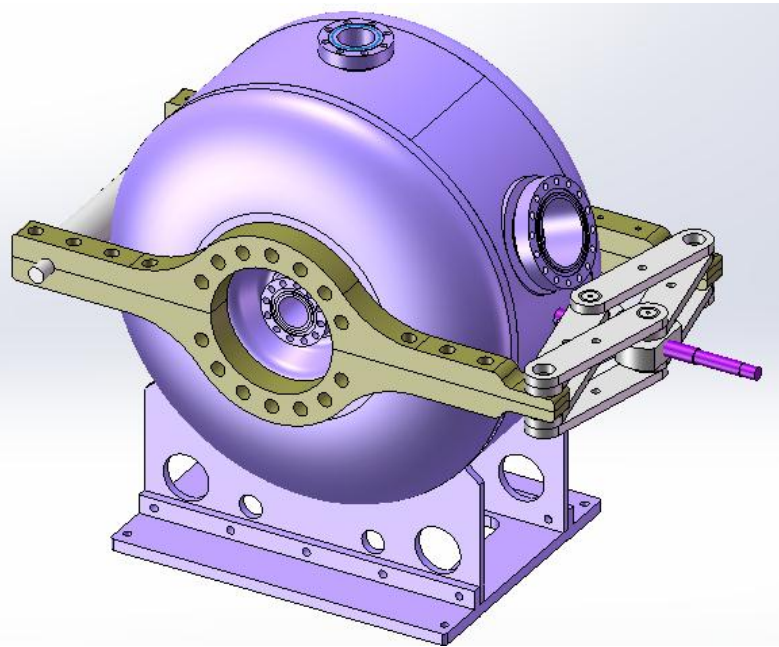
Spoke021 cavity

- 6 cavities in one CM. developed in IHEP, Assembled in IMP. Waiting for tunnel commissioning

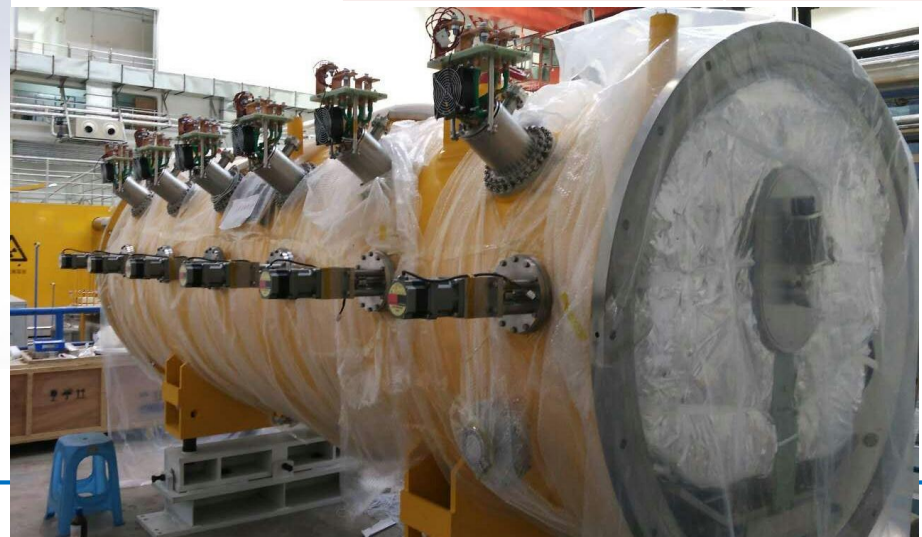
Spoke 021
β_0	0.24
Aperture-mm	40
E_p/E_{acc}	4.4
B_p/E_{acc} $mT/(MV/m)^2$	9.4
G- Ω	71
R/Q- Ω	191
df/dp [Hz/mbar]	-6
df/dp [Hz/mbar] (measured)	<-10

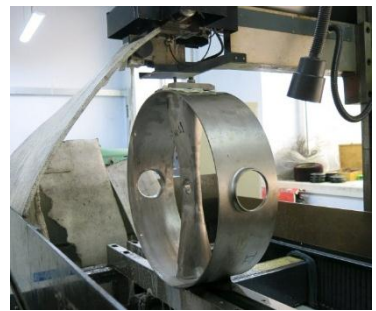
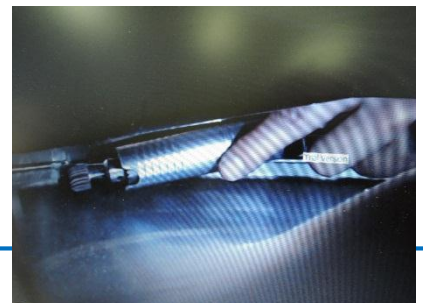
Certification from vendor
Eye inspection

Defect inspection and grinding before final EBW, size control, frequency control

Deep drawing, annealing, machining, frequency control, grinding, EBW

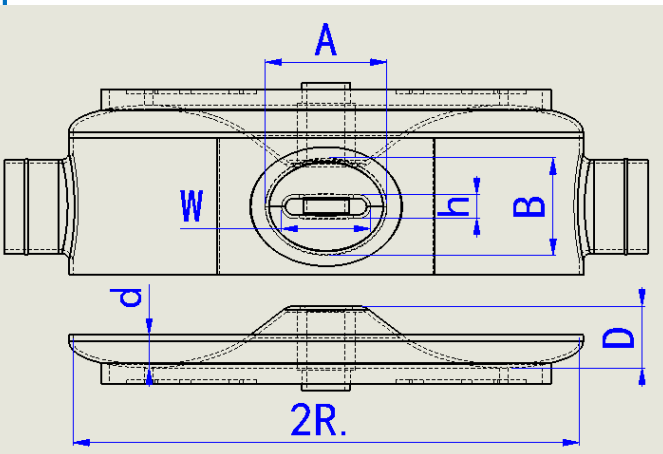
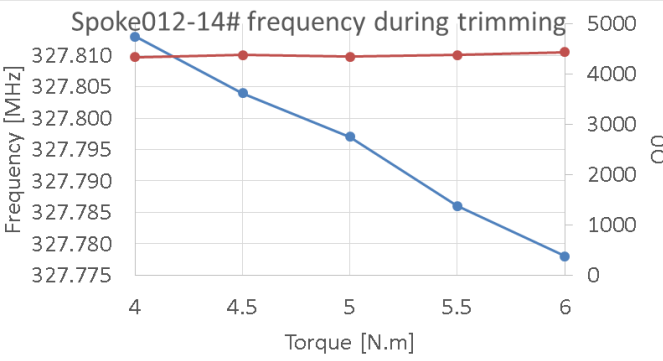
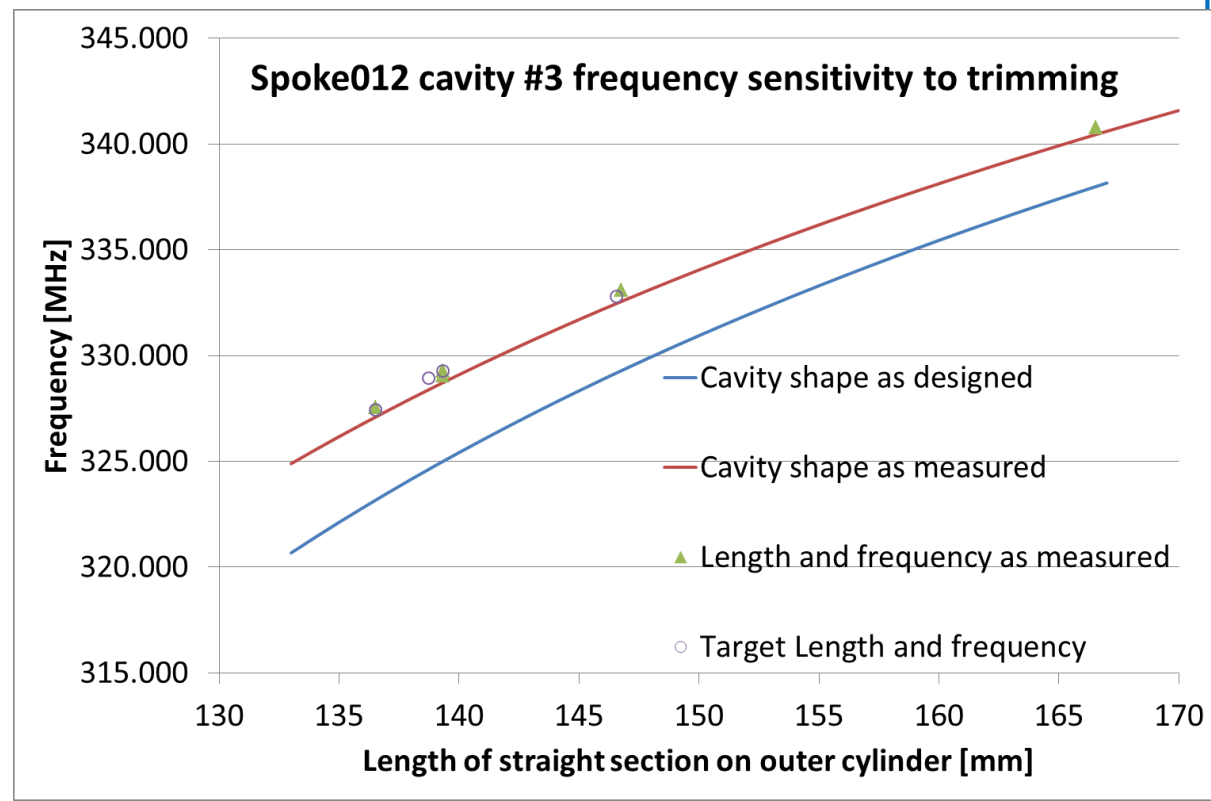
Quality control: frequency control

- Frequency sensitivity of trimming the central ring was calculated based on measured critical sizes.

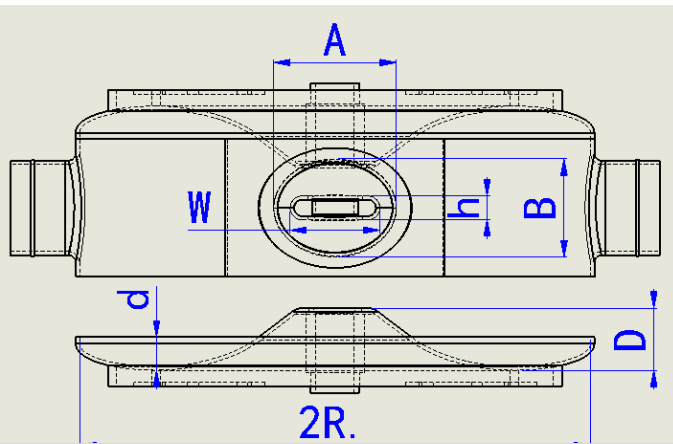
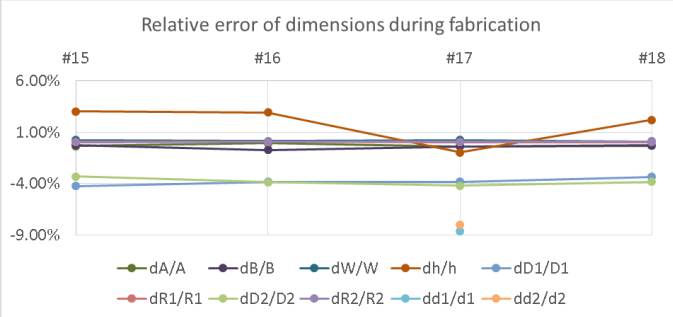
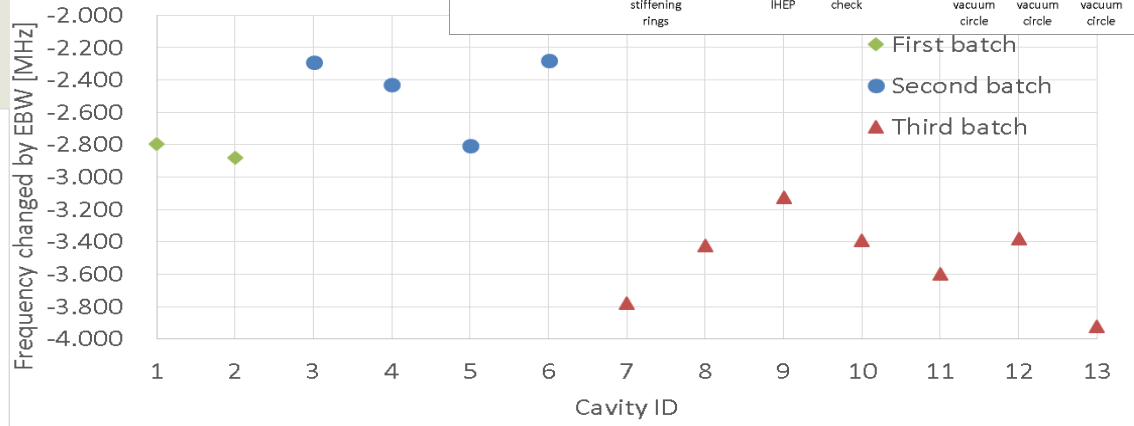
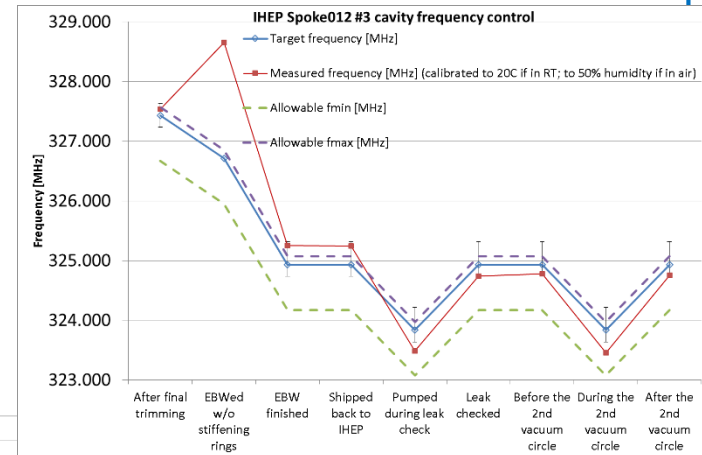
Quality control: frequency control (2)

- F scattering induced by fabrication error is typically 2—4MHz(0.6-1.2%)
- Final EBW used to caused f scattering of 1.6MHz; it is 0.2MHz when stiffening ring were welded first.

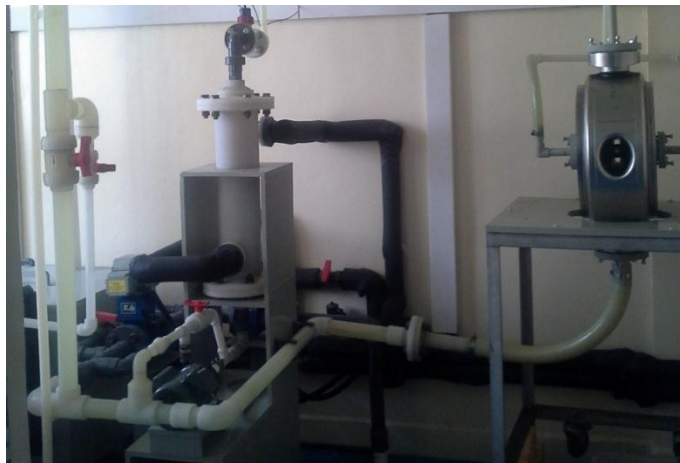
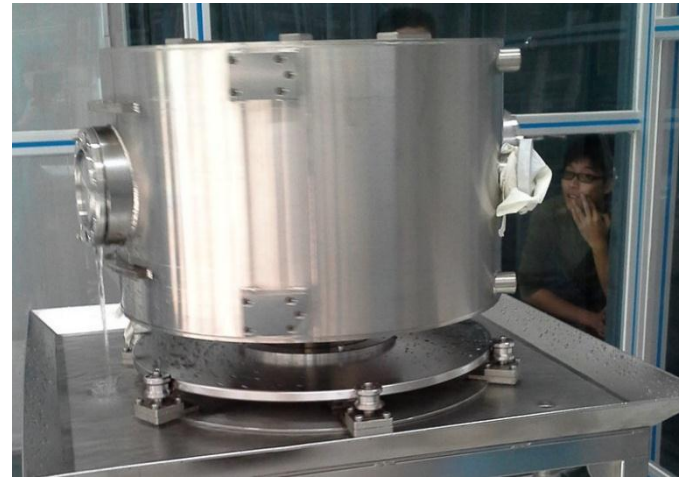
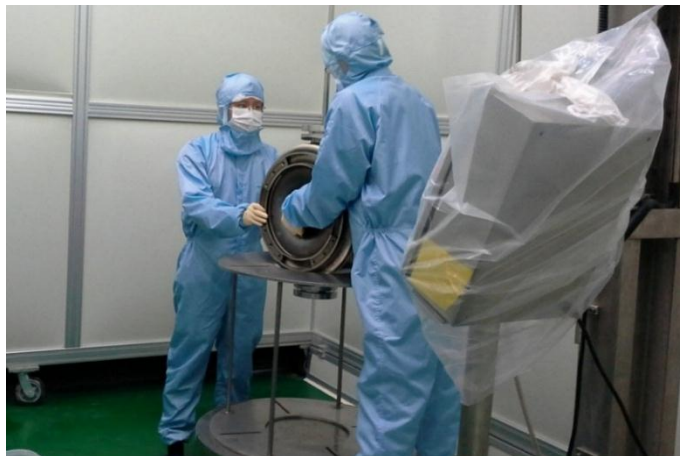
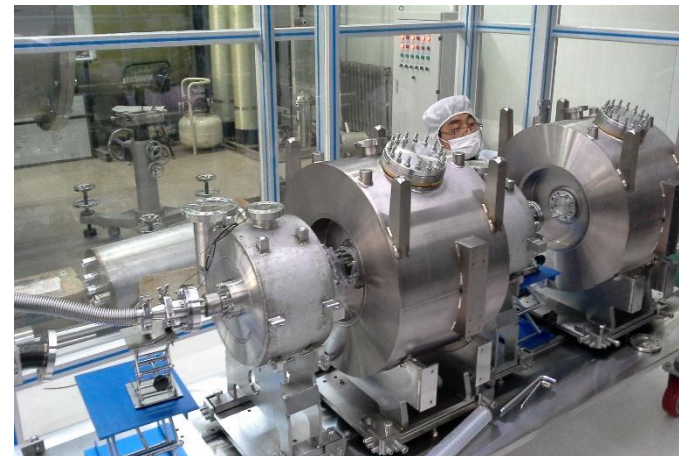
Post processing of Spoke cavities

- BCP in Ningxia OTIC; re-HPR and clean assembly in IHEP

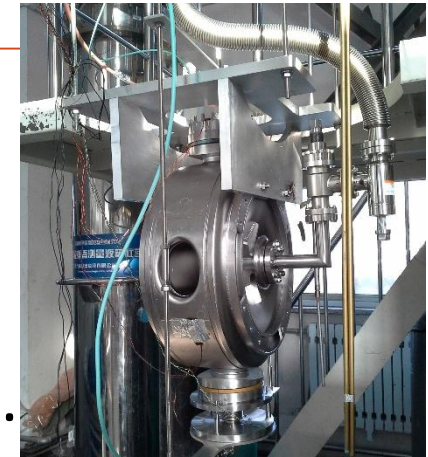
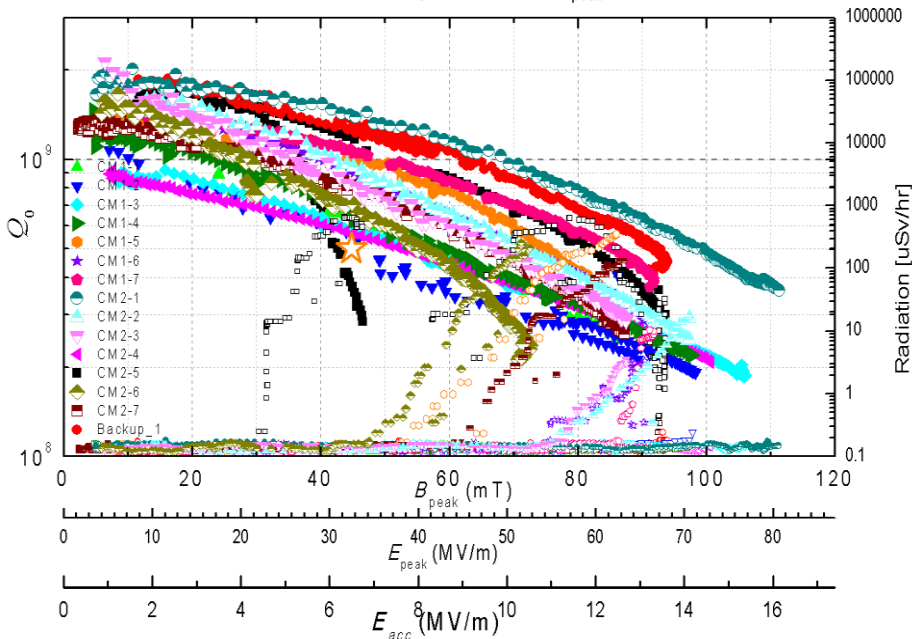
VT results of the spoke012 cavities

- MP conditioned in 1 hour with variable coupler
- Eacc increased by 2 MV/m with better cooling
- 120C baking increases Q_0 by about 50-100%
- At 2K, Q_0 is 6 times higher, $B_p \sim 125$ mT achieved.

Spoke012 4.2K VT, Designed $Q_0 = 5 \times 10^8$ @ $E_{peak} = 31.5$ MV/m

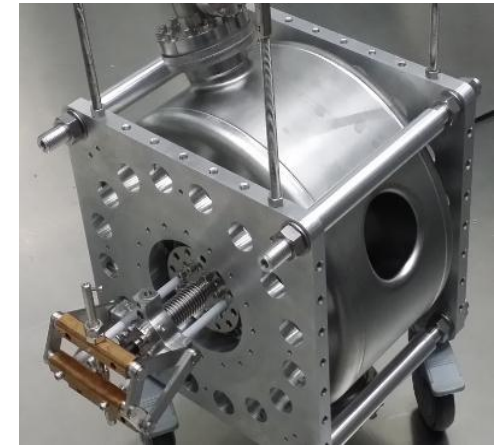
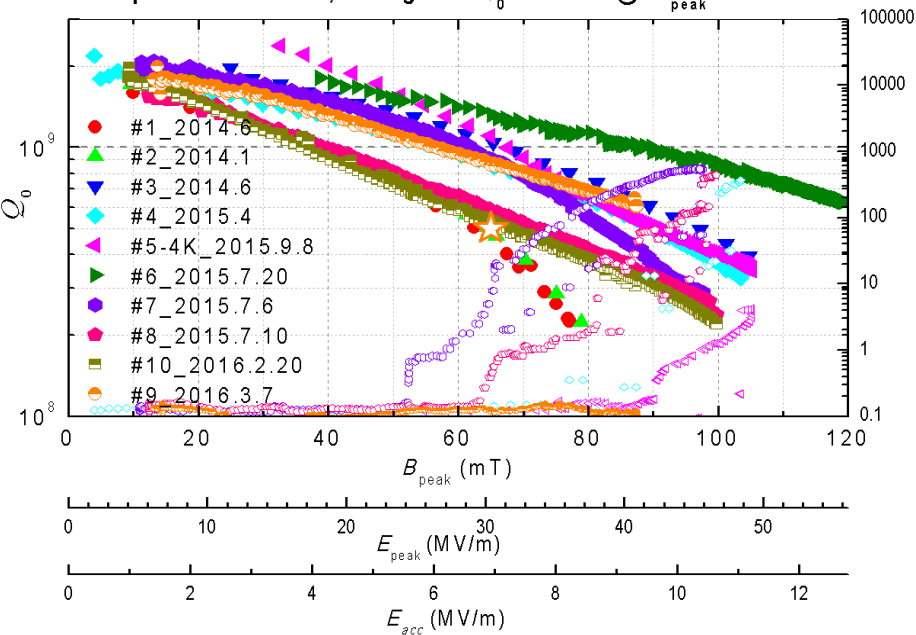
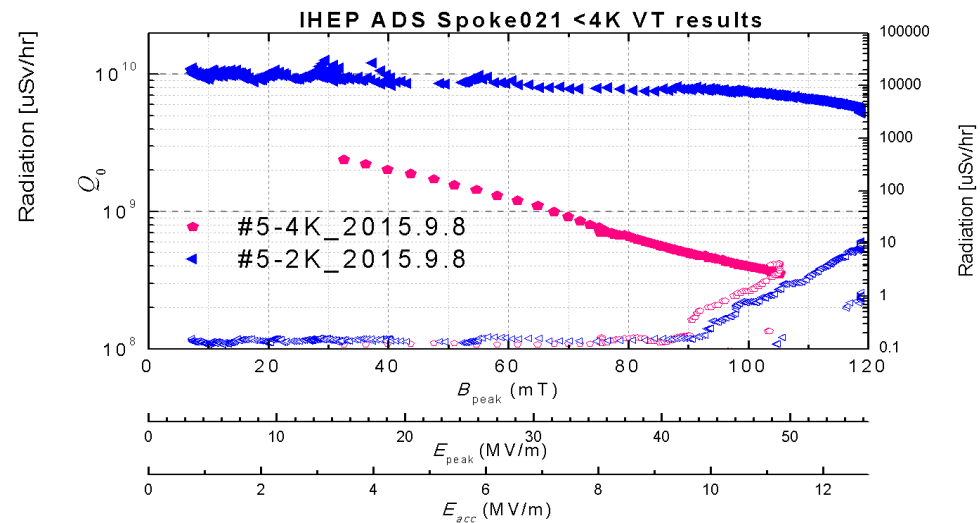
Spoke021 testing results

- MP conditioned in 1 hour
- Design target consistently exceeded
- Bp of 120mT and Rres of 7nΩ achieved at 2K

Spoke021 4K VT, Designed $Q_0 = 5 \times 10^8$ @ $B_{peak} = 65$ mT

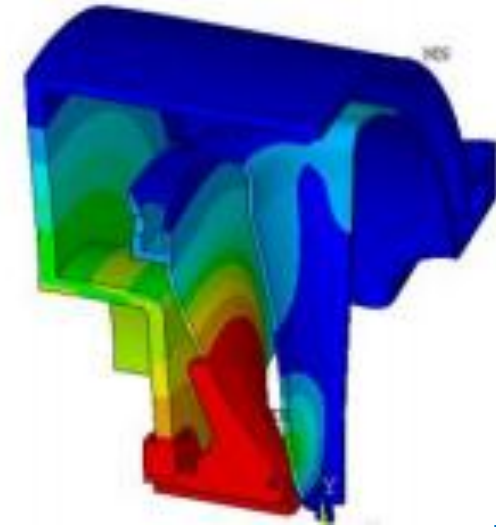
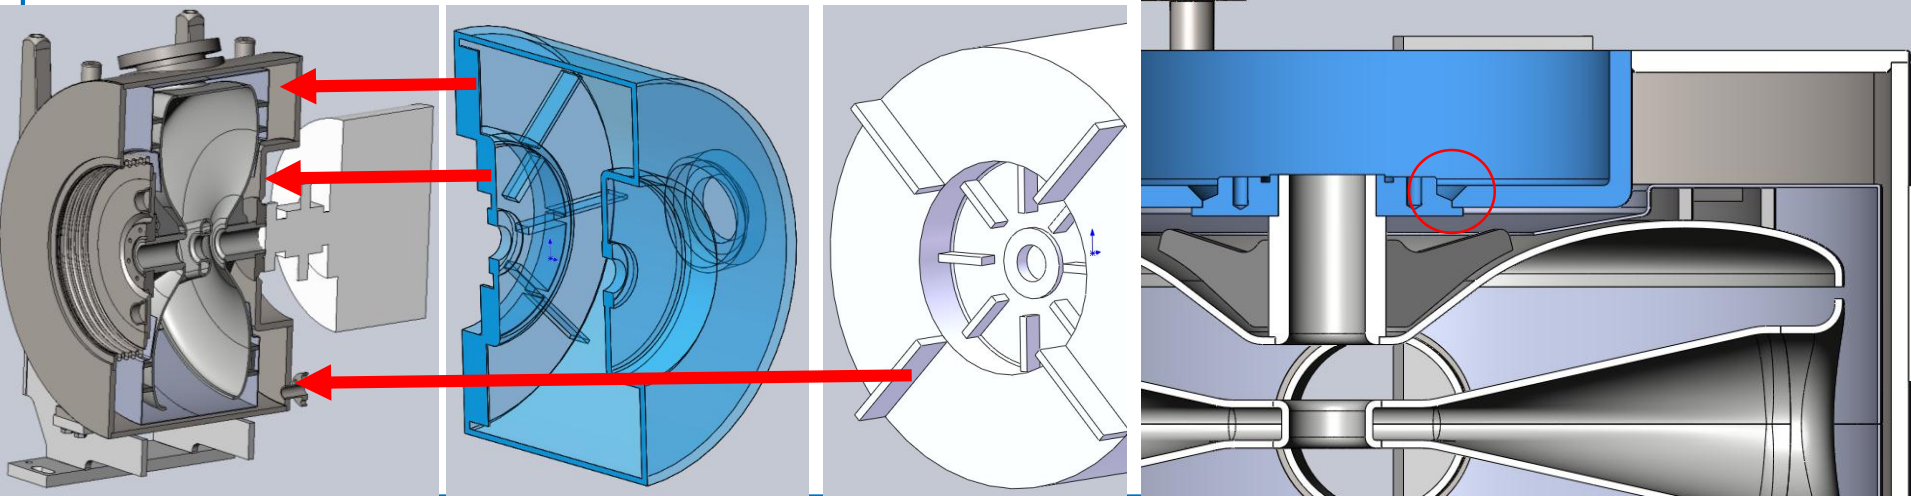
Spoke012 He vessel

- Problem: way too huge df/dp (-130 than -40Hz/mbar)
- Mainly by deformation of beam pipe
- Solution: adding stiffeners to He vessel, and stronger TIG welding

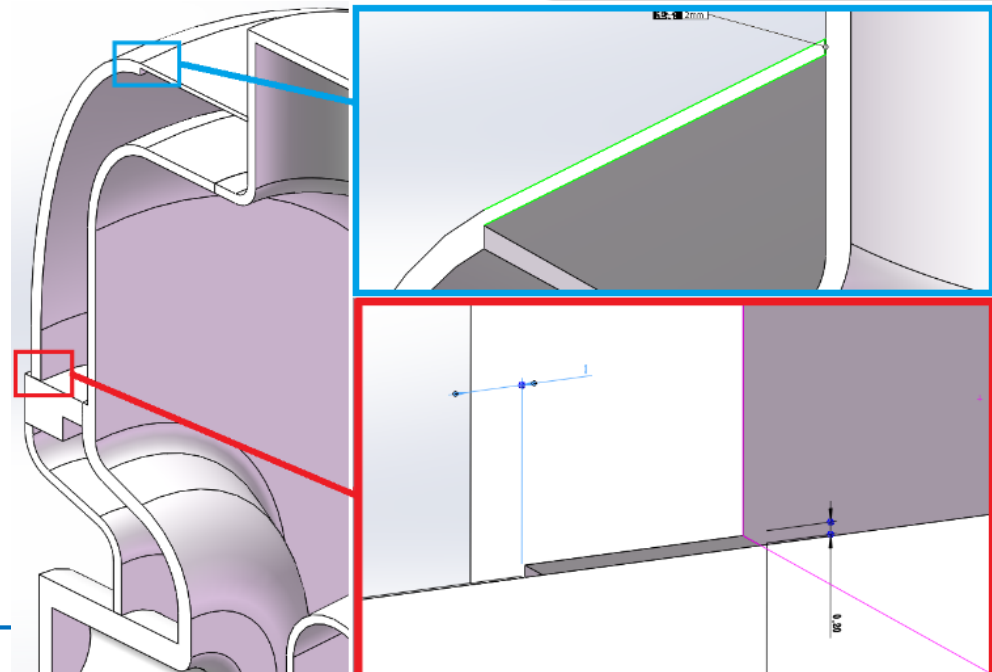
Spoke021 He vessel

- Unexpected high df/dp
- df/dp is extremely sensitive to the depth of one weldment, which was switched from EBW to TIG
- Re-weld with EBW solved the problem

df/dp [Hz/mbar]	Before	After
021-5#	-60	0
021-6#	-40	-13
021-7#	-58	-12
021-8#	-82	-9
021-9#	-67	-15
021-10#	-65	-11

Weld depth[mm] (slide fit 0.2mm)	df/dp [Hz/mbar]
5	-1.0
4	-6.5
3	-16.2
2	-32.7
1	-64.4

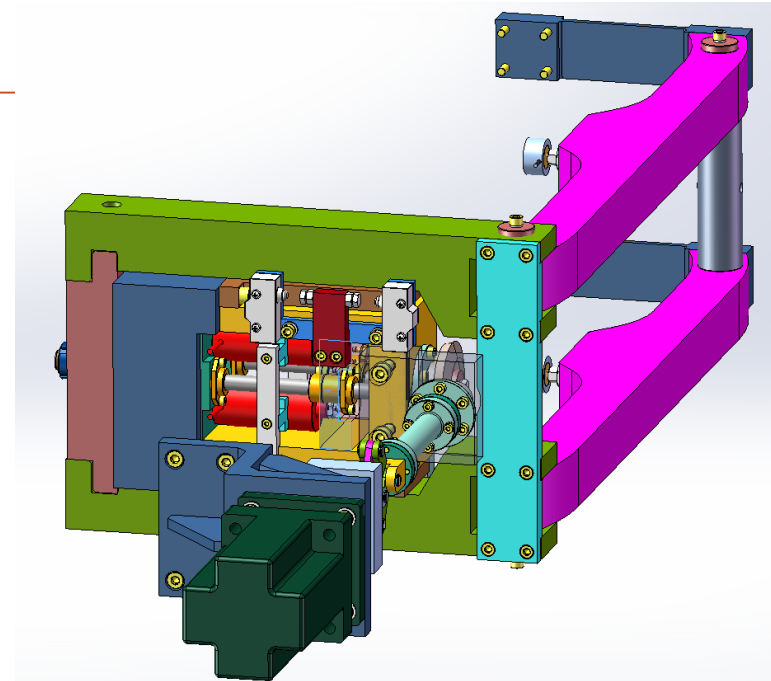
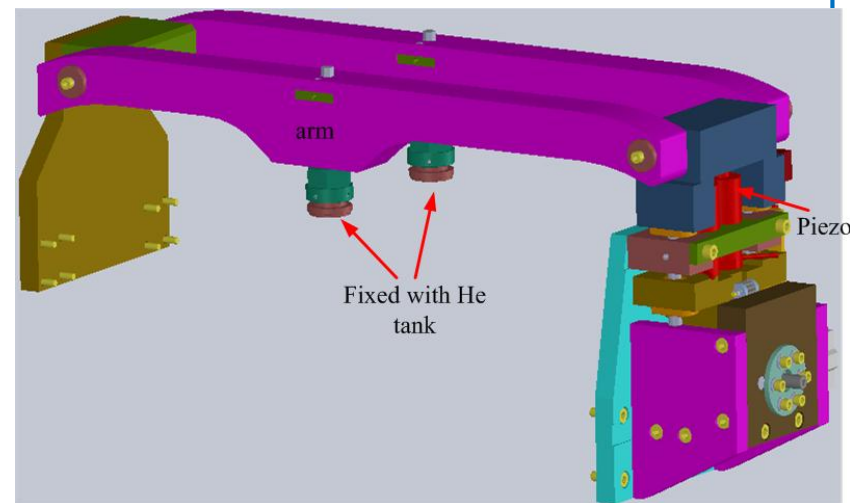
Tuner issue

- Switch from pushing to pulling help reduce df/dp
- Severe backlash and overshoot possibly caused by gears and joints
- They were replaced from service port, which helped more or less

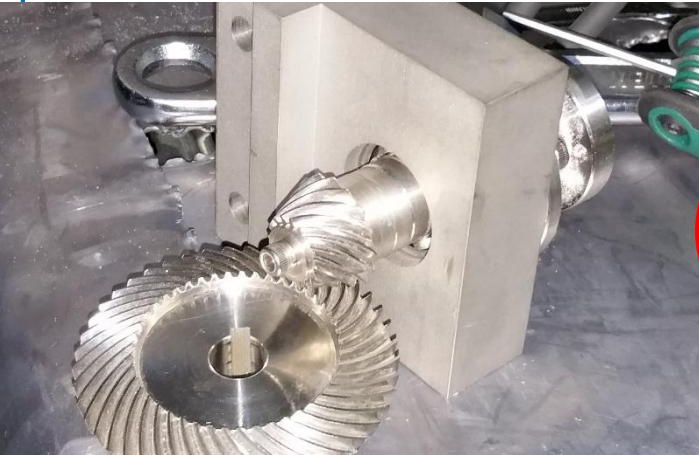
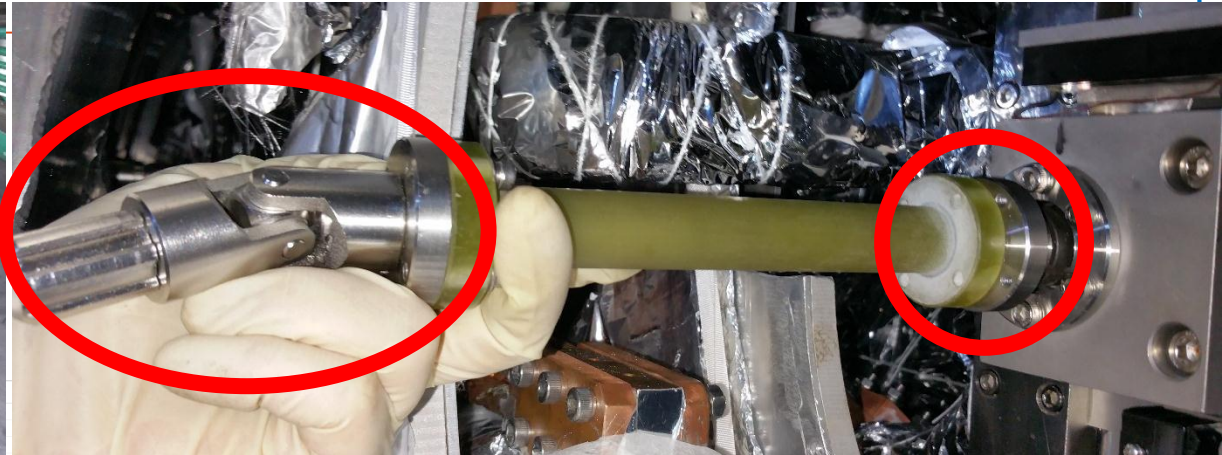
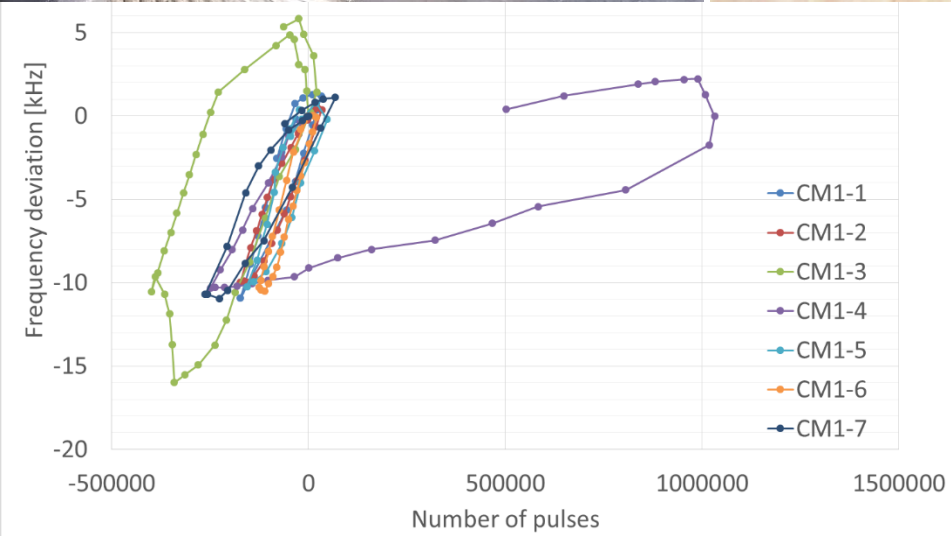
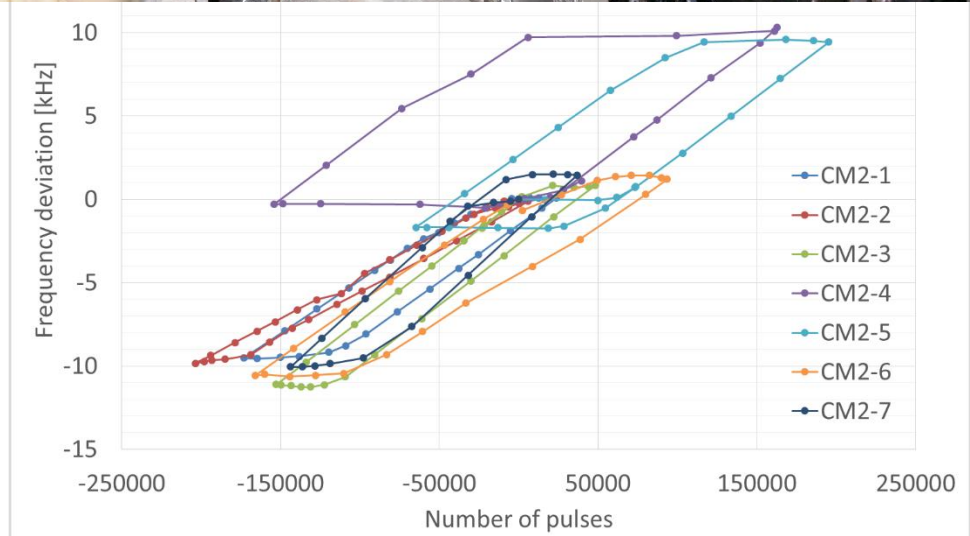
Tuner issue (2)

CM1-1	CM1-2	CM1-3	CM1-4	CM1-5	CM1-6	CM1-7	CM2-1	CM2-2	CM2-3	CM2-4	CM2-5	CM2-6	CM2-7
Overshoot [Hz]	55	105	5200/ 2995	1120/ 215	500	155	117.5	35	0	102	123	104.5	139	27.5
