# FNAL Cavities: QA/QC, qualification, work flow

Alex Melnychuk, Anna Grassellino, Chuck Grimm, Sebastian Aderhold, Damon Bice

September 13, 2016

# Steps of Incoming Inspection for LCLS-II cavities

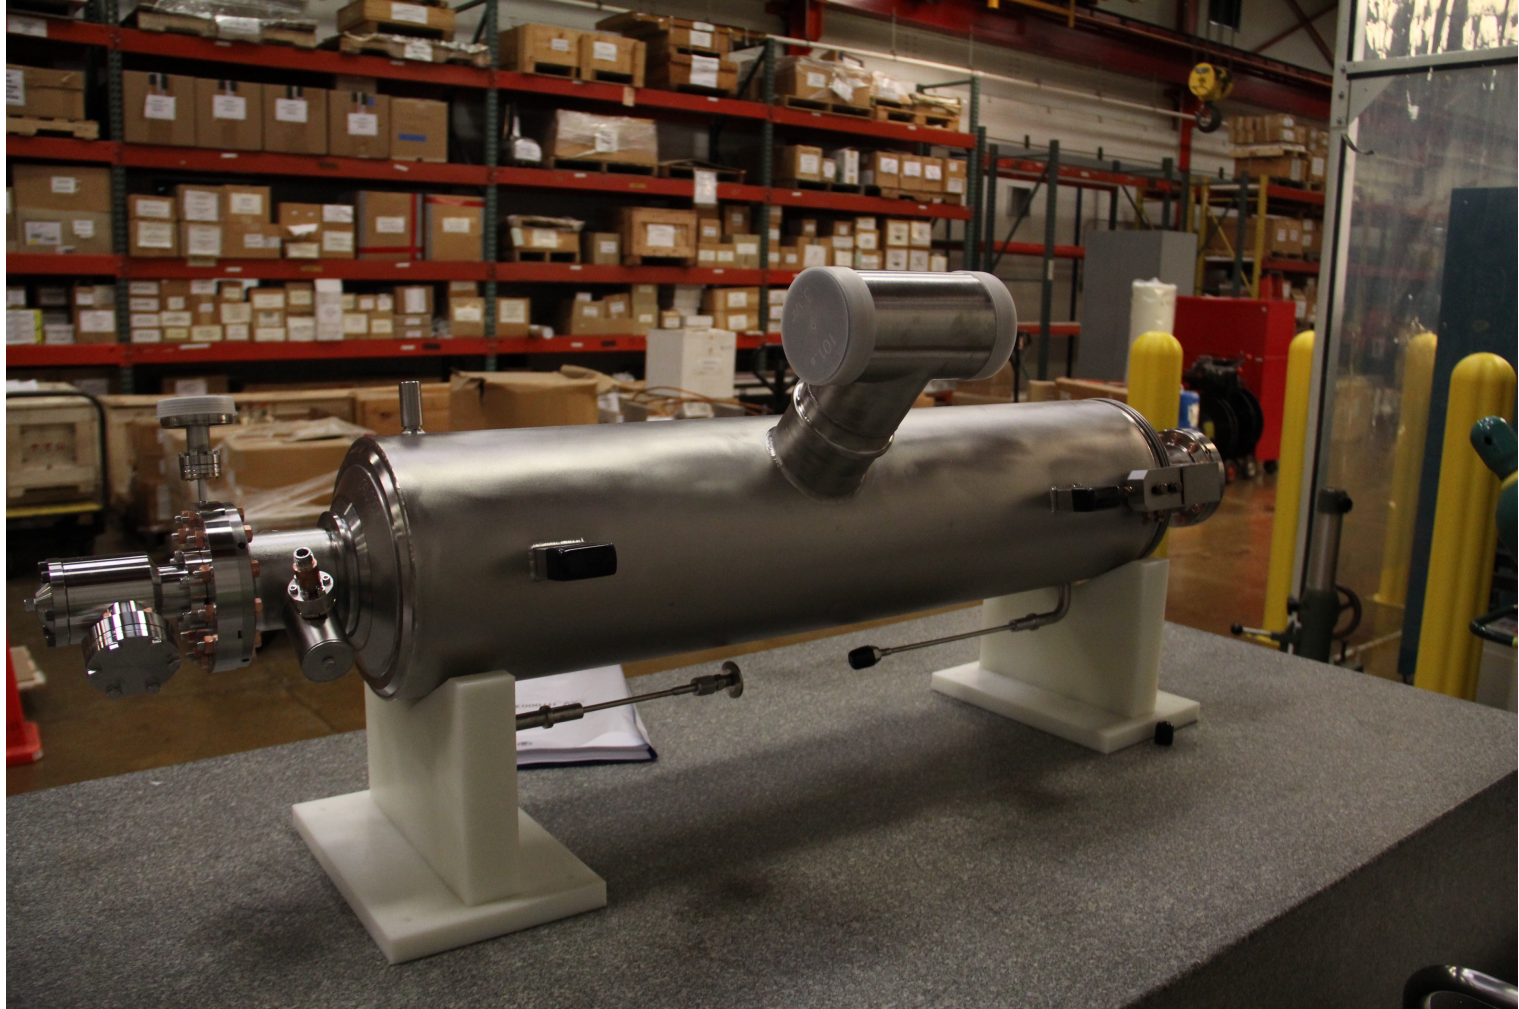
# Cavity in IB4, incoming inspection

- **Visual incoming inspection**
  - Check for visible damage
  - Check presence of all components (screws, washers, feedthroughs,...)
  - Recording serial numbers of all parts in circulation
- **Leak check of Helium space**
  - Only Helium space of the Helium vessel is checked, no connection made to (clean) cavity vacuum
- **RF incoming inspection**
  - Measurement of cavity fundamental and HOM frequency spectrum
  - Measurement of external Q of all antennas
- **CMM measurement**
  - Check certain critical dimensions
  - Only performed on each cavity during early production
  - Might be fully waived or only extended to subset of cavities if no deviations from measurements at vendors are found

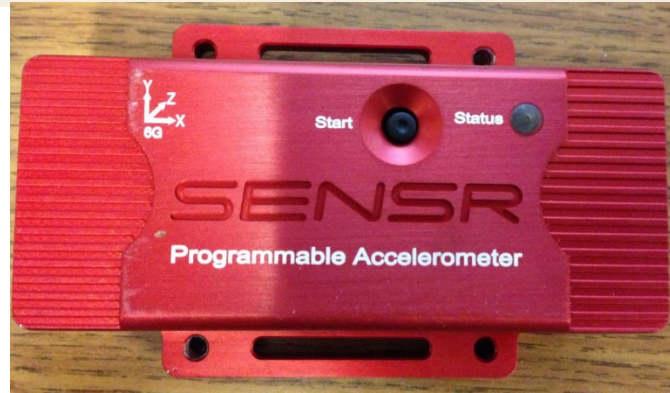
- All cavity data analyzed and at acceptable levels
- CAV0003 example – Data captured in Incoming Inspection Traveler 464305

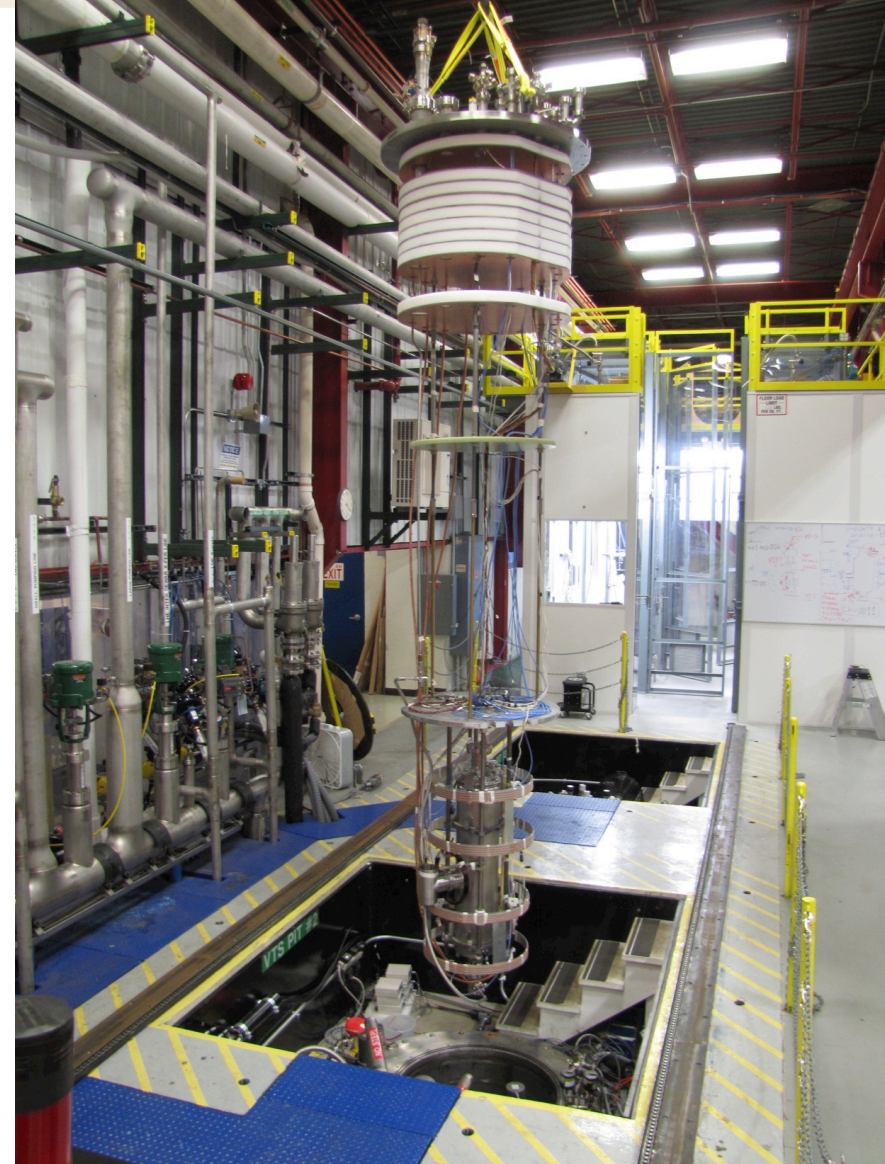
# IB1 Vertical Test Facility

- Three vertical test dewars for SRF cavities measurements
- Using two dewars VTS-2 and VTS-3 for LCLS-II Production (cavities do not fit in VT1), each dewar can safely host 2 LCLS-2 cavities simultaneously
- Cryogenics shared among several different programs – magnets and SRF testing
- Capability of adjusting cool-down rates, test T from 4.2K down to 1.4K
- Remnant magnetic fields < 5 mGauss (passive shielding), and < 2 mGauss (active compensation via coils)
- No active pumping – cavities will either be tested as received in static vacuum or after re-evacuation in clean room (half of cavities have been tested as received 1e-4Torr and half after re-evacuation 1e-6 Torr, no noticeable performance difference)

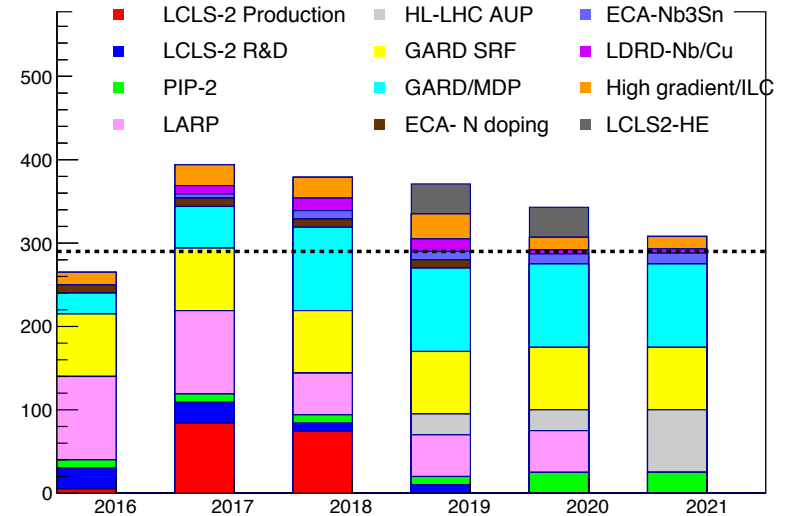
Figure 1. Projection for total number of test days (at cryogenic temperature ~2K), versus fiscal year. Dashed line indicates maximum number of days available at cryogenic temperature.

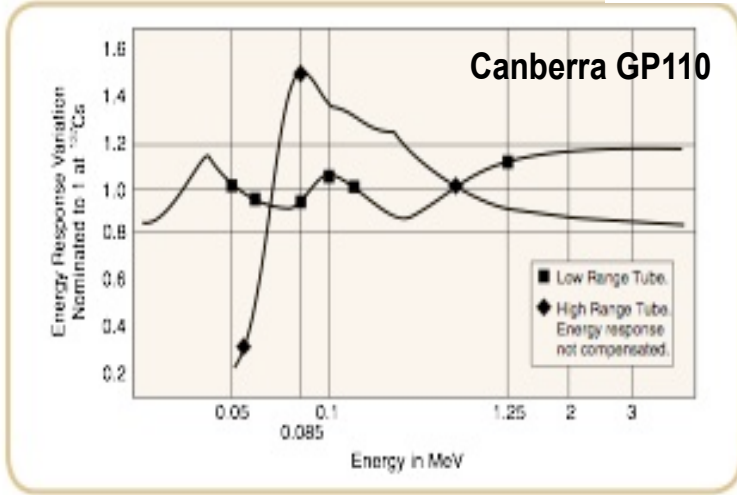
# Field Emission Detection

top detector (on the top plate)

bottom detector  
(bottom of  
construction pit)

- Top detector Canberra GP110
- Bottom detector very similar but smaller size to fit in the available space at the bottom of the dewar: Canberra GP100M
- Installation and commissioning of bottom detector is on schedule

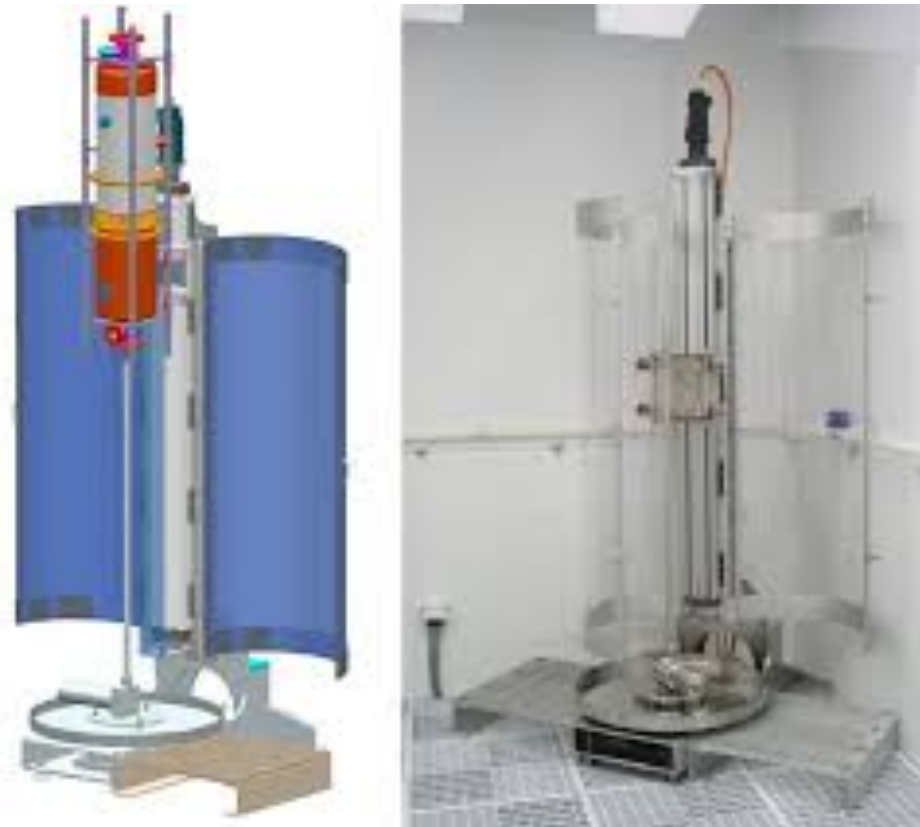
SCSPF HPR TOOL

- Superconducting **C**avity **S**urface **P**rocessing **F**acility
- Built as part of the joint ANL / SCSPF facility
- Utilizes self contained apparatus
- Located in Class 10 Cleanroom

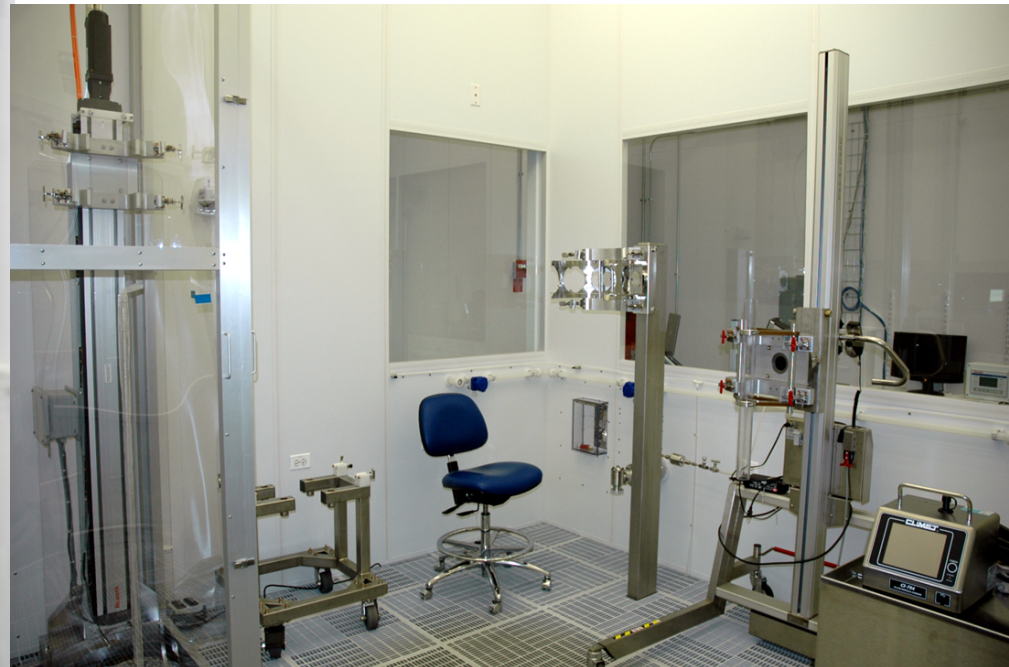
CPL HPR Tool

- **C**avity **P**rocessing **L**ab
- Tool isolated from room by doors
- Located in Class 10 Cleanroom

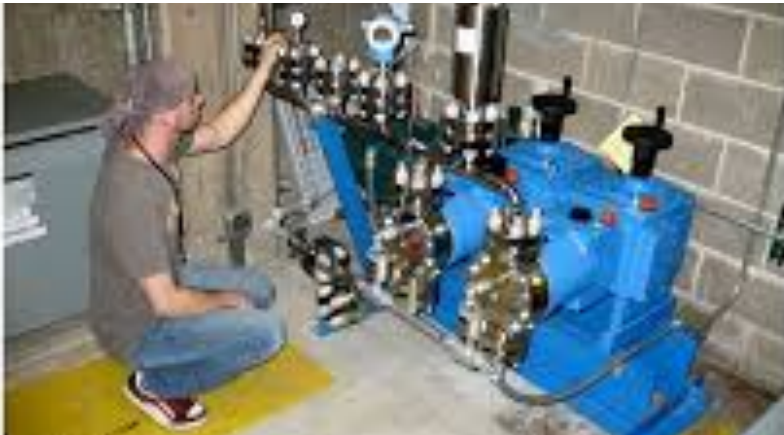
# High Pressure Rinse Water Delivery

- Lewa Diaphragm Pump
- Electropolished S.S. high pressure delivery manifold
- 1200 p.s.i water delivered from two 45 degree fanjet nozzles
- Each nozzle delivers approximately 2 GPM

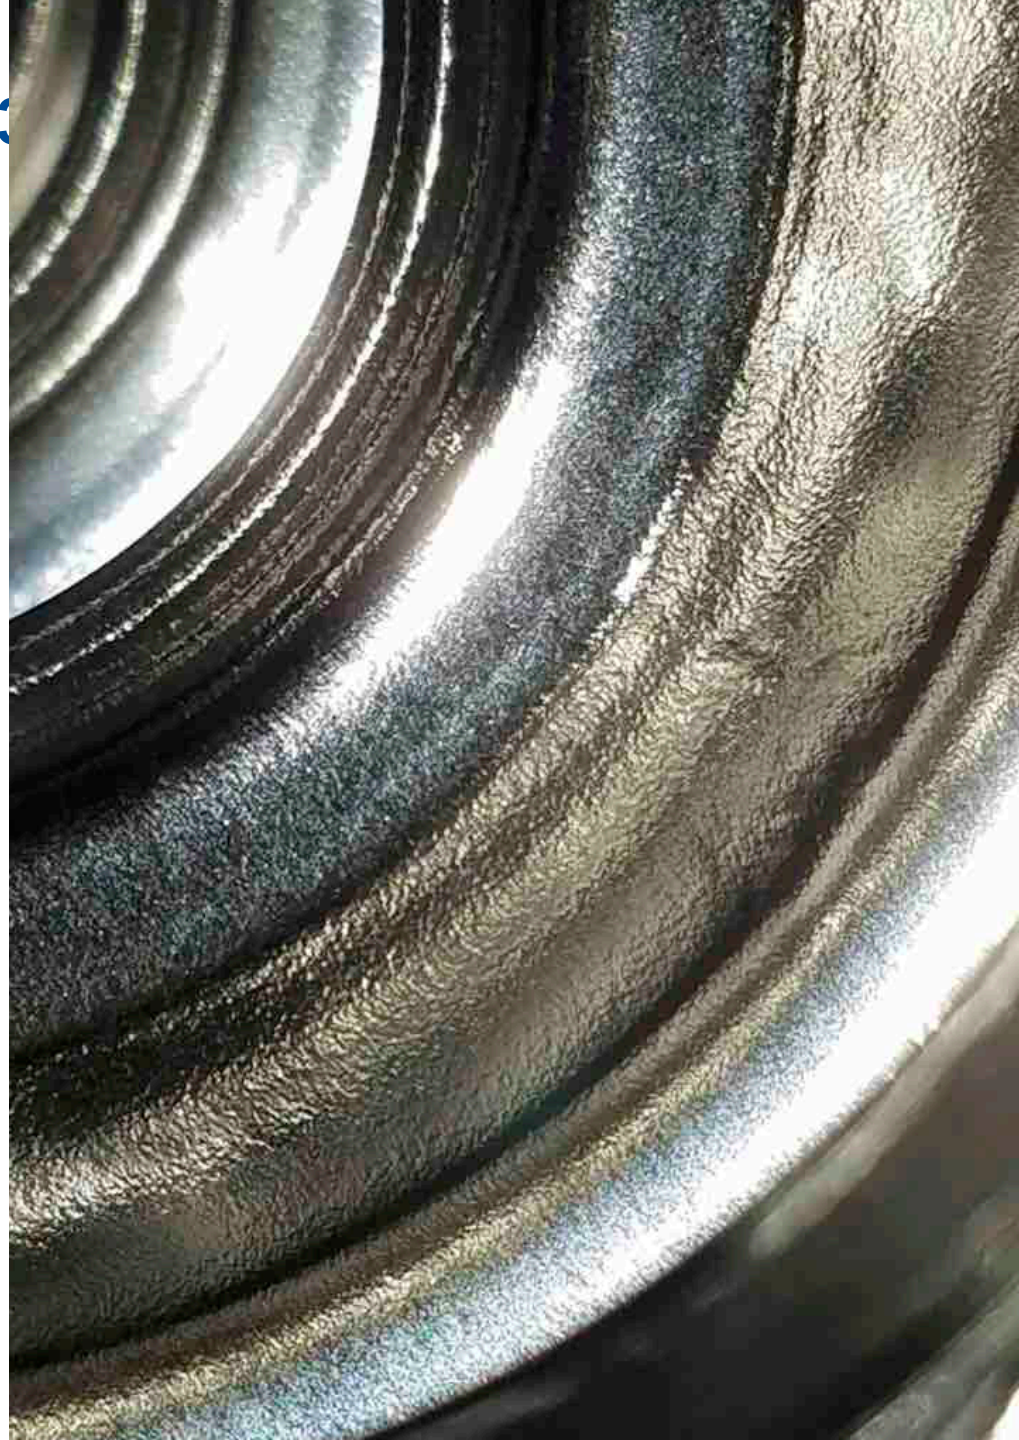
## Optical inspection – CAV003

No major features revealed (no scratches, etc)

But very strange surface appearance – bumpy and wrinkly – not sure why?
