# First TPB coating test and measurements

03/07/2017 Light Det. Sys. Meeting

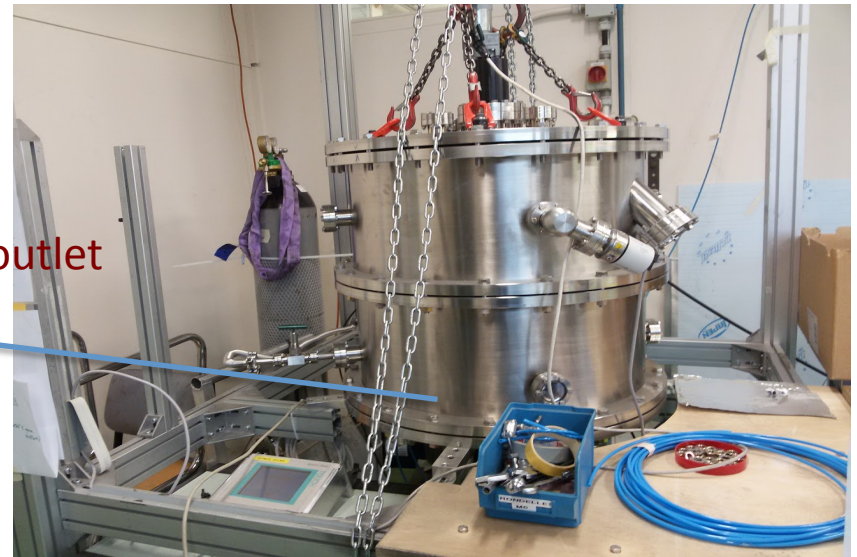
TPB evaporator outlet

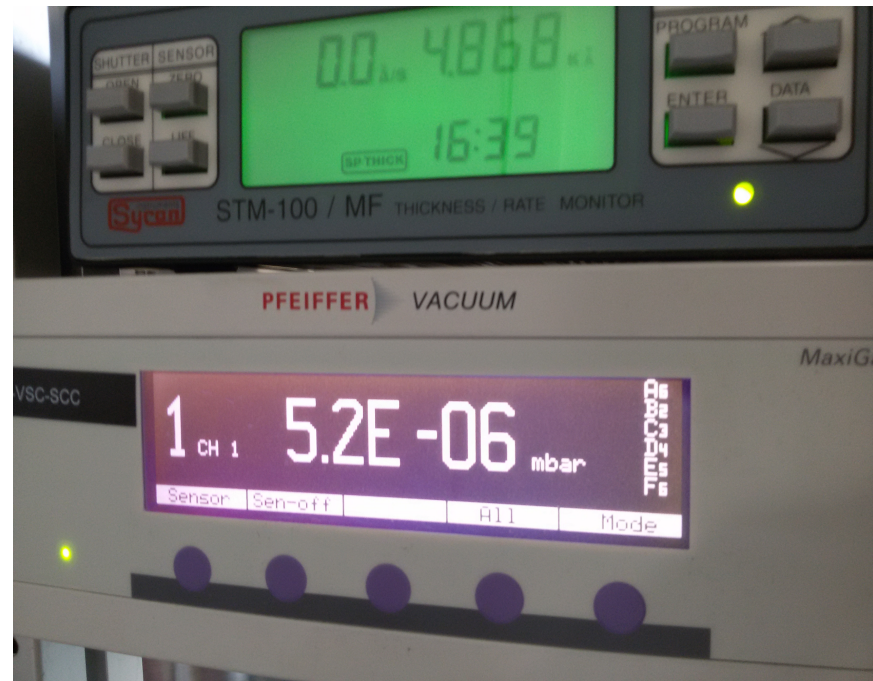
Cristal sensor: measure deposition rate of TPB. Used to checked that all TPB is evaporated

Vacuum measurement sensor.  
Two pumps, 1 turbo pump.

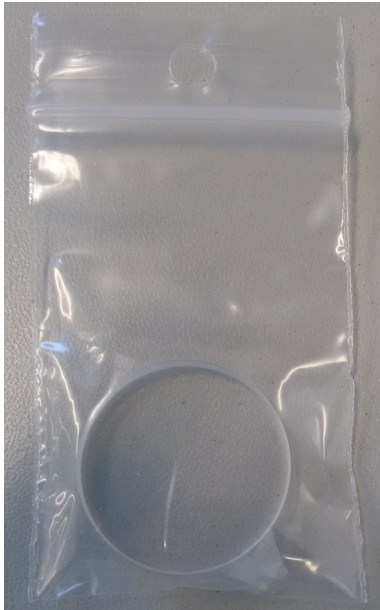
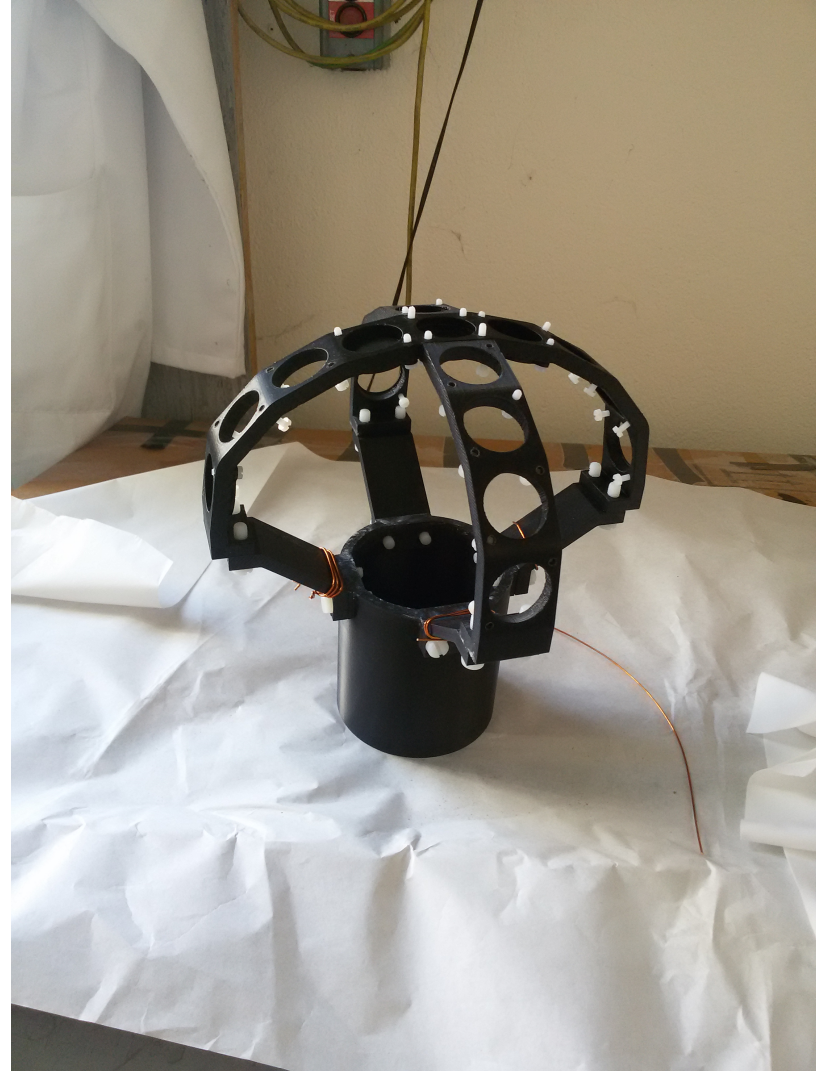
- Measure coating uniformity along the PMT surface
- Use glass cylinders samples mounted on 3D printed mockup

Longer vacuum pumping needed first likely due to plastic outgassing

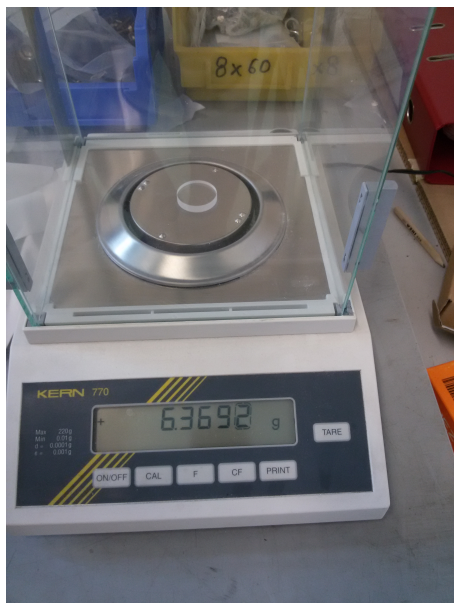
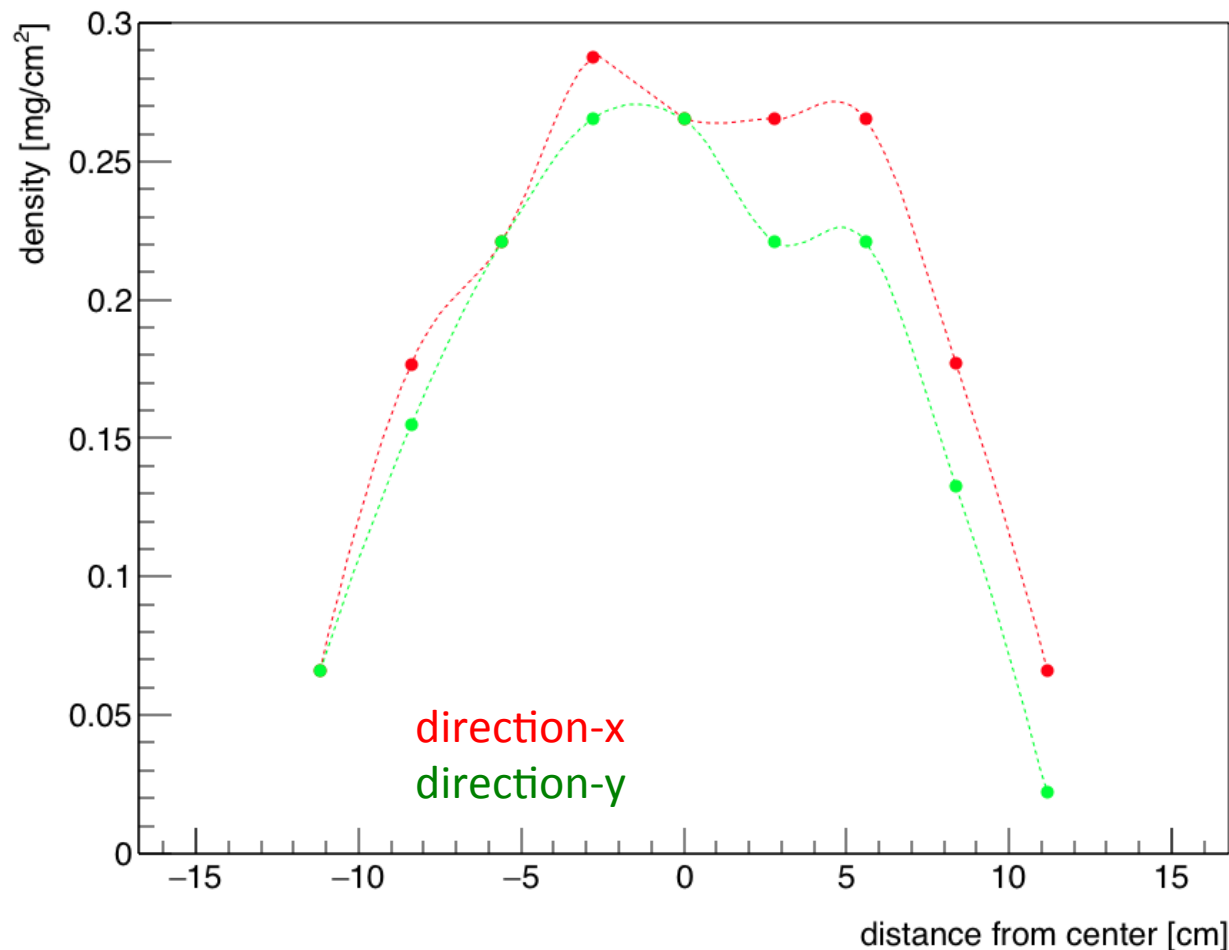
TPB density along the PMT surface

TPB evaporated: 0.8 g

By weighting samples before/after the coating

Similar values obtained with Mylar foils (placed in the center of the PMT)

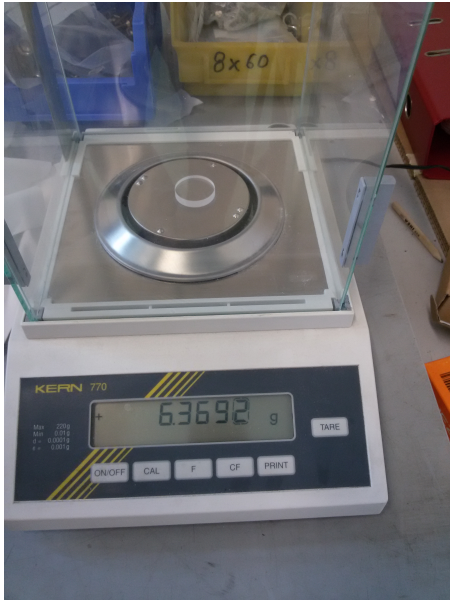
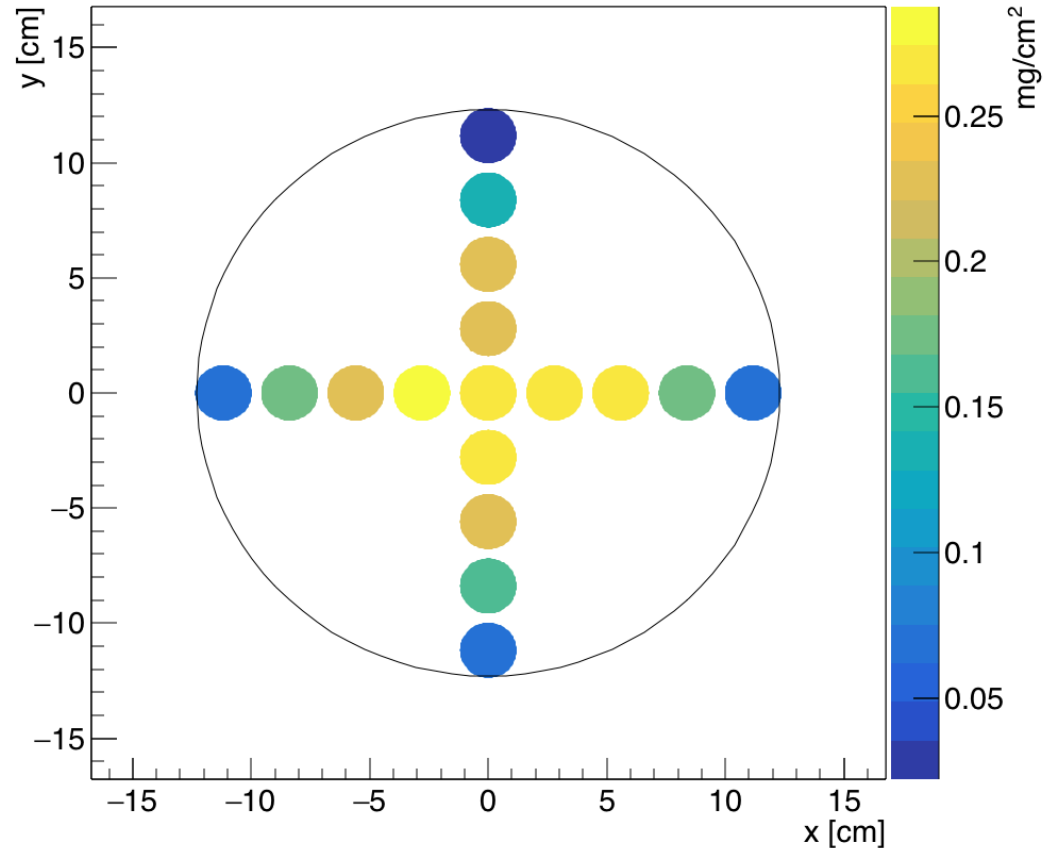
TPB density along the PMT surface

TPB evaporated: 0.8 g

By weighting samples before/after the coating

Similar values obtained with Mylar foils (placed in the center of the PMT)

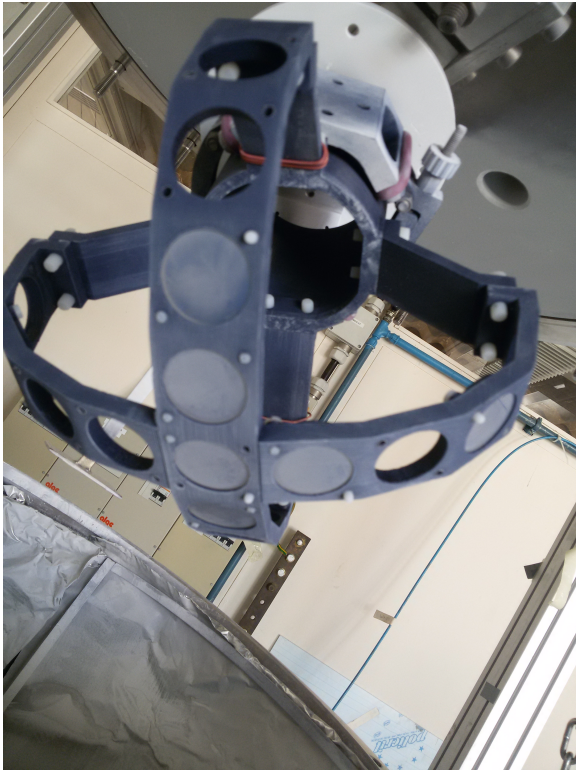
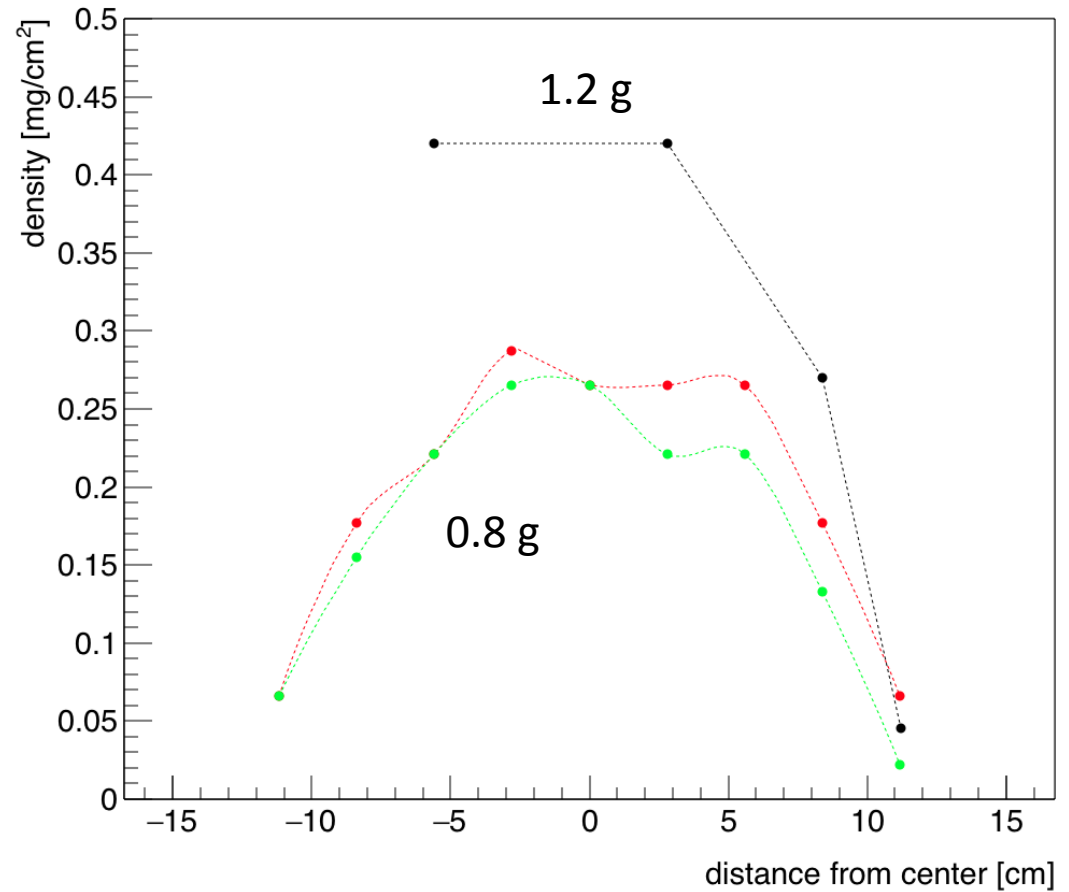
TPB density along the PMT surface

TPB evaporated: 1.2 g

Only on a few samples
