Progress of specimen cutout and damage inspection for used mercury target vessel at J-PARC

Neutron Source Section, Materials and Life Science Division,
J-PARC Center, Japan Atomic Energy Agency

Beam window cutting for target No.2

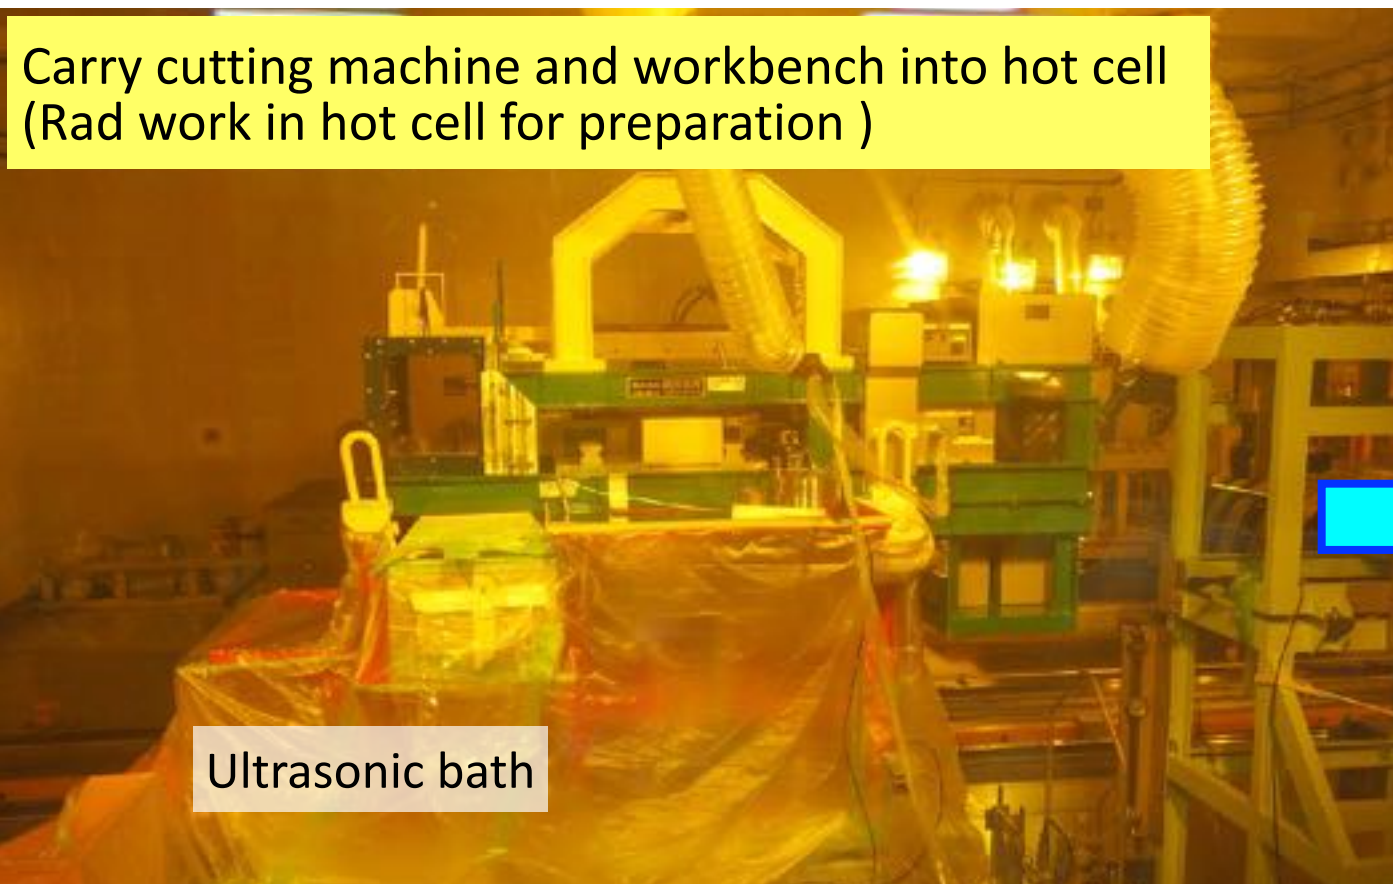
Carry cutting machine and workbench into hot cell
(Rad work in hot cell for preparation)

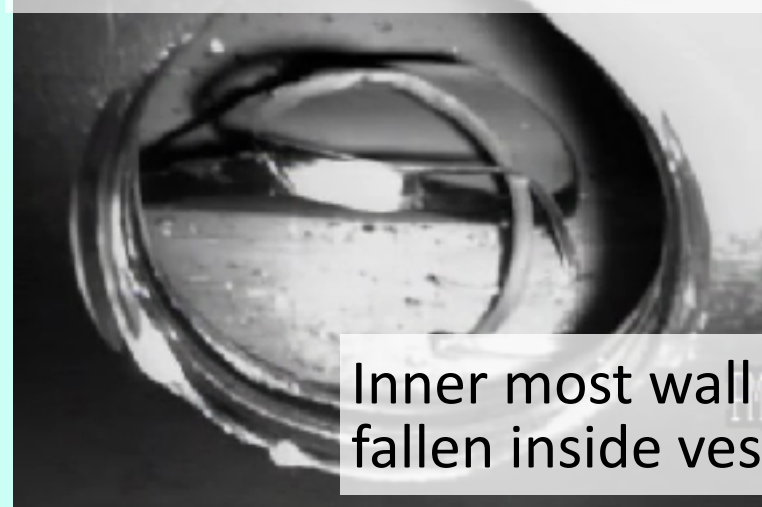
Target No. 3 (Gas microbubble injection)

Failed

Inner most wall of target #3
fallen inside vessel

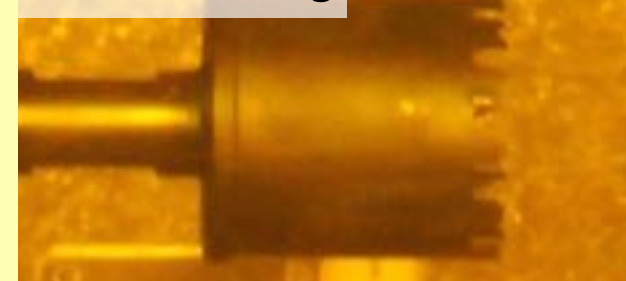
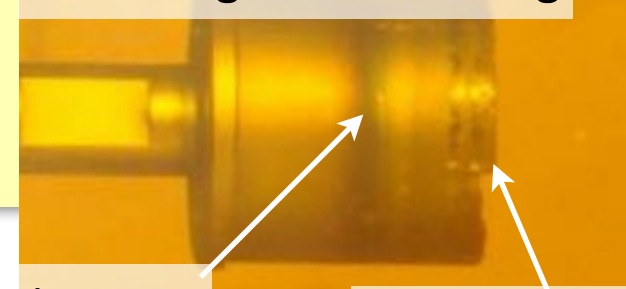
Before cutting

After Target No.5 cutting

Discoloration

Saws broken

Improve saws damage by dry cut, surely pick up specimen

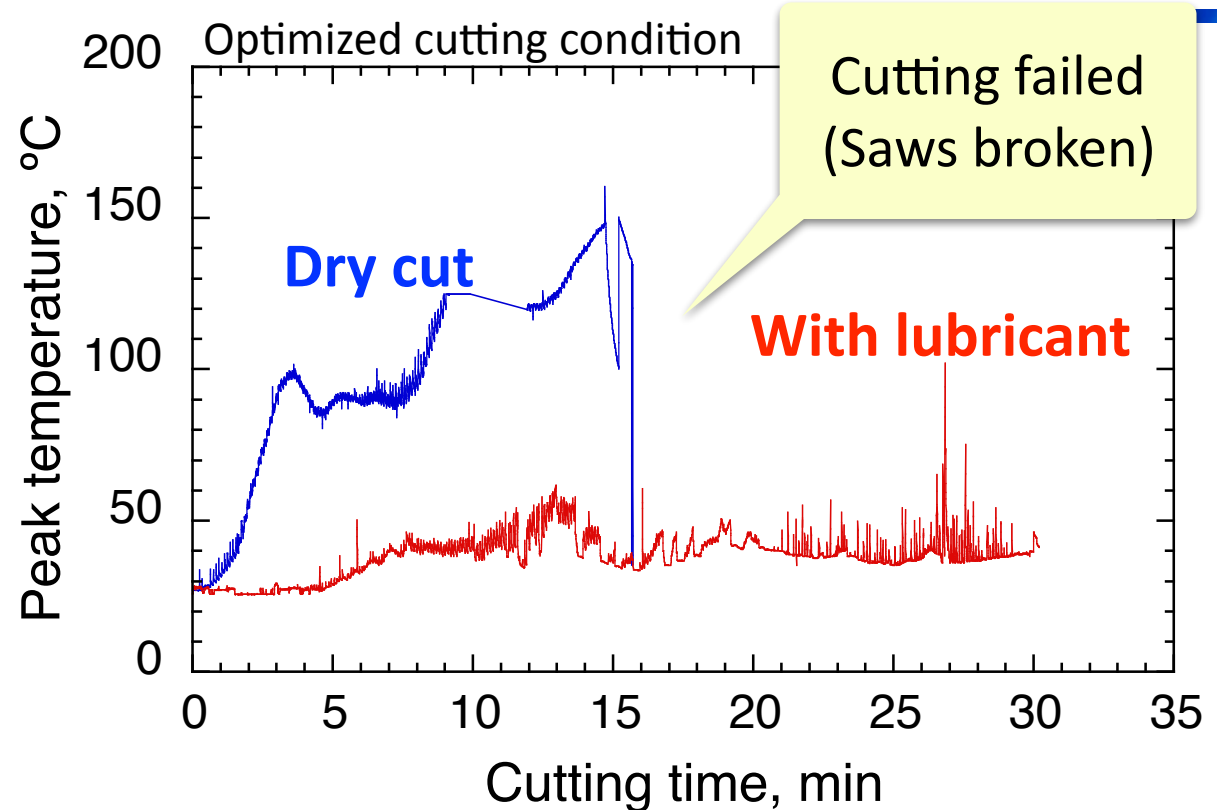
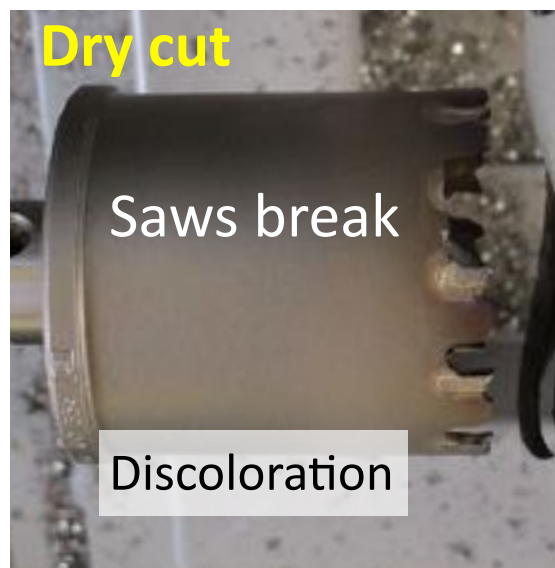
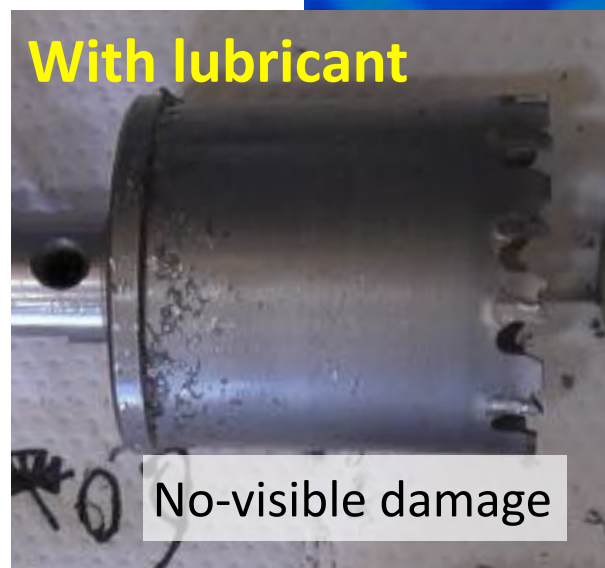
Effect of lubricant on temperature

- Surface temperature of cutter and beam window were reduced by lubricant
- No visible damage on cutter after cutting with lubricant
- Lubricant is essential for surely cutting
- Center drill is difficult to adjust position for resume cutting

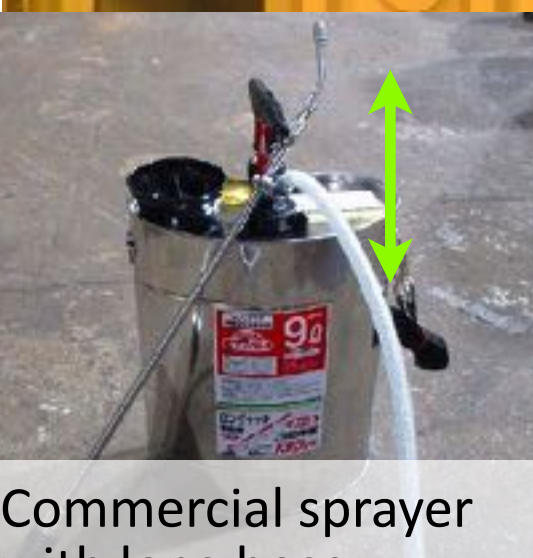
Water shroud surface
Cutting position is 12.5 mm offset from center to downstream

Hose inserted into hot cell by through wall plug
Cutting time: 32 min
Lubricant usage: 900 ml
Tritium release was reduced by reducing cutting temperature

Target No.2 cutting was successful by adopting lubricant spray

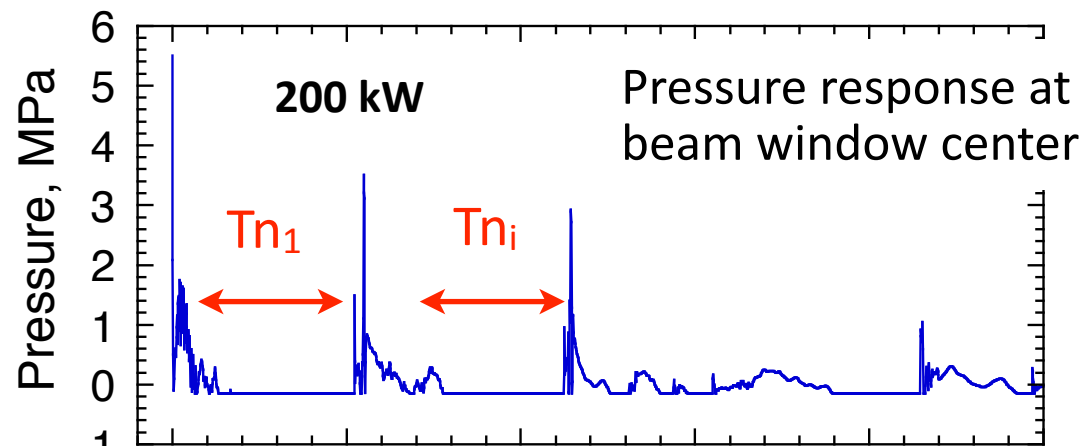
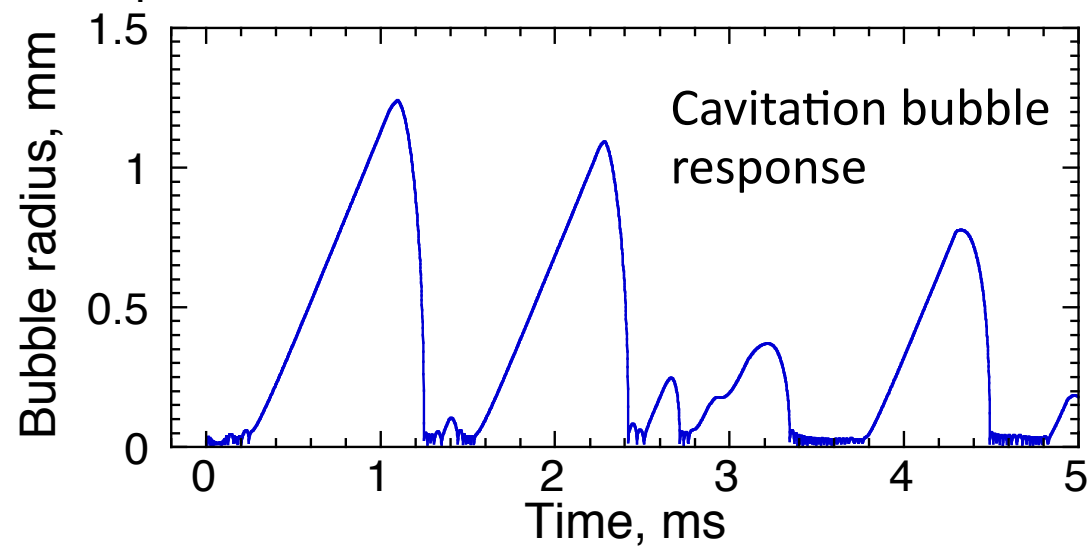
Negative pressure distribution

Longest negative pressure period $\text{Max}(T_{ni})$

- Cavitation bubble radius is proportional to negative pressure period T_n
- Distribution of damage cluster is correlated with the negative pressure period ($\text{Max}(T_{ni})$)
