Commissioning of the CMS Pixel Barrel Detector

Lea Caminada
PSI | ETH

23. 09. 2008

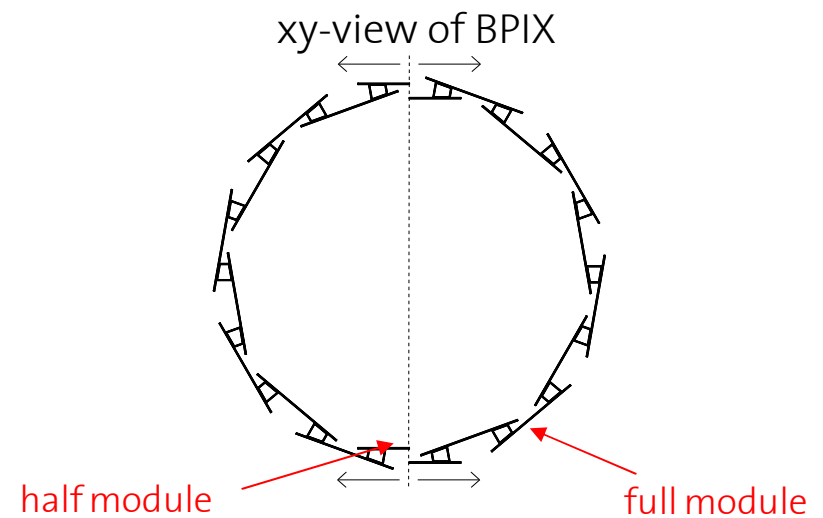
CMS Pixel Detector:

- 3 layers at 4, 7 and 11 cm
- 2 disks on each side at 34 and 46 cm

Barrel Pixel Detector:

- 672 full modules (16 ROCs)
- 96 half modules (8 ROCs)
- 48M pixels
- Pixel area: $100\mu\text{m} \cdot 150\mu\text{m}$

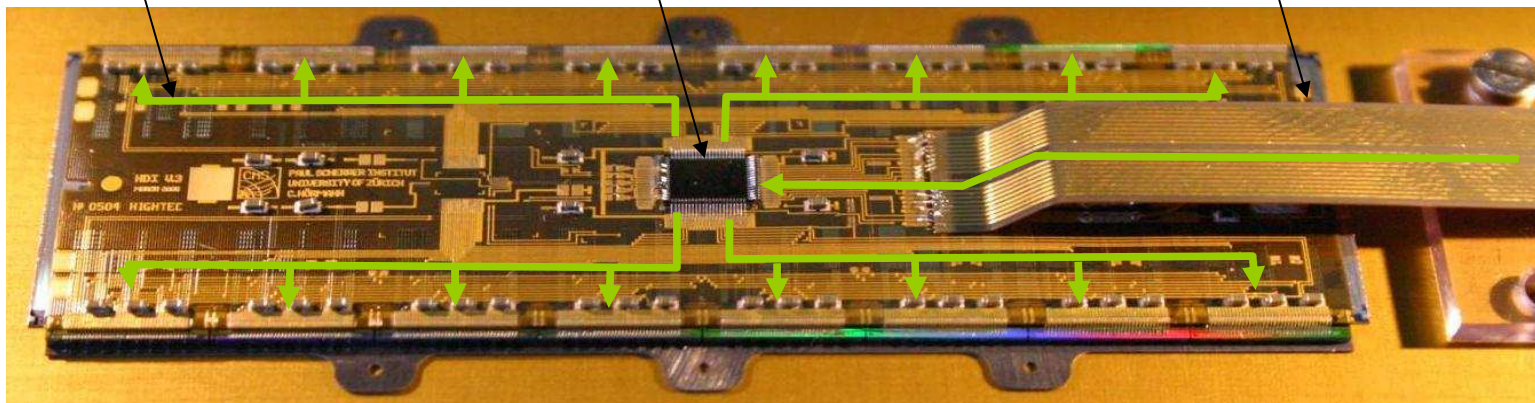
ROC

TBM

signal cable

•control distribution: clock, trigger, i2c

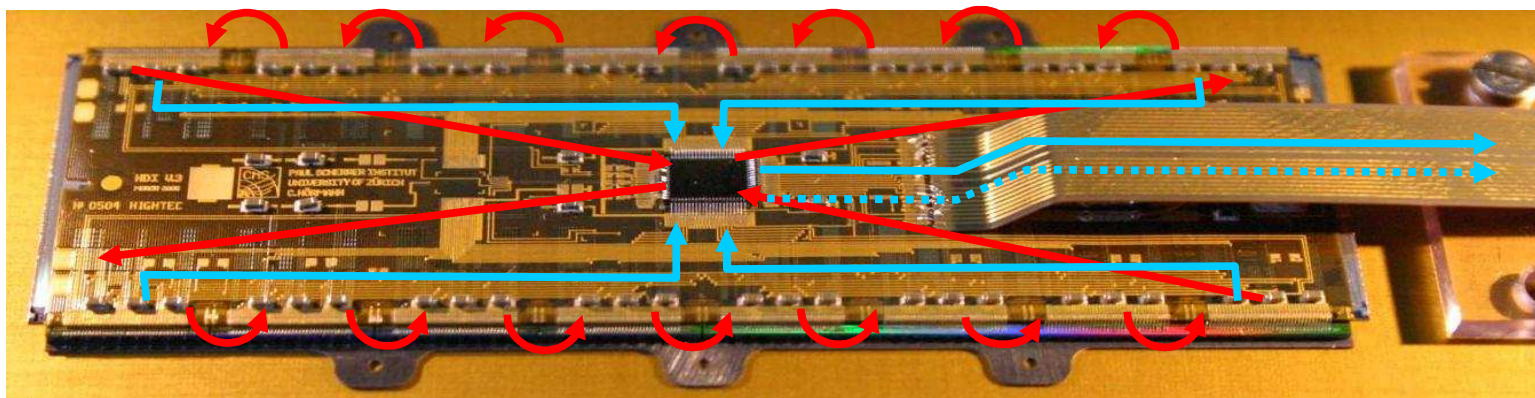
•readout token: TBM→ROC₁→...→16→TBM
•analog readout

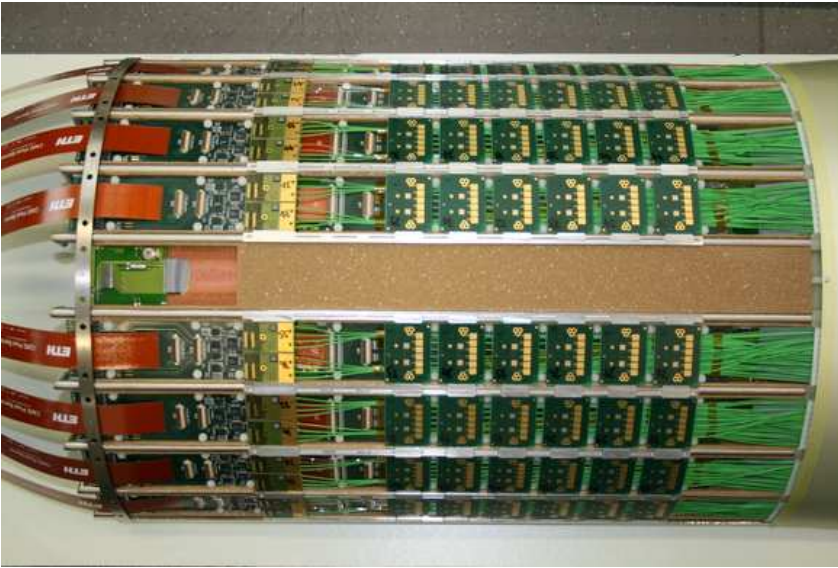
Detector side

Supply Tube

4 supply tubes, 4 CCU boards for detector control

Each of the 32 sectors of the Barrel Pixel detector contains:

- 2 Delay25, PLL, DOH
- 6 AOH (with 6 lasers)
- 4 kapton cables which connect supply tube to detector end flange

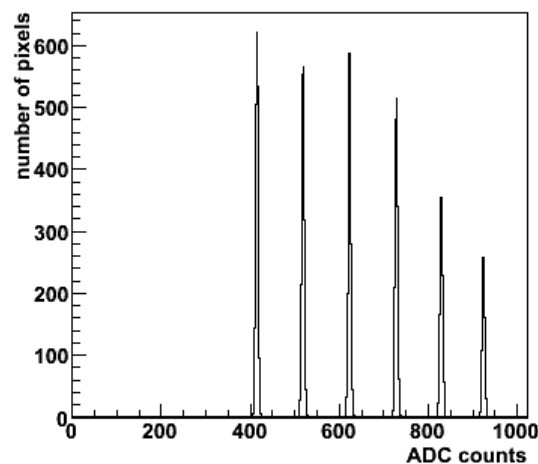
Results for 1 ROC:
Address Level Calibration

- Establish optimal settings (Delay25, PLL, DOH, AOH)
- Determine working region for each ROC
- Address Level Calibration
- PixelAlive
- HV test
- Pixel Noise and Thresholds (SCurve: efficiency as function of V_{cal})

- 4 modules lost (3: no HV, 1: no token, 1: bad ROC header)
- 1 module with bad TBM header (recovered by re-routing)
- 4 individual ROCs that do not respond
 - => in total: 100 non-working ROCs (out of 11520 => 0.9%)
- Address level: RMS 2.5-6 (separation of levels ~100)
- Vcal thresholds extracted from SCurves: mean = 6693 e⁻, RMS = 585 e⁻
 - => thresholds not yet adjusted: need further calibration

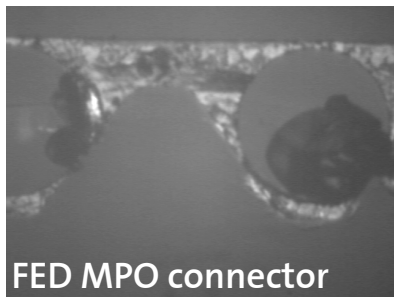
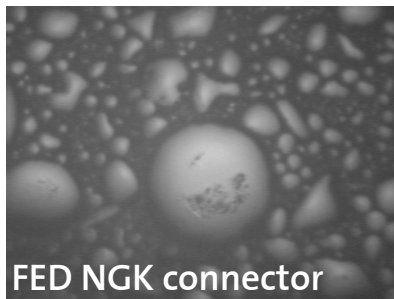
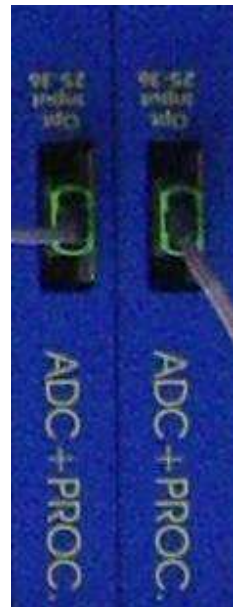
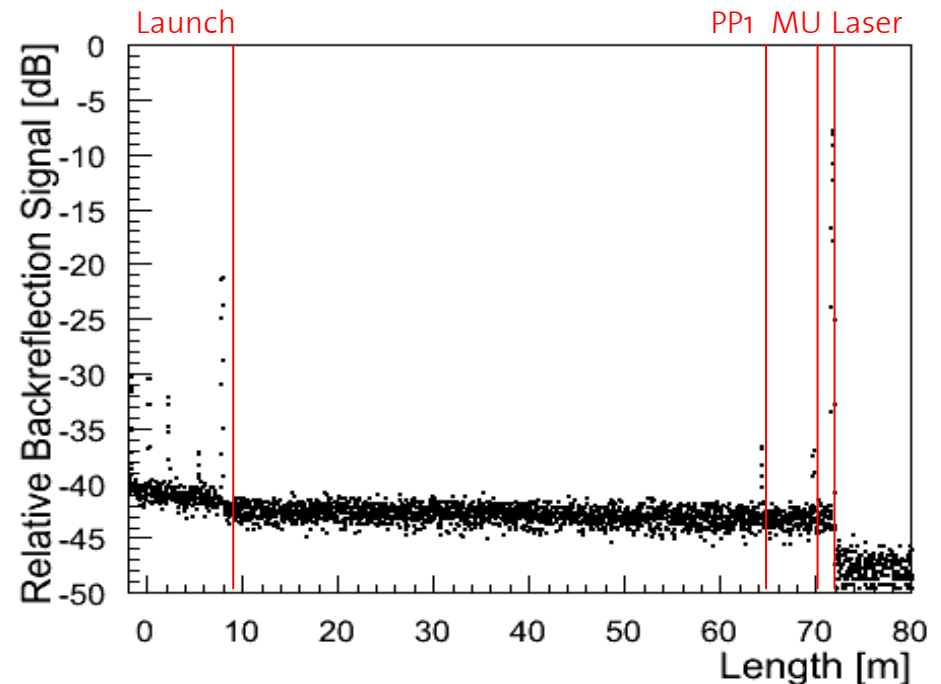
Optical Connections

- 29 ribbons investigated with OTDR and microscope
- all PPO connection good
- 1 bad PP1 connection => recoverd by using spare ribbon
- 19 fibers have reflection at MU connector (11 fibers => noisy, low slope)
- 10 fibers with permanent marks at FED connector
- no fiber lost during all operation

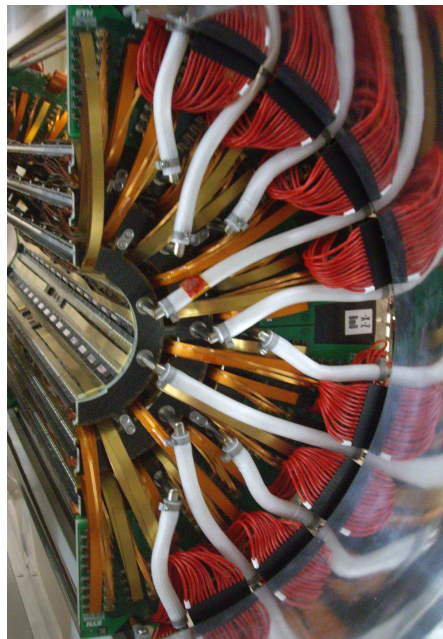
10 cooling lines
(detector end flange)

- C_6F_{14} used as cooling fluid
- 10 cooling lines for BPIX
- each module connected to cooling circuit via baseplate
- Analog and digital opto hybrids connected to cooling circuit by placing small aluminum plates on top of them
- Temperature dependence of AOH: 50 ADC counts/ $^{\circ}C$

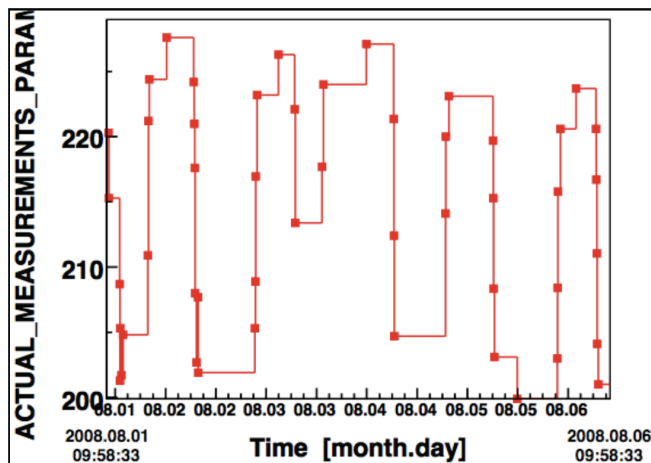
Level of coolant => no leaks
(oscillations due to turn on/off)

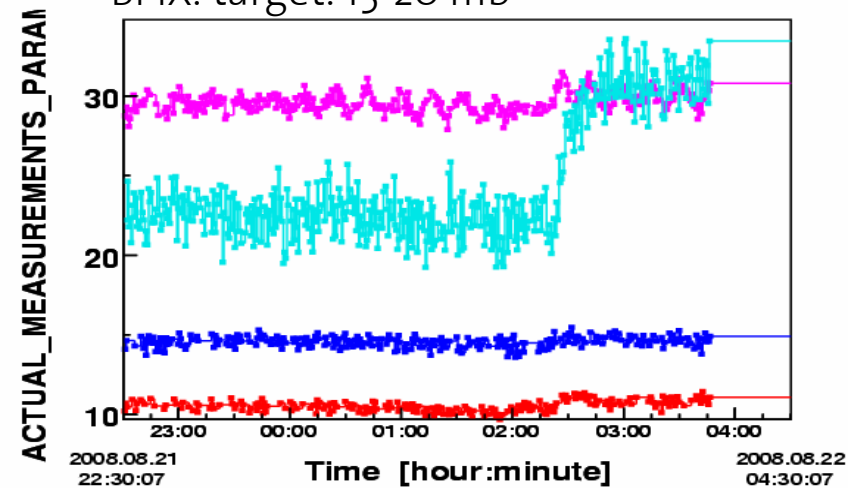
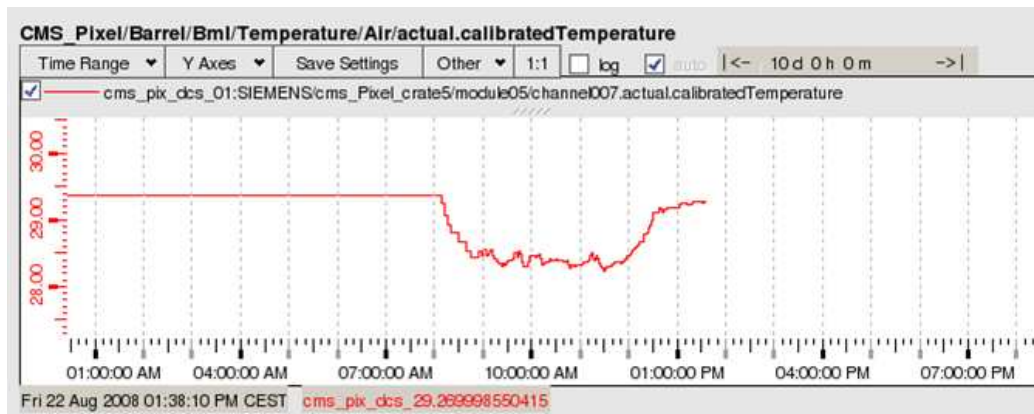
Measurement of differential pressure:
consistent with desired flow rate:
BPIX: target: 15-20 mb

BPIX air temperature when
Strip Tracker is turning off:
Temperature drop of 1.5°C
=> Serious problem for BPIX
(AOH calibration)

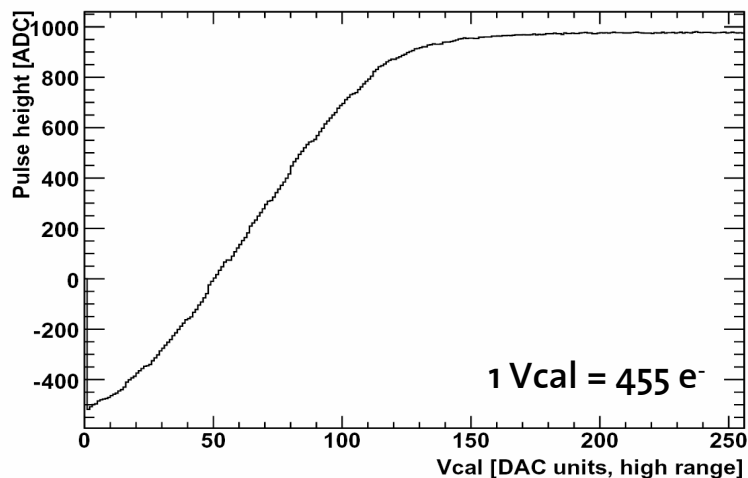
Gain Calibration Curve

Gain Calibration:

- analog readout
=> measure pulse height as function of injection charge (linear range, non-linearity for small Vcal values, pedestals)
- done in module tests, needs to be redone after installation
