Status Of The CMS Pixel Detector

Danek Kotlinski, PSI

Pixel 2008

Fermilab, September 23, 2008

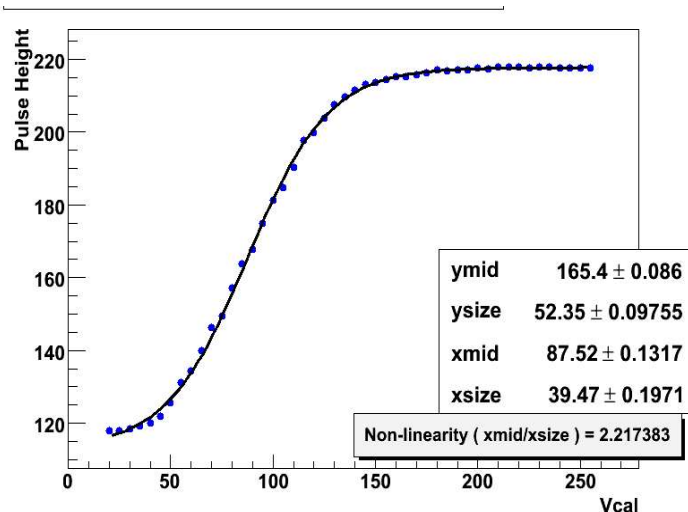
An example of the response of the pixel analog signal.

It worked very well in the LAB and in test beams but we have underestimated the thermal effects in the optical components.

Our AOH (analog optical hybrid) is very, very temperature sensitive, resulting in serious signal drifts (baseline and gain).

This means that in addition to the automatic offset adjustment we need to perform frequent base-line calibrations.

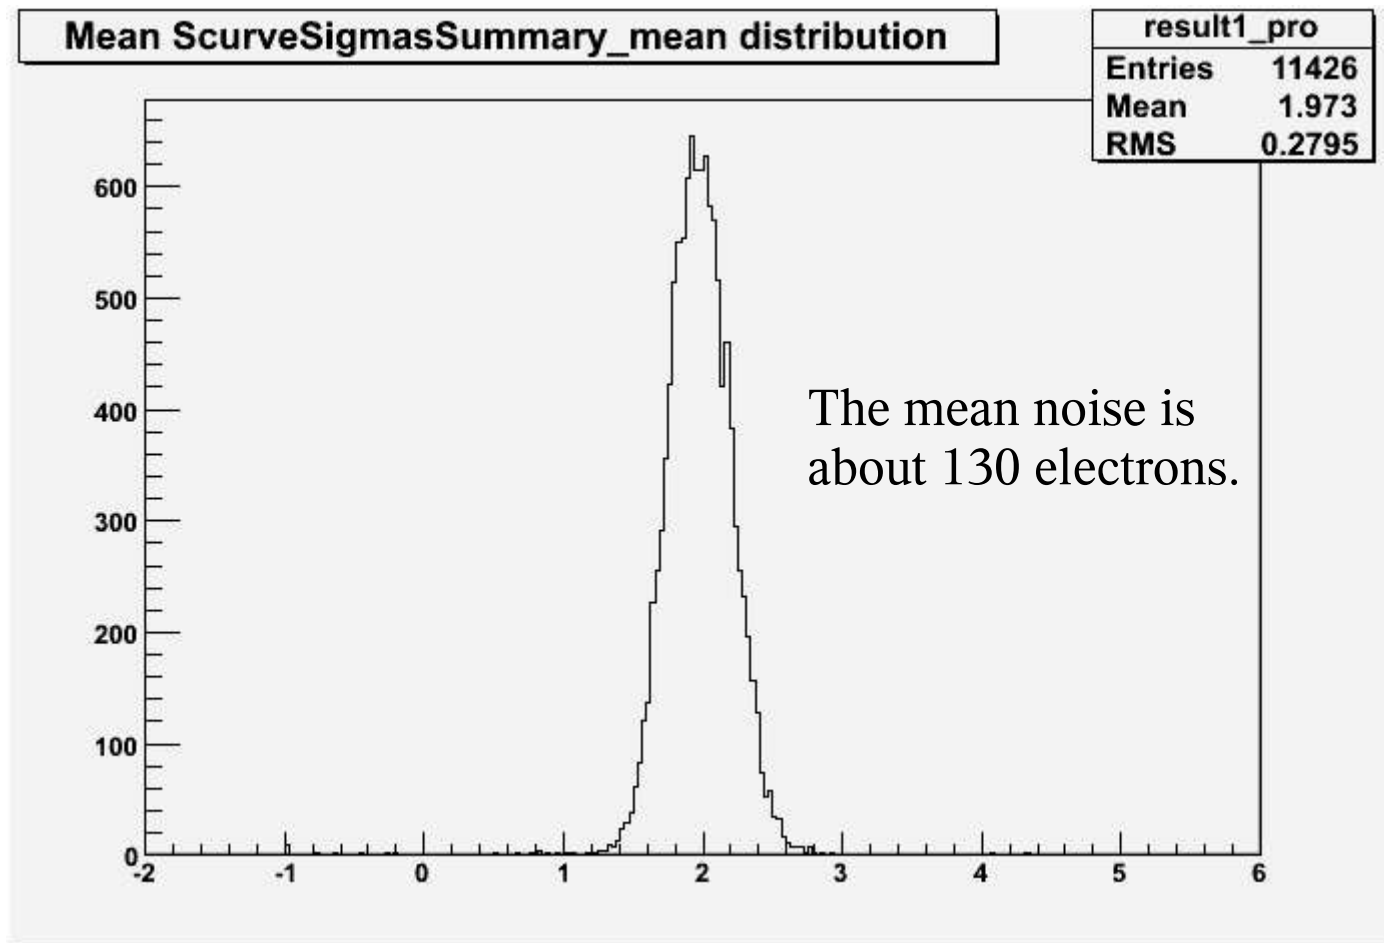
Average noise per ROC

Why is it lower than in the module testing?
