Beam Plug Installation Status in EHN1

Cheng-Ju Lin
15-March-2018

ProtoDUNE-SP ITI Meeting

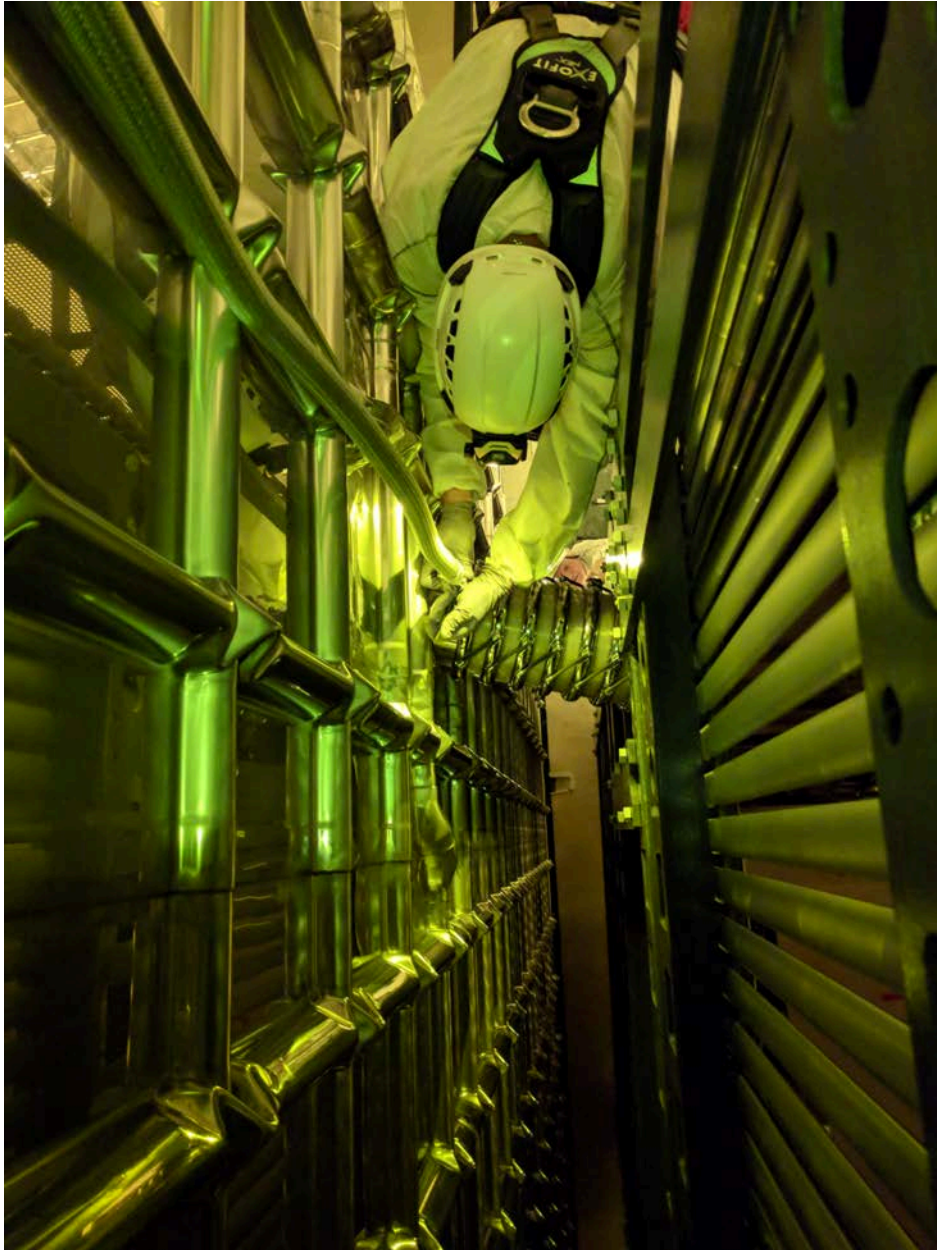
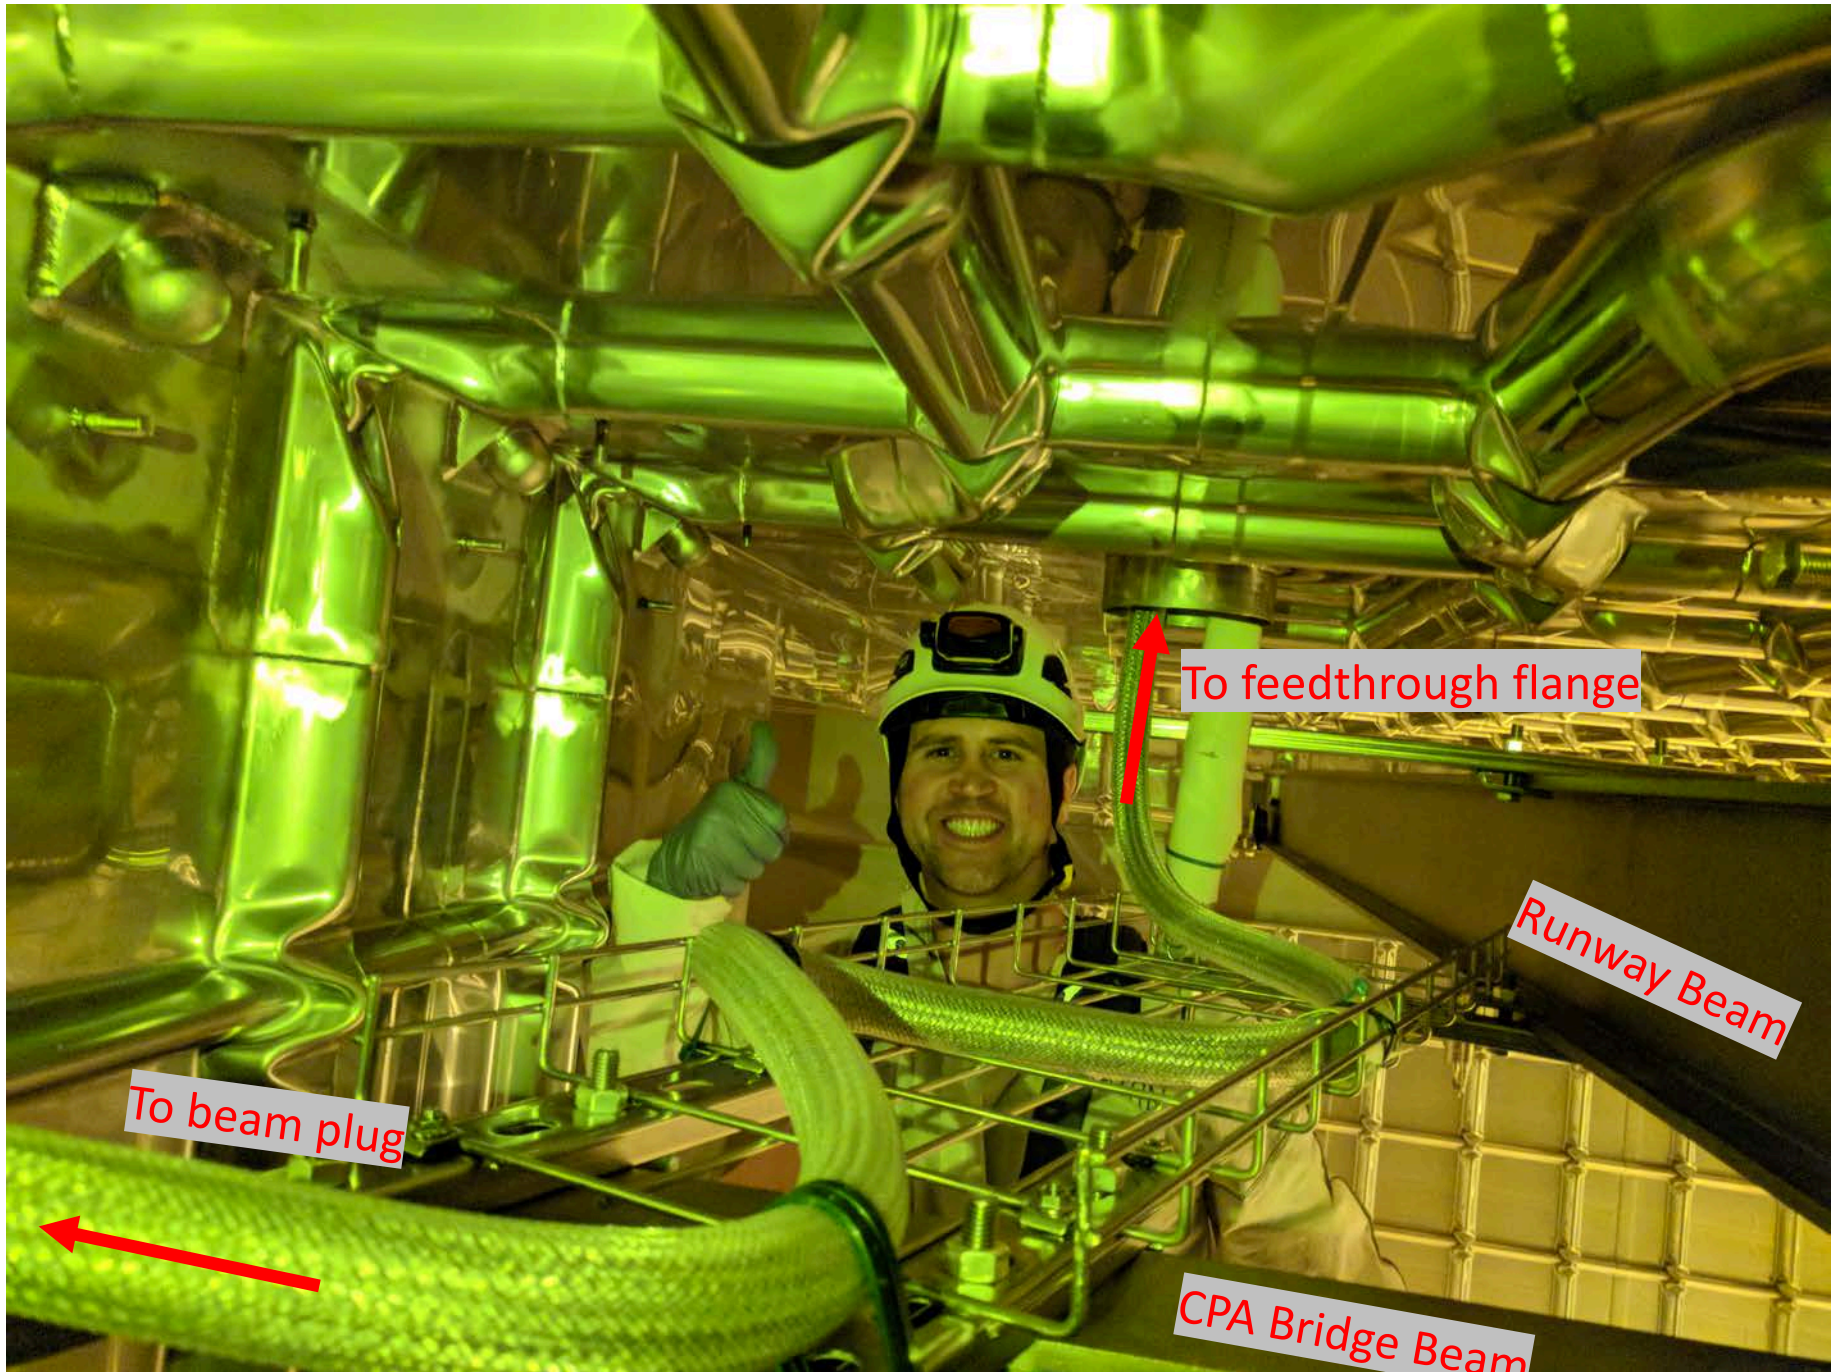
Beam Plug Cable Tray

- Beam plug cable tray installed on top of runway beam and bridge beam C
- For strain relief and routing the ~5m long stainless steel nitrogen hose from the feedthrough flange to the beam plug
- Had to disconnect the hose from the beam plug to remove a twist in the hose
- Thanks to Cole and Jerry for their help

To beam plug

To feedthrough flange

Runway Beam

CPA Bridge Beam

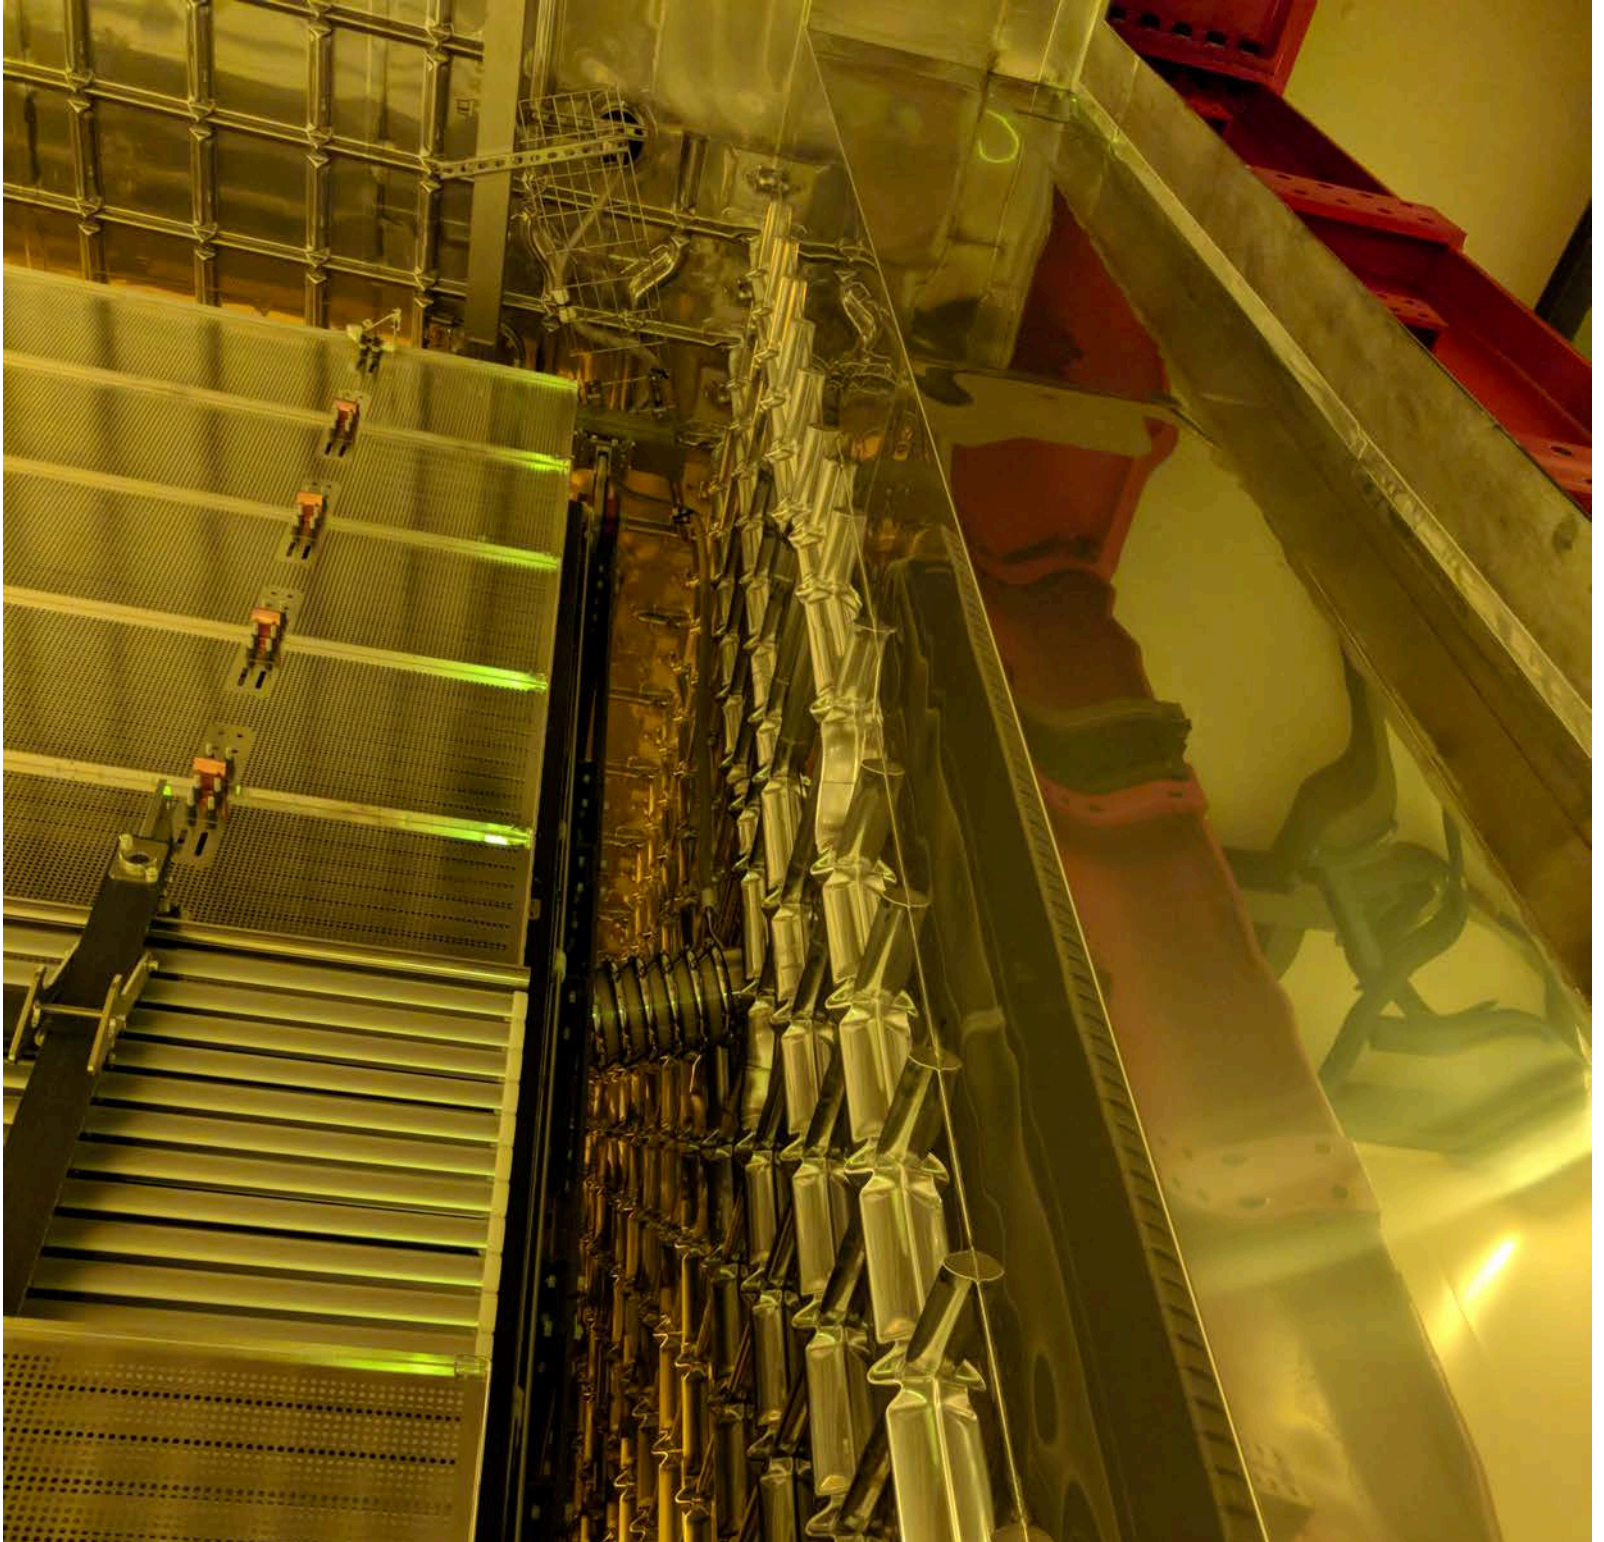
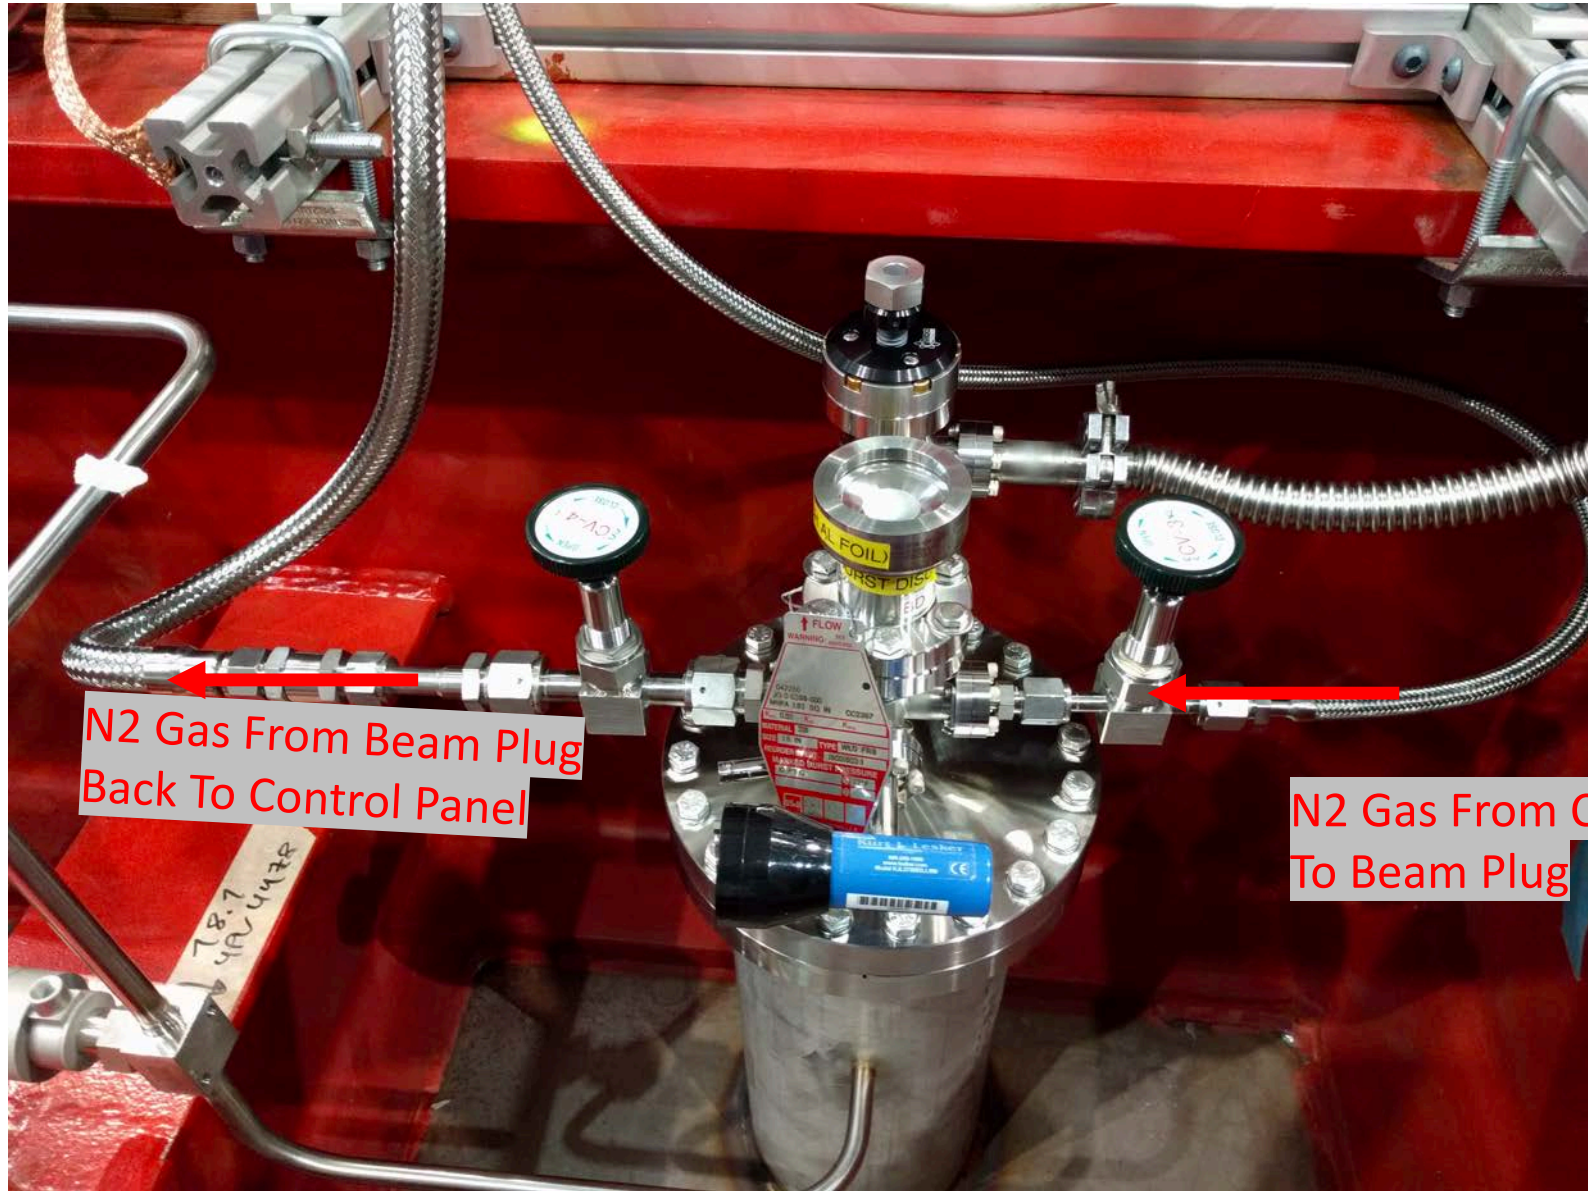
Hose connections between the flange and the gas control panel were made today

Beam plug gas system installation is completed !!!!

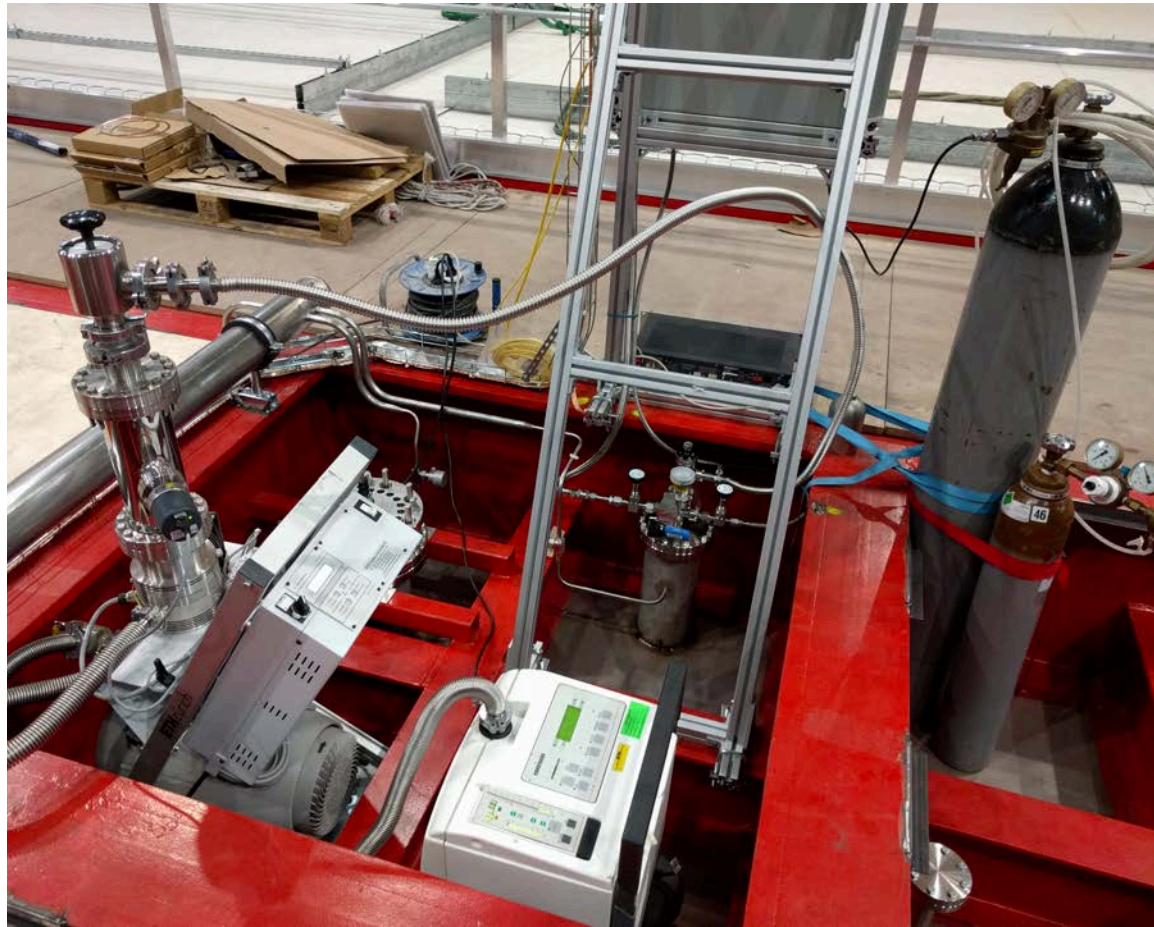
- Spayed He inside the cryostat along the beam plug and gas hose
- Sprayed He on top of the cryostat around the feedthrough flange and sensor
- Vacuum at turbo pump $\sim 5 \times 10^{-7}$ mbar
- Leak rate $< 8 \times 10^{-10}$ mbar L/s

Final Leak Check of the Beam Plug System Completed !!!

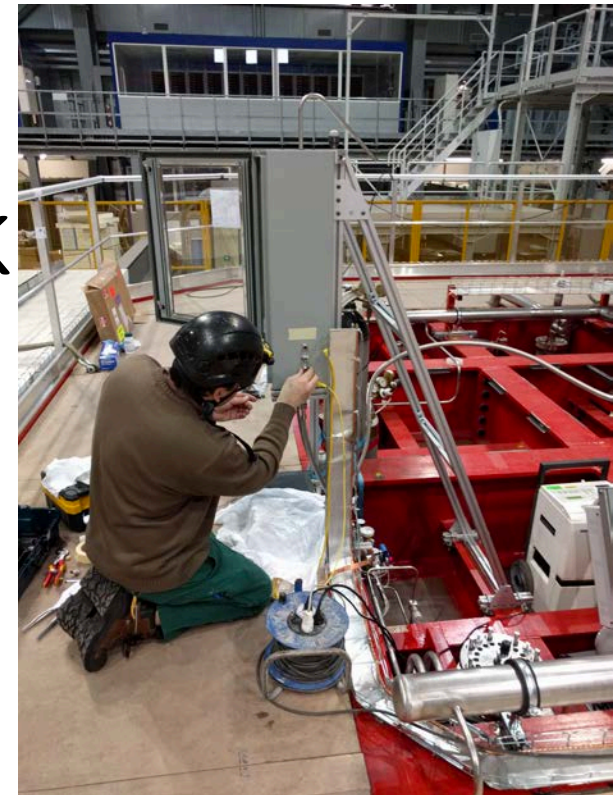
- Integrating 5 beam plug sensors (two RTD, two pressure and one current monitoring) with DCS
- Likely to start cabling tomorrow
