# **Muon g-2 AEM Update**

Brendan Kiburg, Jarek Kaspar May 21, 2018

### Kicker 2, two weeks ago – Resistor Issues

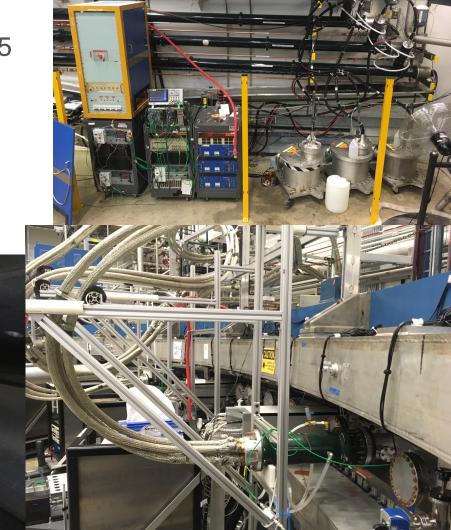
### How a kick is made?

- a charging power supply charges up
- capacitor back to low voltage (700 V) that is discharged
- through a *transformer* into
- a *Blumlein*, which is a HV capacitor (55 kV), that is discharged through
- four 50 Ohms resistors, which convert high voltage into high current into
- in-vacuum *plates*, where the current generates magnetic field that rotates momentum vector of muons

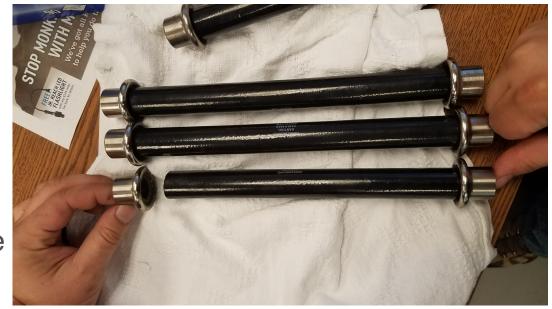
#### Bazooka ∫ dφ/dt

- Kickers were observed to have ugly pulse shapes
  - Corresponding CTAG drop

- Friday, during AD downtime, opened up and found resistor in awful shape
- Replaced Resistors, cleaned fluorinert chillers, recovered old pulse shape friday

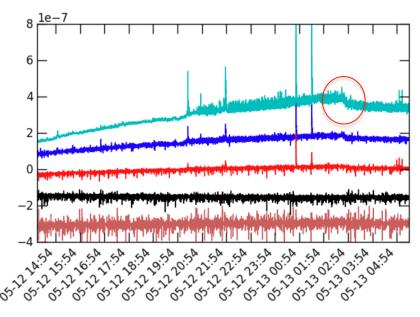
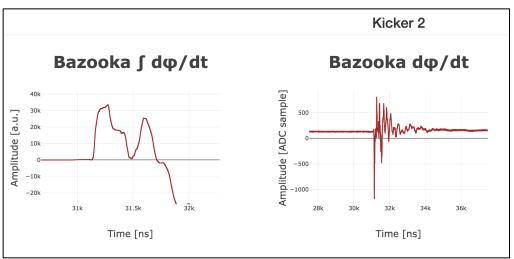
### Kicker 2 a week ago

- Looks even worse than before
- Decided to call it → switch to field.

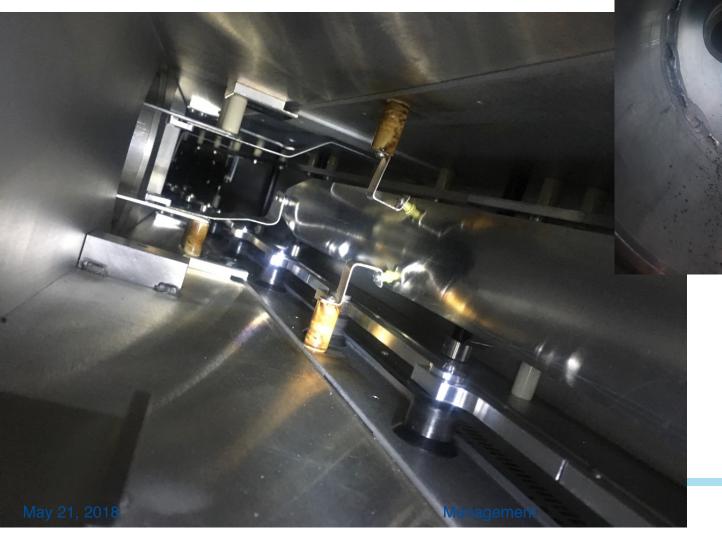
## Kicker 2 a week ago

Burned 2 resistors

Didn't find a problem in vacuum

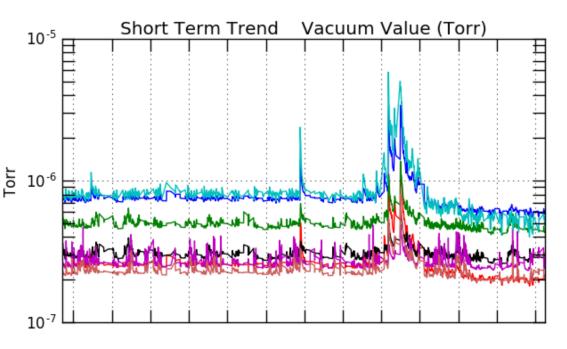
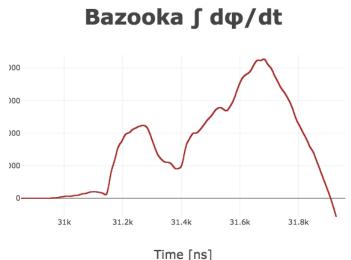
### **Kicker 2 on Saturday**

- Looks even worse than before
- Decided to call it again → switch to field. Examined today.`

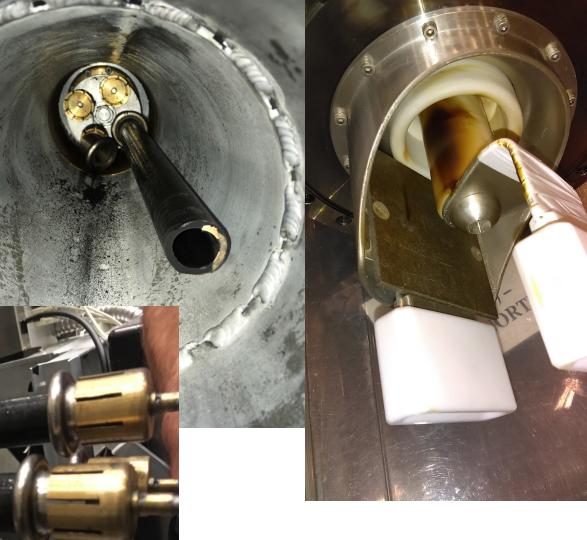
# **Kicker 2 today**

Burned 2 resistors

Problem in vacuum

- More kicker problems
- Last time we replaced what was broken
- This time we are replacing everything
- Two more days to recover, and store beam again
