Cable Routing Tests

Cold Electronics Mechanical Review Feb 11th, 2019

Cable routing tests at PSL: through APA side tube horizontally

Cable routing tests at Ash River: through APA side tube vertically

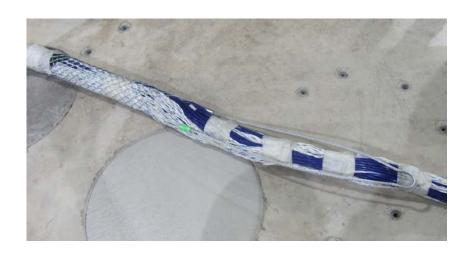
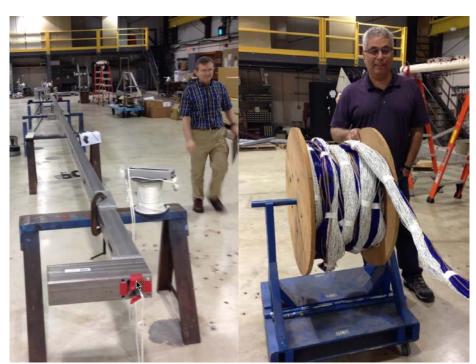
CE cable routing test at PSL (I)

A double APA side tube setup was built at PSL. PSL originally tried just bundling the wires and pulling with a wire mesh cable grip.

The connectors caught on anything protruding into the tube interior.

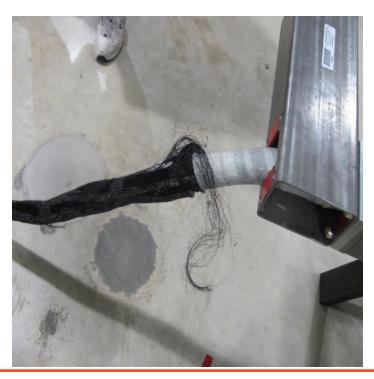
CE cable routing test at PSL (II)

PSL tried covering the connector part of the cable bundle with heat shrink to protect it. Cable volume reduced from 10 CE cables to 9 CE cables.

The connectors still made a bump that caught. The mesh sleeve was damaged during the pull.

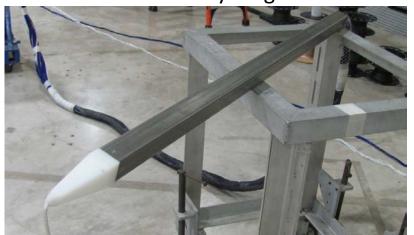
CE cable routing test at PSL (III)

PSL decided to try a rigid cover.

The first ~1.4m cable bundle – where the connectors are, is covered. It's a 2" x 2" tube with a nosepiece to help guide it through the openings.

The rope goes through the nosepiece and connects to the cable grip as before.

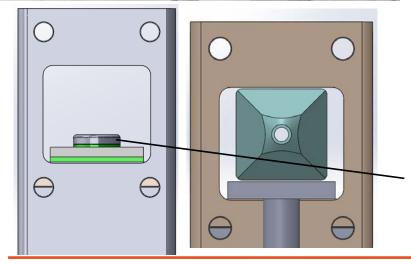
In order to fit past the link, the screw holding the link had to be made flush with the link surface.

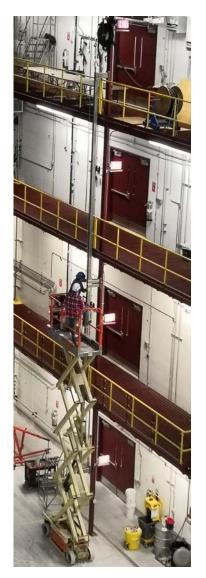
The APA side tube cabling setup was shipped to Ash River, and mounted vertically.

December 2018 we did a series of tests with different configurations of the cable bundle as well as some strain relief trials.

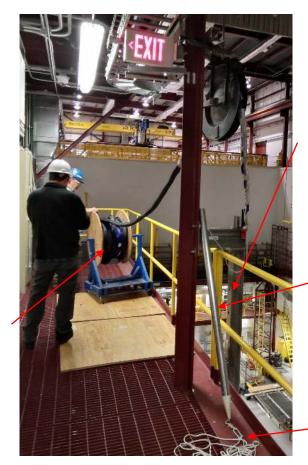
Cabling Setup at Ash River

APA side tubes (mounted vertically)

Guiding head cone (removed from the cable bundle tip)

Guiding rope at the tip of guiding head cone

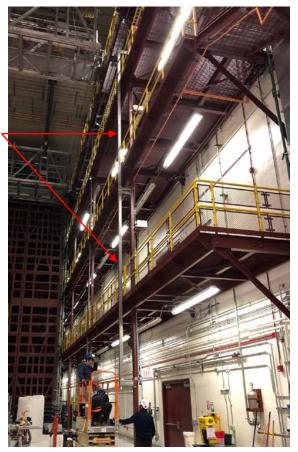
Cable bundle on spool

Cable bundle and cable conduit

Cable bundle (9 CE signal cables and 9 CE power cables)

Cable bundle with sleeve on

Cable grip slid on the cable bundle

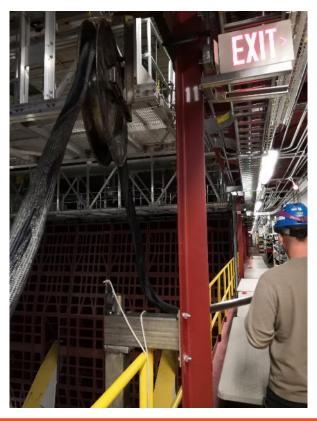
Feeding head cone into side tube

Feed guiding rope through the side tubes

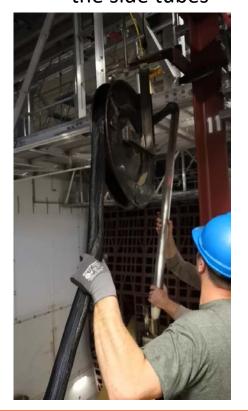
Insert guiding head cone into the side tubes

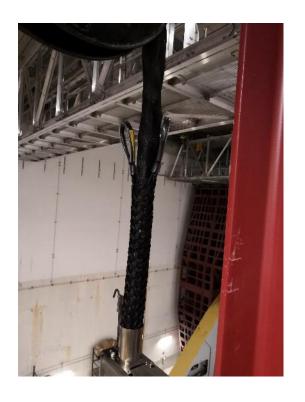
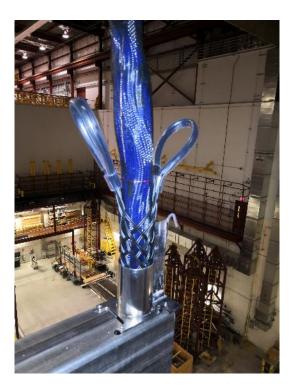
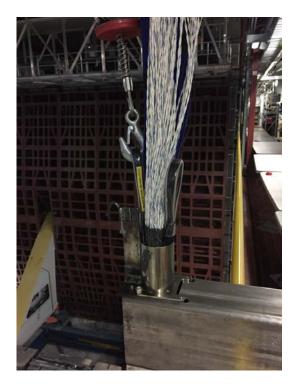
Strain relief (I) with cable grip

Cable grip slides into the conduit

Strain relief (II) with hose clamps

Alternative strain relief option:

The cable bundle was split into two smaller bundles at the top and clamped with two hose clamps.

In this test, the top end of the mesh was pulled downward into the conduit to allow splitting the cable bundle. But the top end of the mesh wasn't taped onto the cable bundle. When trying to pull the cable bundle out upward, the mesh was slipped over the cable bundle by friction between the mesh and the conduit, and jammed the conduit.

Both ends of the mesh have to be taped onto the cable bundle.

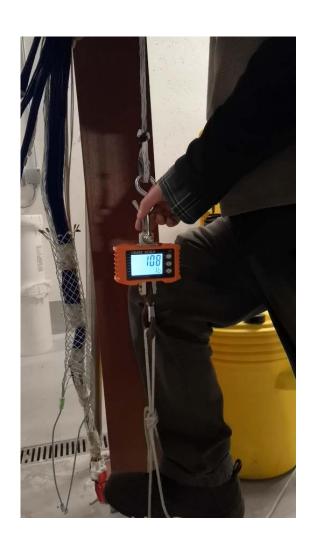
Cable bundle pull test

Cable pull test was done on every single data and power cable at the bottom.

Strain relief (I) with cable grip

Every single data cable and power cable were further pull tested at 100+ lb. No slipping was observed at the cable grip location at the top.

Strain relief (II) with hose clamps

Max pull force was recorded until cables were observed slipping at the clamping location:

max pull force is 50 ~ 80 lbs for power cables max pull force is 80 ~ 100 lbs for data cables

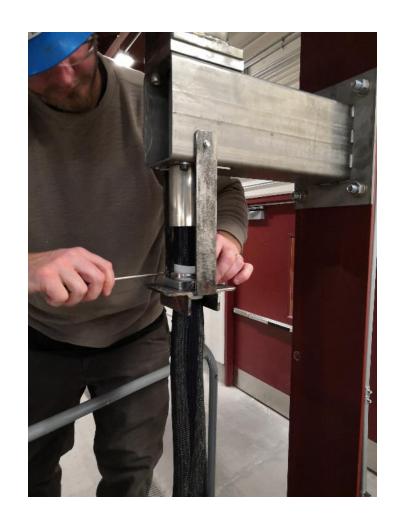
Tried feeding 100 mm extra cable length into the conduit

To accommodate cable shrinkage at cold

Cable bundle was pulled up by 10 cm from top.

Cable bundle was then clamped at bottom.

Released cable bundle from top, but the 10 cm extra length couldn't get into the conduit.

It's impossible to squeeze 100mm extra cables into the conduit.

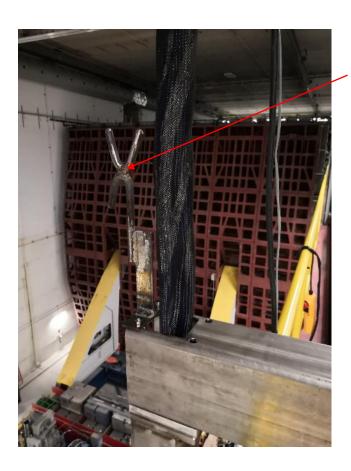
Cabling test after conduit was removed

A hook welded onto the end T-bracket for supporting the cable grip

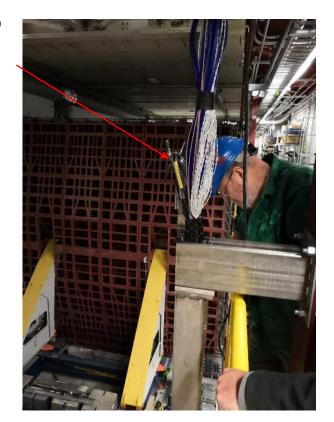
Cable bundle was stuck in the side tube several times.

Damage occurs when feeding cables with conduit removed.

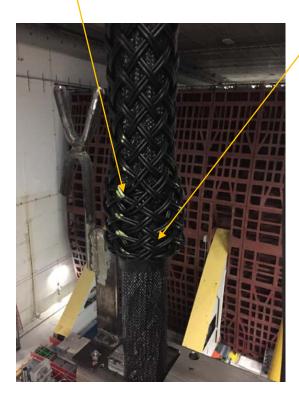
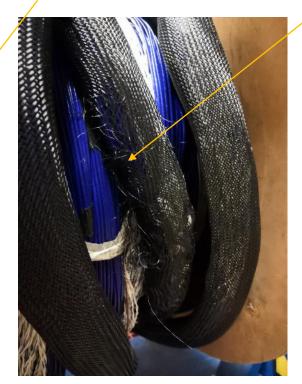
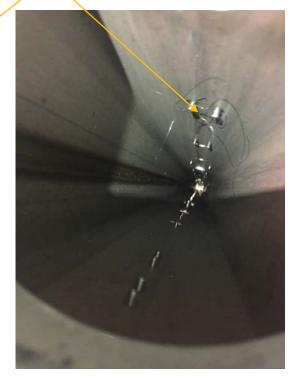
Damage revealed after cable bundle pulled back out from top

Scratches on cable grip

Cable grip folded over likely occurred during pulling cable bundle upward.

Sleeve was damaged and fibers caught at screws

The bottom end of the cable grip shall be taped onto the cable bundle for it to stay in position well, so maintain proper gripping on the cable bundle.

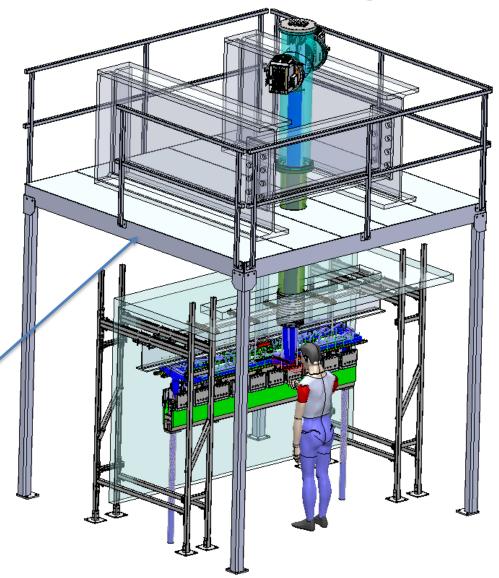
Mockup of cabling from upper APA to feedthrough port

Commercial mezzanine 10'x10'x10' (stairs not shown)
