LEM Production and Tests in Cold Box for ProtoDUNE-DP

E. Mazzucato (CEA Saclay/Irfu)

- LEM Production
- LEM HV Tests in Cold Box

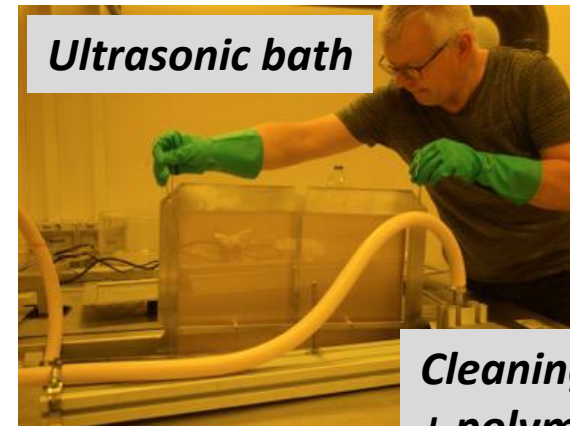
Ultrasonic bath

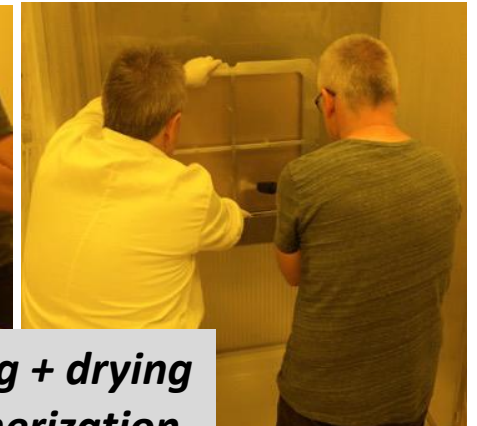
Cleaning + drying + polymerization

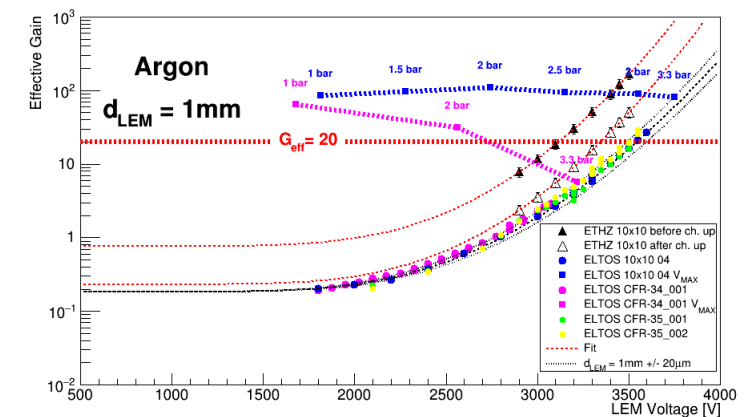
- Amplification gain inside the LEM depends on gas density ρ or P/T :

$$G_{\text{eff}} = Ce^{\alpha d} \quad \text{with} \quad \alpha = Ape^{-Bp/E}$$

- $G_{\text{Ar}} @ 88^\circ\text{K}$ and ~ 1 bar $\Leftrightarrow T = 20^\circ\text{C}$ and $P \sim 3.3$ bar.

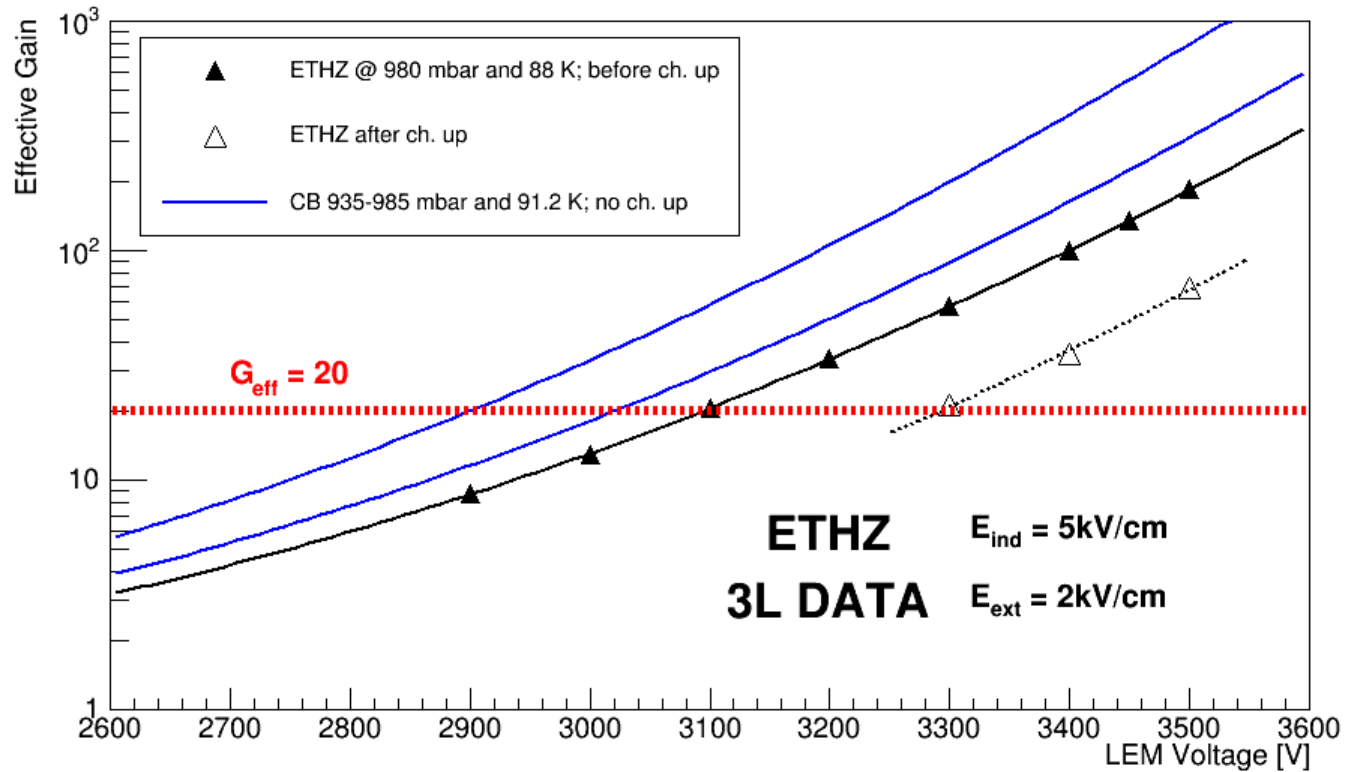
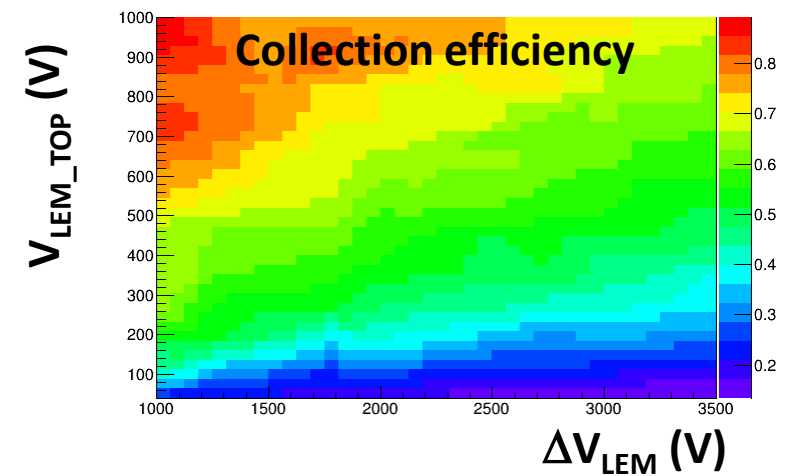
Effective gain

$$G_{\text{eff}} = \varepsilon_{\text{extr}} \times G_{\text{LEM}} \times \varepsilon_{\text{ind}}$$

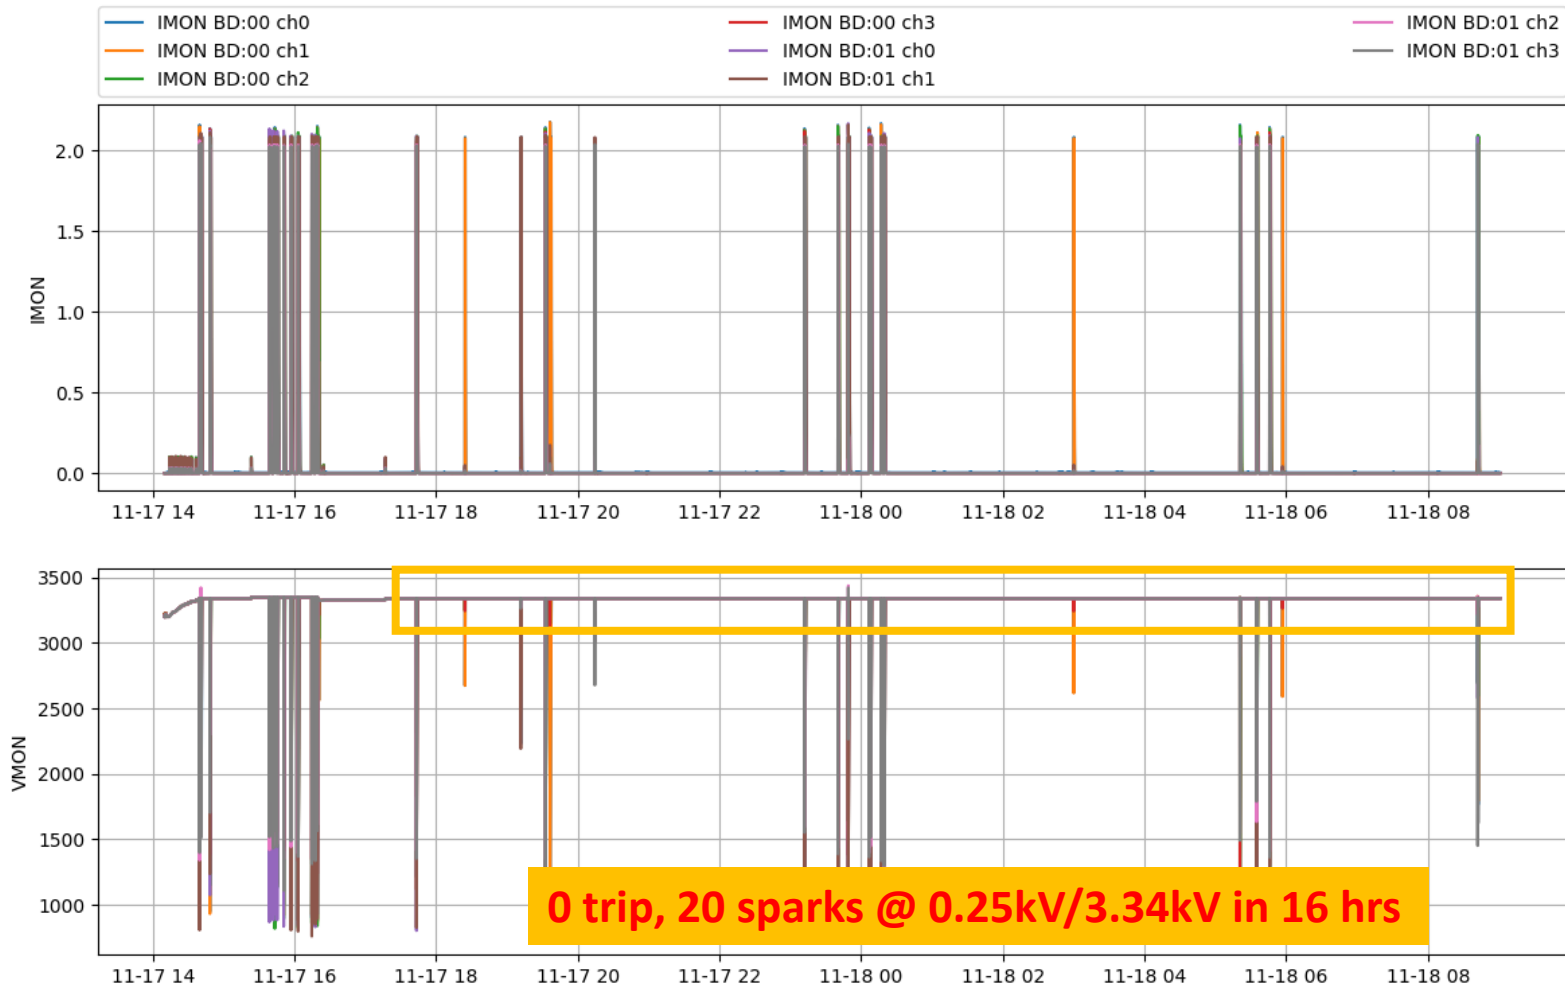
CRP2 : $V_{TOP} = 0.25\text{kV}$ and $V_{BOT} = 3.34\text{kV}$

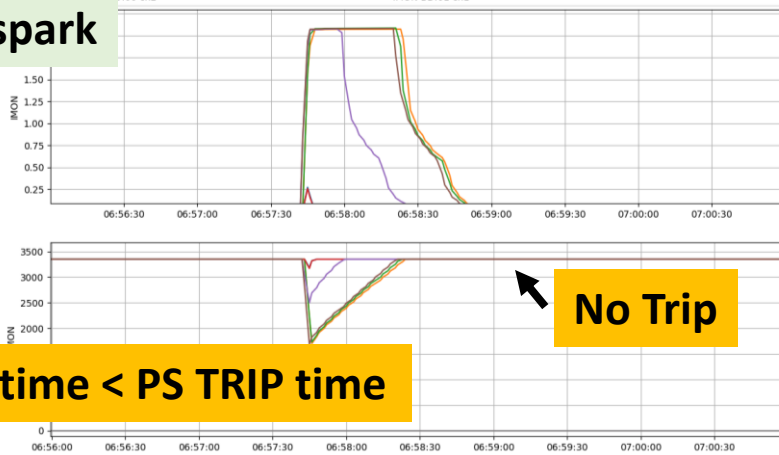
1 spark

Recovery time < PS TRIP time

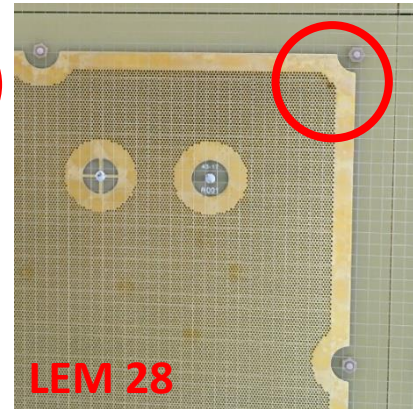
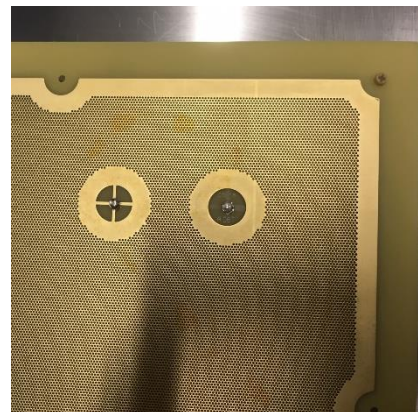
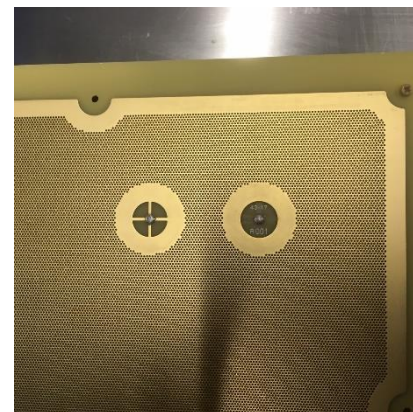
Inspection of CRP1 after removal from the CB revealed dark spots on 4 LEMs

- Points to a weaker regions of the LEM
- Detailed E-field calculations needed

- Treated with potassium permanganate @ CERN to remove carbonized FR4 inside holes. Copper surface unaffected.
- Cleaned at CEA/Irfu and tested up to 3.2kV @ 3.3 bar
- Back on CRP1

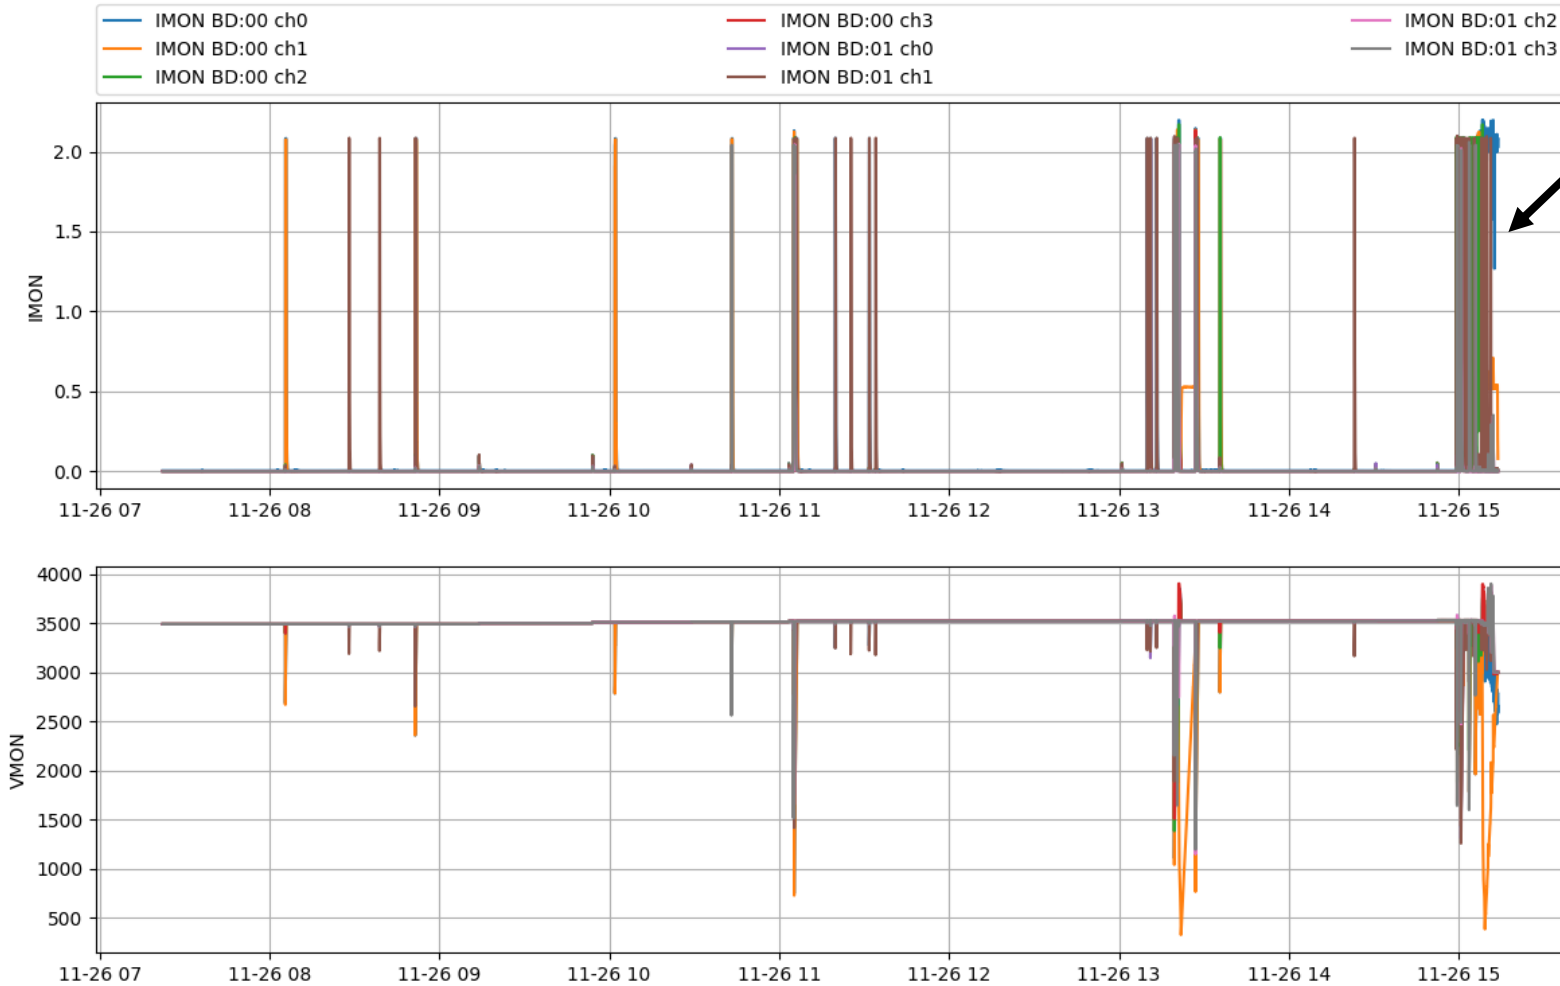
CRP2 : $V_{TOP} = 0.50kV$ and $V_{BOT} = 3.55kV$
