Fermilab Performance Acceptance Test Report
650 MHz EM Shielded Coupler Vacuum End Cleanroom
Particle Acceptance Test Report
ED0008448, Rev. -

Introduction

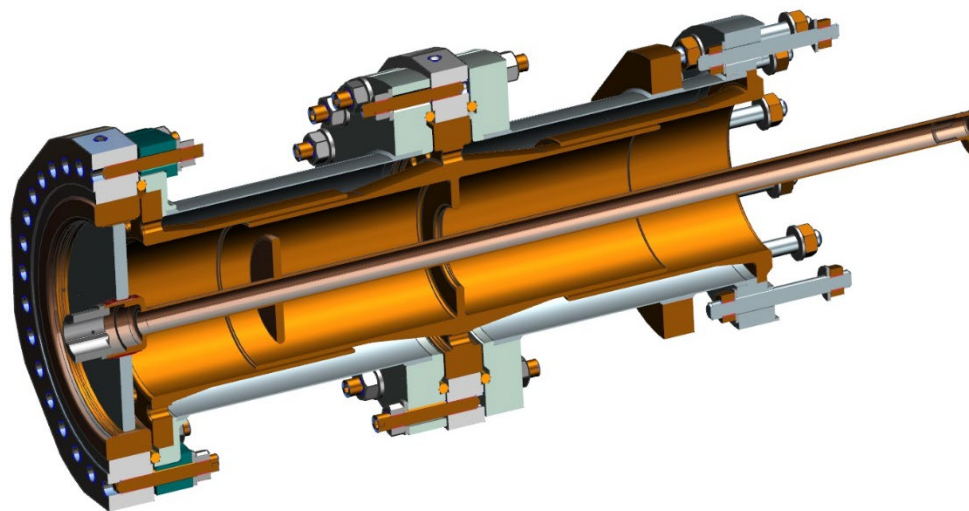
Picture 1: Configuration of new design of PIP-II main 650 MHz coupler, vacuum part.

Configuration of new design of PIP-II main 650 MHz coupler includes electromagnetic shields with narrow gaps and chambers between them and outer shell, Pic.1. Assembling will be done with Teflon jig which is contacting with electromagnetic shields and moves. It can generate particles which potentially can contaminate superconductive cavity during assembling procedure. It was decided to perform testing assembling to check applicability of new configuration for superconducting cavities.

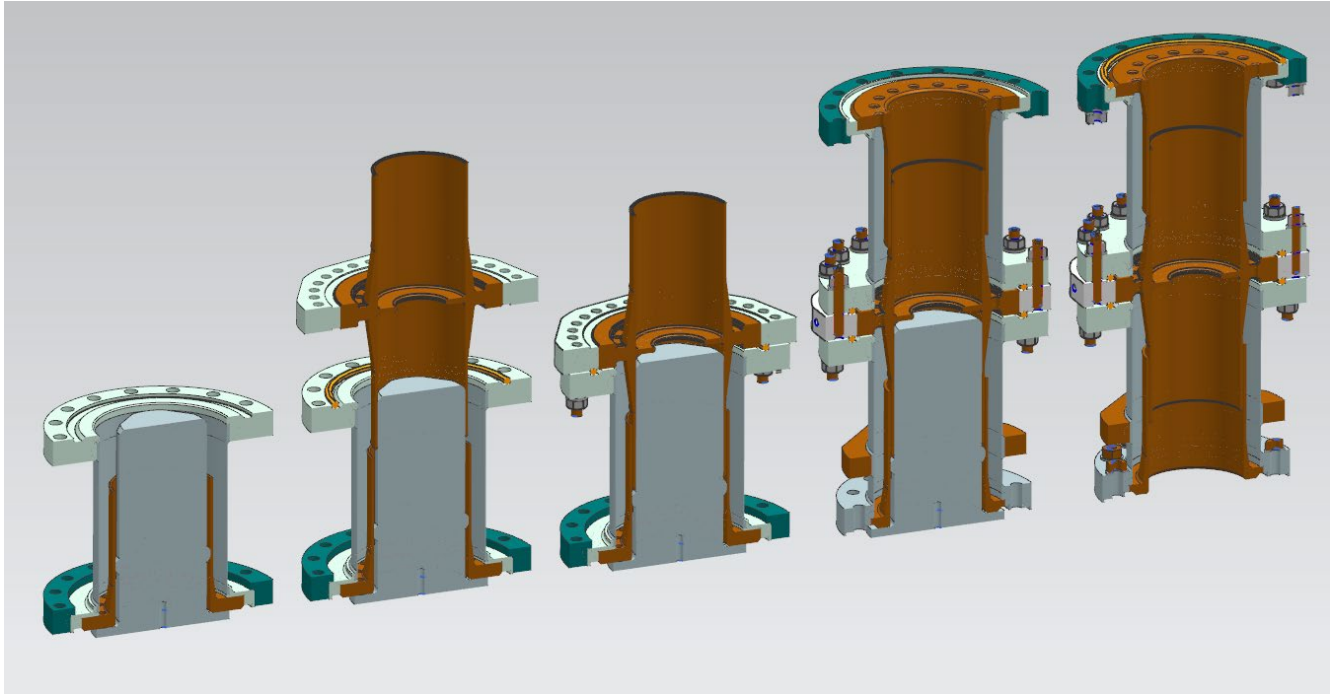
Picture 2: Assembly sequence with Teflon insert.

The Teflon insert (TI) was used keep axial symmetry during assembling, Pic. 2.

First it was checked how many particles was generated by inserting TI inside the copper parts. TI was inserted in to parts and removed. Numbers of generated particle were read at particle counter. Numbers of particle were a few, ~3 ~5.

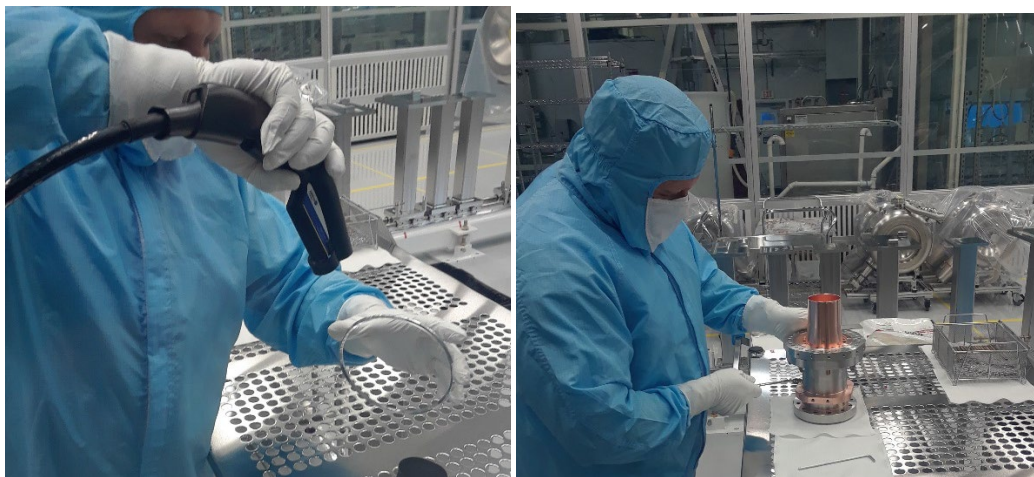
Picture 3: Clearing parts by flow of Nitrogen before assembling and assembling.

Then parts were cleaned by flow of nitrogen and number of particles became zero. Cleaning was fast and easy.

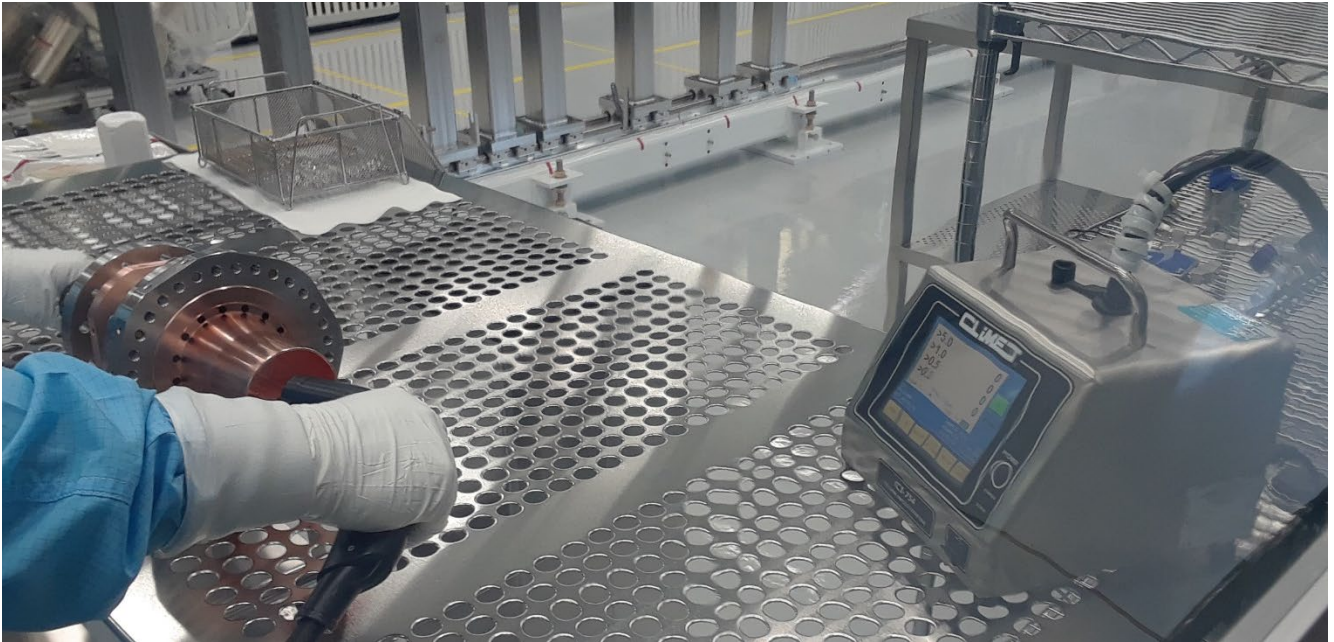
Picture 4: Intermediate test for particles. Zero number of particles on the counter screen.

Then full assembling was performed with intermediate cleaning of assembled parts by nitrogen flow. After final assembling the practical counting was performed. Number of particles was indicated as zero

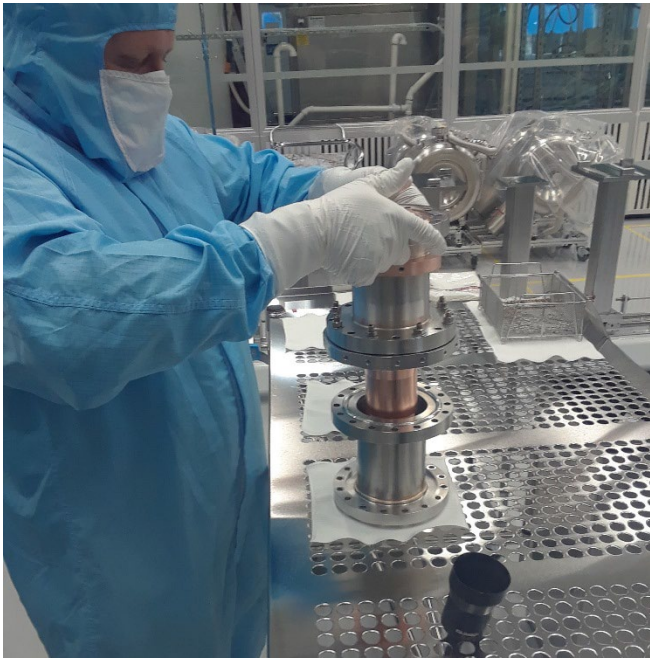
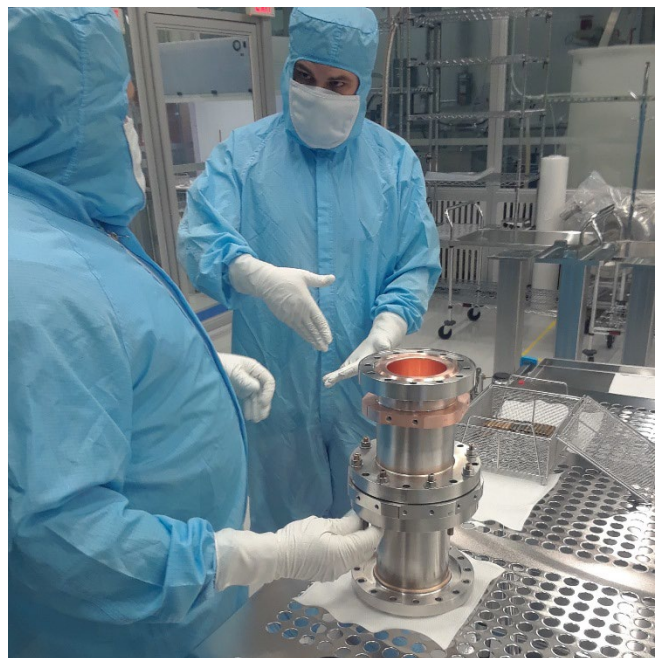
Picture 5: Further assembling

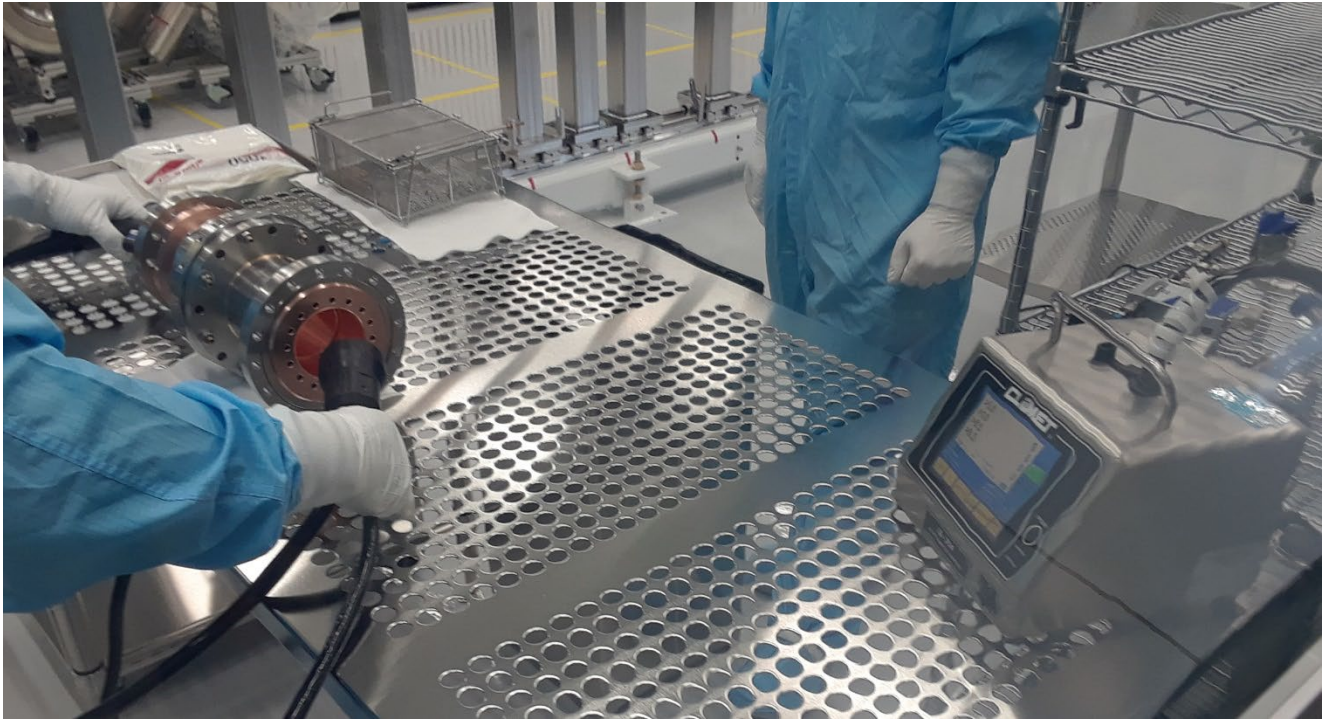
Picture 6: Test of full assembly of outer conductor for particles. Counter indicates zero number of particles.

Conclusions:
New configurations can be assembled 'particle free' and it can be used for superconductive applications.
