# AP0 Target Status and Plans

Ralph Ford, Yun He  
TSD Topical Meeting  
Jan. 17, 2019

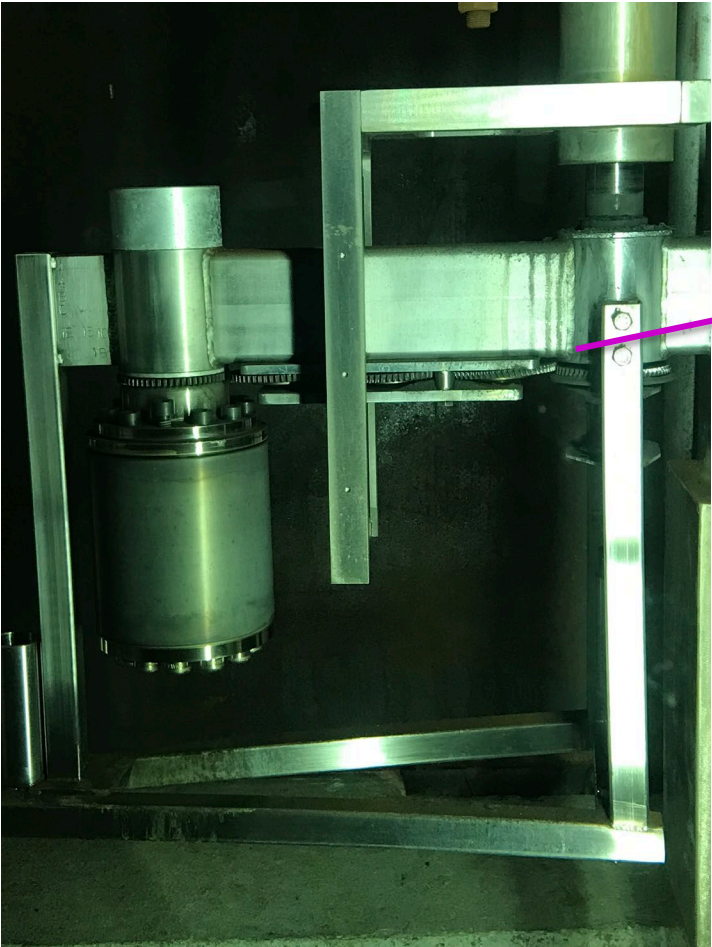
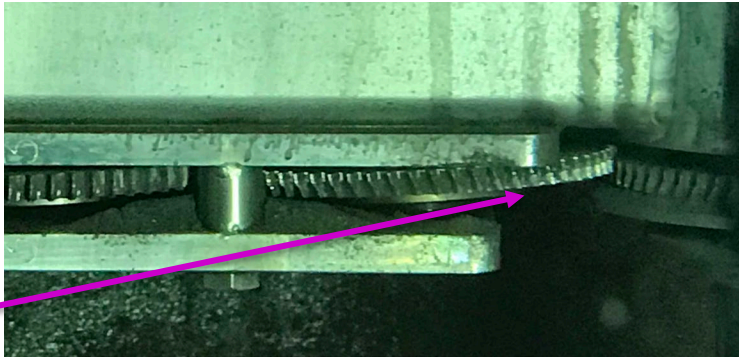
# T18 in AP0 Alcove

Rotation gear drive transmission failure  
turns freely in the CCW direction but freezes at times in the normal CW direction

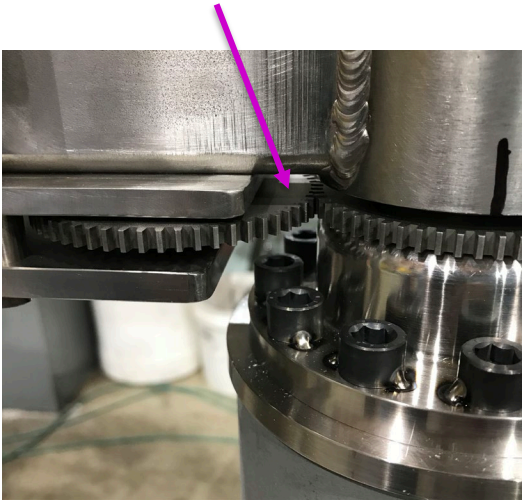
New gear looks like this

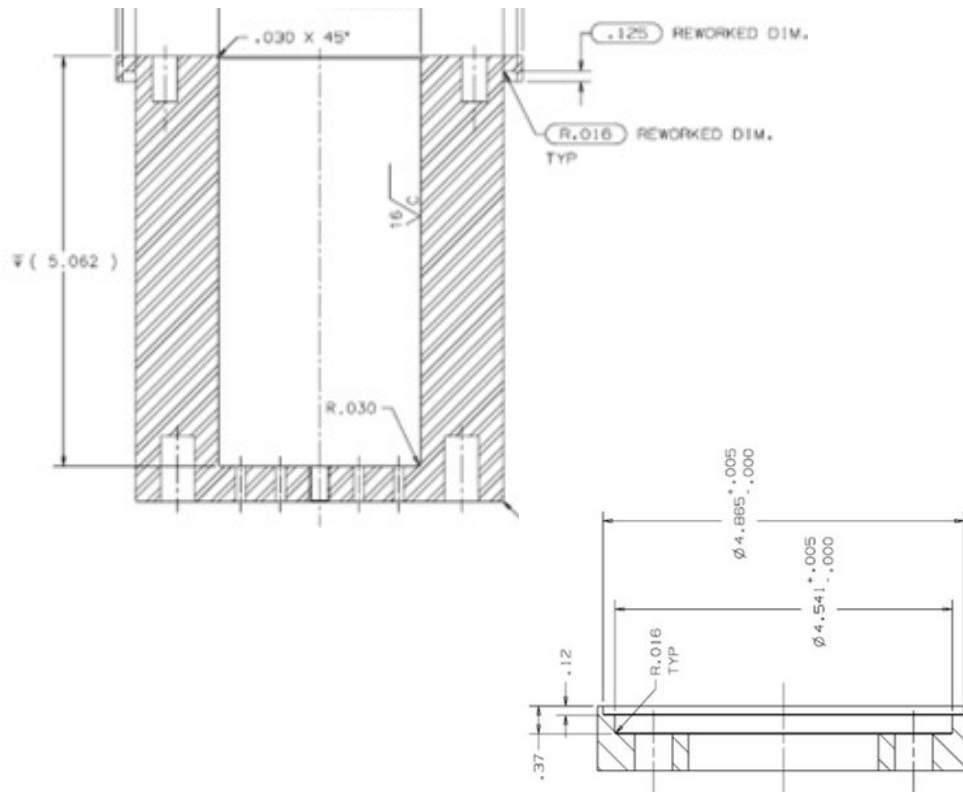
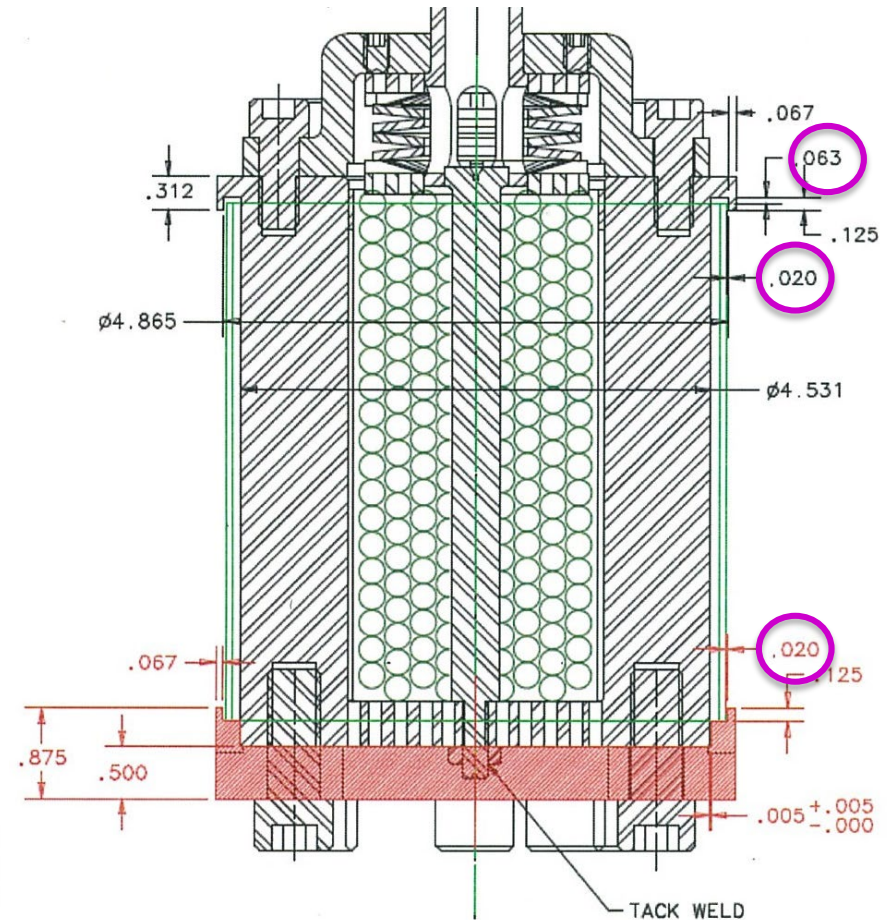
- F10113926 (Inconel cylinder)
- F10113914 (Bottom plate)

Modifications to fit the Carbon-Carbon cover over the Inconel target cylinder  
0.020" + 0.020" radial clearance / 0.063" axial clearance at room temperature  
0.010" + 0.010" radial clearance / 0.038" axial clearance at 350° C

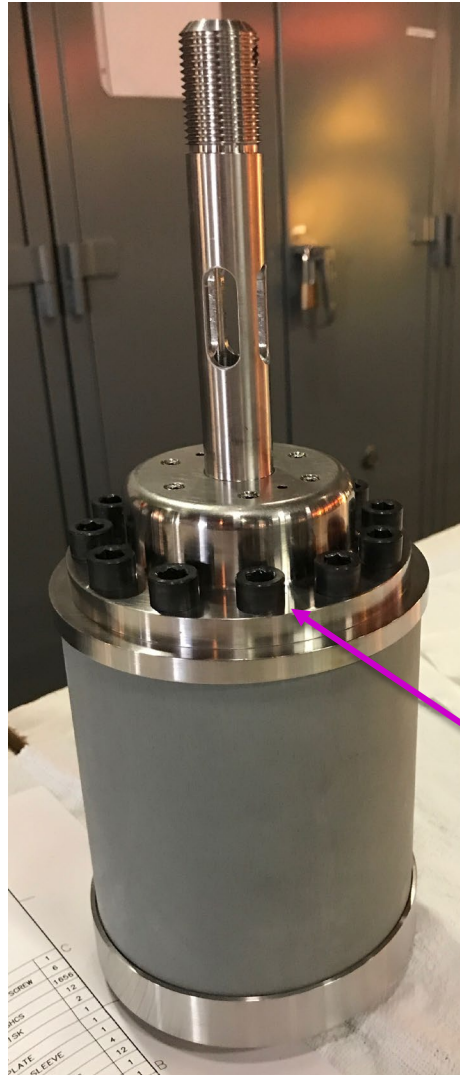
Shrink fit shaft to clamp nut

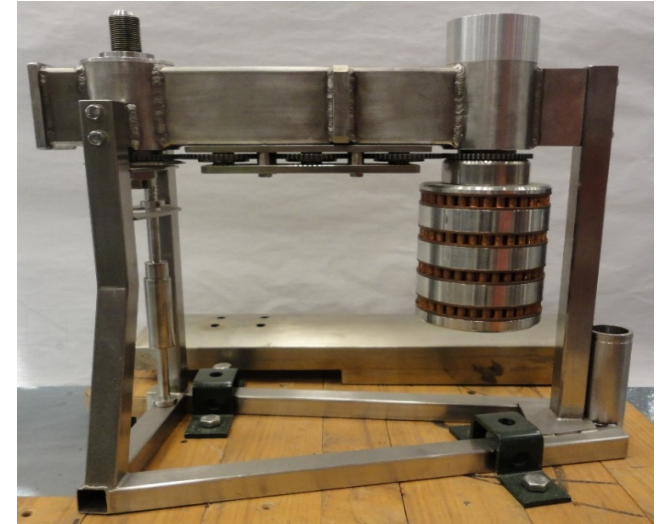
Target #15 support frame is used for Target #19

Bolts are tack welded (Top & Bottom)

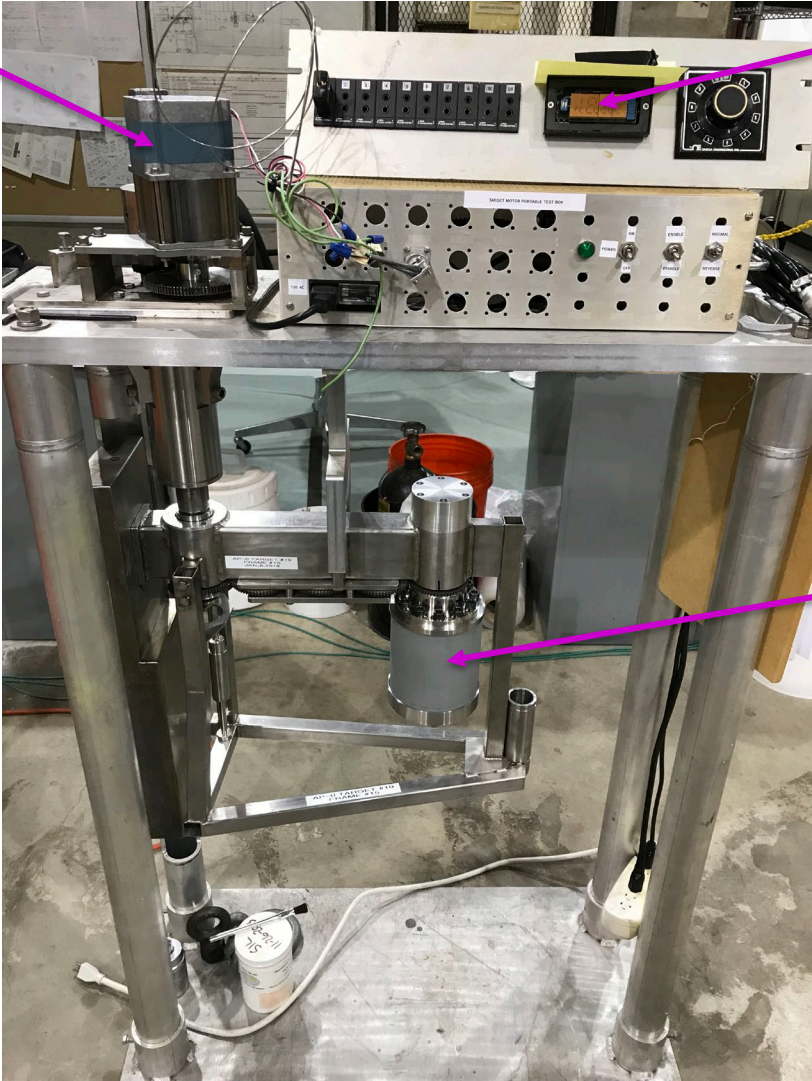
Motor

Motor temperature readout (65° C)

Target #19

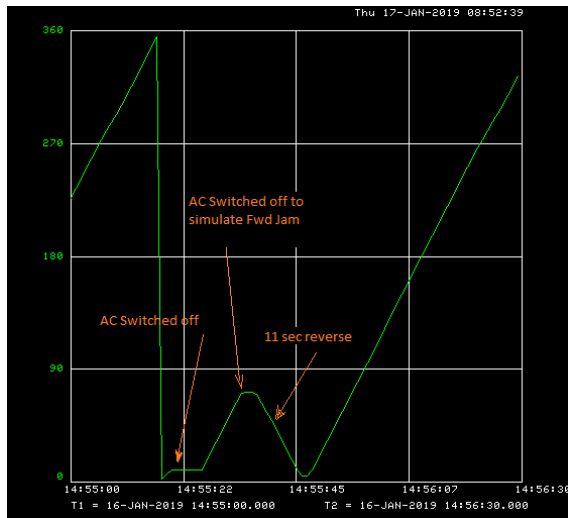
Jan. 16 14:55:00 – 14:56:30pm

- The PLC is monitoring resolver bit 5 of 0-15 to determine if rotation stalls.
- If rotation stalls, the PLC switches motor drive to "Reverse" for 11 seconds which should be about 1/4 turn of the drive shaft. The PLC will switch back to Forward after the reverse move is complete or if the reverse rotation stalls during the 11 second period.
- The jam recovery sequence will repeat whenever forward motion stalls. If the total number of jams for either Fwd or Rev exceeds a preset limit then PLC will disengage the motor power. The user must then reset the jam counters on Acnet and re-enable the motor power.

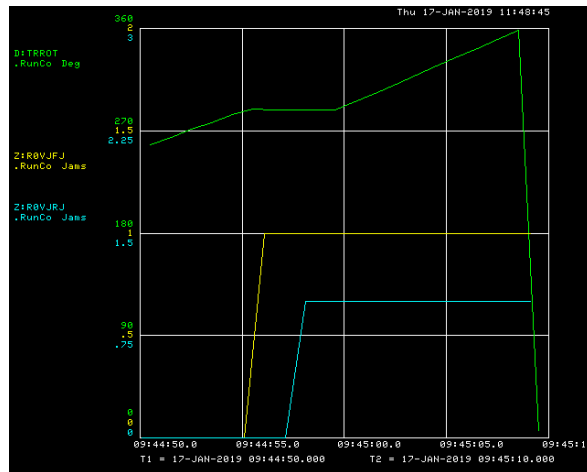
Jan. 17 9:44:50 – 9:45:10am

A forward jam with a reverse jam

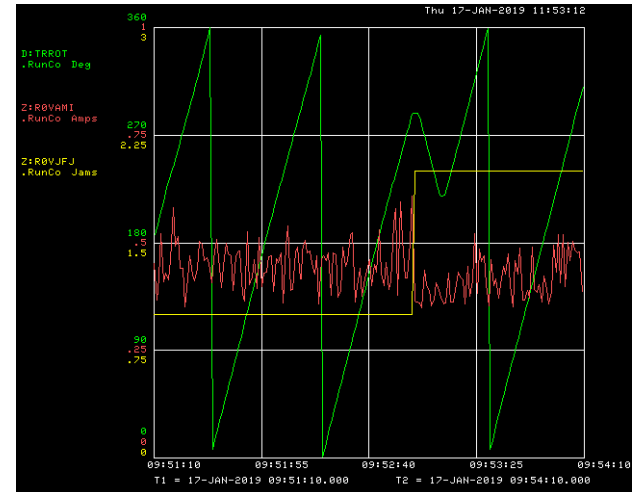
Jan. 17, 9:51:10 – 9:54:10am

A single forward jam, followed by the reverse motion for 1/4 turn and then back to normal operation. [AD Elog 147153](#)
