# Status of CNT wire ESS R&D

July 22, 2019

J-PARC Slow Extraction G

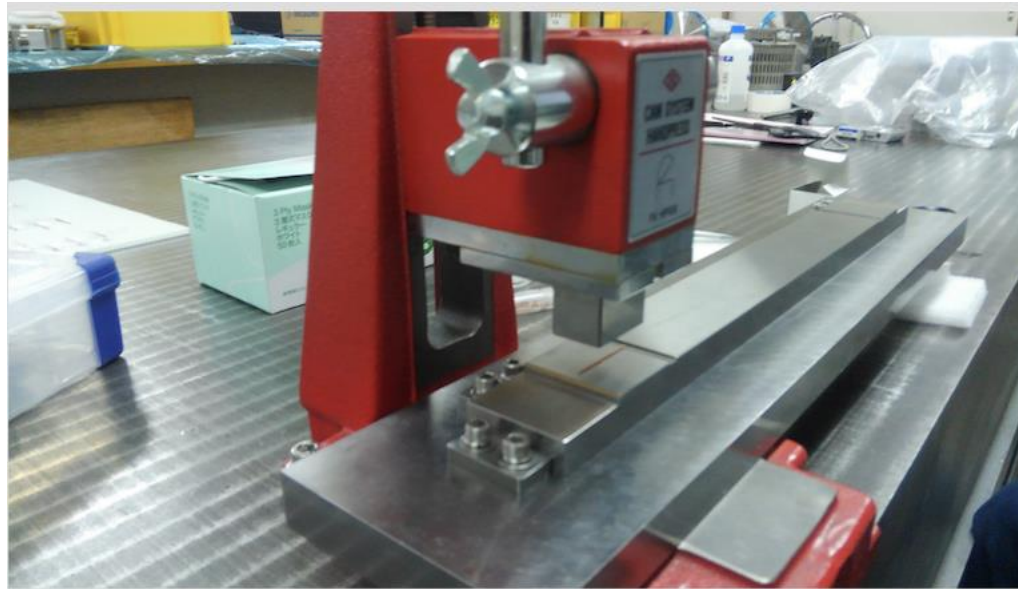
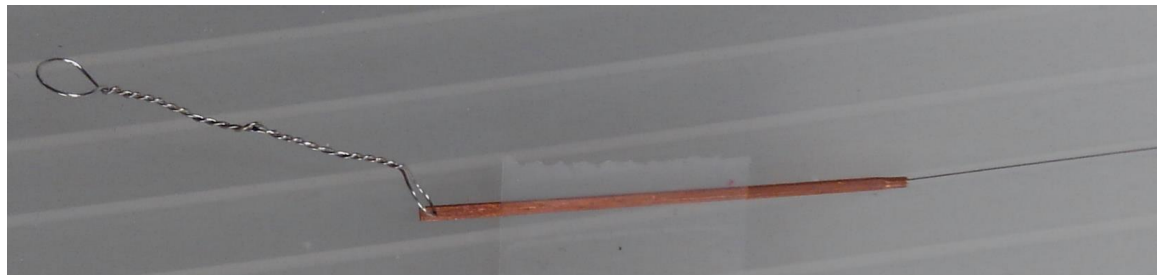
# CNT stranded wires by Hitz

CNT:  $\Phi$  10nm, L=300 $\mu$ m

wire:  $\Phi \sim 76-81 \mu\text{m}$  (spec. >3.0N, >750Mpa)

Copper tube cramping of both ends of CNT wire

Copper (C1220) tube:  $\Phi 0.7 \times \Phi 0.3 \times 30\text{L}$

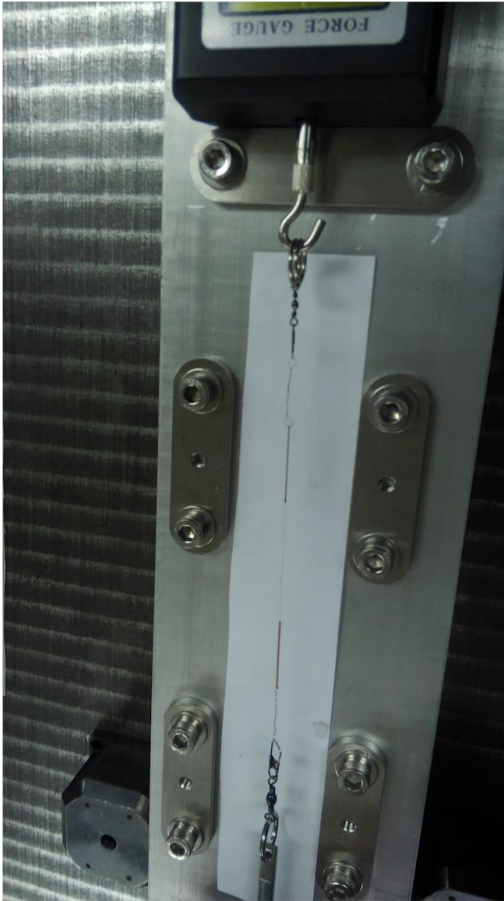
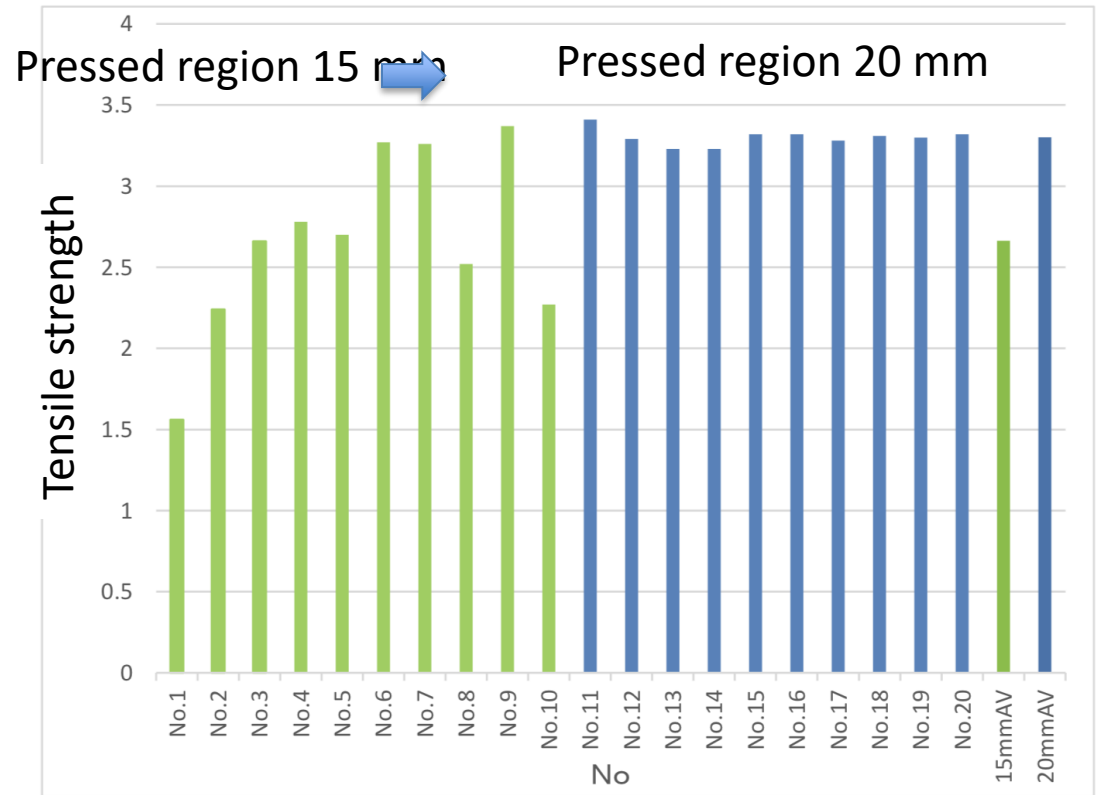
# Tensile strength measurement with copper tubes

The tensile strength has been improved to be similar to the strength w/o the tubes

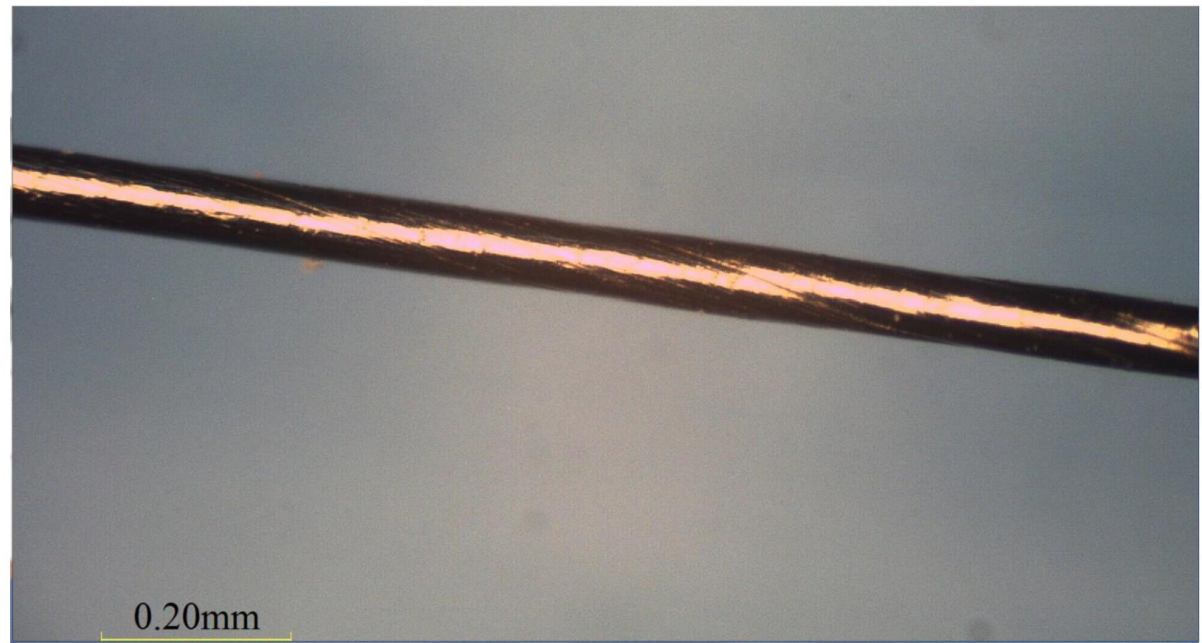
Carbon nanotube (洗淨前)

Before ultrasonic  
alcohol cleaning

luster on surface  
by increasing CNT density  
on surface

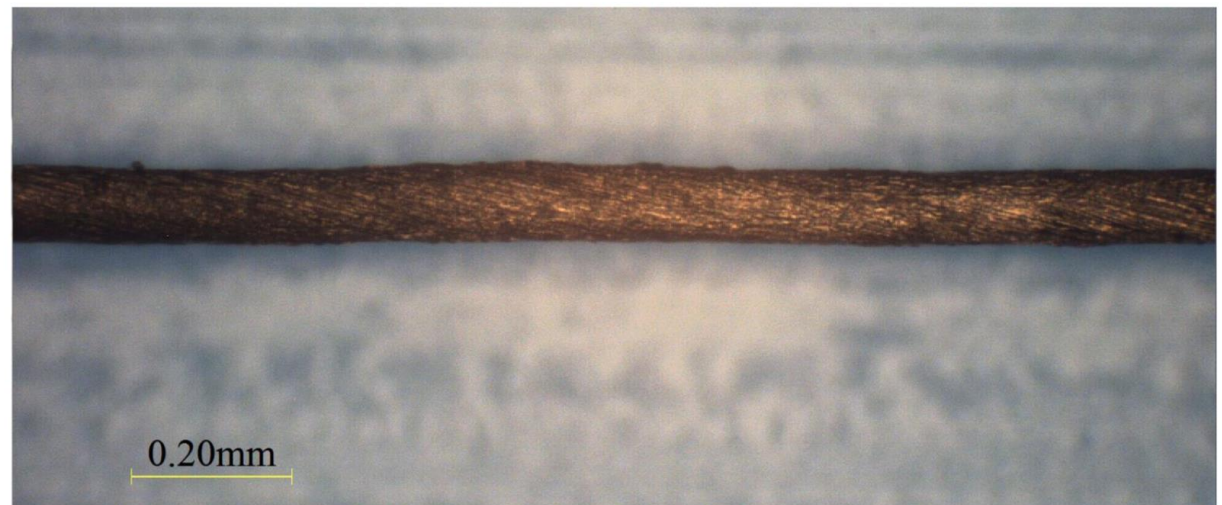
Carbon nanotube (洗淨後)

After Ultrasonic  
alcohol cleaning

No luster on surface

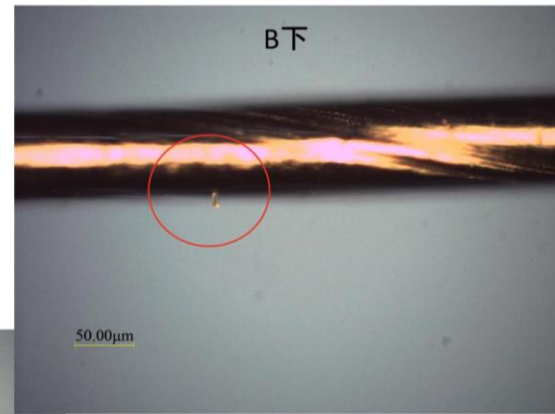
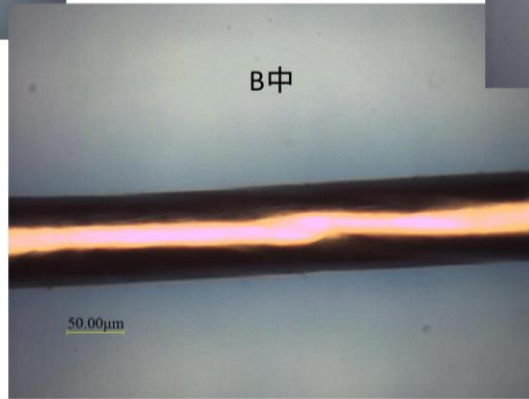
Fray

Frayed in 10mm from  
copper tube edge

Frayed In 10mm from  
copper tube edge

The wire center does not fray

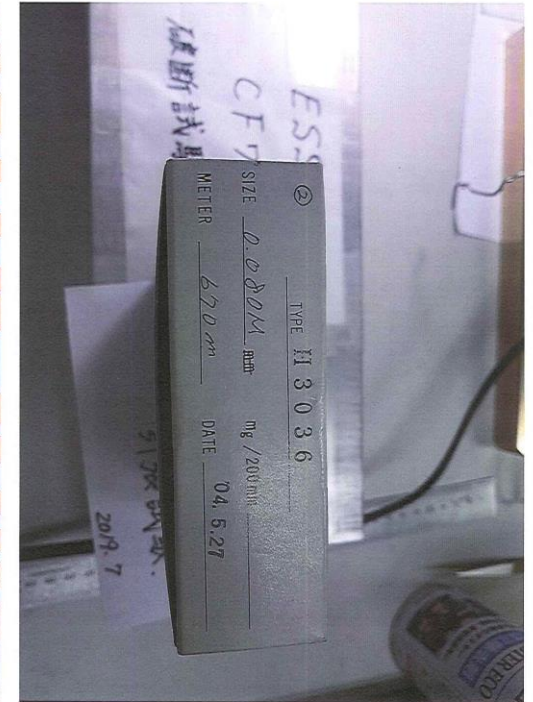
W/Re (3%) wires  $\Phi 80 \mu\text{m}$  as reference of CNT wires

Tension strength with copper tubes  
(wire only spec.  $2950 \text{ g/mm}^2$ )

1. 14.5N
2. 14.6N
3. 14.3N
4. 14.3N
5. 13.1N

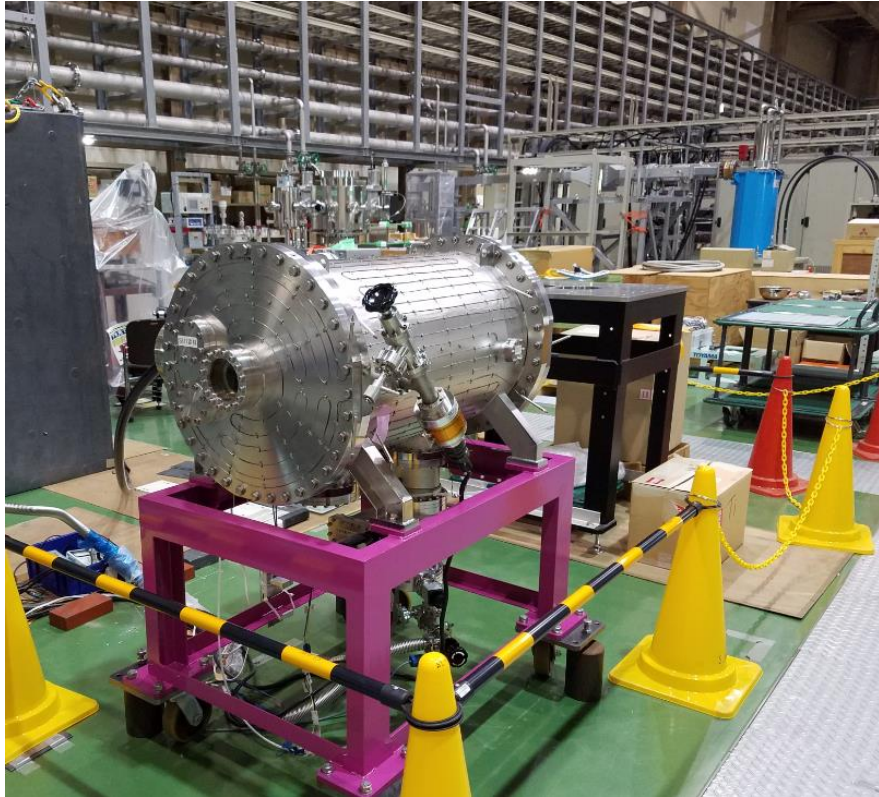
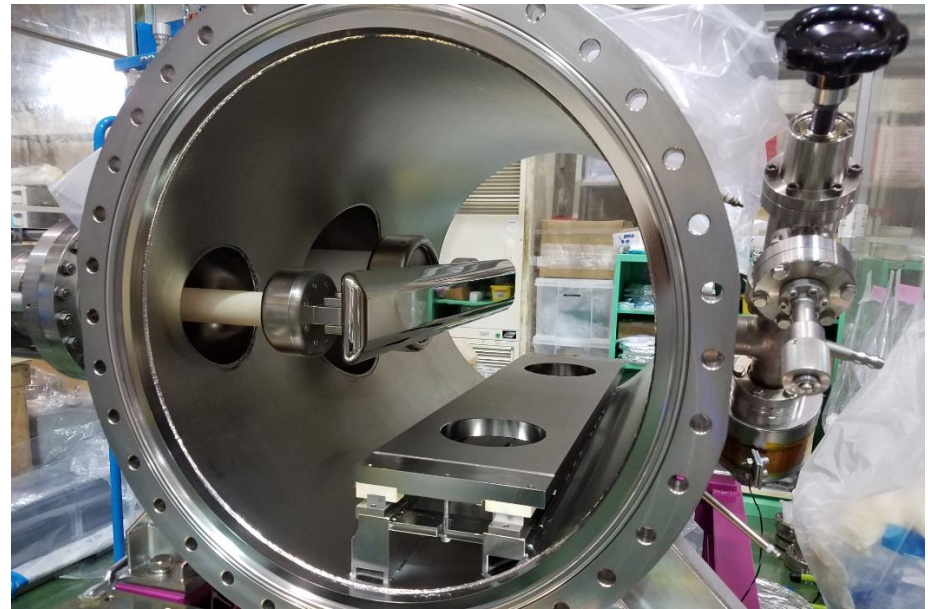
# 2019/06/17~06/18 electrode installation

A 110 kV High voltage test w/o anode has been finished.
