J-PARC Horn Operational Status and Upgrade Plan

T. Sekiguchi

2019. 10. 22

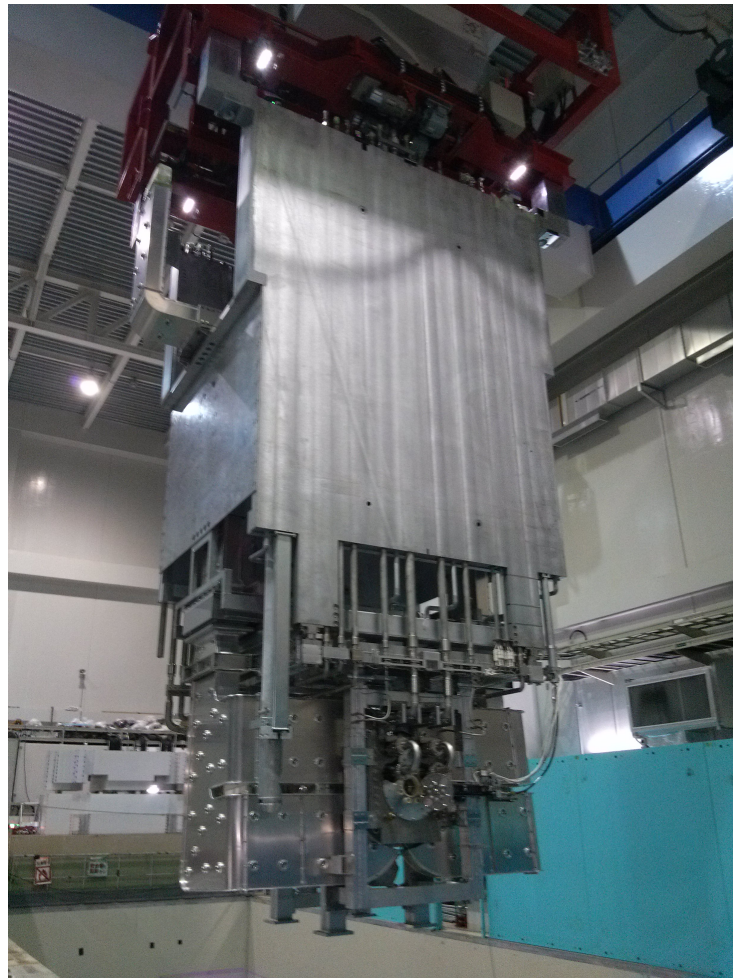
Horn1

Target and magnetic horns are located inside He vessel at Target Station

- **Aluminum coaxial conductor by A6061-T6**

- 3mm(10mm)-thick inner (outer) conductor
- Fatigue: 310 MPa \rightarrow 68.9 MPa after 2×10^8 cycle at 97.5% C.L.
- Corrosion: Strength reduction $\times \sim 0.43$
- Allowable stress: **29.6 MPa**

- **320kA pulsed current (design)**

- Toroidal magnetic field: 2.1 T (max.)
- Pulse width: 2~3 ms
- Cycle: 2.48 s \rightarrow **1.3 s** \rightarrow **1.16 s**

- **Water cooling**

- Heat deposit: 32.8 kJ/pulse (1.3 MW)
- **Spray water onto inner conductor**

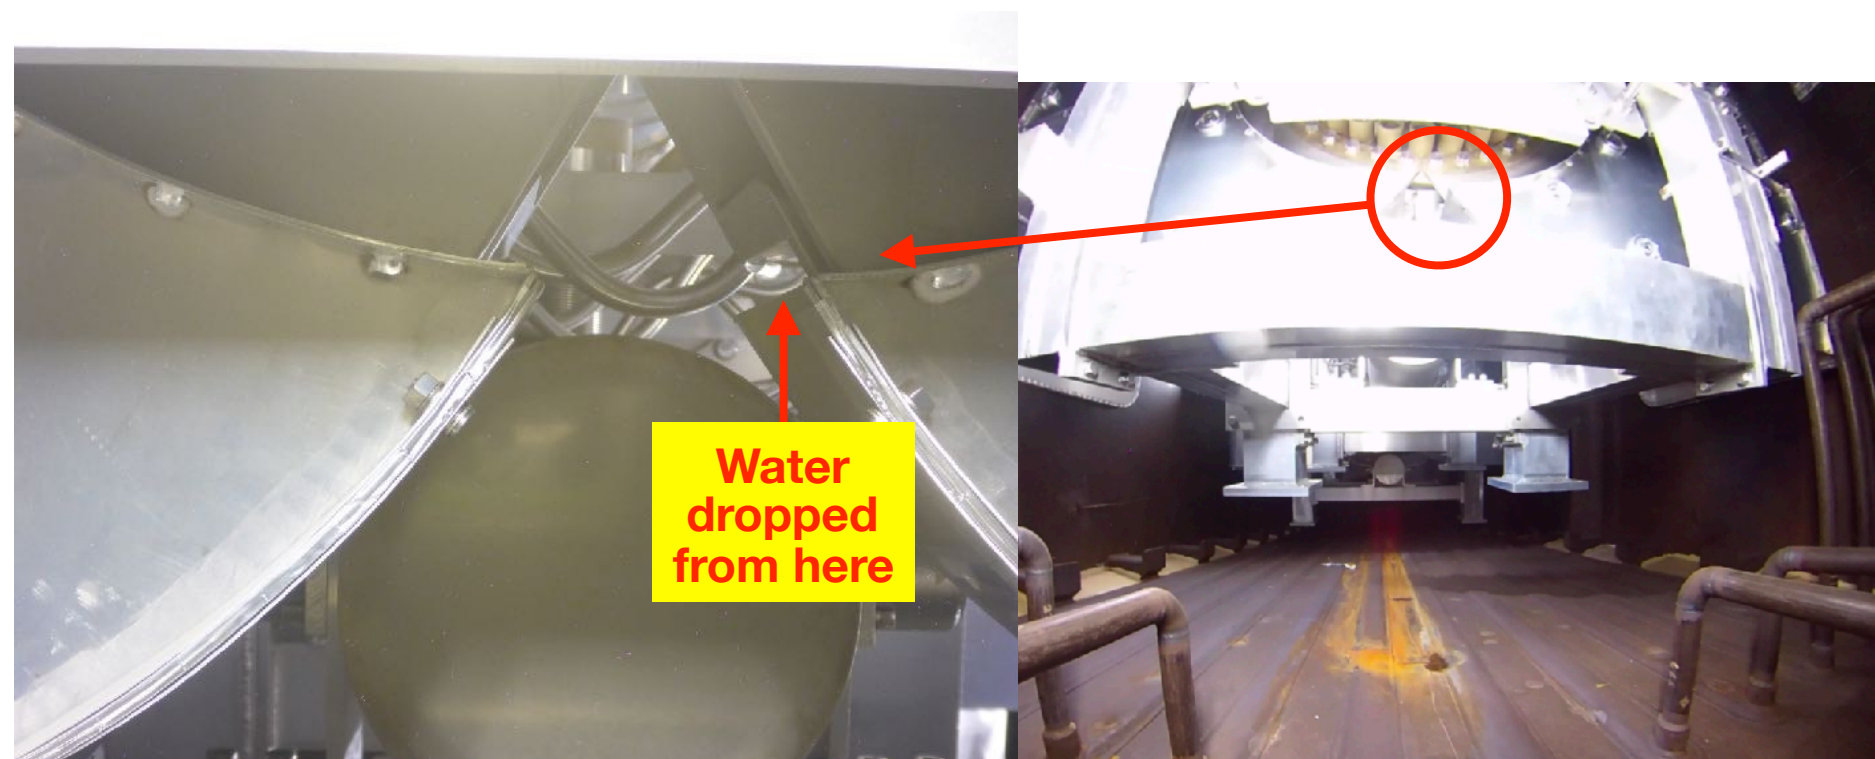
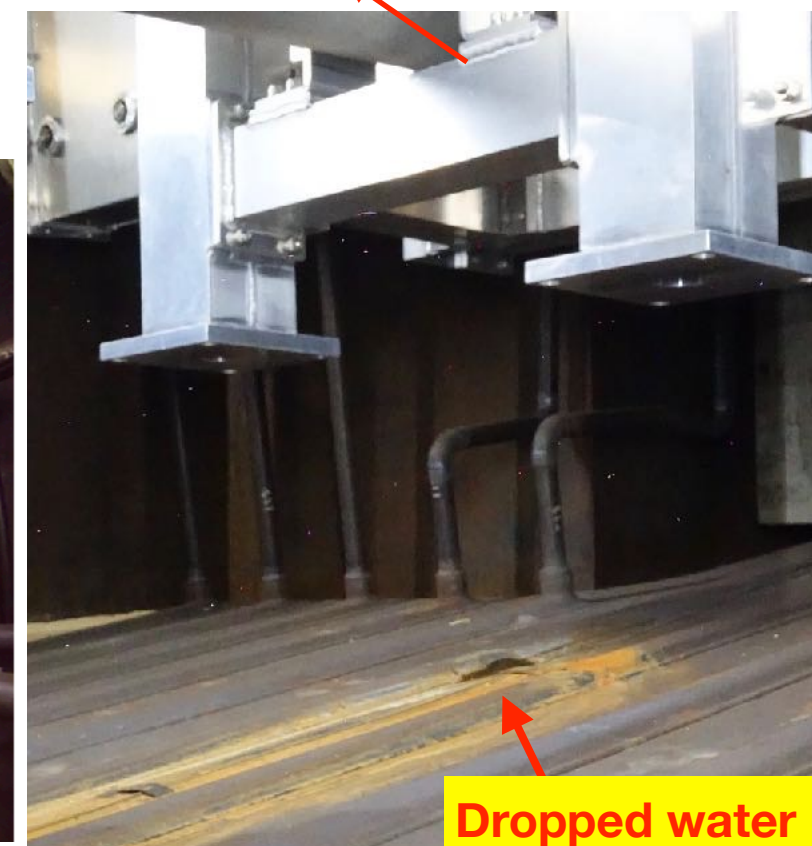
- **Investigation performed after beam operation**
 - **Before opening He vessel**
 - One-by-one horn operation and water circulation
 - Check water level → **Horn1 caused water drop**
 - **In-situ investigation after He vessel opened**
 - **Remote camera inspection during horn operation**
 - Special visual inspection tool lowered through $\phi 65\text{mm}$ through-hole
 - **Observed actual water drop from upstream of horn1**

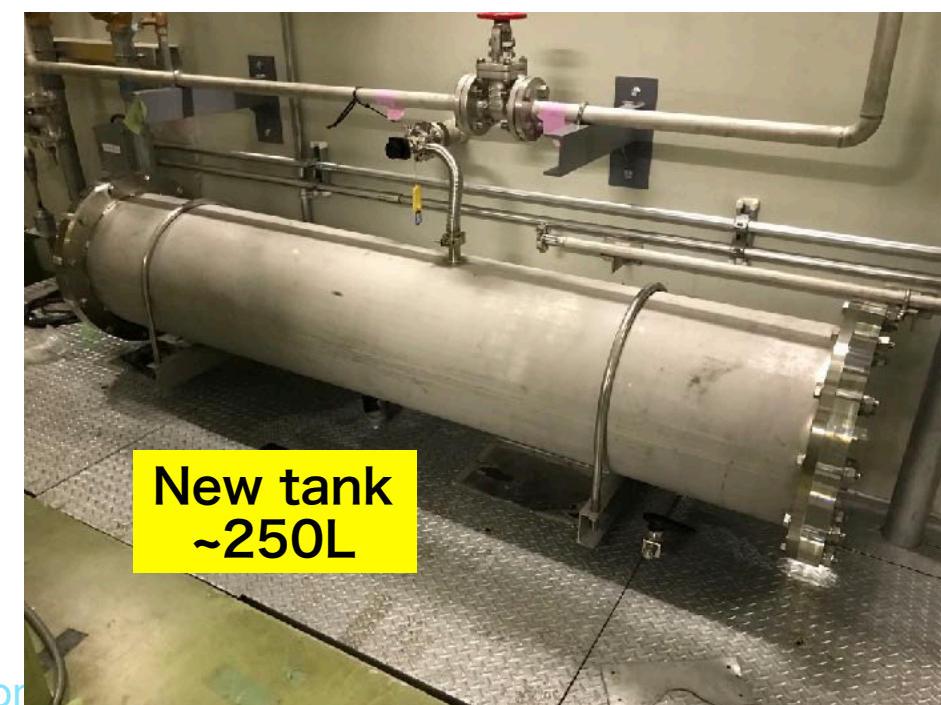
1st/2nd generation horn1

• Expected reasons of the drop

① Corrosion at the upstream seal

- A step structure at the upstream flange created a water pocket
- If water stays at a tiny gap, a gap corrosion occurs

② Beam heating caused thermal expansion of bolts

- Contact pressure at seal reduced

③ Higher pressure inside horn than before

- Outlet pressure of new He blower is higher by ~4 kPa than before (~115kPa@Horn1)

- Al knife-edge seal → **Helicoflex seal** ⇒ **Countermeasure for thermal expansion**
- **Remove step structure** ⇒ **Avoid corrosion**
- Al bolts ⇒ **Ti bolts** ⇒ **Countermeasure for thermal expansion**

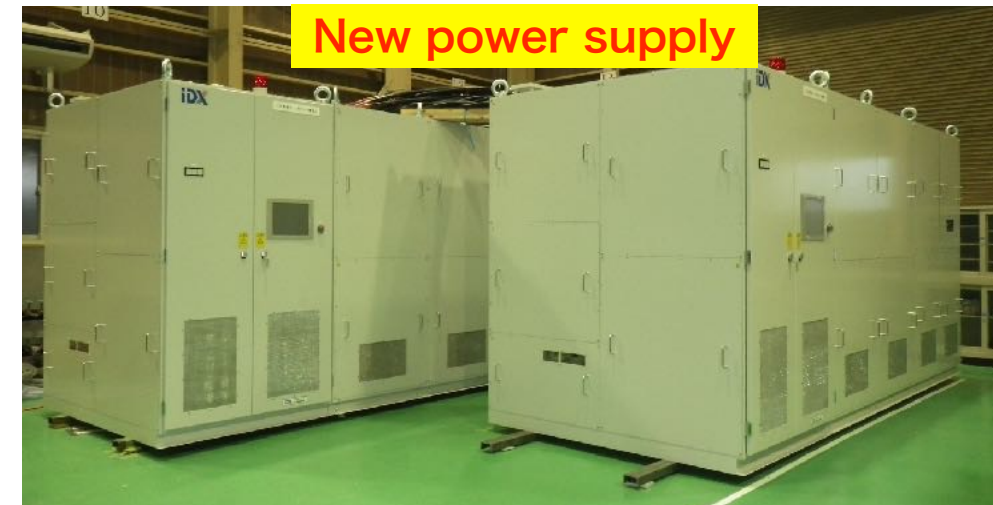
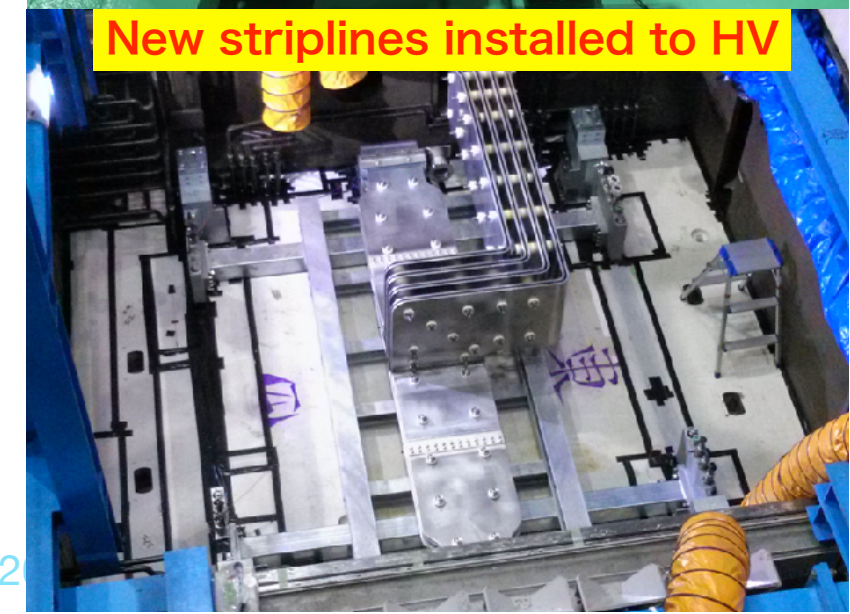
- **New power supplies** with energy recovery
 - Operation voltage < 6 kV at 320 kA
 - Charging time < 1 sec
- **New low impedance striplines**
 - $L \sim -40\%$, $R \sim -30\%$
 - Wider and thicker stripline plates
 - Stronger against Lorentz force
- **New transformers** for 320 kA operation
 - High mechanical strength
 - High magnetic field tolerance
 - High cooling performance

Parameter	horn1	horn2	horn3
Operation current	323 kA	323 kA	323 kA
Operation voltage	<u>5.85 kV</u>	<u>5.72 kV</u>	<u>5.91 kV</u>
Returned voltage	4.60 kV	4.78 kV	5.00 kV
Voltage recovery rate	78.6 %	83.6 %	84.6 %
Pulse width	2.00 ms	2.01 ms	2.08 ms
Charging time	<u>0.71 s</u>	<u>0.54 s</u>	<u>0.52 s</u>

- Three transformers should be placed in the existing space
 - Available space for transformers is very limited \Rightarrow **compact design needed**

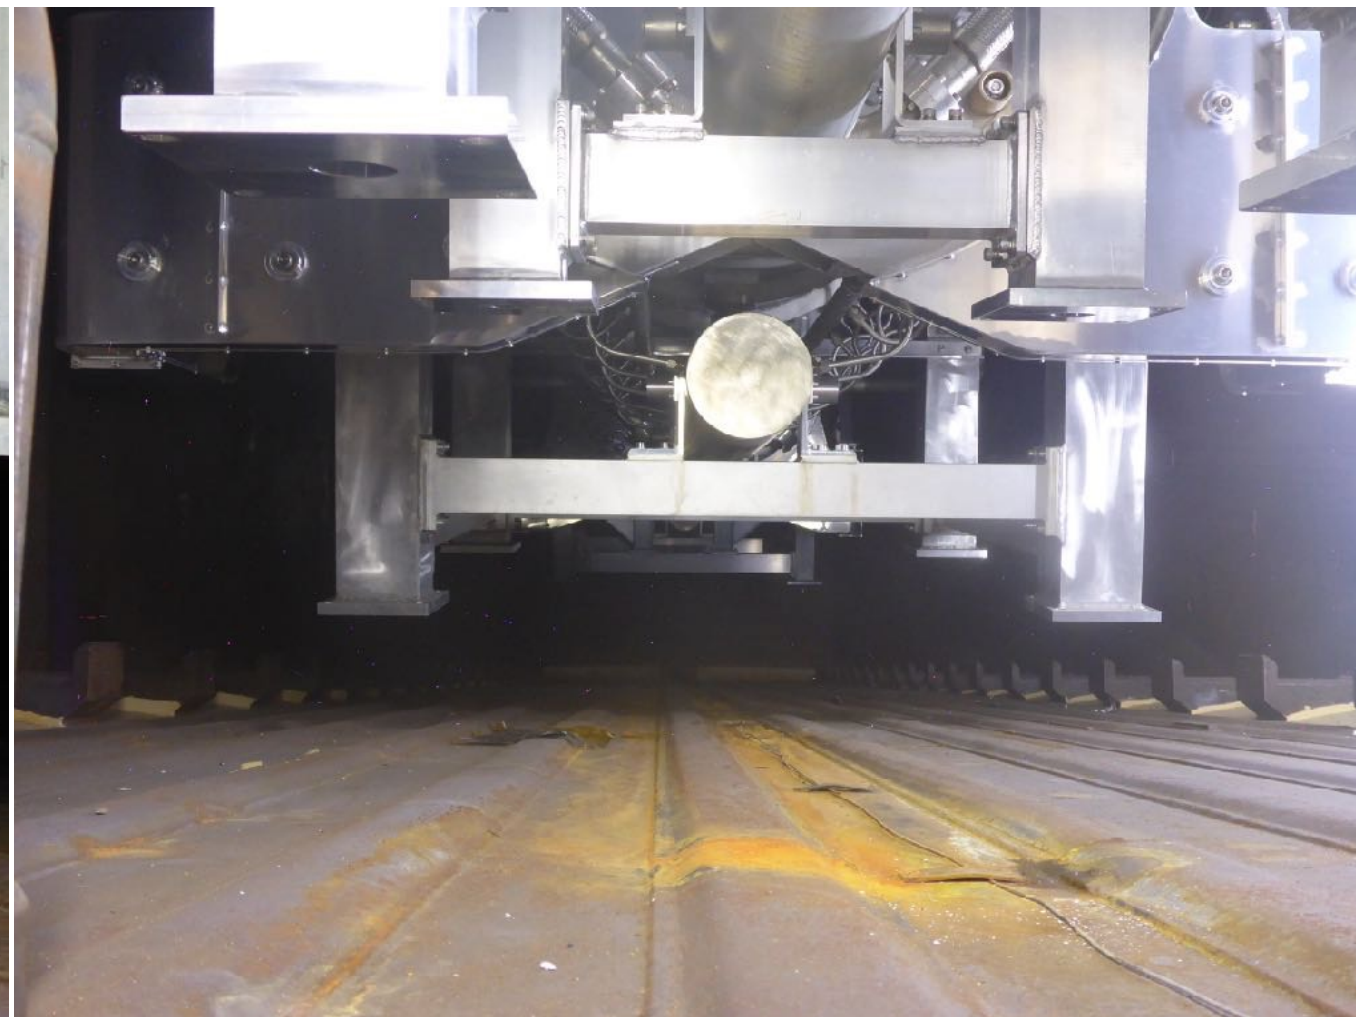
December 2018

- Drop rate : **~5 L/day**
- Dropped water was **evaporated**
- **No** additional significant **corrosion**
- Horn surface is still **clean** (shinny)

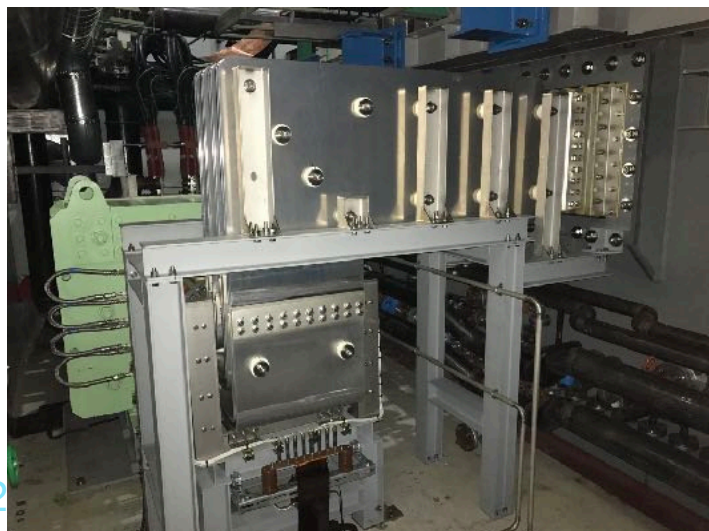
- For horn1, all upgrade were completed
- 320kA test operation performed
 - Charging voltage : 6.05 kV as expected (\Leftrightarrow 5.8 kV, rated 7kV)
 - Pulse width : 1.98 ms as expected (\Leftrightarrow 2 ms)
 - Short-term (24 hours) continuous operation performed
 - No problem observed \Rightarrow ready for 320 kA

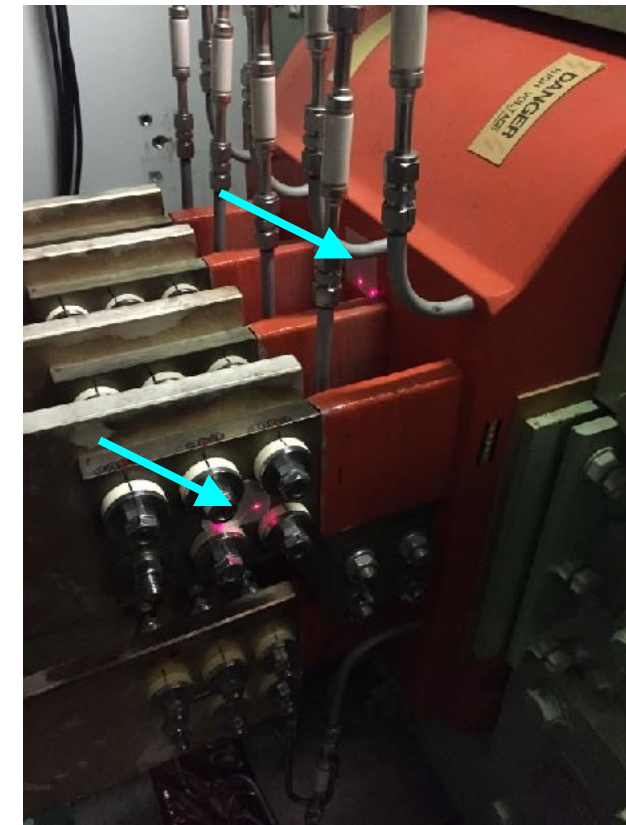
- **1.3s operation w/ current setup**
 - If no budget, we must use current setup for high rep. rate operation ==> Is it feasible or not?
 - A concern on temperature at epoxy insulator < ~60°C
 - 4 hour operation at 1.3 s cycle
 - Measured temp. at various points
 - ~60°C @ copper busbar
 - ~50°C @ nearby epoxy insulator
 - 1.3 s cycle operation is feasible but new transformer should be prepared for a safe and stable operation

Horn1	Horn2&3
Primary busbar	<50°C	<50°C
Primary epoxy	<50°C	40°C
Secondary busbar	48 °C	60 °C
Secondary epoxy	38°C	48°C
Iron core	<50°C	<50°C
Aluminum busbar	35°C	34°C

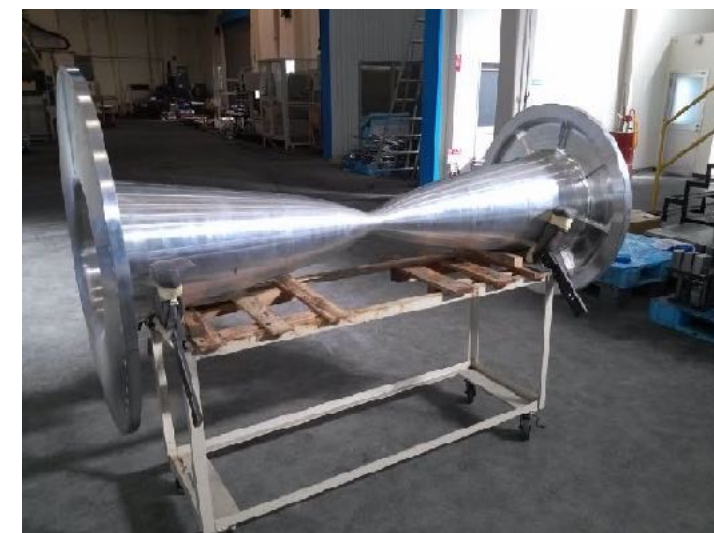
Outer conductor:
Al-Alloy

- **Large displacement@Horn2 \Rightarrow $\sim 1\text{mm}@320\text{ kA}$**

- Inner conductor was modified to reduce displacement.
 - Adding ribs on both upstream and downstream ends
- Transient stress analysis for Lorentz force and Joule heating
 - Done by RAL team (P. Loveridge)

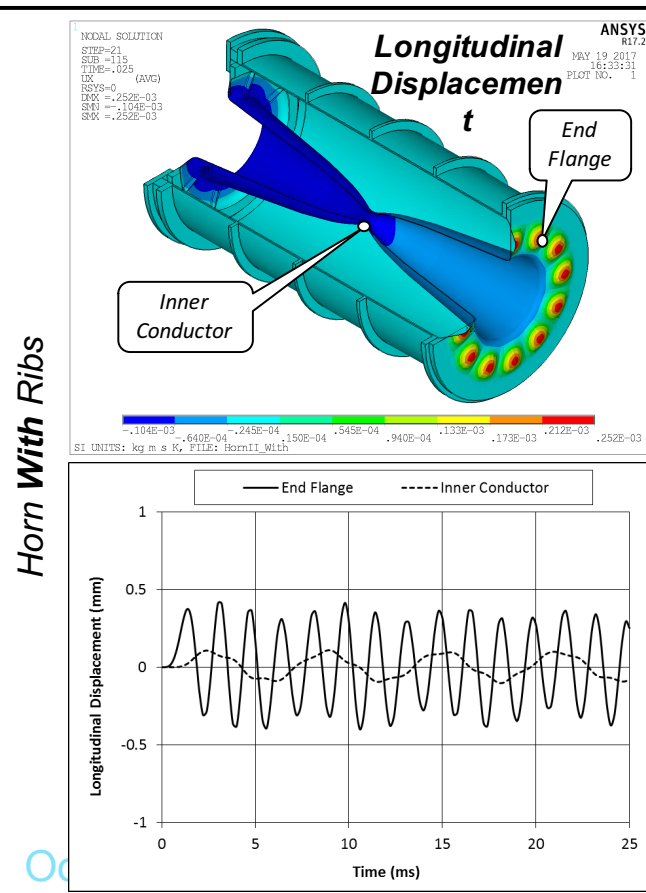
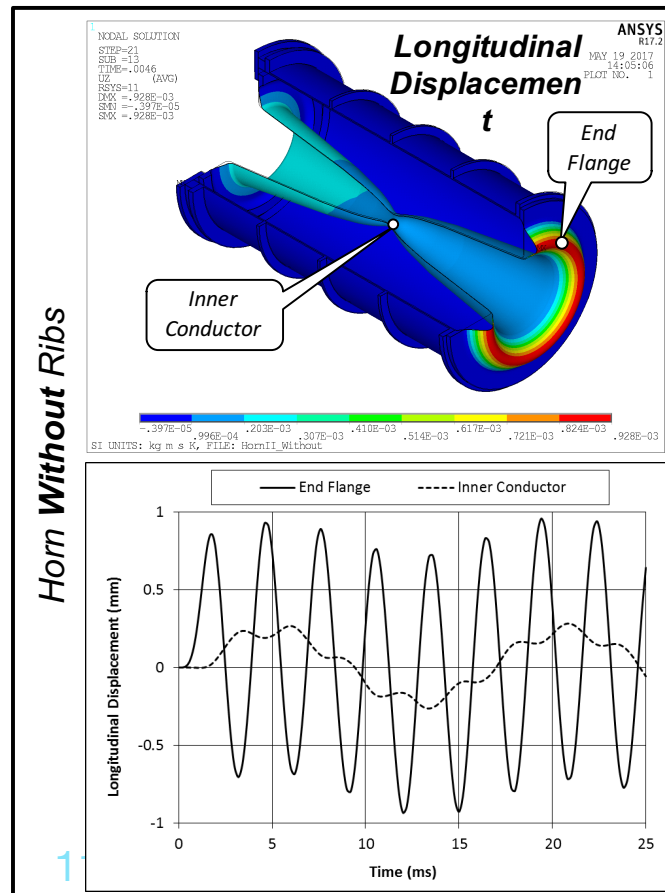
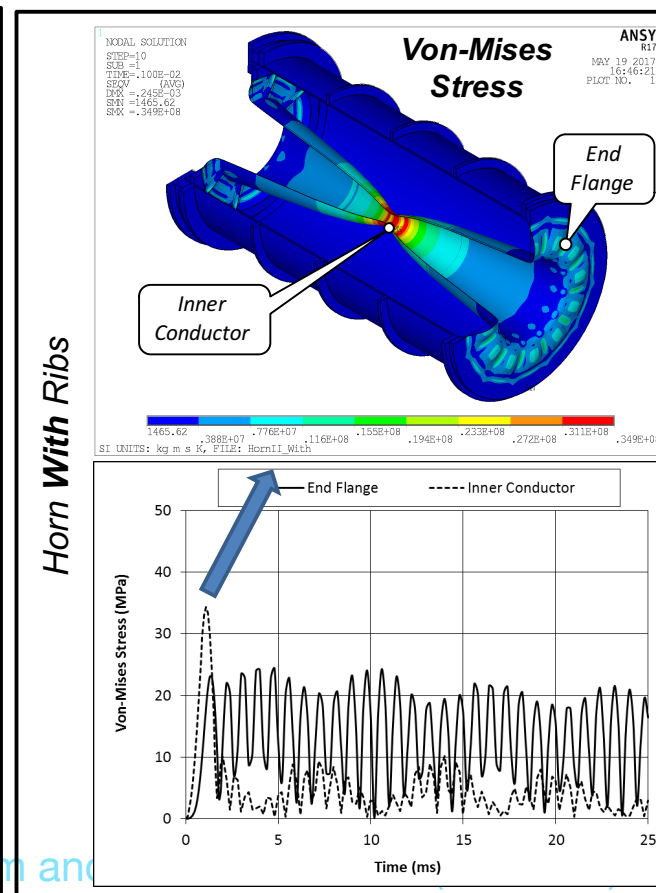
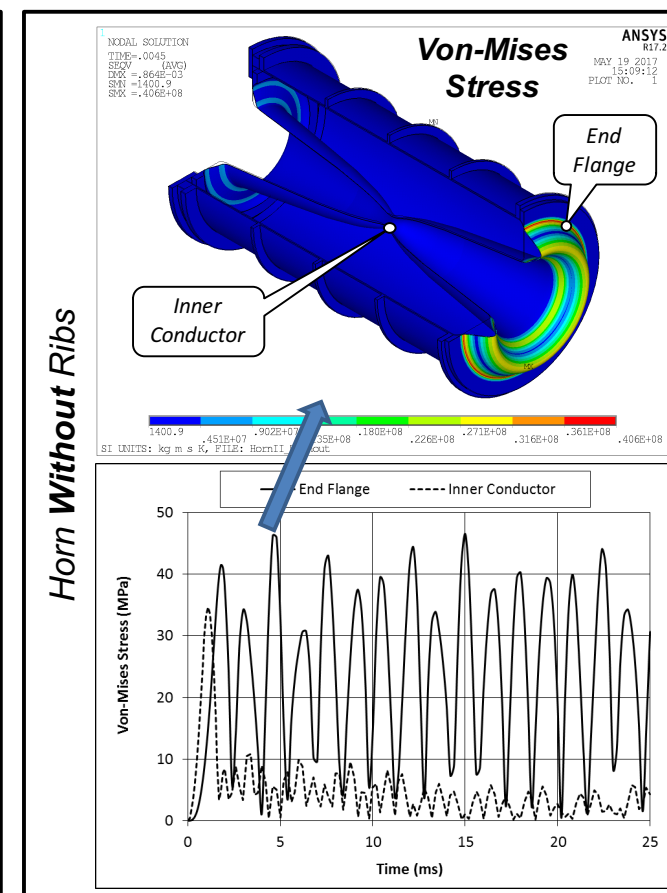
Transient Analysis: Displacement Results (320 kA)

FEM results

- Displacement reduced from 0.93mm to **0.25mm**
- Stress at endplate also reduced from 45MPa to **24MPa**
- Design modification and outer conductor production to be done

Transient Analysis: Stress Results (320 kA)
