# SLAC Proposal for PX L-band Couplers

Chris Adolphsen

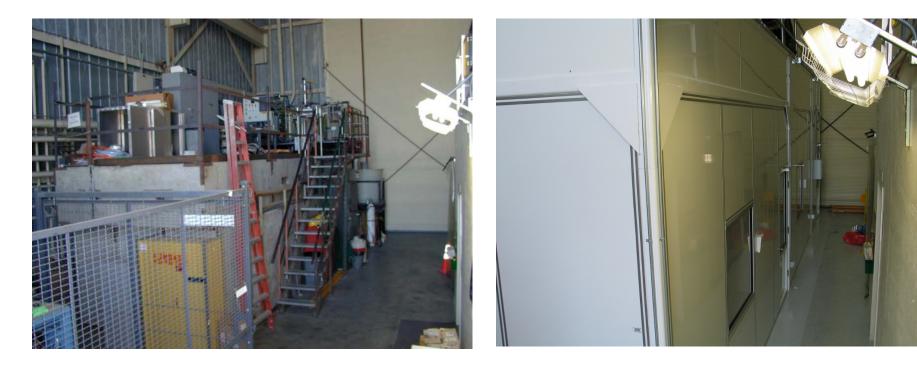
- Building 006 High Bay before cleanroom (left picture)
- Building 006 High Bay after cleanroom (right picture)

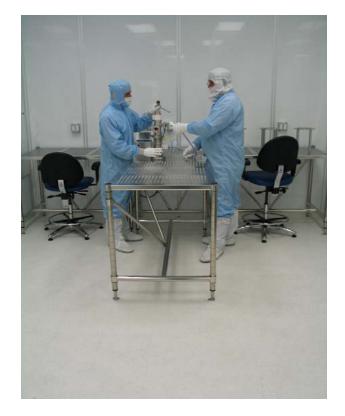
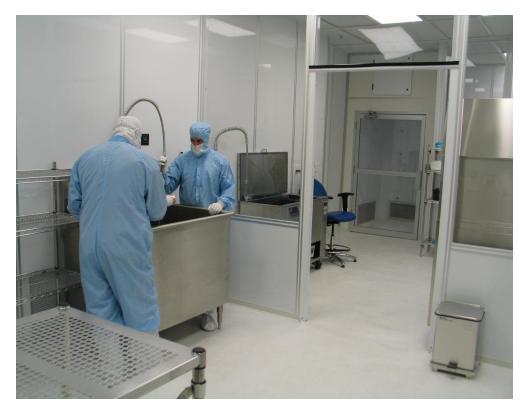
#### Ultra Pure Rinse Station in class 10 area

- Class 10 cleanroom 24 ULPA Filters (99.999% @ 0.12)
- Cleanroom size is 16' x 12'

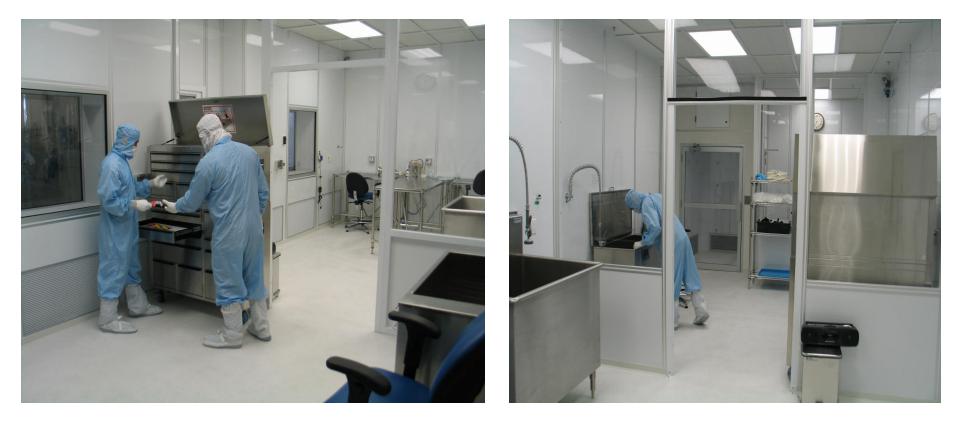
#### Ultrasonic Wash Station in Class 100 area

- Class 100 cleanroom 10 HEPA Filters (99.97% @ 0.3)
- Cleanroom size is 12' x 12'

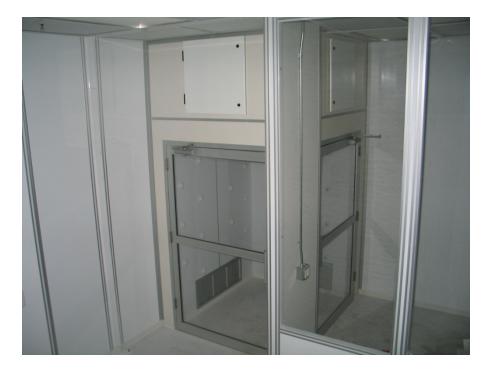
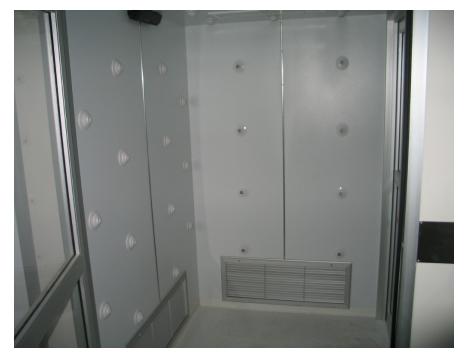
- Air Shower
  - All material and personnel will go through the Air Shower to remove particulates prior to entering into the cleanroom.

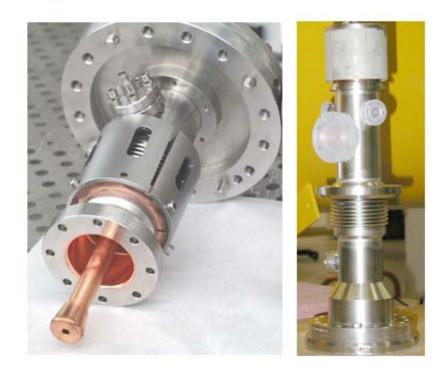
Power Coupler Sub-Assemblies and RF Processing Stand (4 MW Peak Power)

Processing of First Pair after 150  $^{\circ}$ C Bake: Power (MW) -vs- Time for Pulse Widths of 50,100, 200, 400, 800, 1000  $\mu$ s

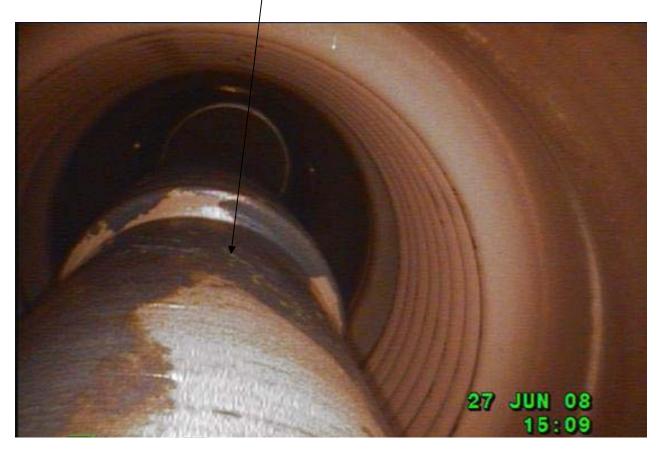
# **Coupler Inspection Results**

Failed inspection: Warm inner conductor with extensive oxidation.

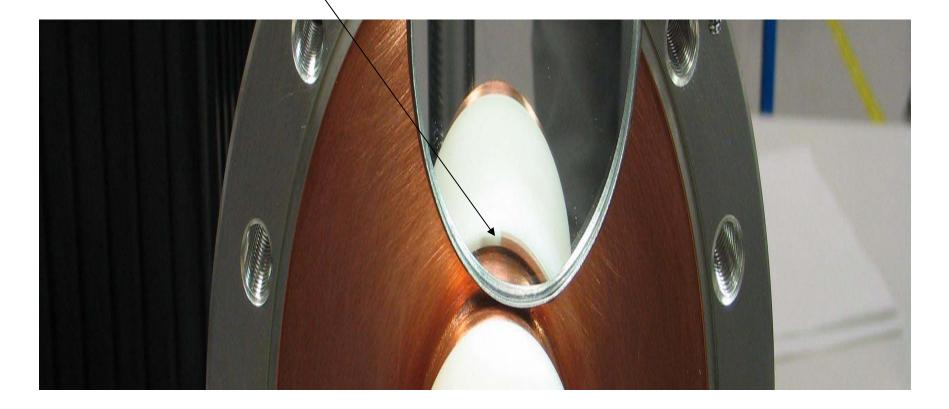
# **Coupler Inspection Results**

Failed Inspection: Here the part has copper plating on the ceramic. The ceramic has to be free of metallization.

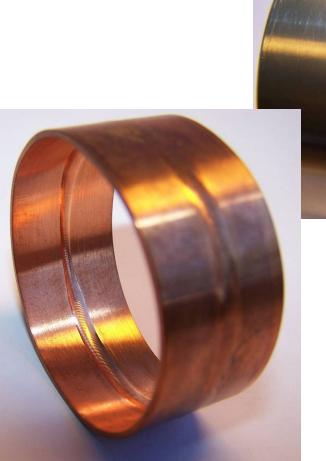
## SLAC Klystron Group is Building a Cold Section using TIG Welding instead of E-beam Welding

Parts from an Orsay sponsored study of TIG Welding
