CRT Ongoing Activities

Minerba Betancourt (Fermilab) and Umut Kose (CERN)

October 09, 2019

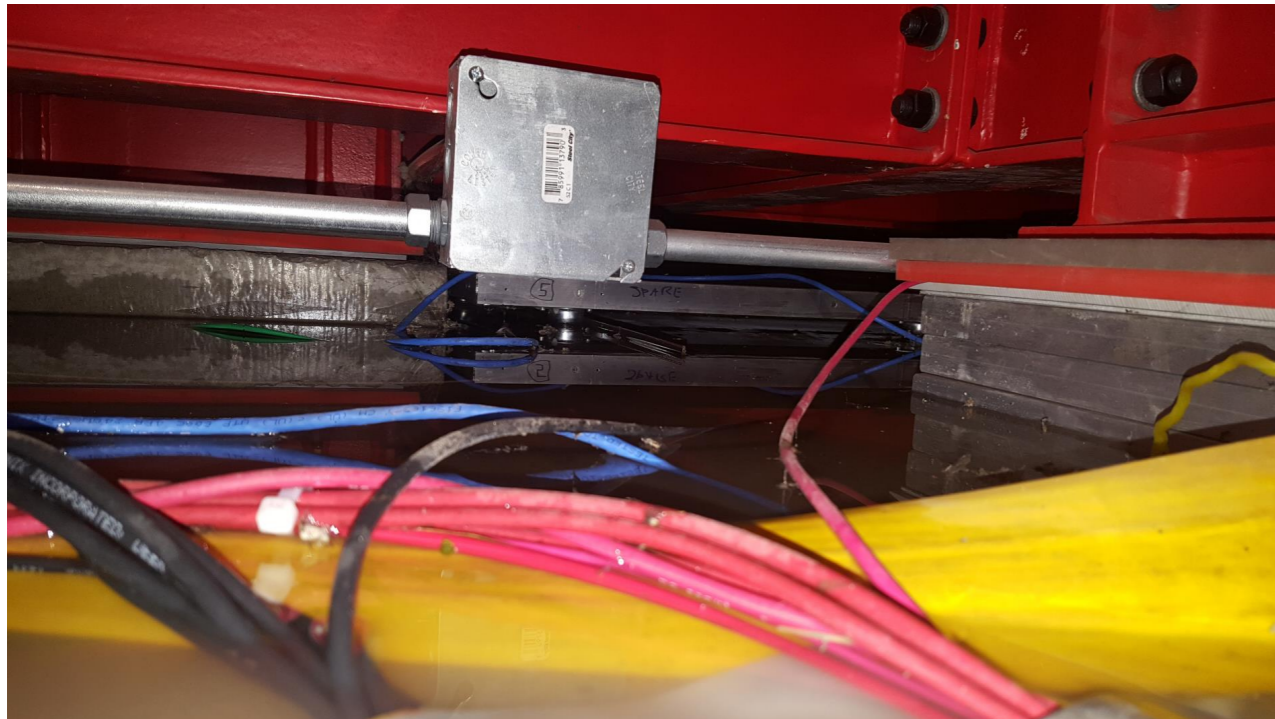
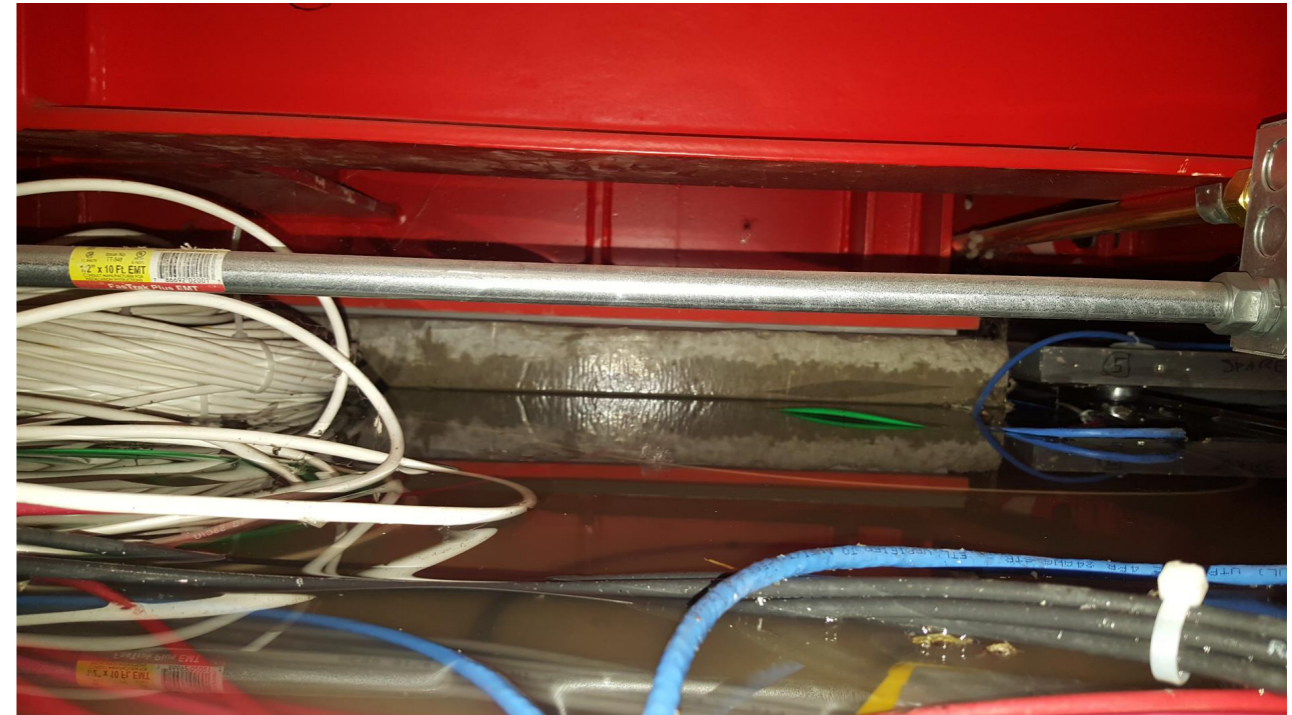
West, center

Water at the Pit area

- We had a sump pumps failure at the Icarus building
- The water depth was higher than the underside of the bottom CRT panels

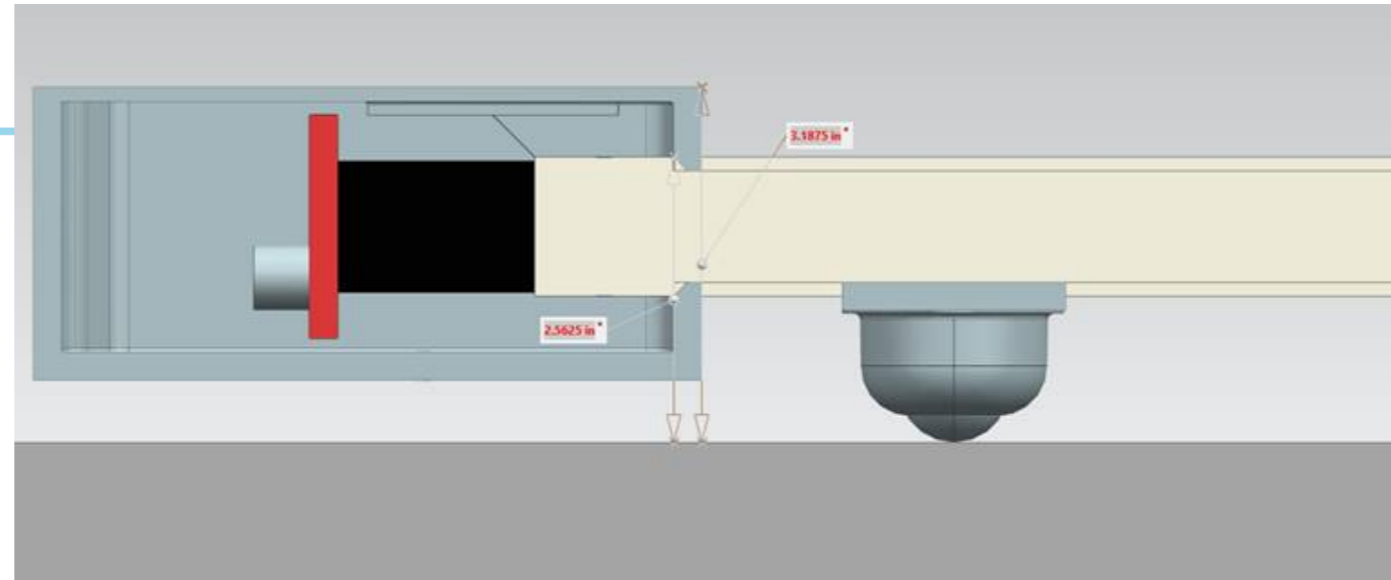
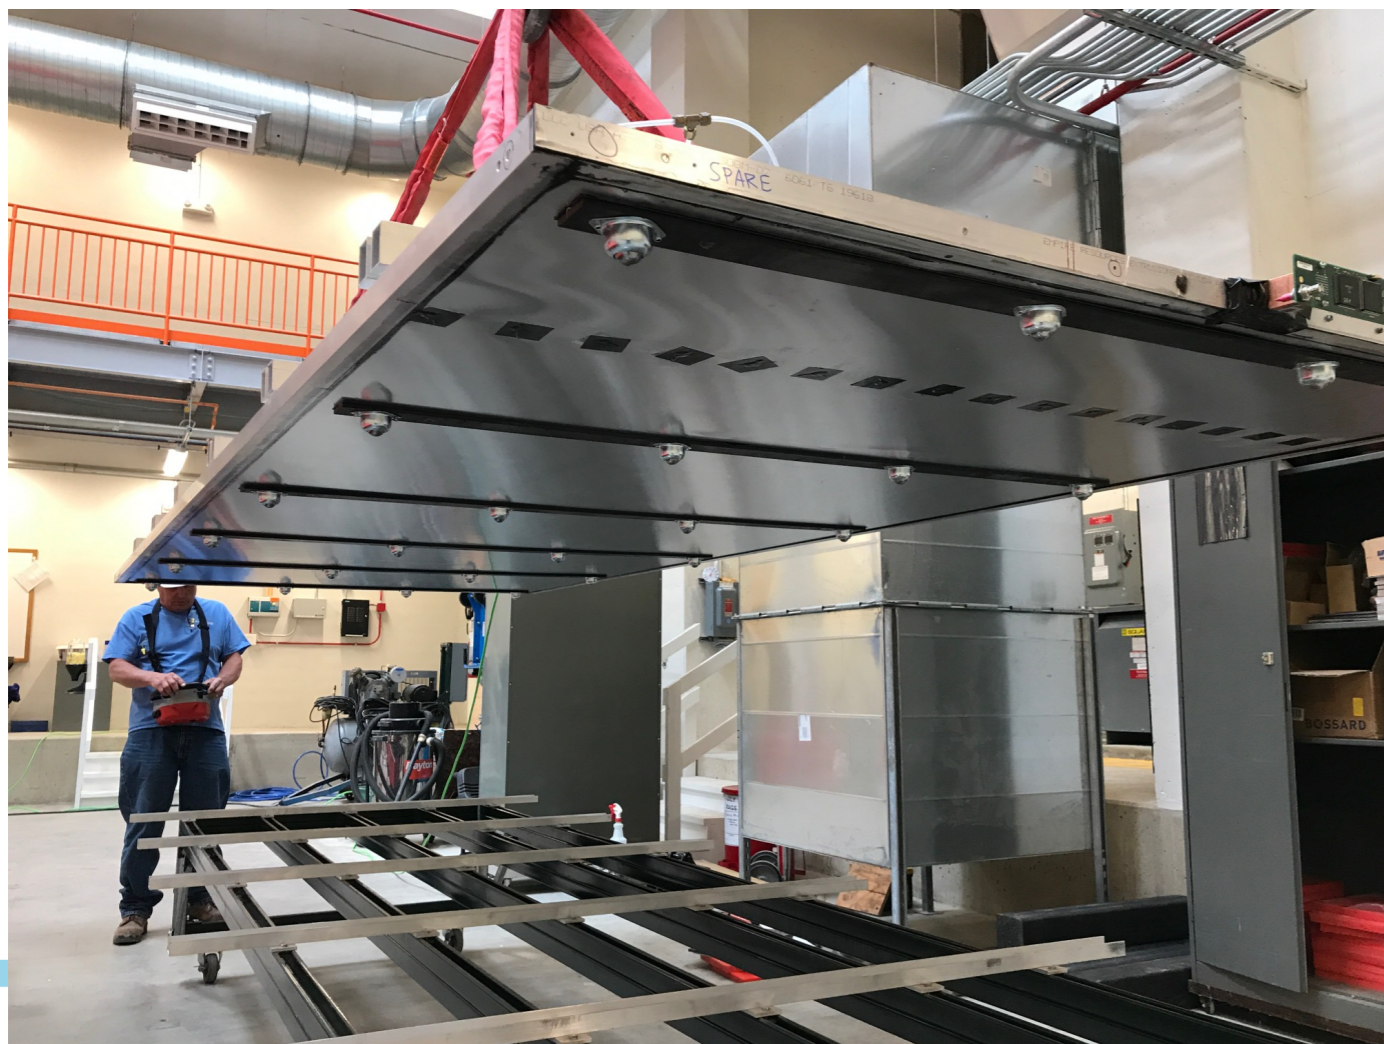
Distance from the floor to bottom CRT and water level

From Justin Tillman: We glued ball [transfers](#) to the bottom of the CRT's for installation purposes. The distance from the floor to the top of the CRT is 2.563" and to the top of the electronics protection box is 3.188". the box was not designed to be water tight, it has holes for the wires.

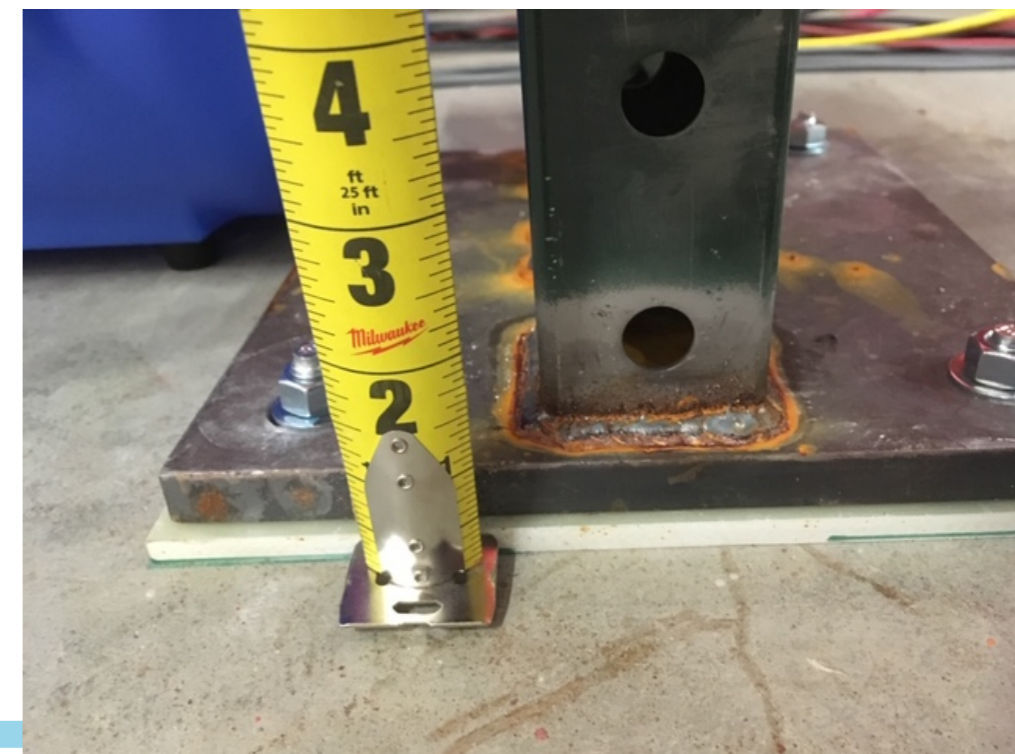
Water level: ~2 inches

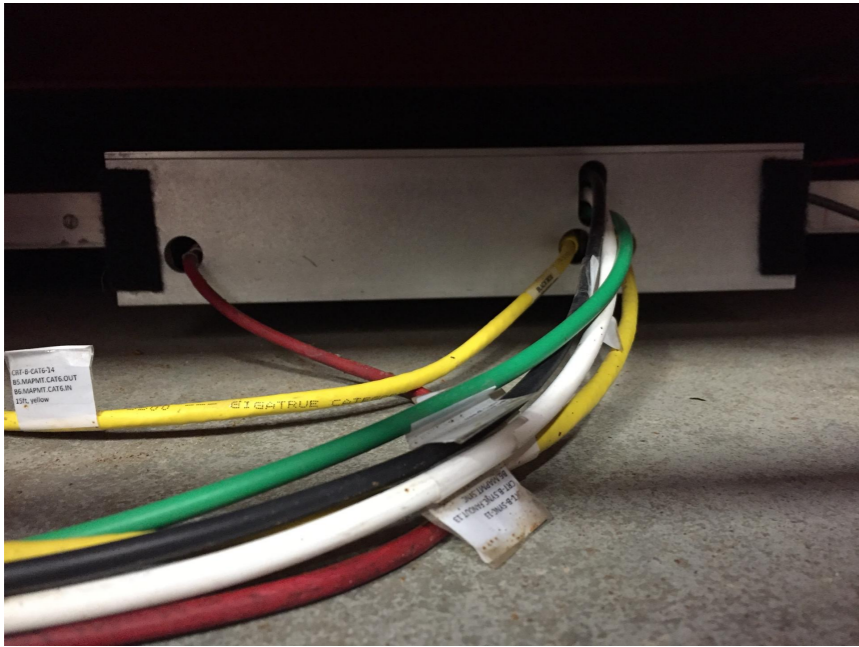
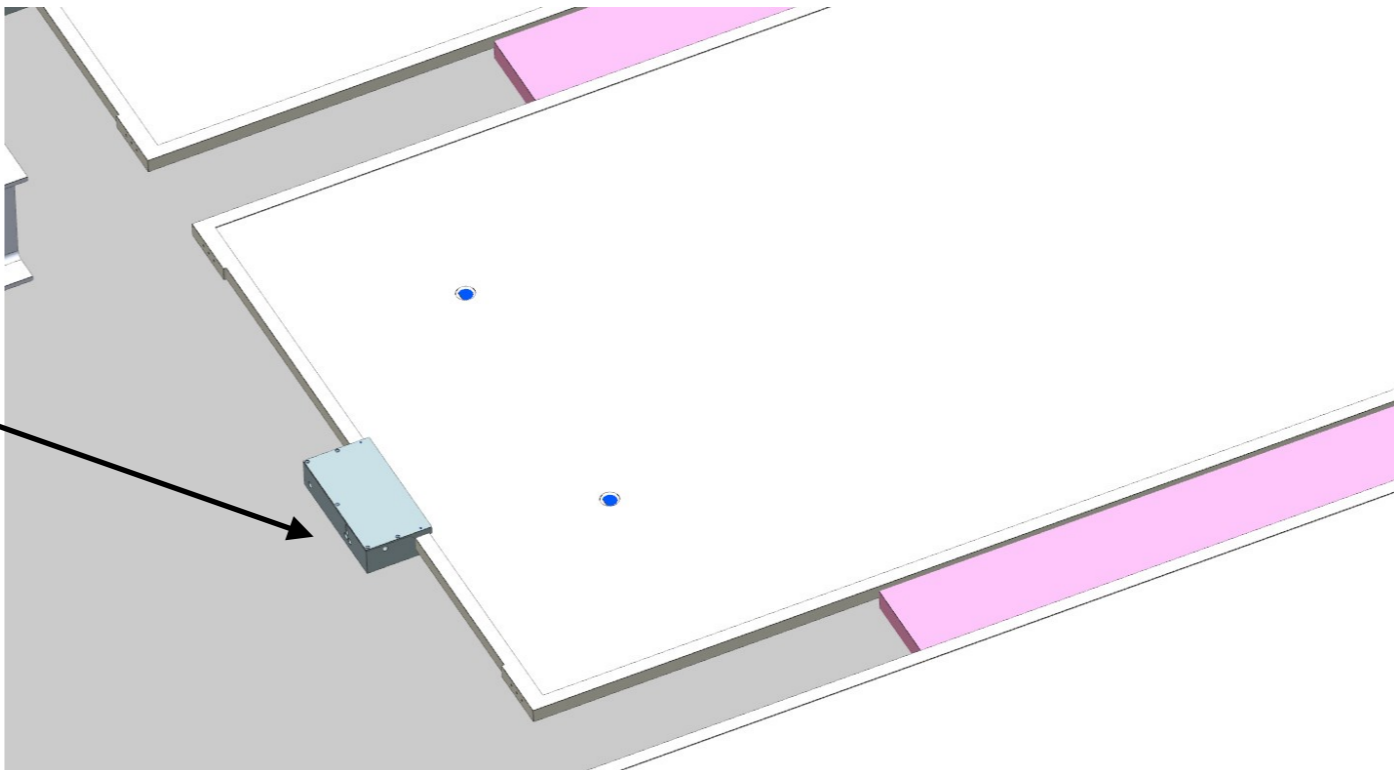
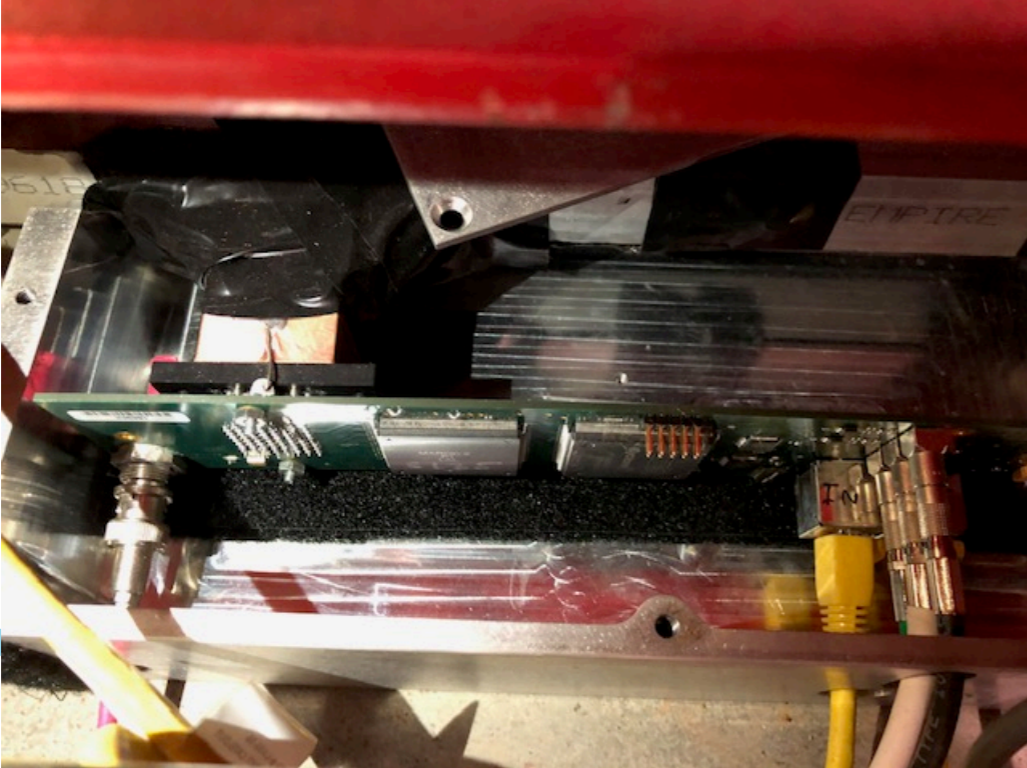
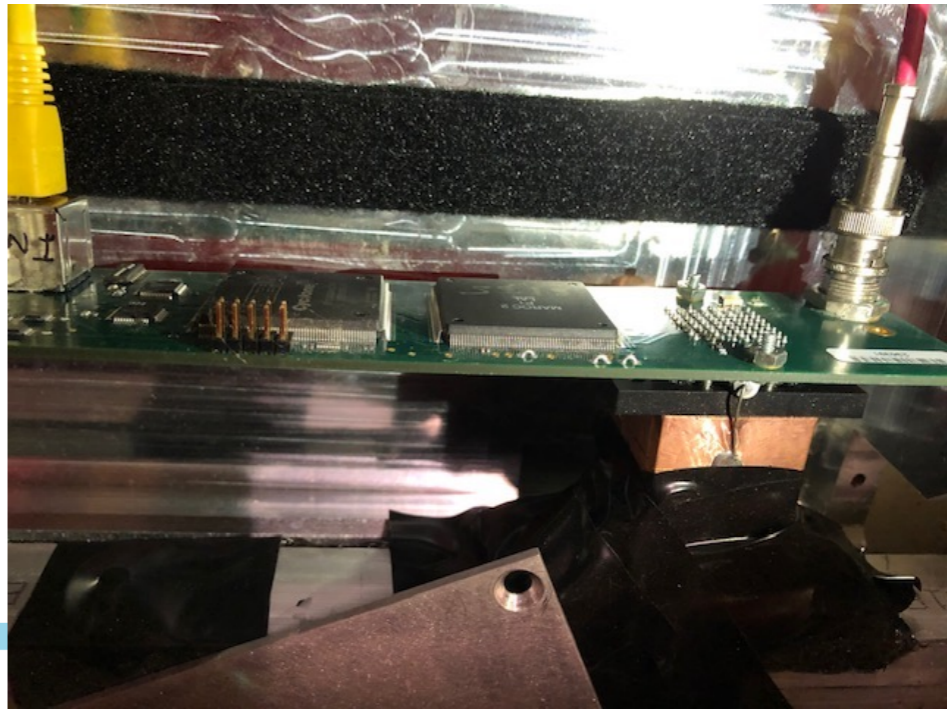
Board Inspection at West Side

We inspected the two boards at the west side and we did not see any sign of water inside the box

Everything look pretty clean inside the box

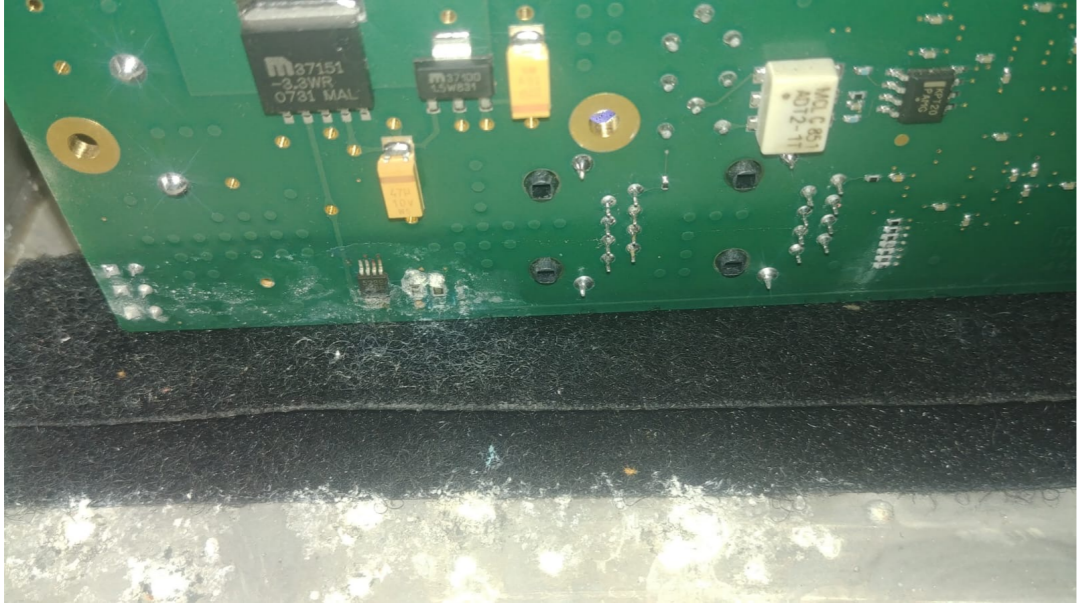
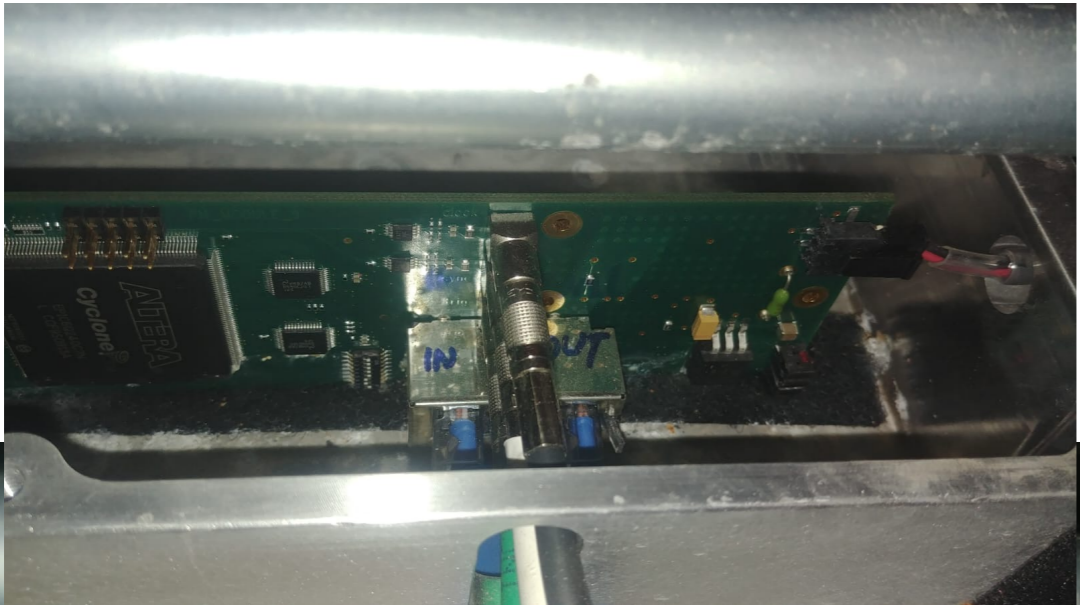
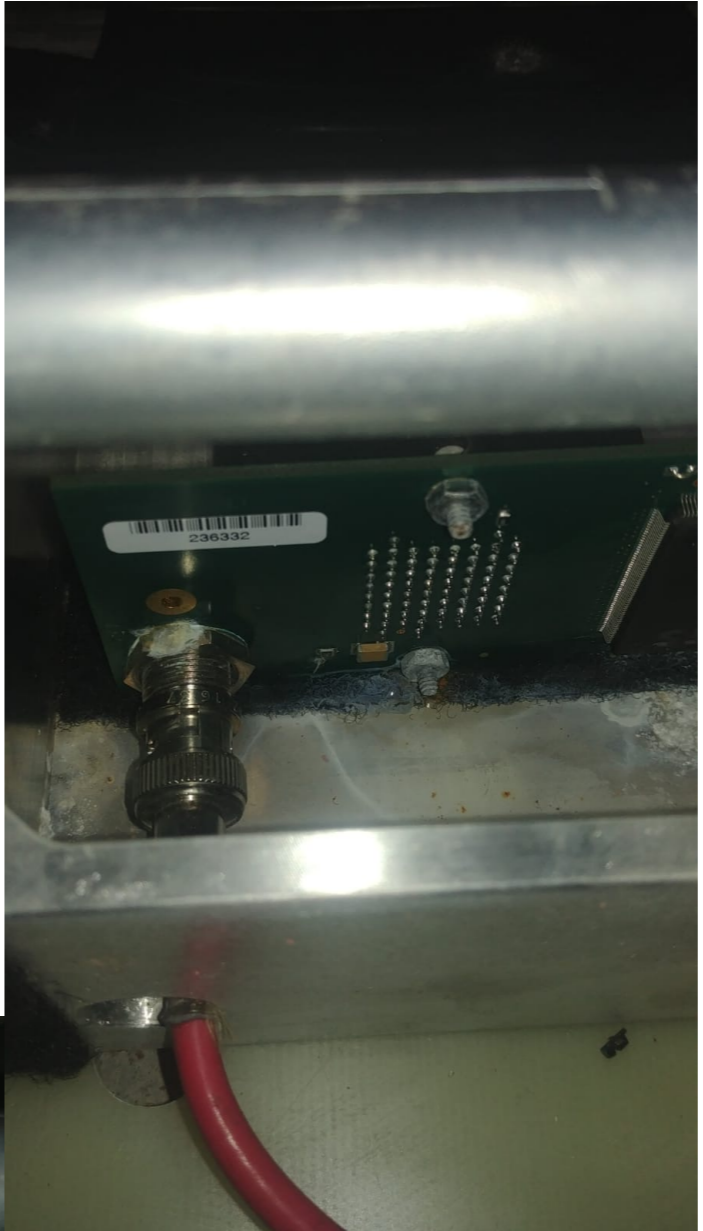
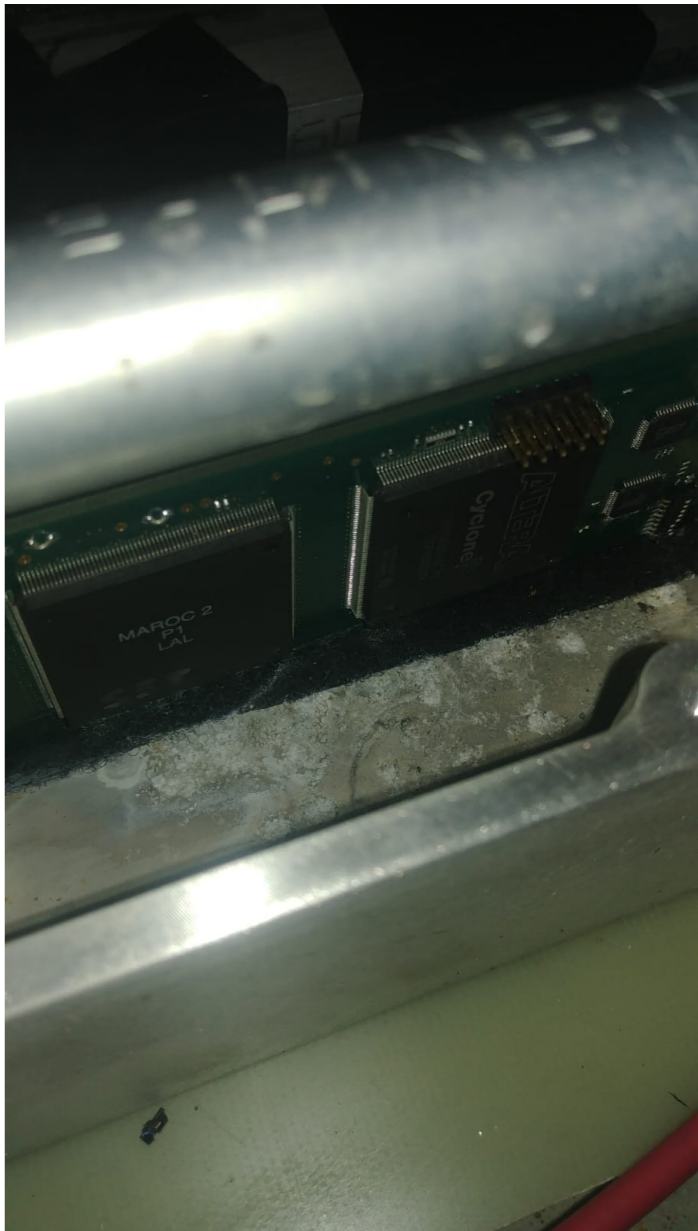
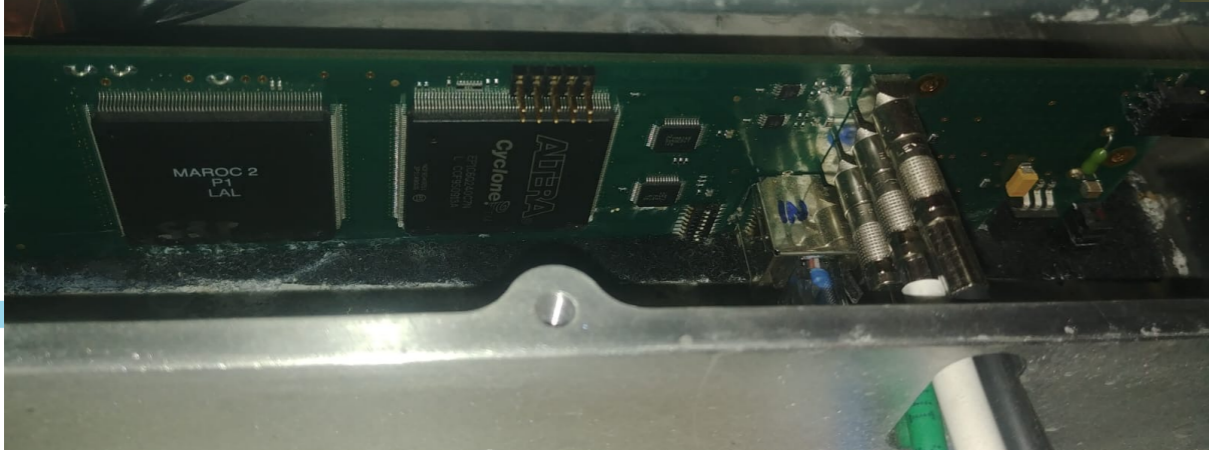
Board Inspection at East Side

We inspected two boards at the East side, both boards has corrosion. Water touched them

- Measure the resistance between center pin and ground at the clock cable (50 ohm)
- If they look good, we will try to power on and check the current drawn
- If the clock is ok
- Check individual boards
 - Make a setup with a spare PMT connected to USB and laptop and then repeat connecting to the USB just one board at the time
- If the boards are ok, we could power on the system
- If there are damage boards, we will need to replace them
- Replace the two accessible boards from the East side
- Cat and I have been exploring the possibility of replacing the boards that have water contact, we have spare boards
 - Schedule TBD, we do not have technician available to move the modules out
- Confirm CRT software will work on the server
 - Have software working with artdaq

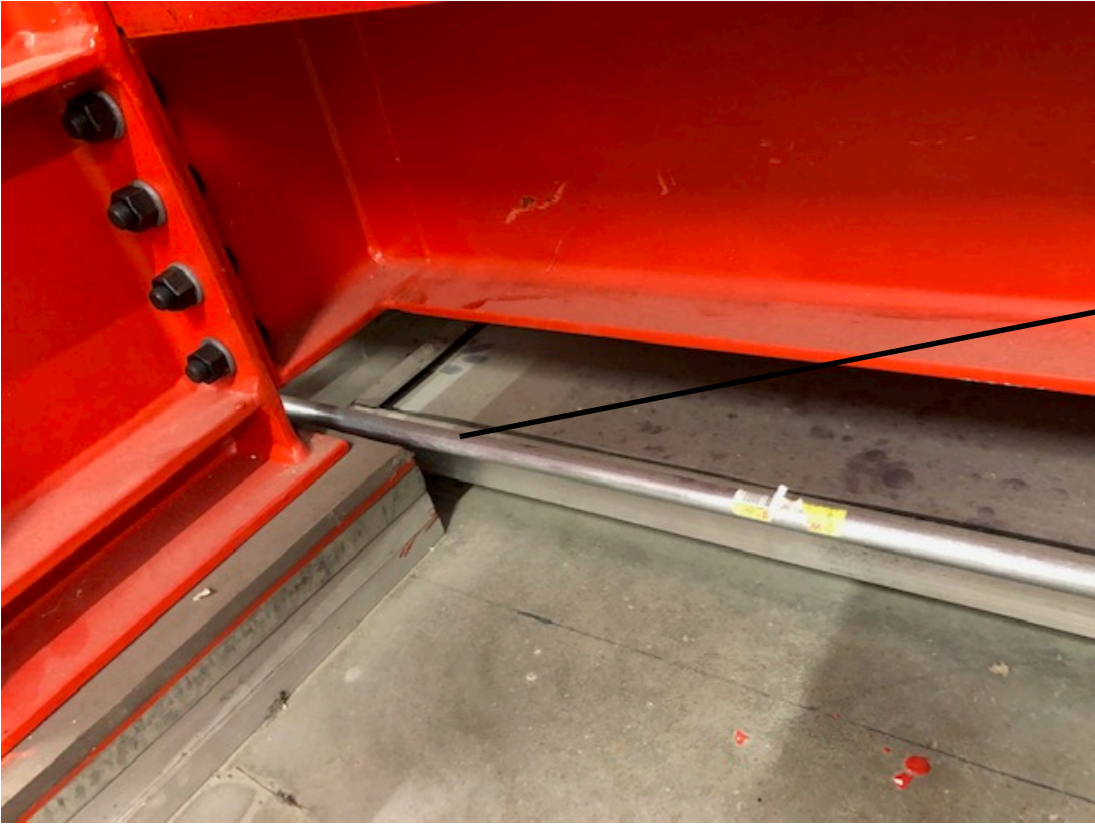
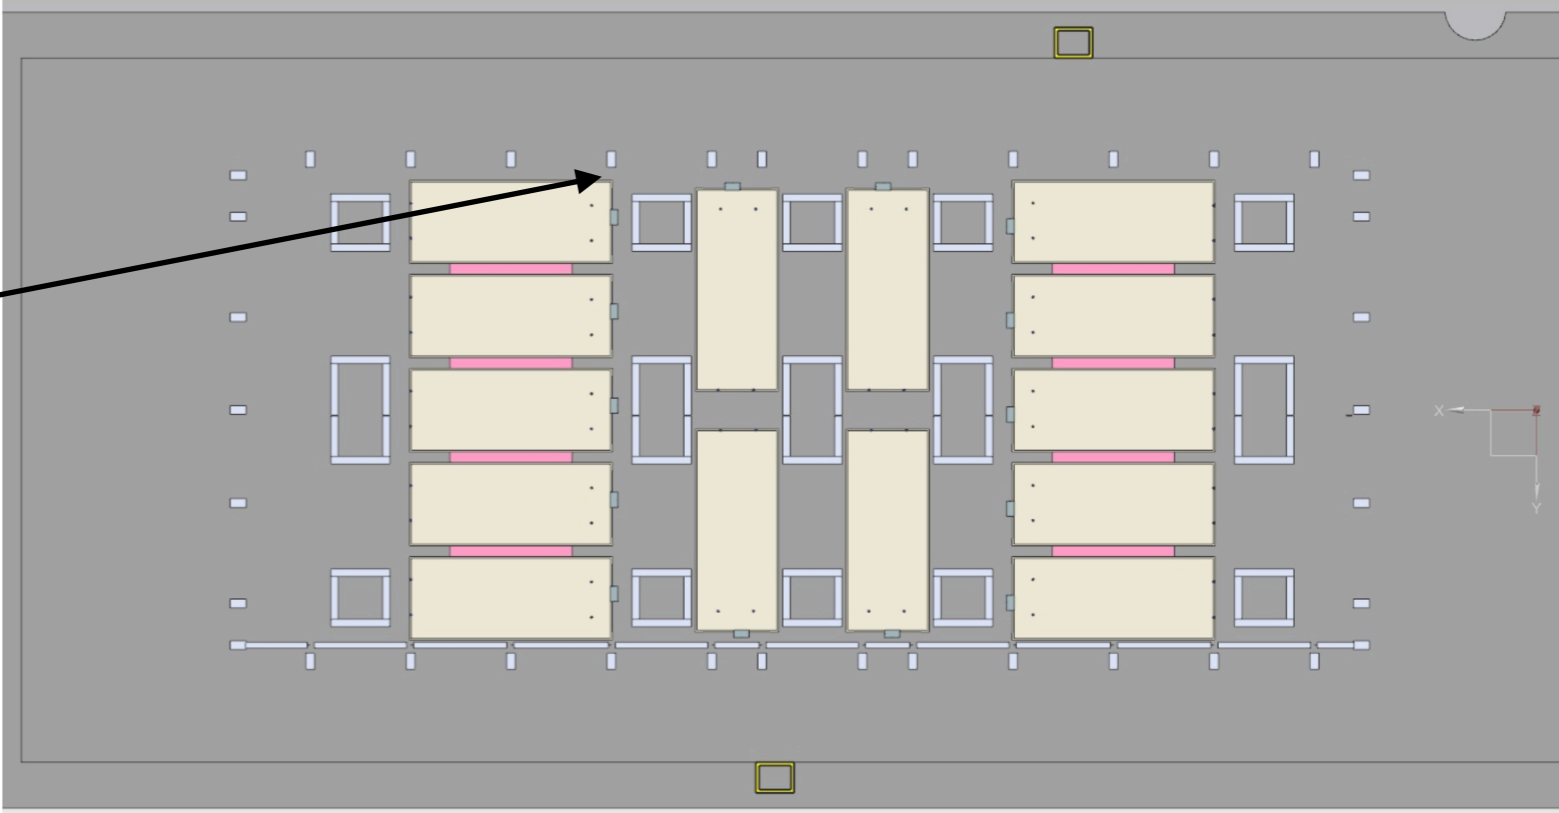
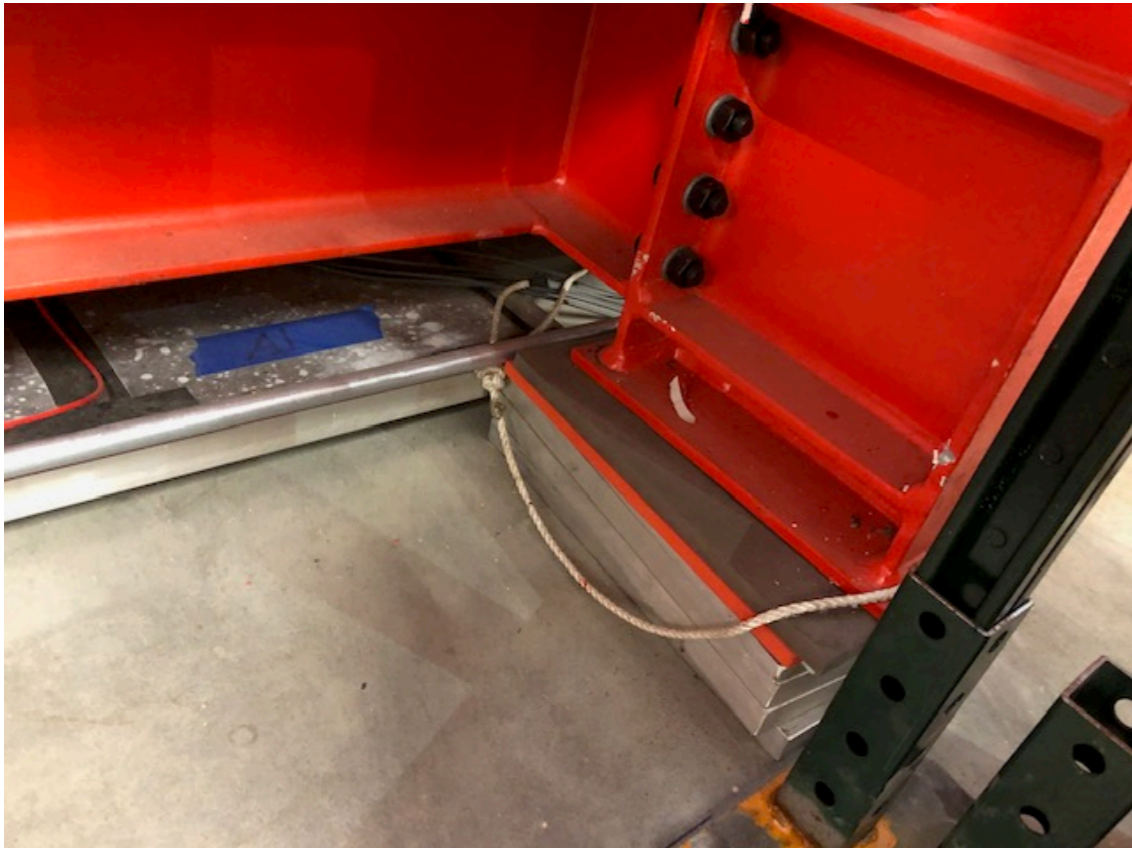
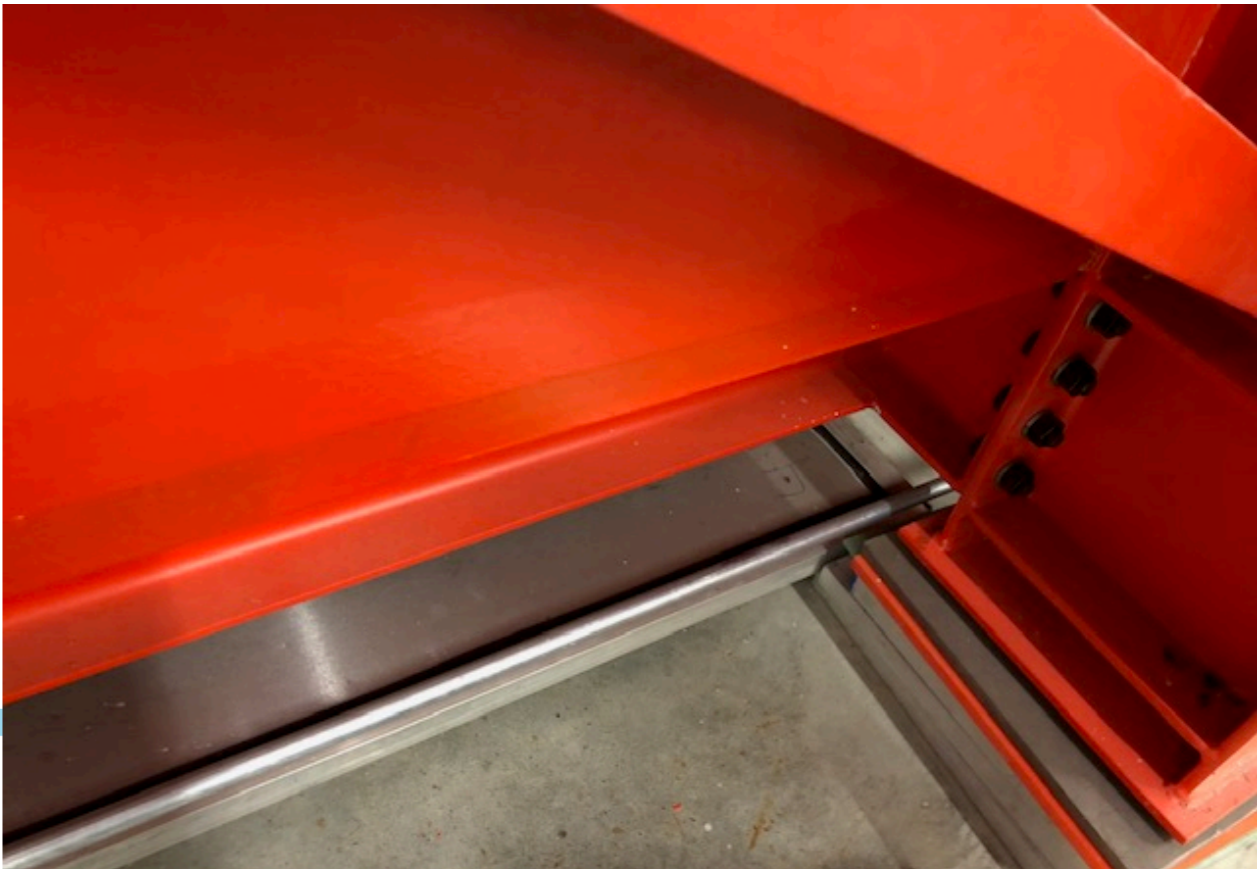
Boards on the inside are very difficult to reach

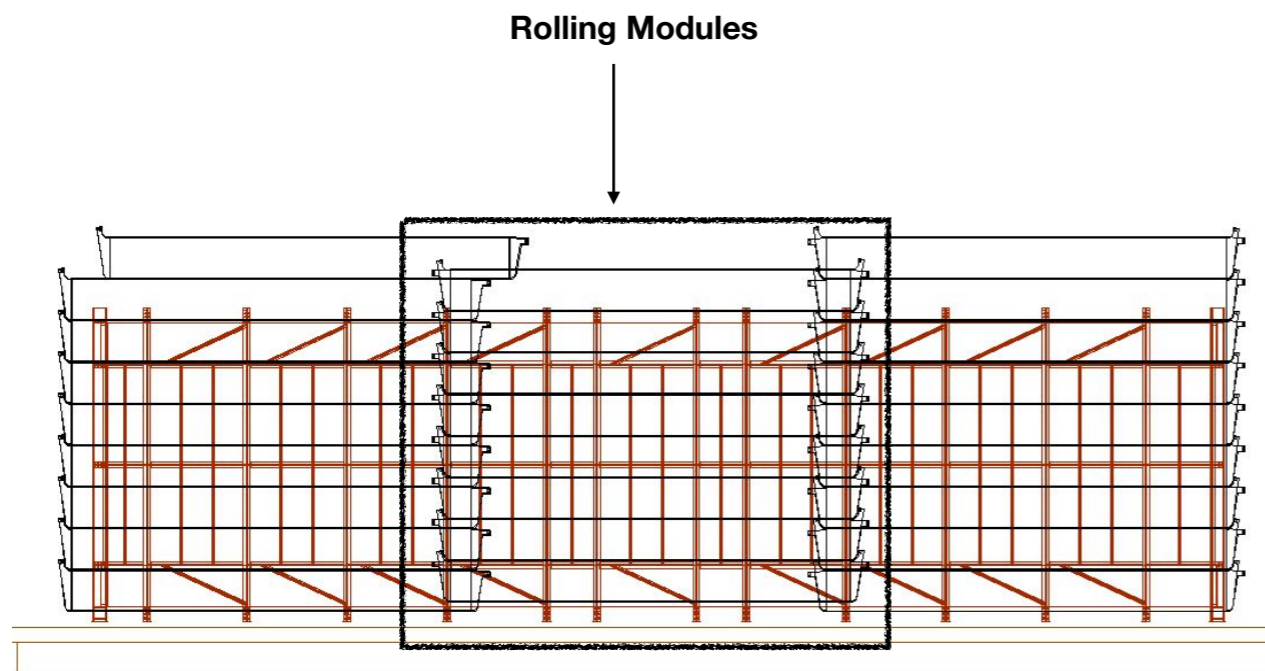
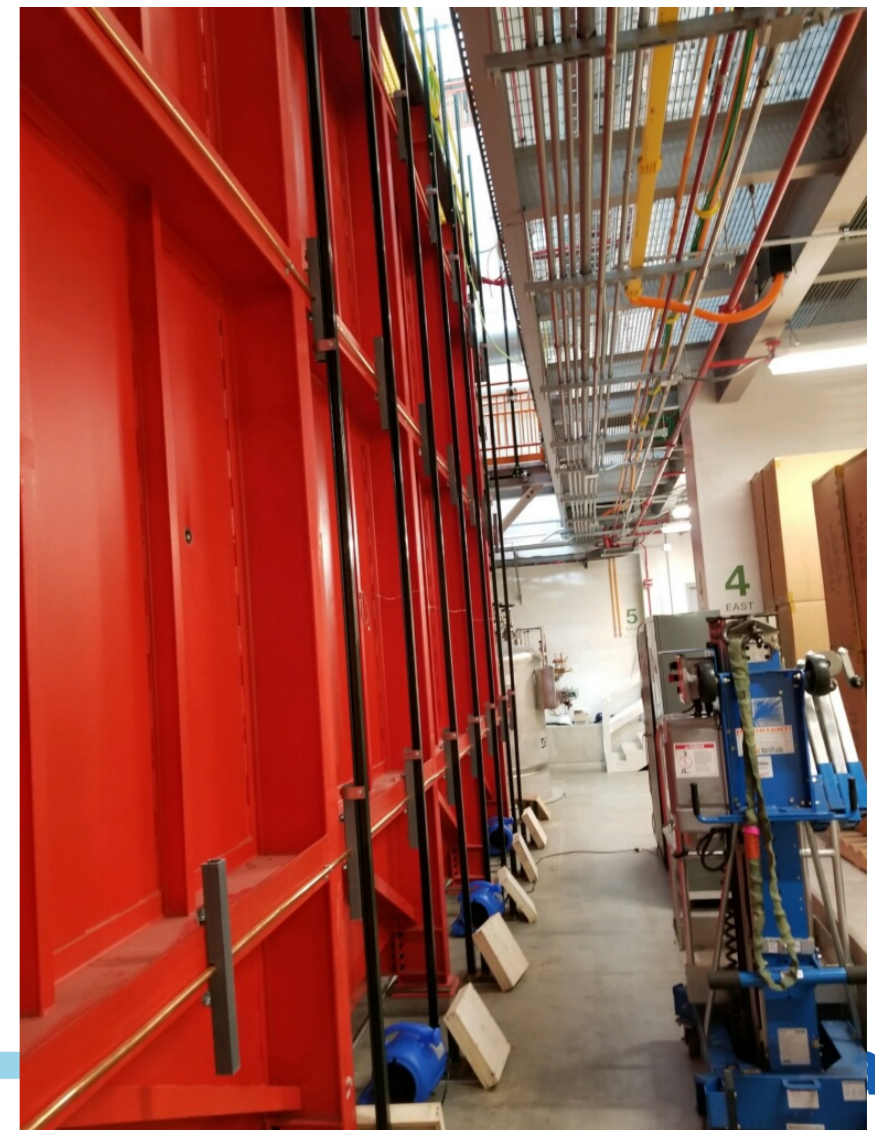
Partial side CRT Installation

- We need to install the CRT support for the rolling side CRT (East and West)
 - Install unit strut, install aluminum plates, install rolling parts, put post on the rolling parts
 - Waiting for parts to complete the unit strut installation
- Partial installation of some modules at East and West side
- Include the installation of the electronics
