# **Summary of Hatch cover mock-up test in J-PARC**

**Oct. 21, 2019**

**KEK IPNS**

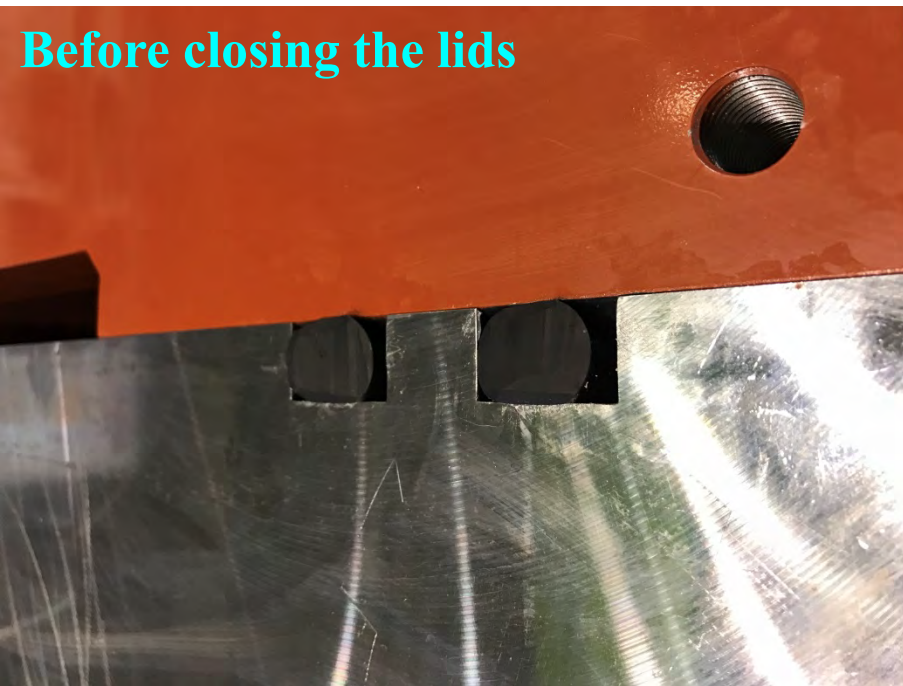
# Vacuum test by FNAL and KEK members (Apr. 18)

- 4) We cut the gaskets in such a way that the ends of gaskets were 2 ~ 3 mm above the surface of the cross member.
- 5) We closed the lids and tried to evacuate the mock-up.  
-> We could not evacuate!
- 6) We opened the lids and checked the gaskets.  
-> The ends of the gaskets fell under the surface of the cross member.

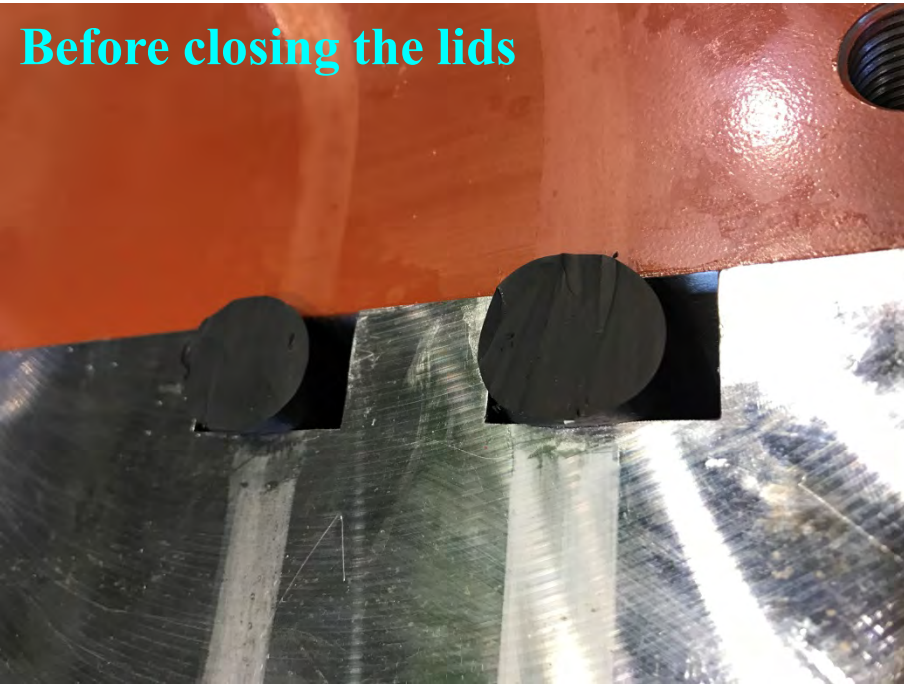
Before closing the lids

**7) We installed new gaskets and cut the gaskets in such a way that the ends of gaskets were 5 ~ 6 mm above the surface of the cross member.**

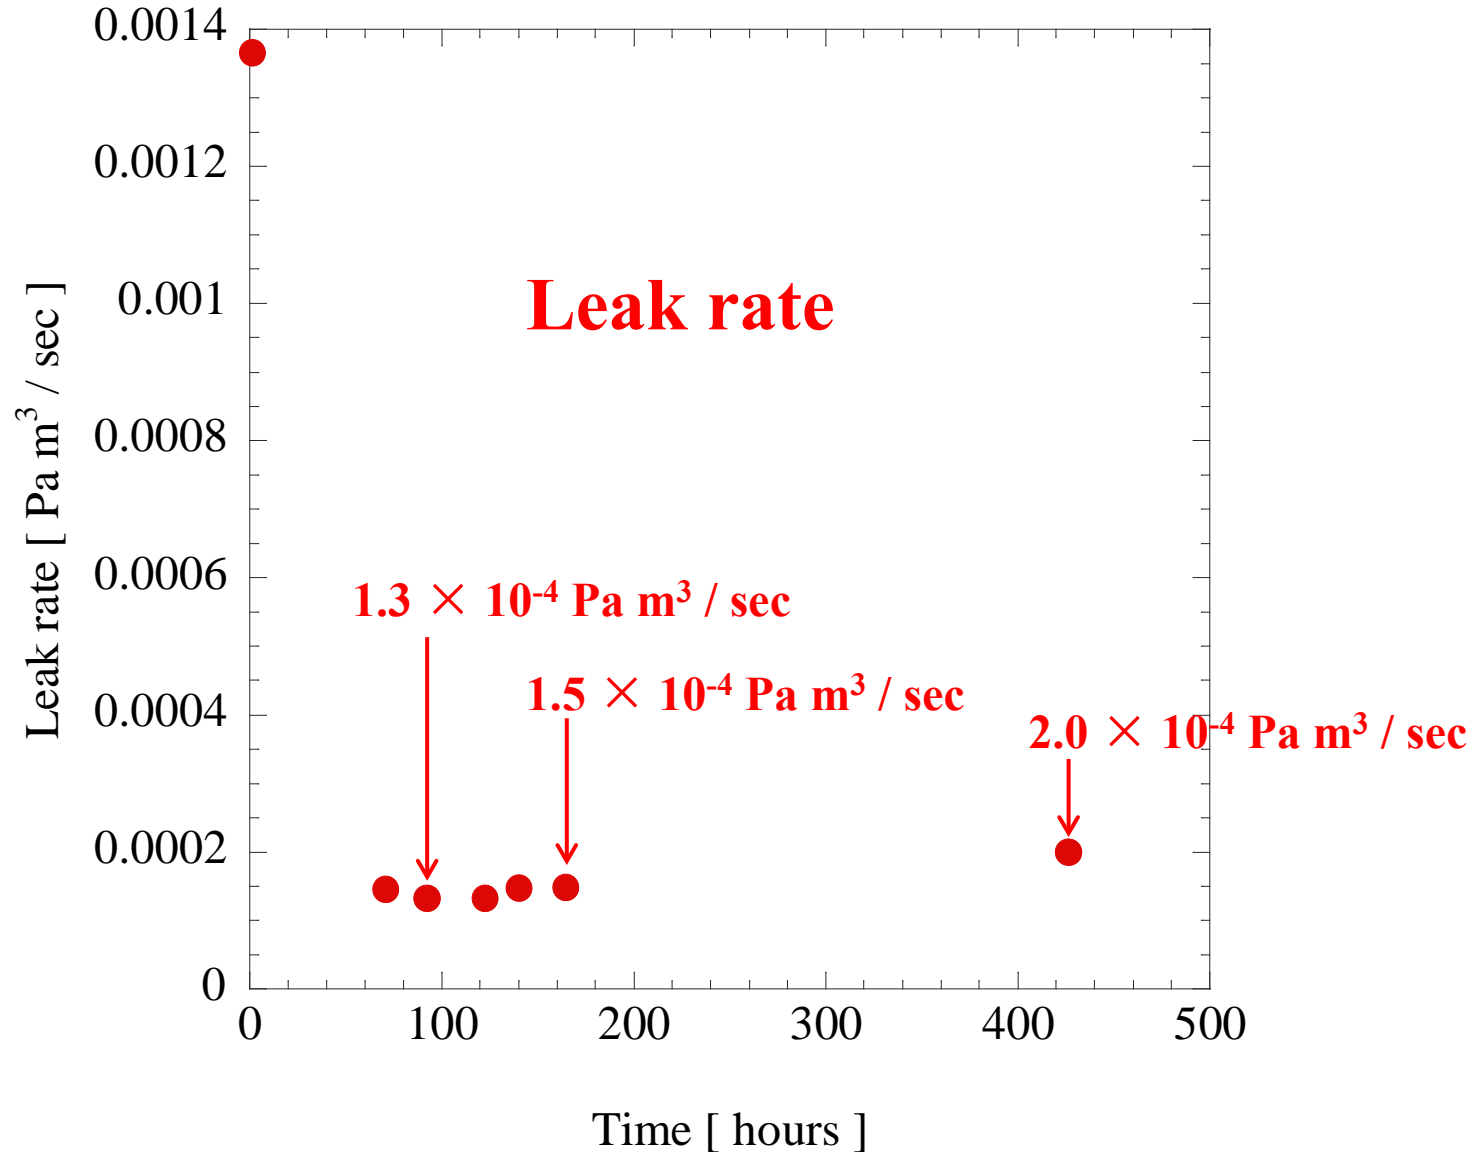
# Long term vacuum retention test by KEK members (from Apr. 19 to May 7)

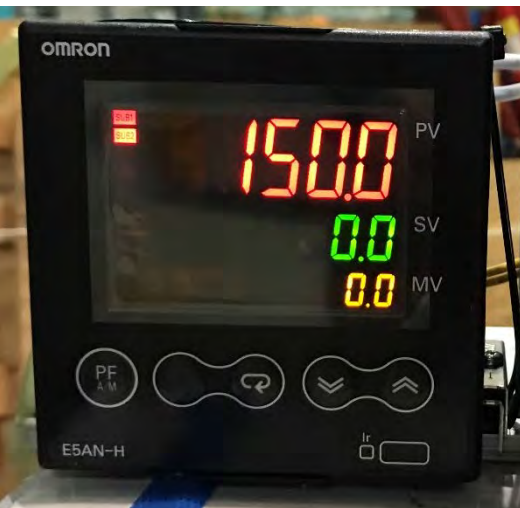
We did the long term pressurized test and observing the pressure drop.

Nitrogen gas, atmospheric pressure + 0.5 atom

← absolute pressure 150.0 kPa

The test started on May 23

The pressure goes down 149.7 kPa on Jul. 6

0.3 kPa / 44 days →  $9 \times 10^{-6} \text{ Pa m}^3 / \text{sec}$

The mock-up test for the hatch cover has finished successfully in J-PARC. The leak rate were  $9 \times 10^{-6} \text{ Pa m}^3 / \text{sec}$  and  $8 \times 10^{-6} \text{ Pa m}^3 / \text{sec}$  at the pressurized tests with nitrogen gas (atmospheric pressure + 0.5 atom). At the helium leak test, **no detection from outside** and  $10^{-3} \text{ Pa} \sim 10^{-6} \text{ Pa m}^3 / \text{sec}$  from the leak check ports. The excellent design of FNAL was proved!

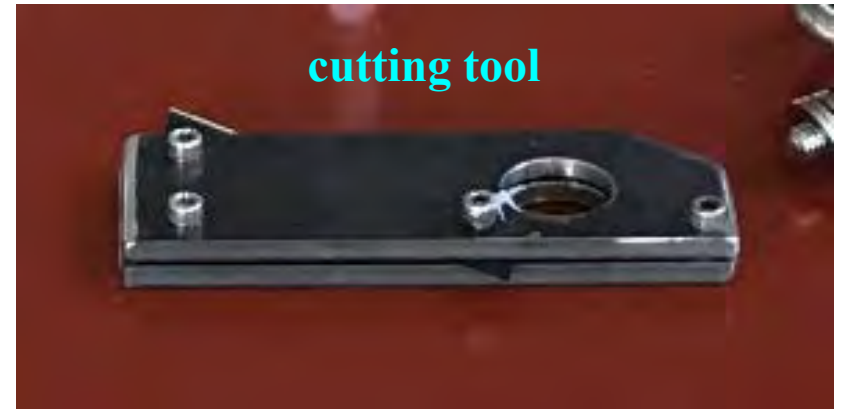
Next, we used new gaskets for the cross member and closed the mock-up.  
We cut gaskets with a new cutting tool.  
The gaskets of the top lids were reused.

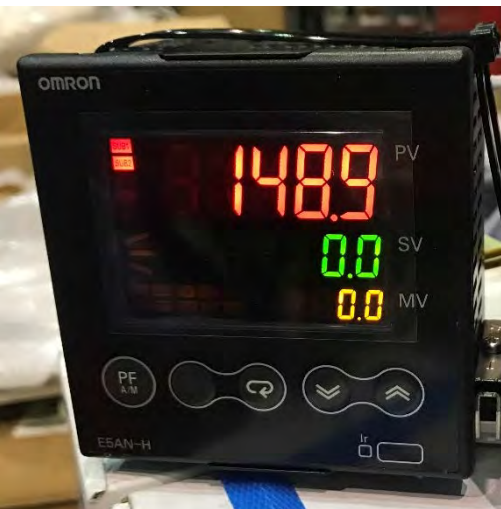
We did the long term pressurized test and observing the pressure drop again.

Nitrogen gas, atmospheric pressure + 0.5 atom

← absolute pressure 148.9 kPa

The test started on Jul. 25

The pressure goes down 149.6 kPa on Sep. 17

0.3 kPa / 54 days →  $8 \times 10^{-6} \text{ Pa m}^3 / \text{sec}$
