ProtoDUNE-DP Commissioning and Operations

Edoardo Mazzucato CEA/Irfu

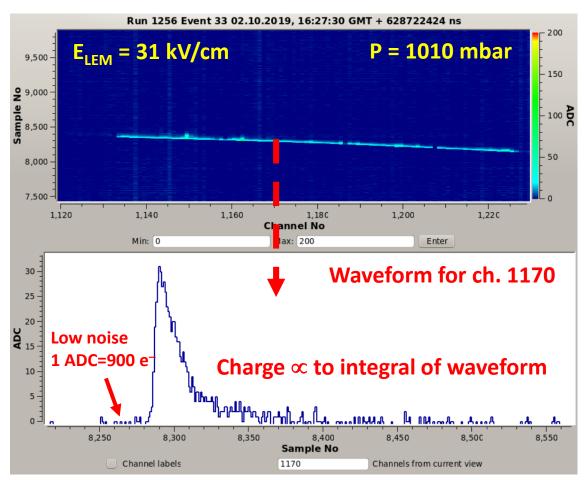
Horizontal muon track

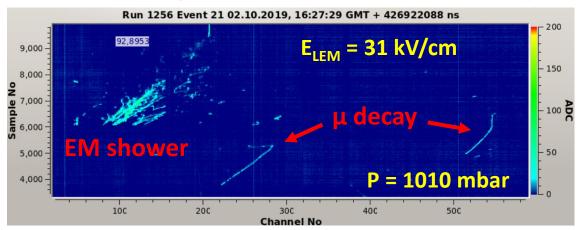
Electromagnetic shower + two muon decays

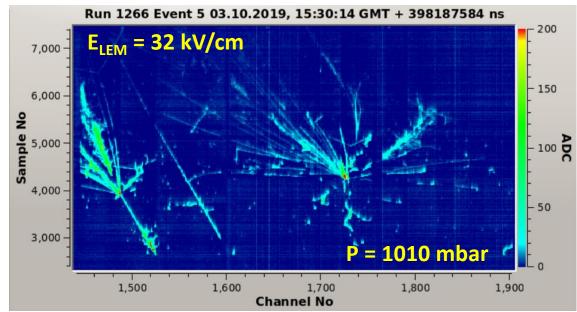
Multiple hadronic interactions in a shower

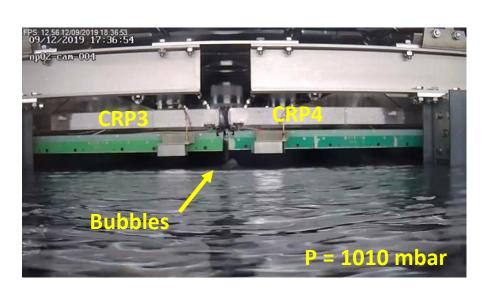
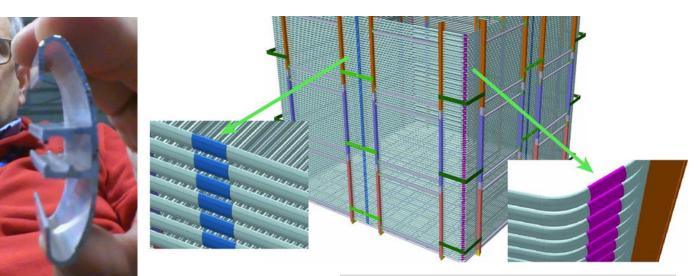
- Origin of the bubbles not well understood yet.
- Bubbles are created over a large surface inside the first profile ring(s) of the field cage.
- Bubbles are trapped inside the top part of the C-shape profile.
- Bubbles exit from the clips connecting two profiles.
- Linked to hydrostatic pressure. Increase of cryostat pressure (> 30mbar for 1/2h to a few hours) stops bubbles for some time.

- Bubbles temporarily disappear by increasing the pressure (35 mbar).
- By keeping high pressure (high pressure cycles) the quality of the surface gets worse after a few hours. Field cage bubbles reappear after two days if the pressure is kept high.

- Bubbles popping up from the middle of the field cage sides create most of the LAr surface waves or ripples. Not possible to operate the CRPs in presence of the field cage bubbles.

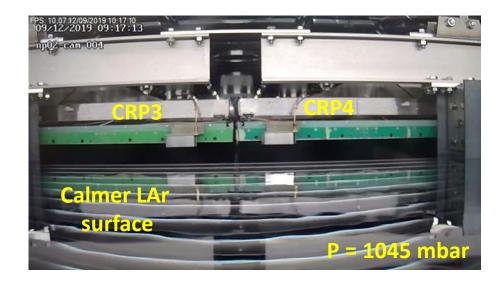
Bubbles may also exit from the FC corners but no camera there.

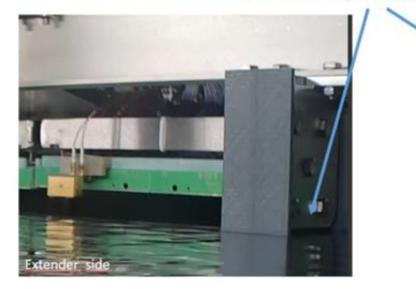
LAr level increase (21/10 – 23/10)

- Put the liquid in contact with the metallic connection plates of the FC vertical support.
- Check if bubbles disappear after some time due to reduction of temperature gradient in the gas phase and/or in the field cage supports.

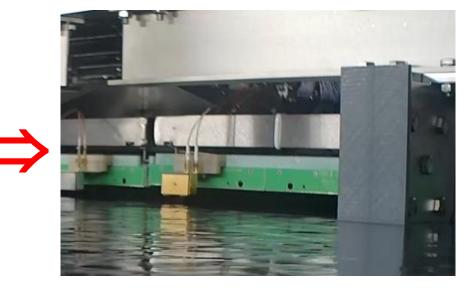
metallic connection plates of the FC

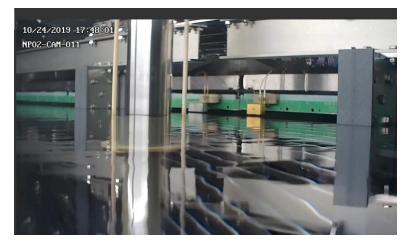
Overpressure cycle on 24/10

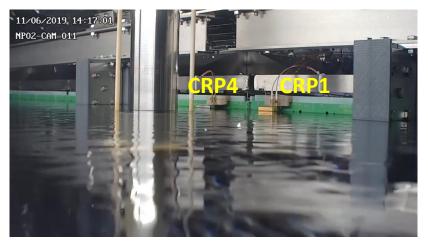
On 06/11 : still no bubbles

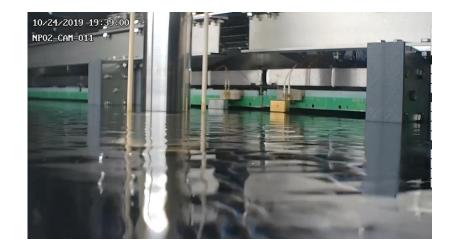
At the end of the overpressure cycle on 24/10

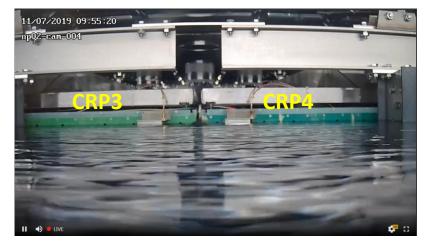
On 07/11 during filter bypass operation

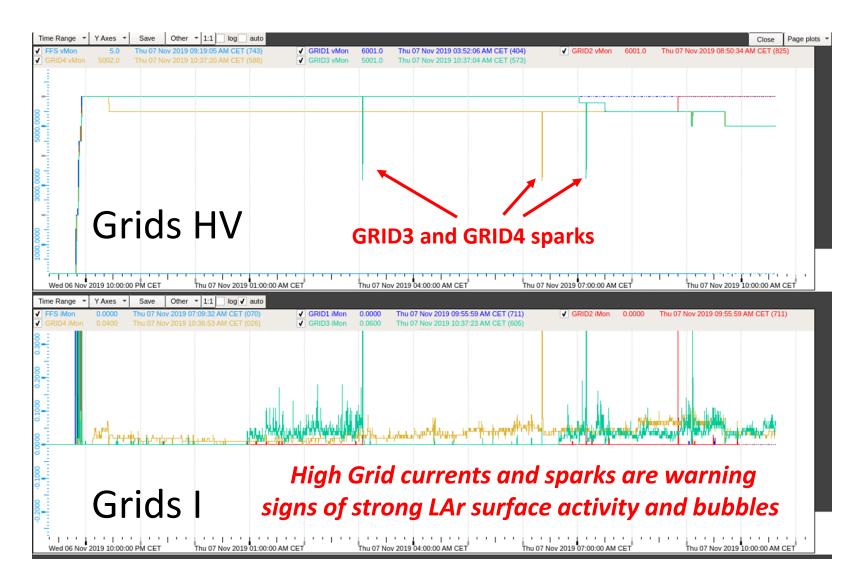
Filter cleaning operation on Nov. 7th

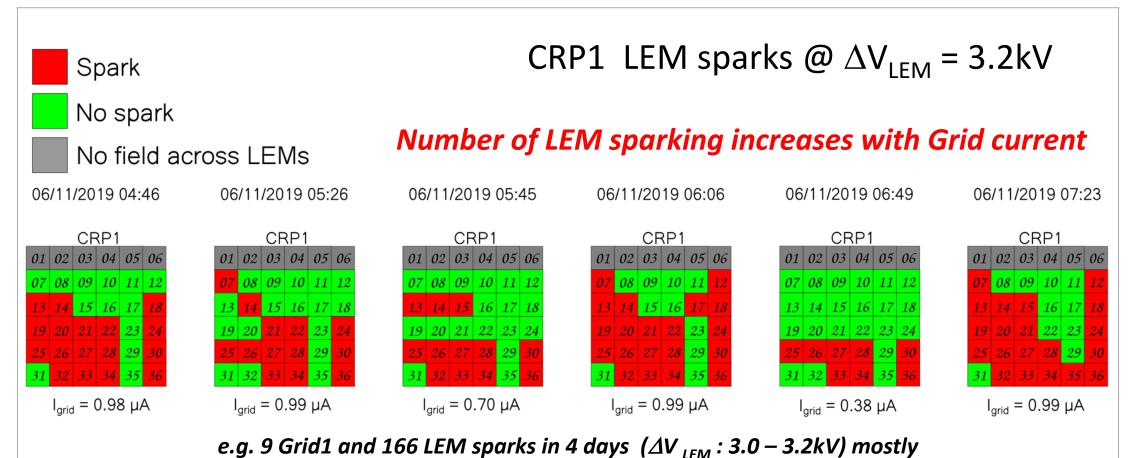
LEMs and GRIDs HV stability

associated with Grid sparks. LEM alone spark rates < 1/hr per CRP.

Important to disentangle contributions to sparks from LEMs, Grids and from ripples on LAr surface

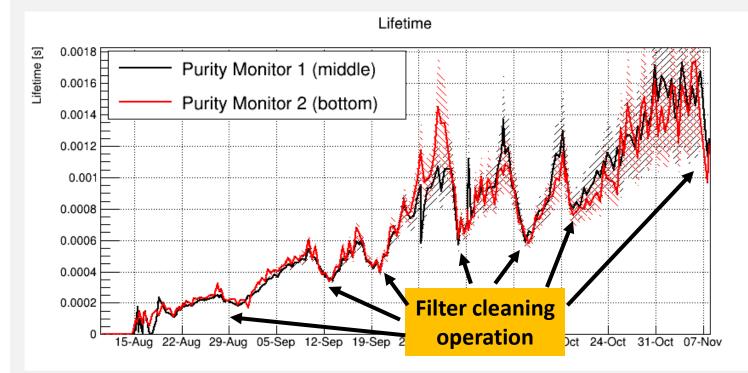
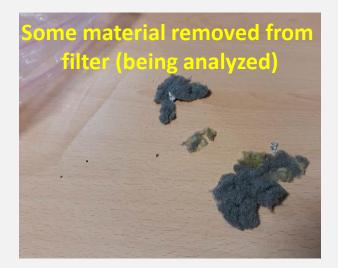
- LAr purity monitored so far by two 17 cm long PMs located at the bottom of the cryostat and in the middle.
- Recirculation improves e⁻ lifetime by factor 2.7 every ~4.5 days (1 volume recirculated).
- LAr purity limited so far to about 1.5 ms e⁻ lifetime by several filter clogging and cleaning operations.
- Lifetime consistent with track attenuation measurements.

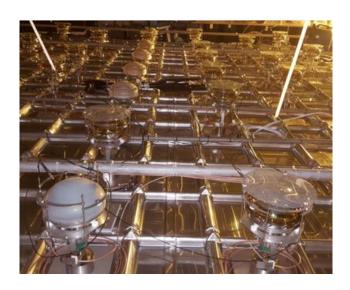
- All 36 PMTs operational. Low noise.
- Daily PDS data taking and calibrations.
- PEN/TPB : ~20-30% in S1 signal amplitude.
- All PMTs see S2 electroluminescence signal produced in gas phase.
- Fit of slow component (τ_{slow}) is a LAr purity indicator.

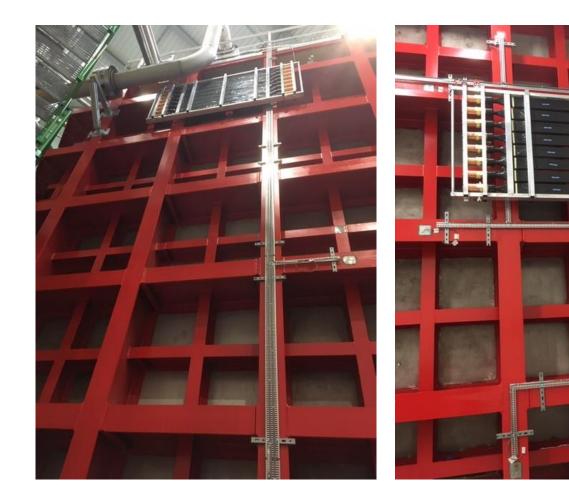
- CRTs installed on opposite sides of the cryostat and defining a downward angle.
- Commissioning should start in about a week.

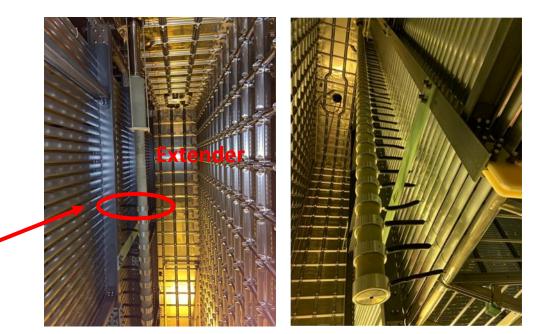
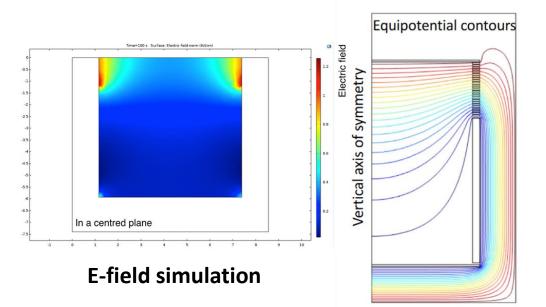
- Cathode foreseen to operate at 300 kV.
- However on Aug. 11th, during ramping up a PS trip occured at 250 kV due to a short between the first equipotential ring connected to the FC and the extender inner conductor.
- Very likely due to a crack inside the vetronite surrounding the HV inner connector.
- Located at about 1.2 m drift distance.
- Maximum operation voltage is 150 kV.
- At 120 kV, nominal field of 500 V/cm can be obtained in the upper part of the TPC. Longer drifts are possible.
- Can possibly be repaired, but intervention is delicate.
