Flange preparation and leak testing on top of the cryostat

Filippo Resnati with inputs from documents written
by Andrea Zani

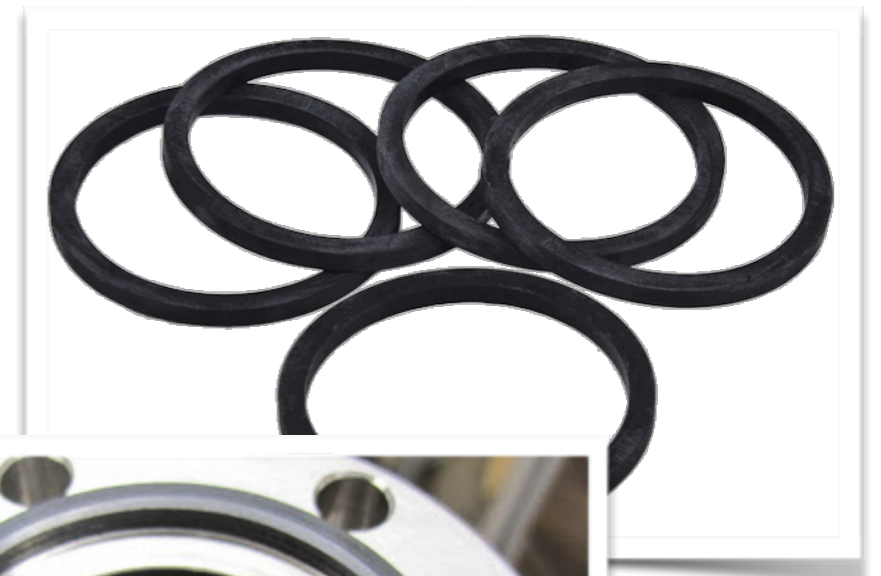
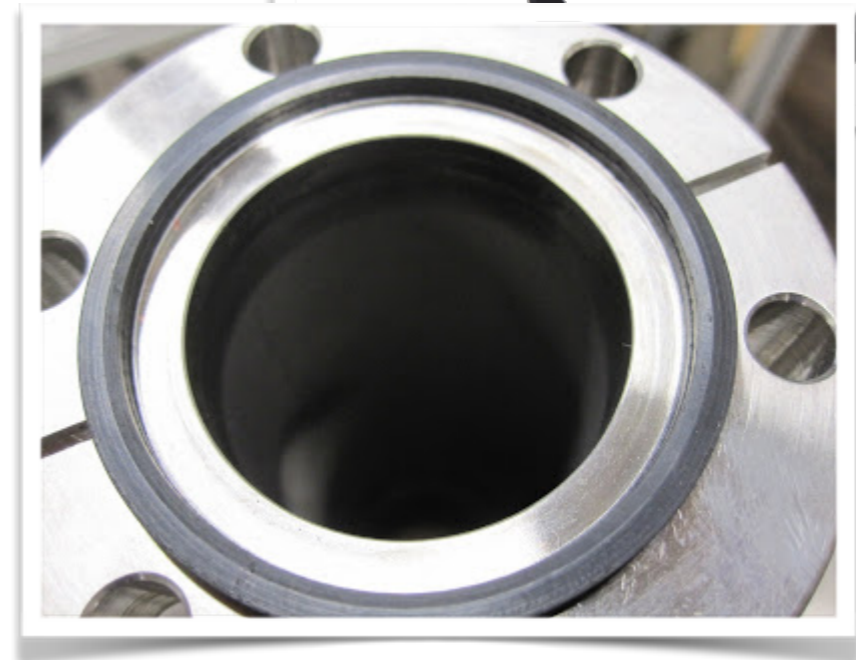
For temporary sealing with blind flanges Viton (instead of copper) gaskets may be used

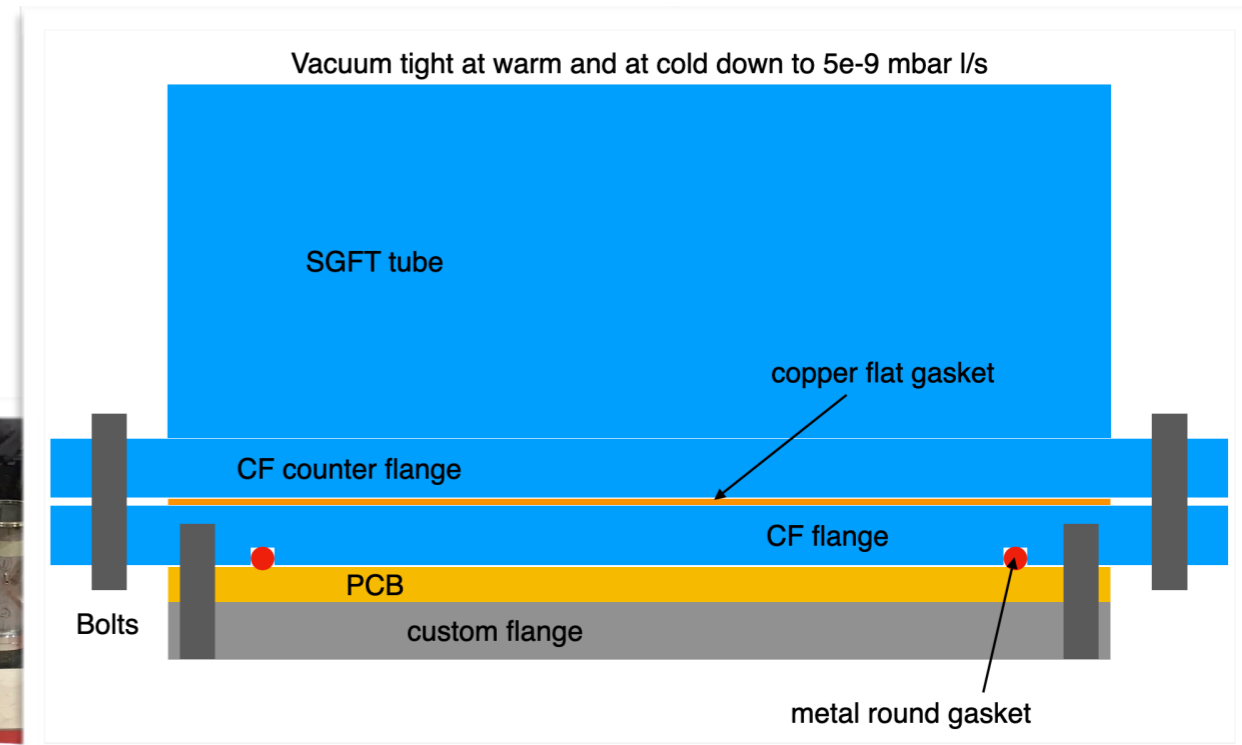
For instance, the SGFT case

12 chimneys (10 finally installed)
that host the cold electronics

Each SGFT was leak tested to level of few 10^{-9} mbar./levels prior the installation in NP02. Three randomly selected of the 10 installed were tested also in cryogenic conditions. Report of the leak check can be found at <https://edms.cern.ch/document/2143281/1>
