# Search for weld pit formation mechanisms: Weld coupon EP

# Motivation, Objectives, Techniques

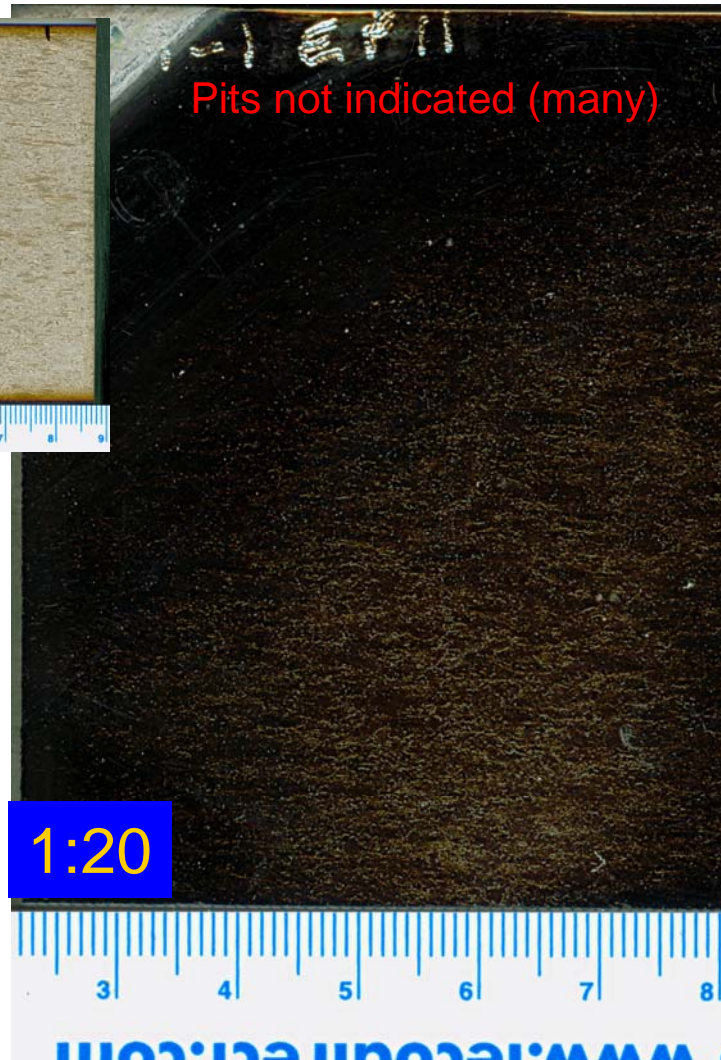
EP-11  
31 °C 303 min  
263  $\mu\text{m}$  removed  
410 GU  
20:1 anode:cath

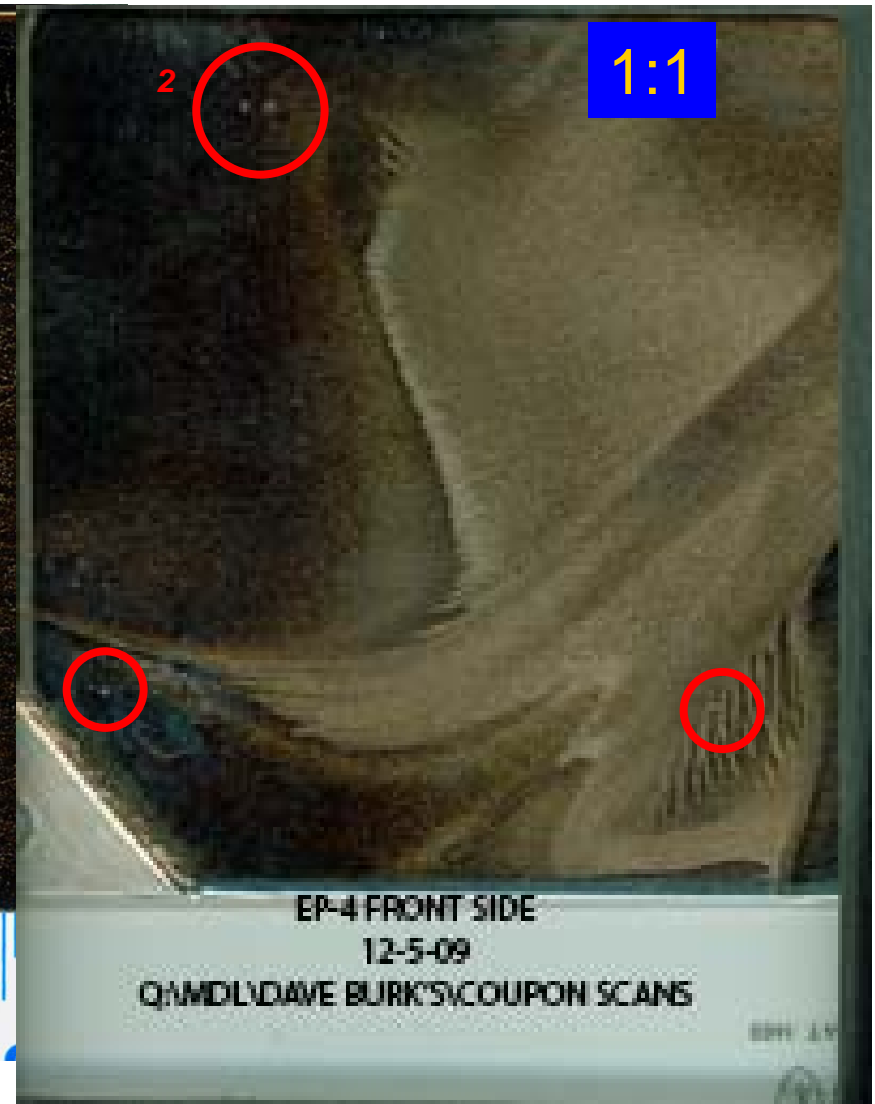
EP-4 31 °C 120 min, 160  $\mu\text{m}$  removed  
456 GU 110 nm Ra  
4 pits / 50  $\text{cm}^2$   
1:1 anode:cath

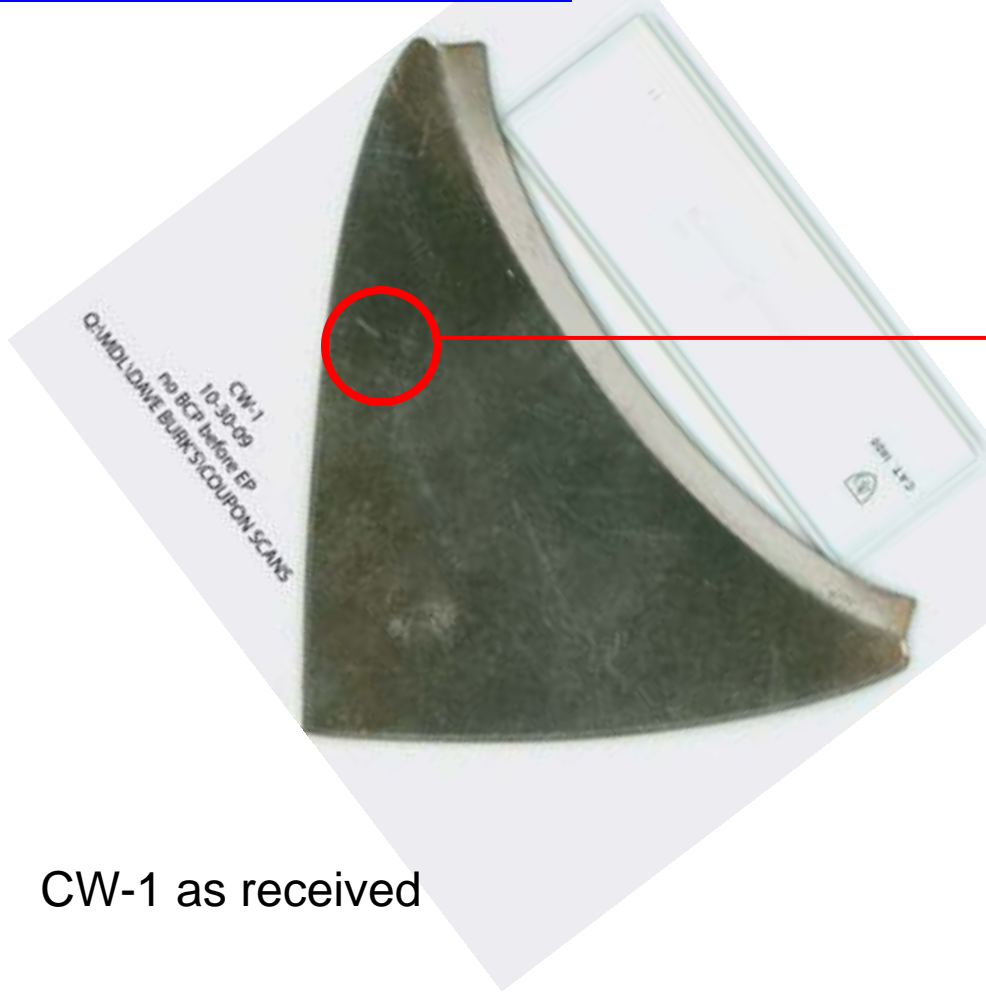
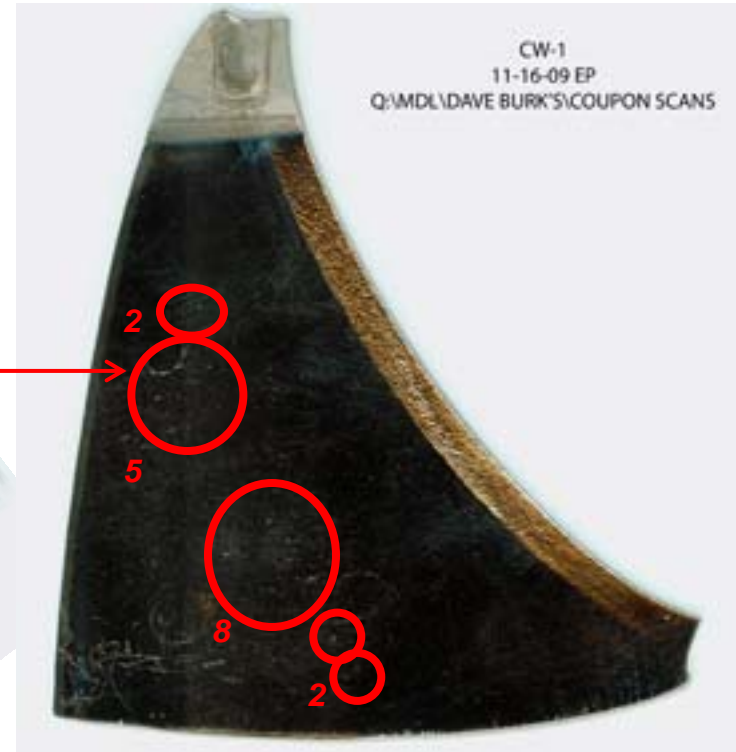
CW-1 EP  
29 °C  
298 min  
168 µm removed  
**466** GU  
73 nm Ra  
18 pits / **40** cm<sup>2</sup>

**Cold-worked coupons** RF SIDE and reduced to 72 dpi

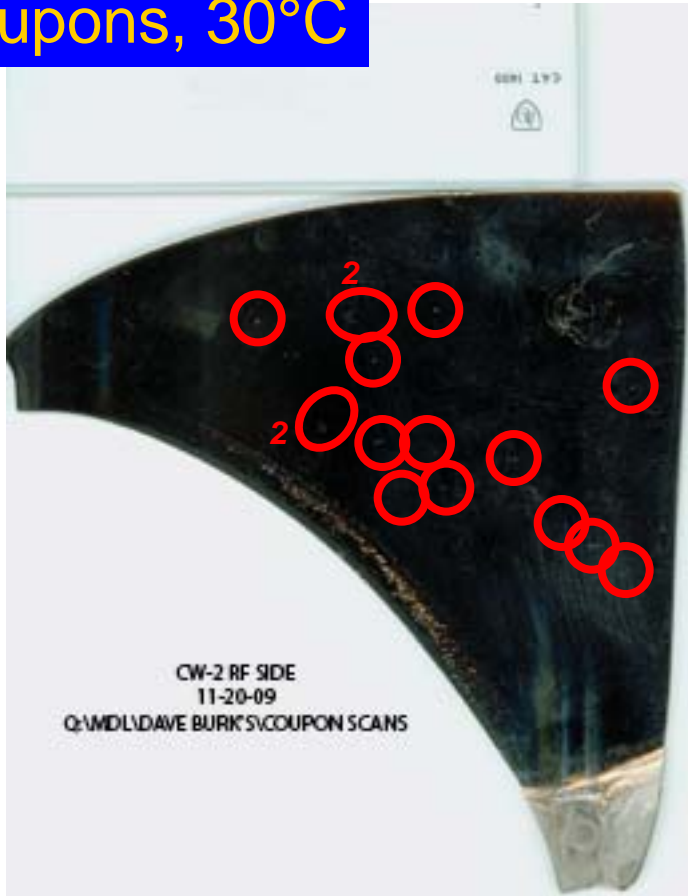
CW-2  
30 °C  
300 min  
193 µm removed  
**465** GU  
30 nm Ra  
**16** pits / **40** cm<sup>2</sup>

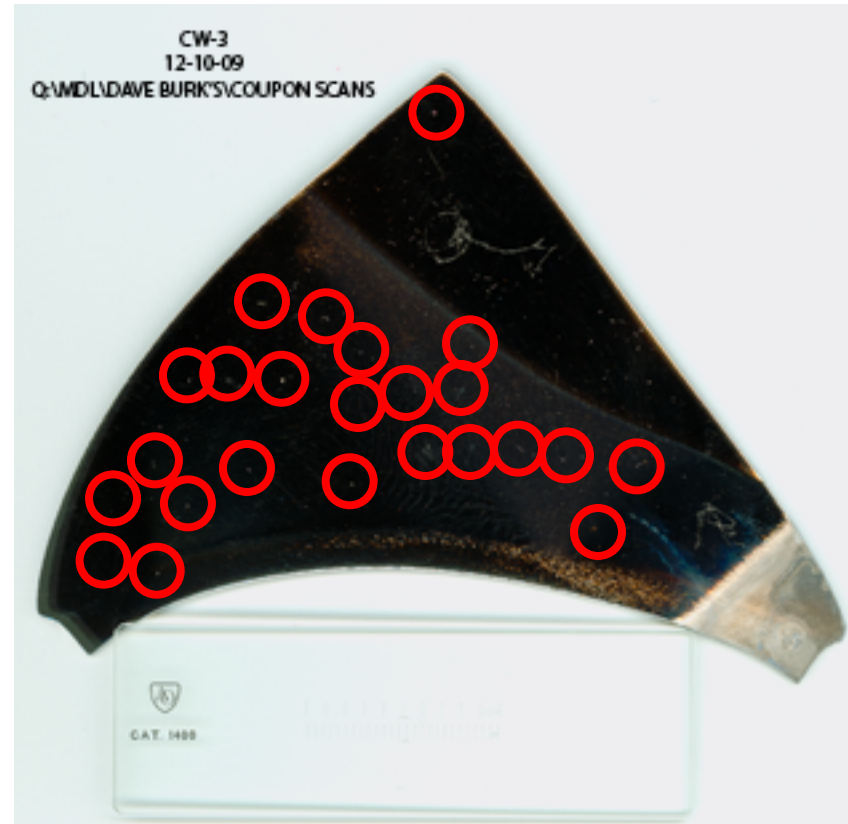
CW-3  
31 °C  
298 min  
189 µm removed  
**422** GU  
60 nm Ra  
**>20** pits / **40** cm<sup>2</sup>  
Some larger defects

**Cold-worked coupons** RF SIDE and reduced to 72 dpi

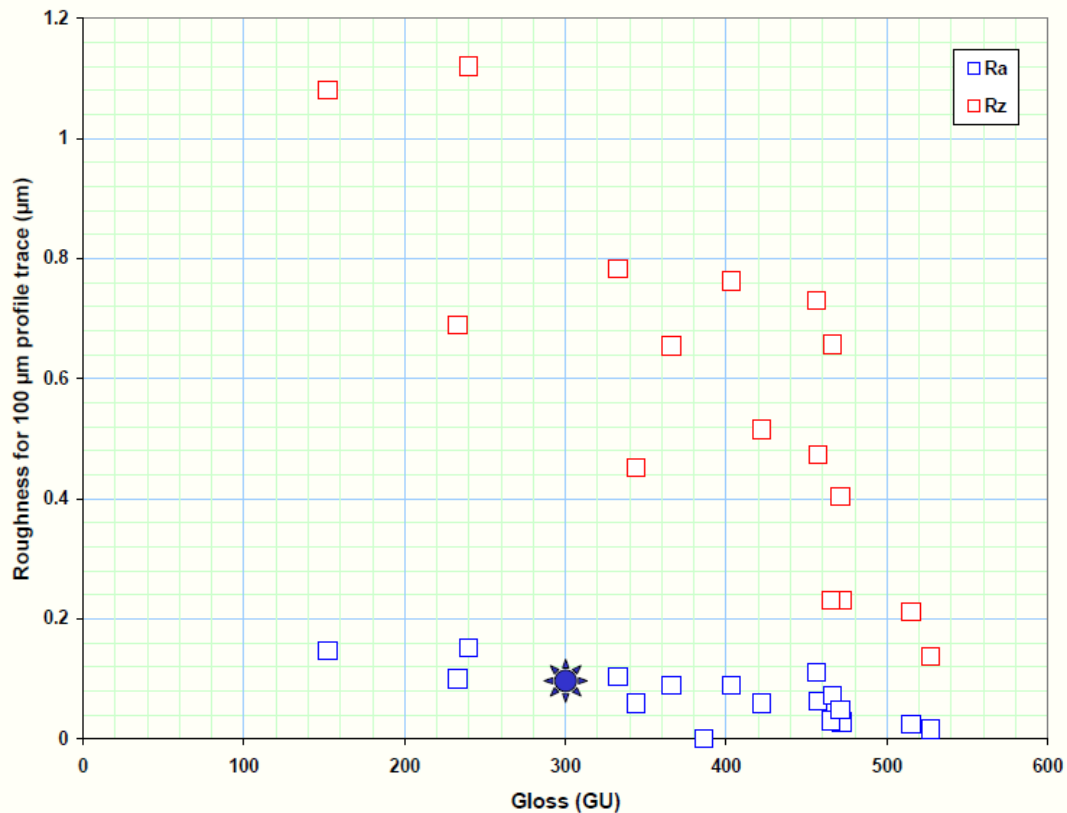
## Coupon Roughness vs Gloss

Trend suggests target of < 0.1 μm Ra corresponds to gloss of 300 GU or better

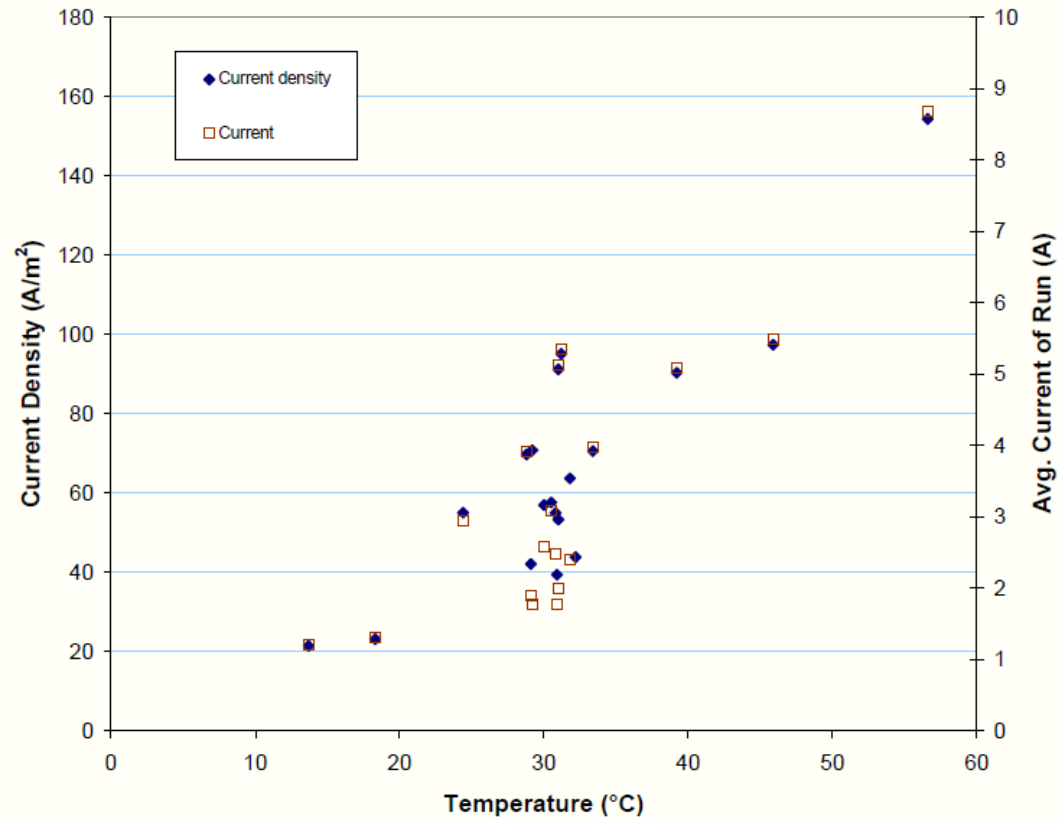
EP current vs Temp. at 14.5 to 15 V

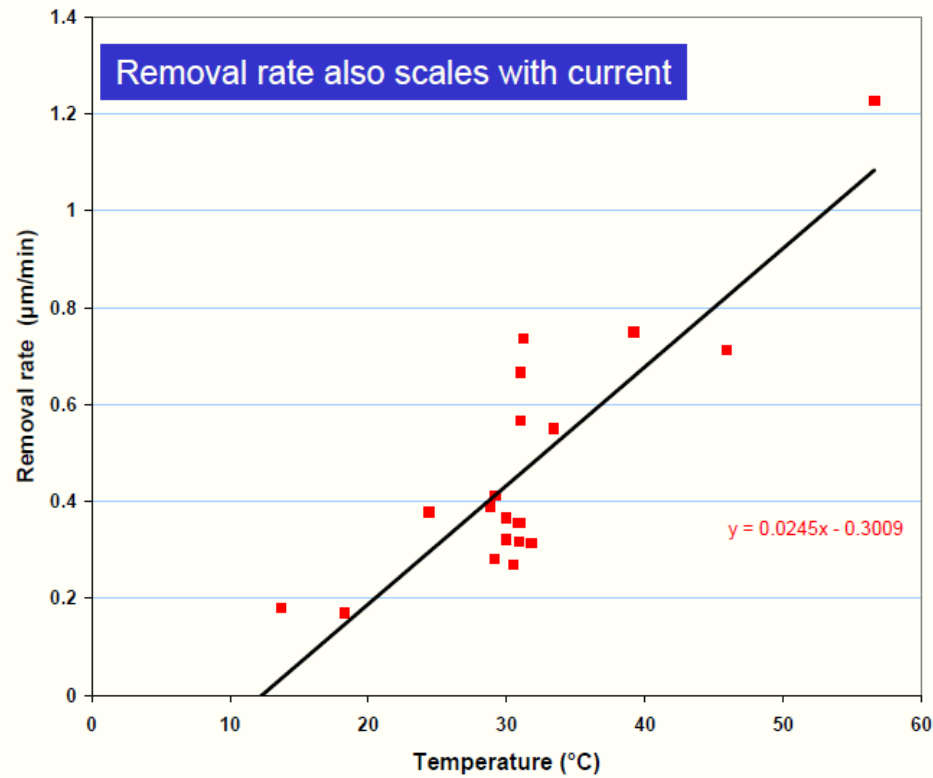
Removal rate vs. temperature at target 14.5 V, 50 A/m<sup>2</sup>
