6th SRF Materials Workshop, Tallahassee, FL 2/18/2010

Fundamental Surface Chemistry of Nb Oxidation

Miki Nakayama, Tuo Wang, Nataliya Yufa,
Dan Killelea and Steven J. Sibener

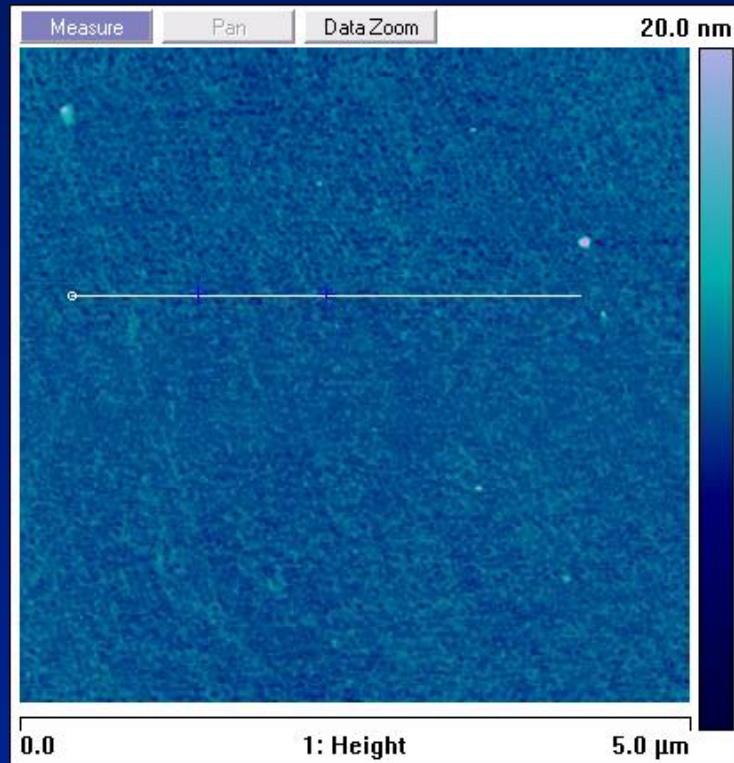
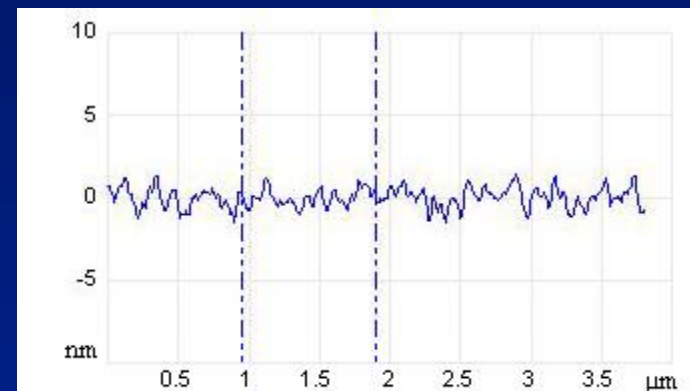
Cavity-grade Niobium Samples Can Be Polished to Sub-nanometer RMS Roughness

Atomic Force Microscopy Image of As-Received Sample

Average roughness is <0.5 nm

- FNAL supplied & Cabot Microelectronics polished samples used at UC for initial oxide studies; polishing achieves $< 1\text{nm}$ rms roughness
- Initial exploration of the efficacy that different heating, sputtering, and polishing preparations have on the quality of the interface

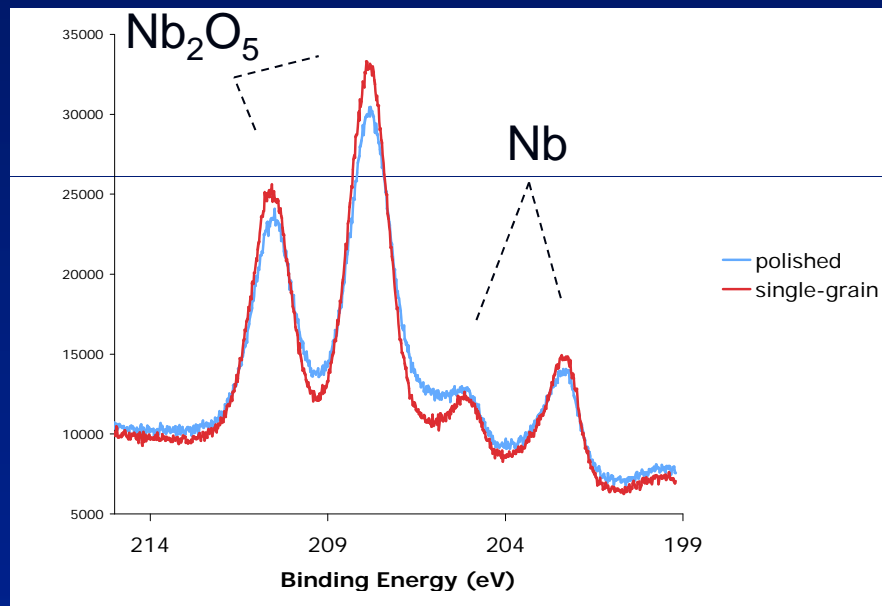
XPS of Pristine Sample – Nb 3d Nb_2O_5 Dominated Interface

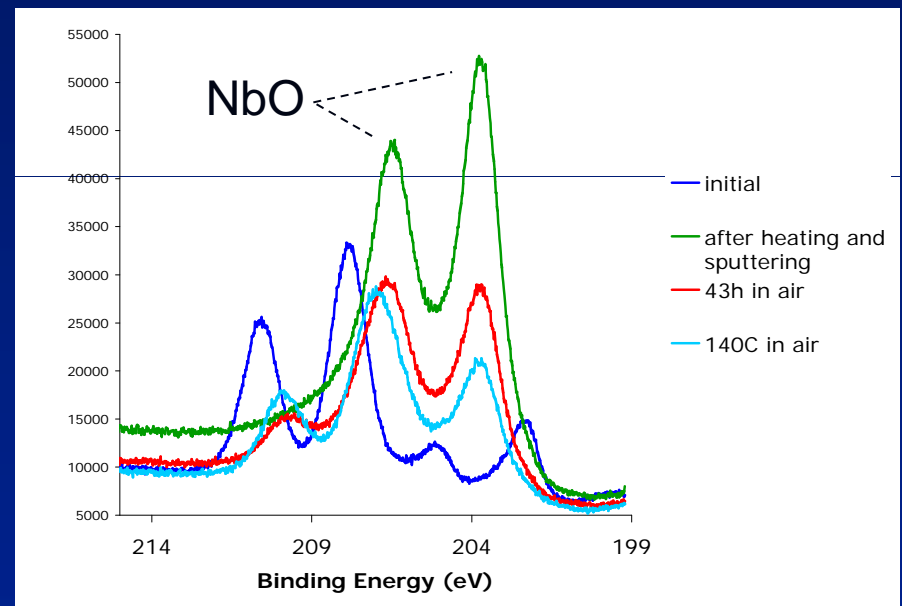
Heating in Air and Aging Thermal Treatment 1 Hour at 140 °C

- Oxide thick as Nb XPS peaks from underlying Nb are relatively weak

- NbO robust and persistent in UHV after sputtering and heating
- Surface region reincorporate O upon air exposure or heating in air

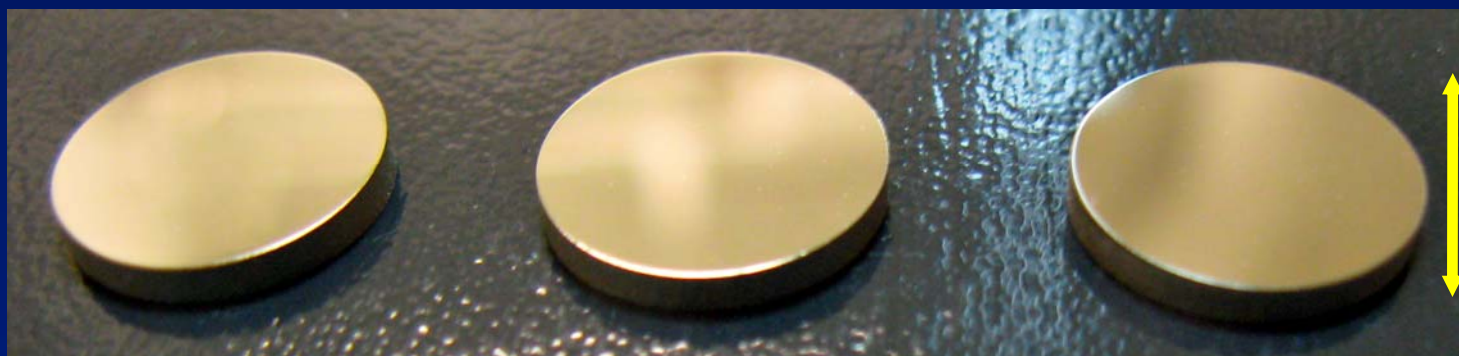
Niobium Single Crystals Nb(110), Nb(111) and Nb(100)

- Three crystal faces, material 99.99% purity
- Polished to $\sim 0.1^\circ$ of crystallographic orientation
- Final polish 0.05 microns
- Source: Surface Preparation Lab, Zaadam, The Netherlands
