Project: Microboone PMT to Laser PS Interlock System

Doc. No: B060514PMT_Laser_Intlk

- The interlock system has three parts.
 1. The High Voltage Pod

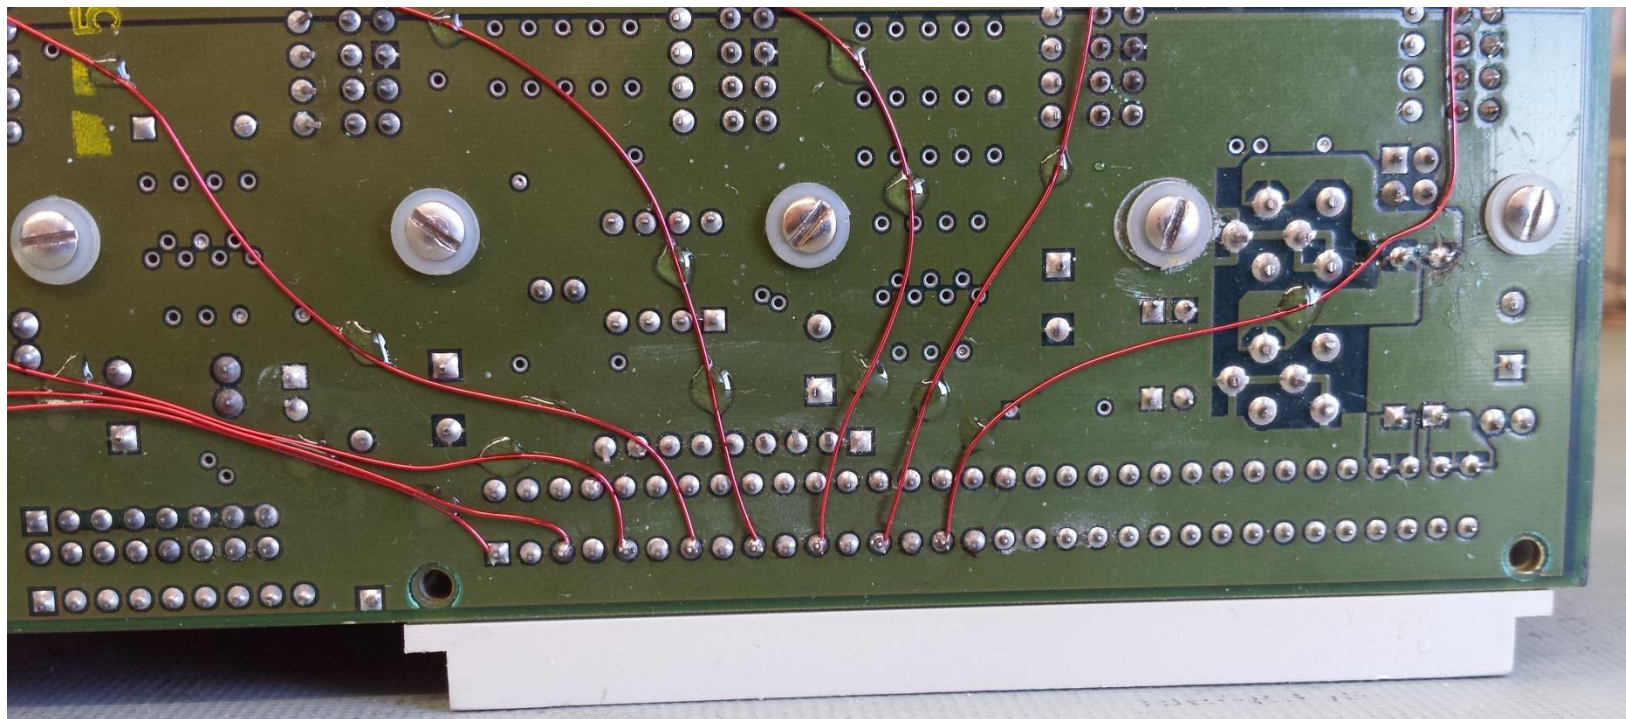
Wires added to bring the On/Off status to the back plane connector.

Requires addition of wiring to bring the HV status to spare pins on the back plane connector
 2. Back plane DIN to Header Adapter

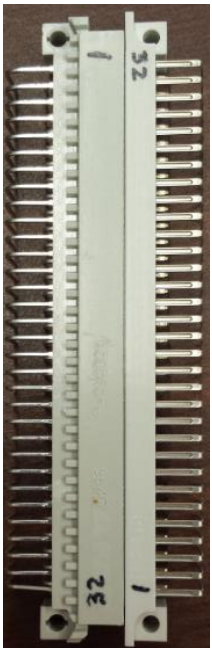
DIN-Header Adapter

Male

Female

NOTE: Because we are mating with pins on the back plane the order of the pins will be reversed.

- DIN-Header cards have a problem with the DIN connector not close enough to the board edge.
 - The boards will need to be cut or sanded to remove material up to the silkscreen line.

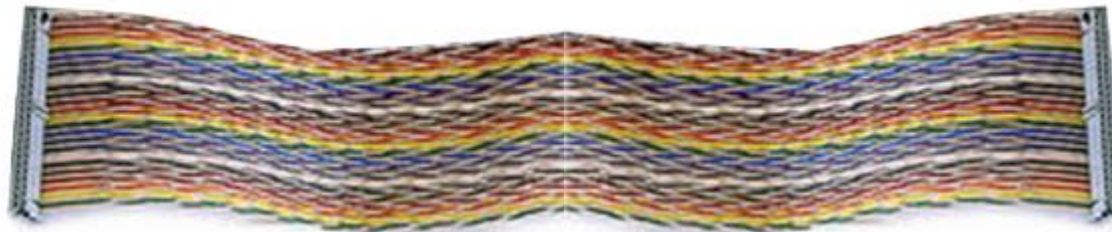
-
-
- A 16 conductor ribbon cable is needed to connect between the HV crate and the Laser Interlock chassis.
 - Five (5) cables will be needed.
 - A shorting connector is needed to by-pass the extra input.

One end of this cable needs to be flipped to correct an error on the chassis PCB.

- Discovered the condo connectors have a bad footprint. Rows are swapped causing the signal from the MPod to be shorted to ground.
 - We will flip one of the header connectors to fix the problem. We can do this because the order of the signals is unimportant. Need a note that indicated the cables are special.

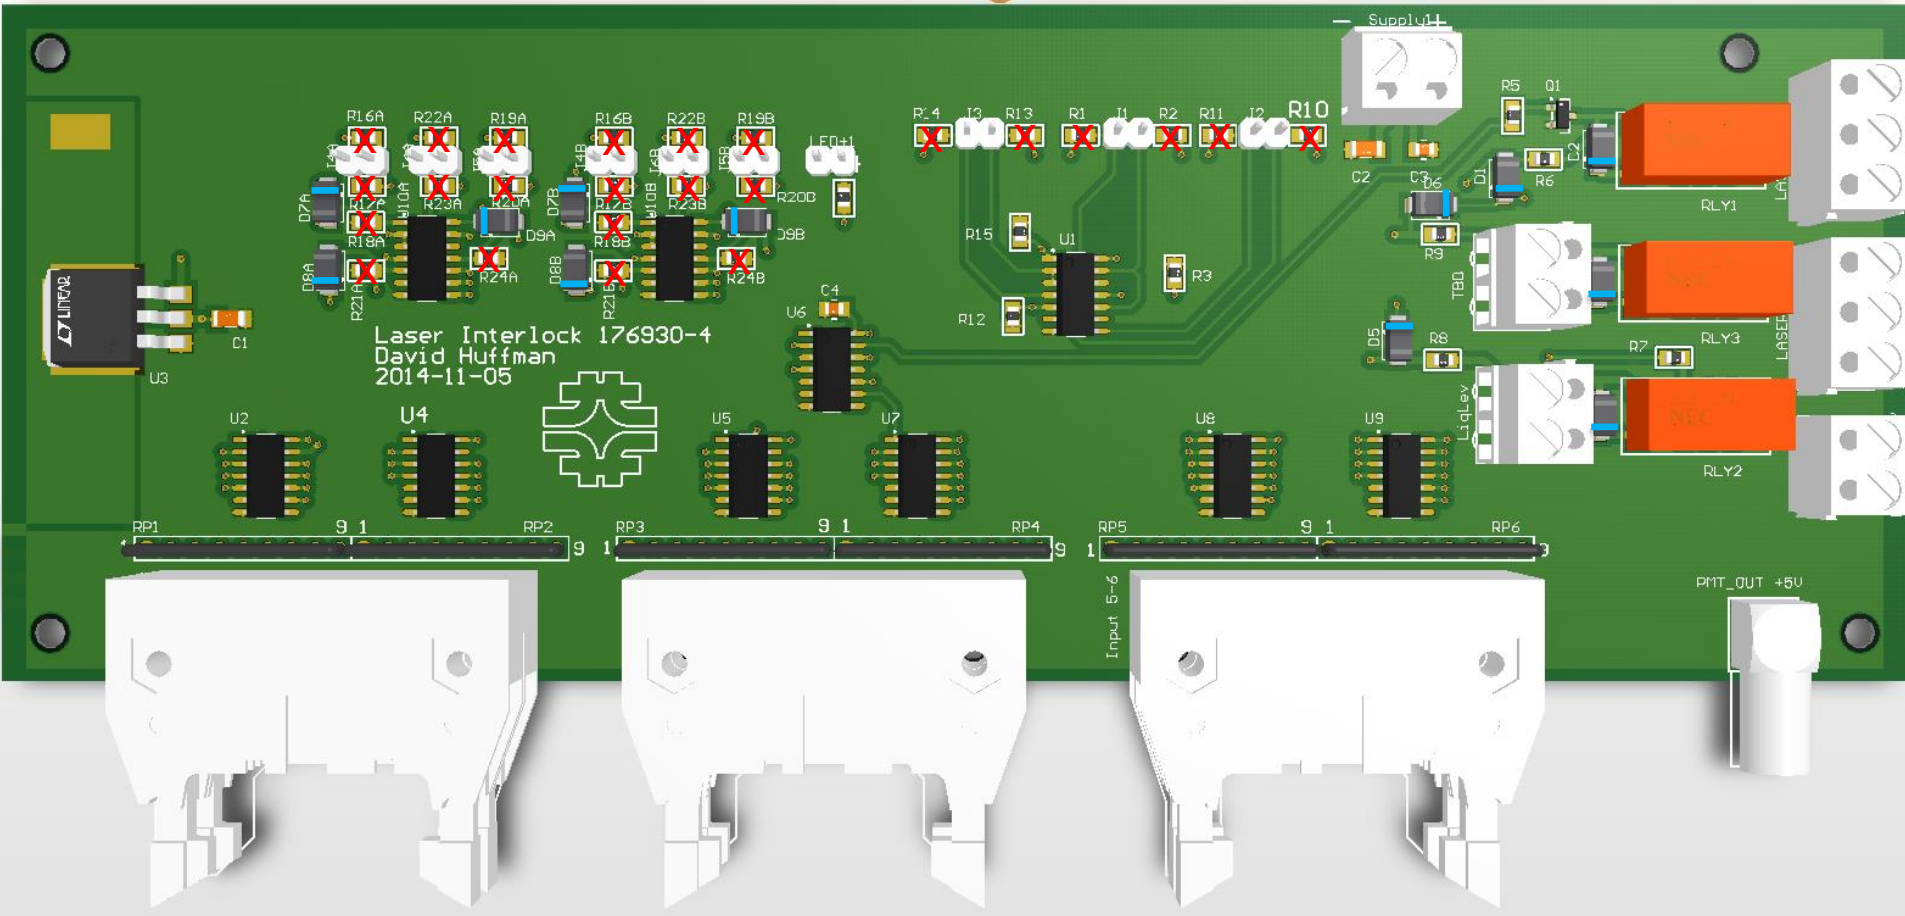
Top View

Do Not Load Reverse Direction

- 12/4/2014 11:22:52 AM
 - errors! Found two inputs on the final OR gate tied high. They should have been pulled low. Lifted the pins and tied it to its neighbor(4&5)(9&10).
 - The outputs of the relays are incorrect. The Laser outputs were moved to the NO NC terminals. The PMT outputs +5 and dry contacts are wrong.
 - The relay footprint is in question...
 - Footprint was wrong. Changed the library but did not update the project.
 - Added a jumper on the bottom of the board to fix the problem.
 - Changed R7, the PMT_OUT +5V signal, to 200 Ohms. This gives the maximum current and power if the output is shorted.
 - Replaced R7 with 0 Ohm resistor. This relies on the LDO regulator's over current and temperature protection. Smallest trace is 15mils. with 1/2oz copper there is 10sq mils, IPC table shows outside trace good for 1Amp with 22°C temperature rise.
