An Epic Tale: ICARUS Ground Short Search

Linda Bagby on behalf of the Grounding Team

Technical Working Group Meeting

June 26, 2020

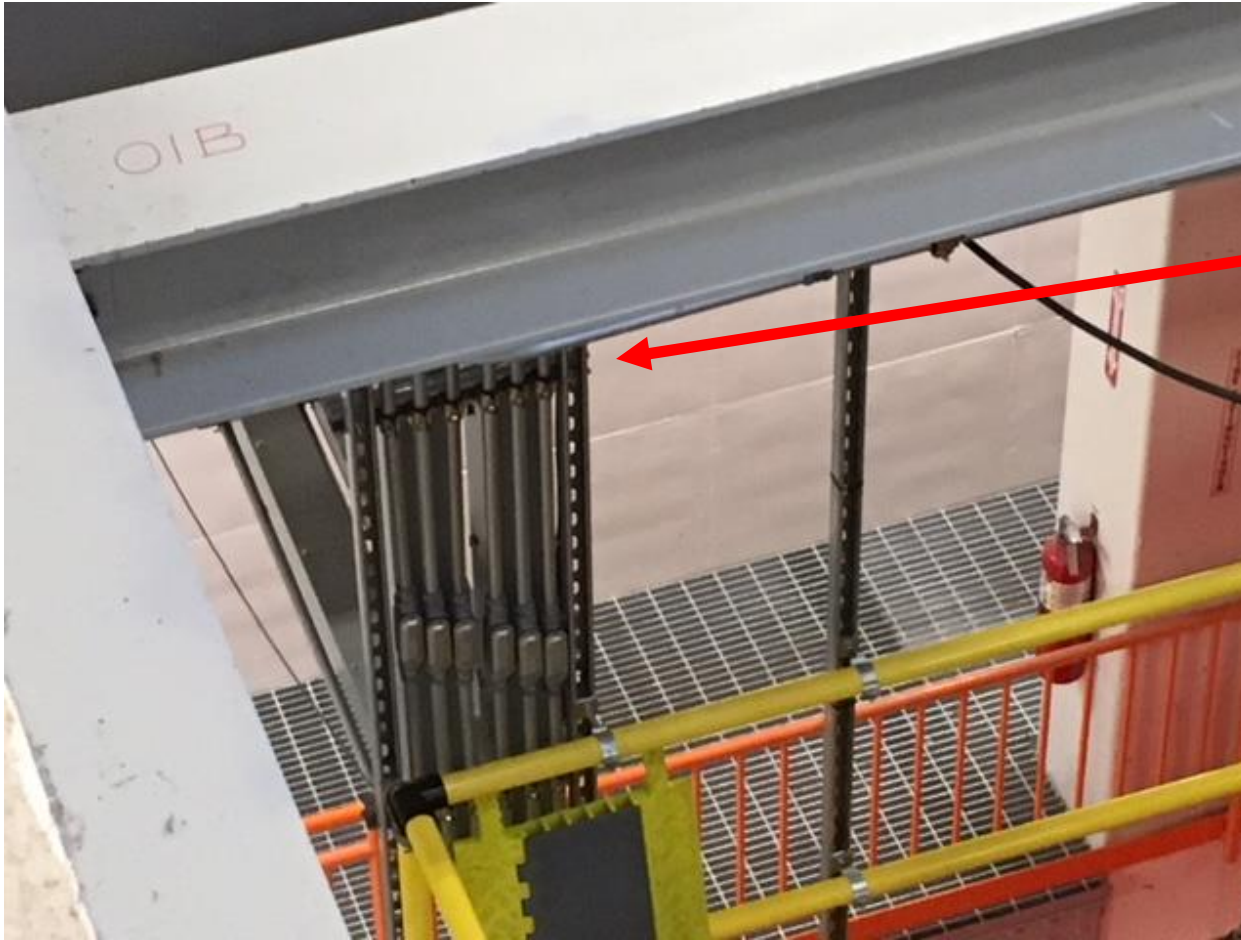
Vacuum Conduit

'break point'

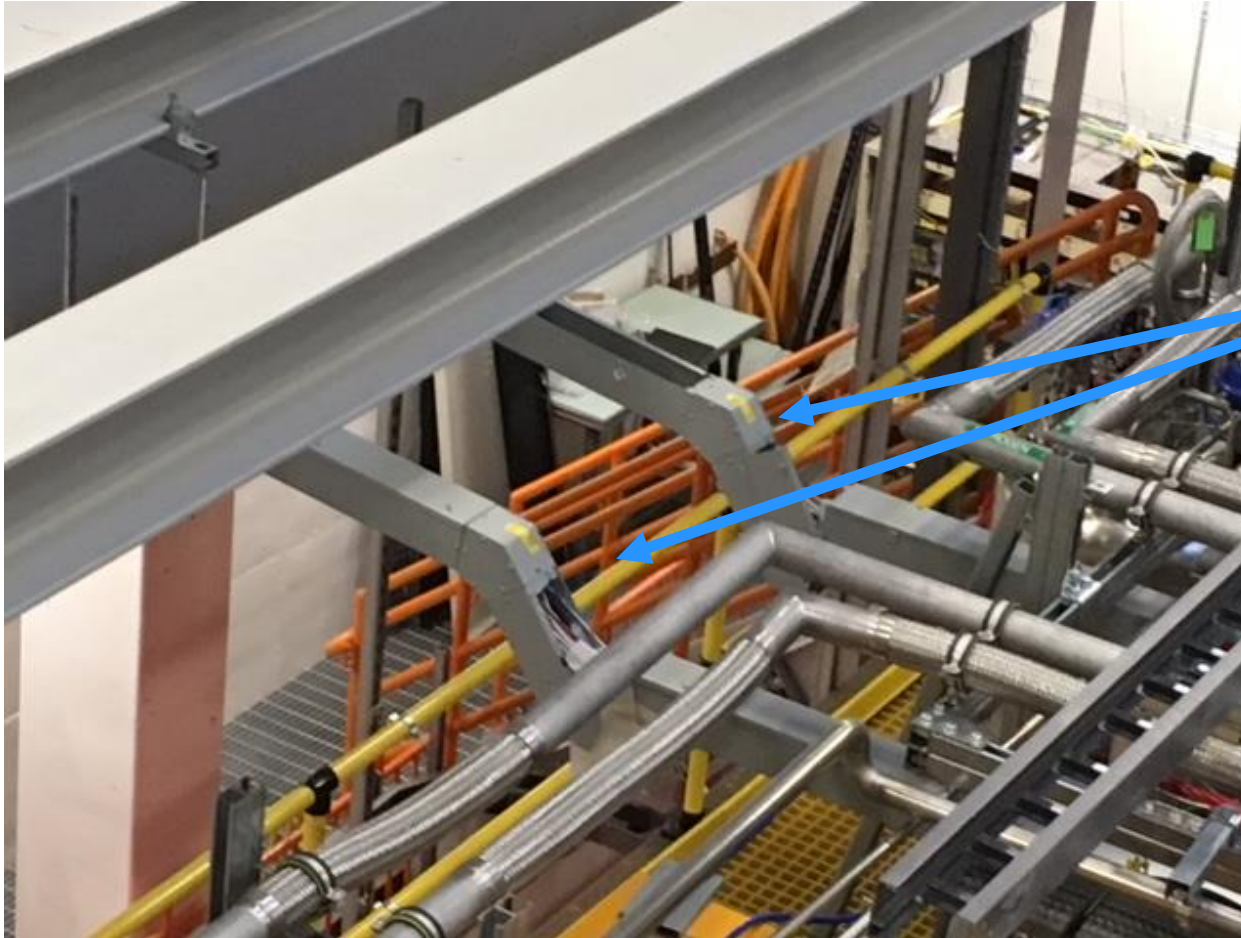
Wire Way

'dog leg'

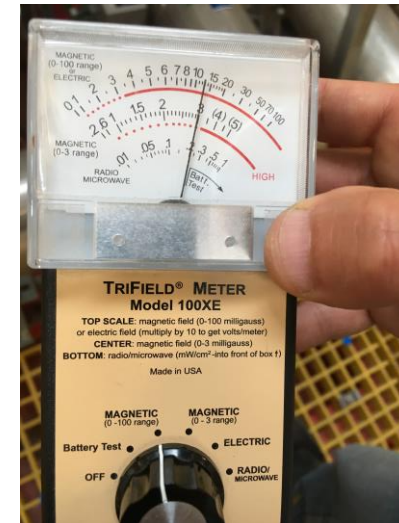
Magnetic Pick-Up technique

- Applied a 10kHz stimulus signal across the experiment, south end.
 - Spectrum analyzer and hand held magnetic pick-up probe scan--nothing.
 - Moved source to north end, and performed another scan with analyzer and a new tool from Joe Harris' arsenal--
- pointing to the SE condenser flange area.

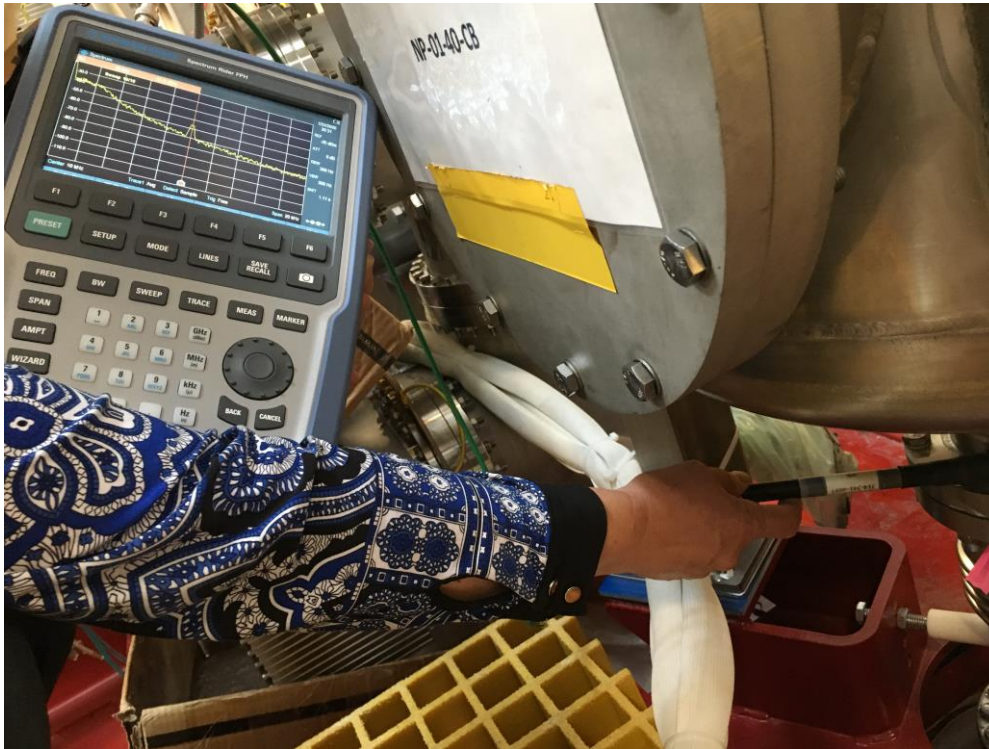
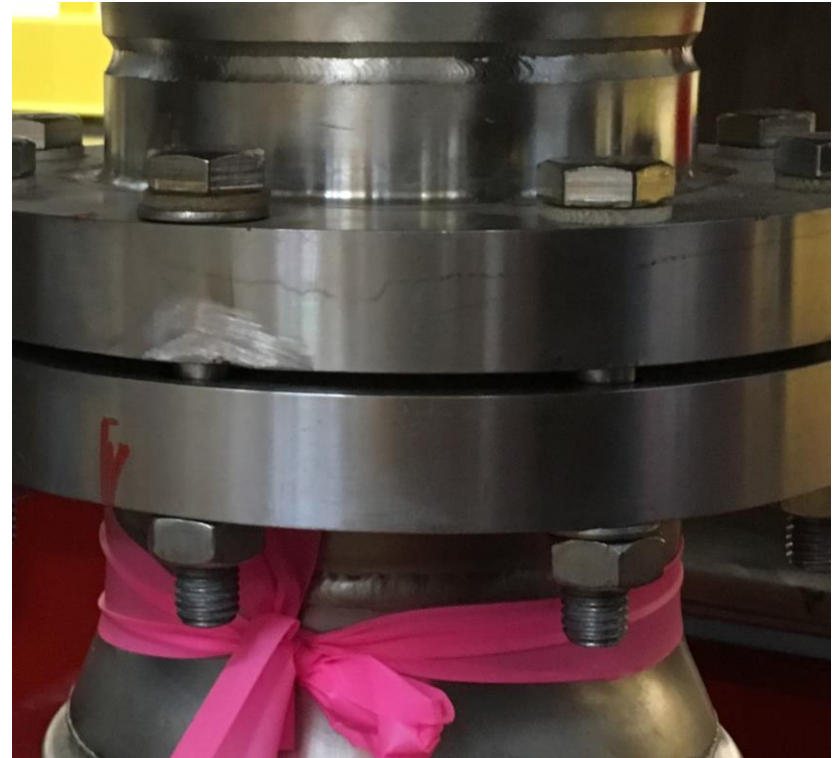
Magnetic Pick-Up technique

- Using the analyzer and some keen eye balls, the magnetic field generated by the stimulus signal is measurable across 2 bolts. Hardware stack is different.

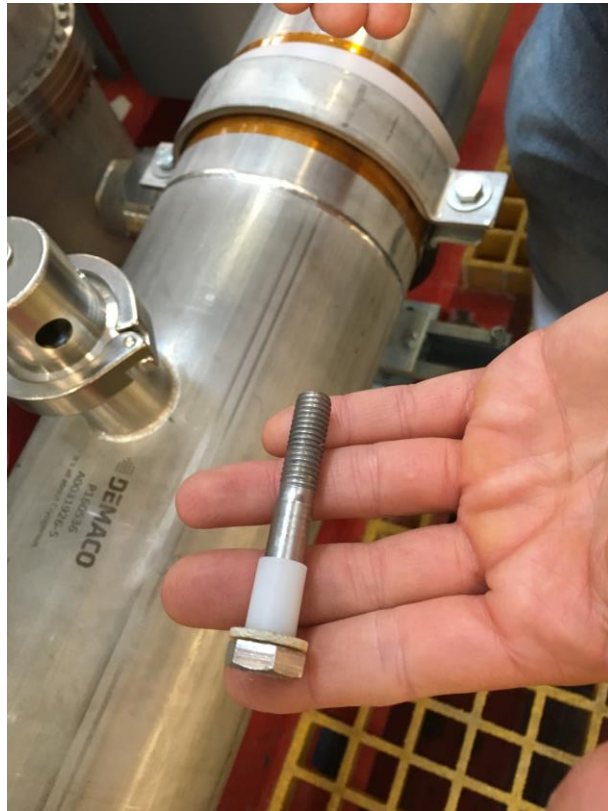
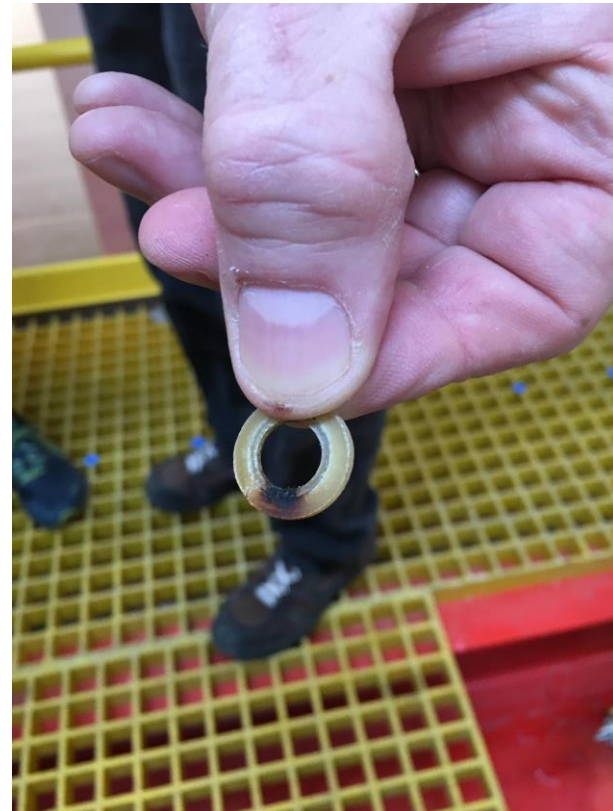
Smoking gun????

- Verified there was a sleeve—it's just long enough to cover the flange thickness.
- The external stimulus application changed the resistance from 1Ω to $.5\Omega$ so we knew we did something.....

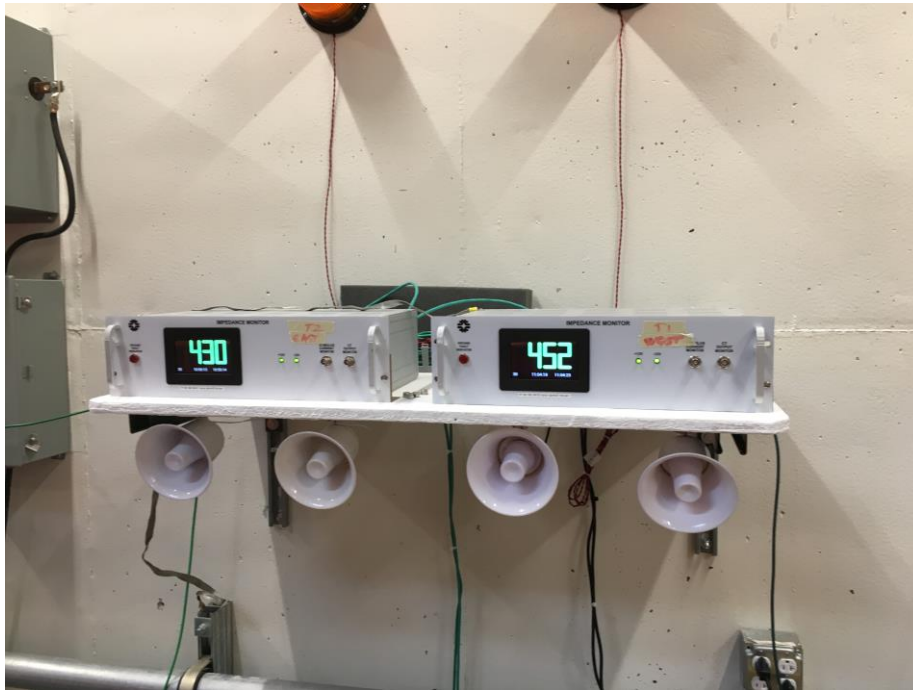
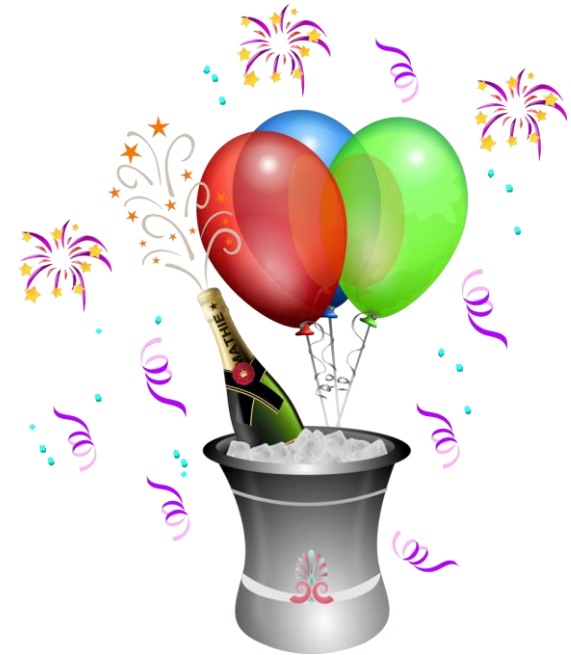
Short cleared--

- By cleaning the carbon off of the washer and reordering the stack, the detector to building ground resistance increased from $.5\Omega$ to $11\text{k}\Omega$.
- First glance at Impedance Monitor NOT displaying 5Ω .

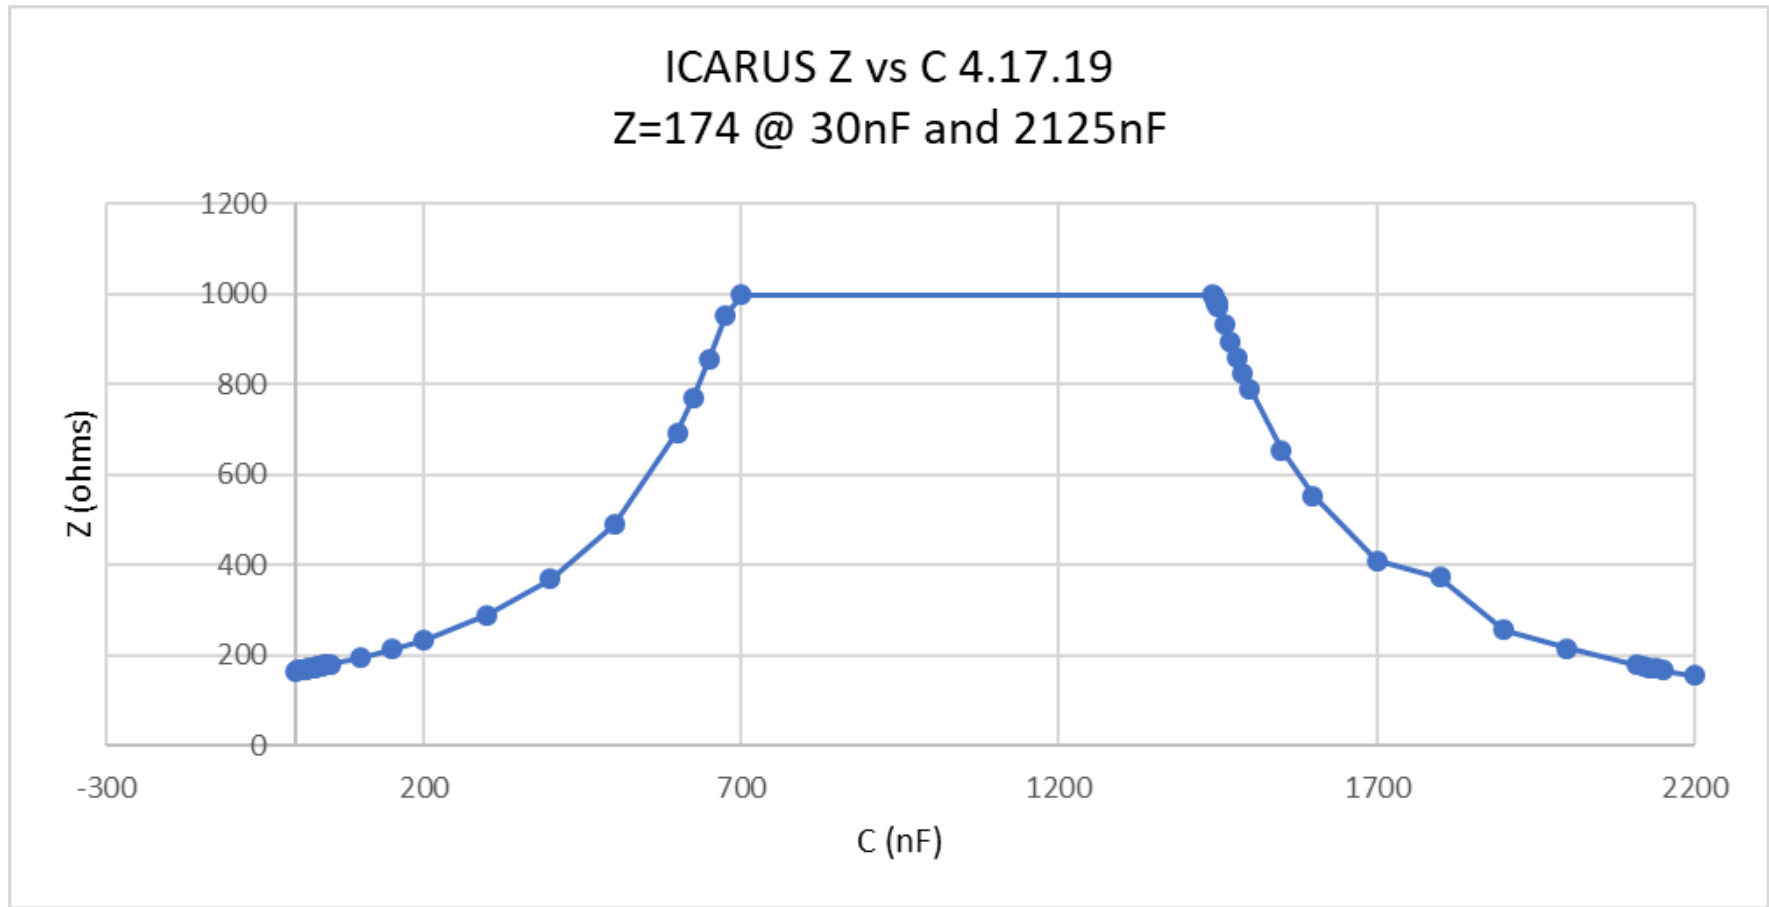
Looking at the curve

June 20: $Z = \sim 190\Omega$, +C decreased Z, C_d : $\sim 2\mu\text{F}$
