Vertical cavity testing at RRCAT

Praveen Mohania (On behalf of VTS team) / RRCAT

PIP-II Technical Workshop

Date: 02-12-2020

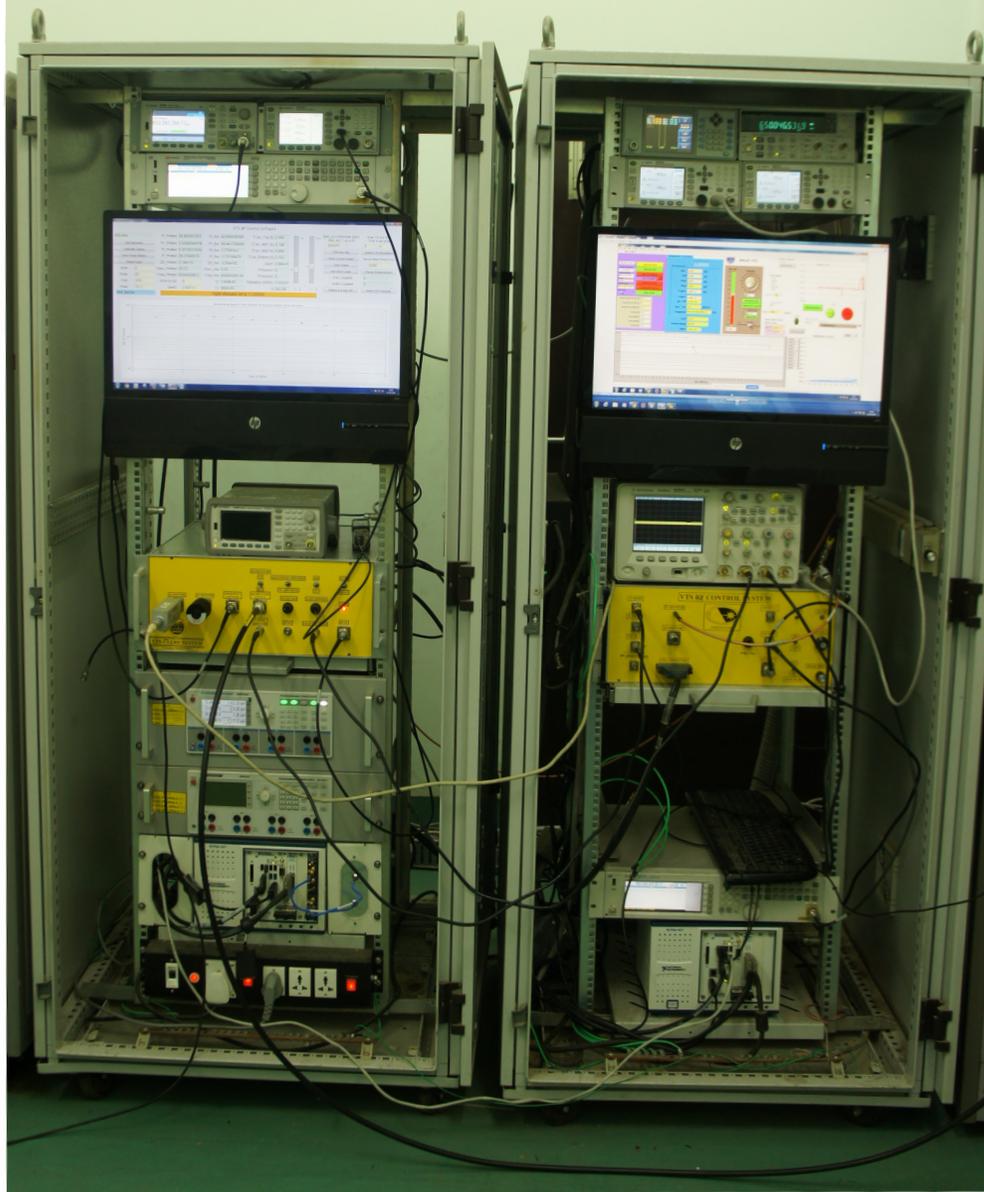
At present three independently operational RF systems are developed and out of which two are being used at the VTS (Left) and the third is installed at the Horizontal Test Stand (HTS) (Right). **RRCAT has one operational VTS cryostat and provision for another cryostat.**

The RF system at HTS was used to test our first dressed cavity with a unity coupler as a part of commissioning trials of the HTS and tuner testing. The availability of this system provides an option to qualify a dressed cavity with critical coupling.

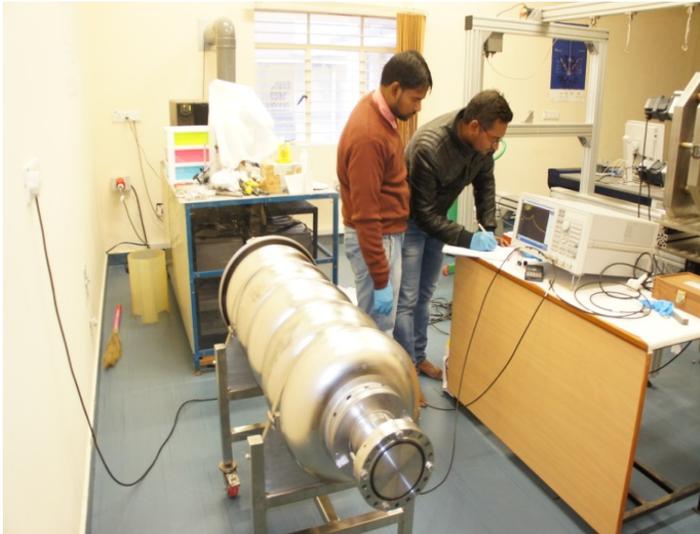
After final tuning of the cavity the pickup and fundamental power coupler quality factor are measured and optimized. At present we keep FPC at $\sim 1 \times 10^{10}$ to 2×10^{10} and pickup coupler at $\sim 2 \times 10^{12}$ to 3×10^{12} for 650 MHz cavities. The cavity is then sent for further processing.

After final processing, the cavity is inserted in the Vertical Test Stand. The resonant frequency and through loss of the cavity are then remeasured and compared with the expected loss based on coupler measurements. This step is needed to ensure that RF connections are OK before cooldown.

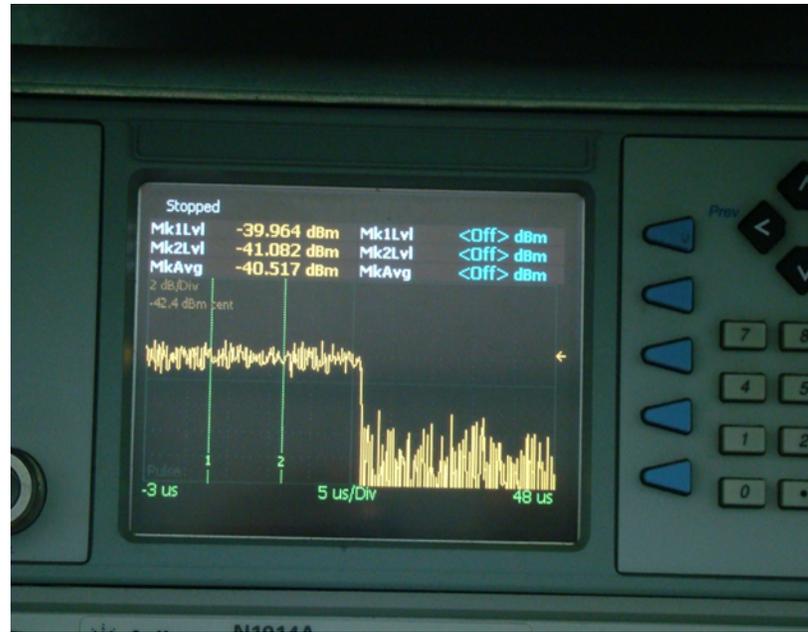
Breakdown inside RF cavity at 4.2K at 100 mW input power. At 2K, the phenomenon was subdued. (test of 503 cavity)

1. Helium Leak (encountered twice in about twenty tests). Interestingly only in single cells, but not in multi-cell so far.
2. Low 'field quench/gas breakdown' like signal (encountered twice during five cell 650 MHz cavity tests): This problem is still not fully understood; it appears to be specific to our facility as FNAL has not encountered such phenomenon.

The RF cavity shows a signature which is similar to what is expected in case of cold leak/low field quench, i.e. the transmitted power signal increases gradually and then suddenly falls at power levels close to ~ 100 mW. During our last test, this phenomenon did not occur for π -mode but occurred at other modes. Previously, it occurred at π -mode also. Interestingly, if the power is suddenly increased when the field inside the cavity is gradually increasing, it is possible to overcome this phenomenon, as if it were a kind of multi-pacting barrier. But its origin still remains unknown.
