# Gradient R&D in the US – Overview and Summary

**Joe Ozelis**  
**Fermilab**

(on behalf of collaborators at ANL, Cornell, FNAL, JLab, and KEK)

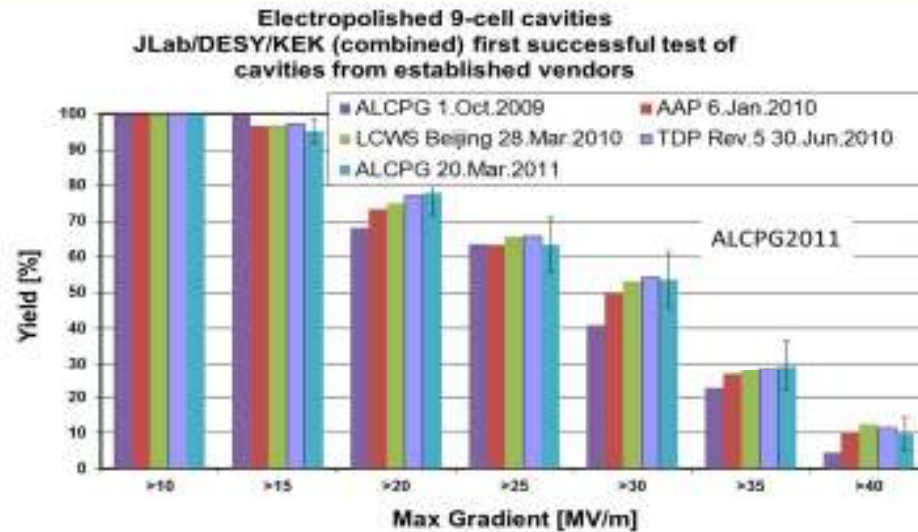
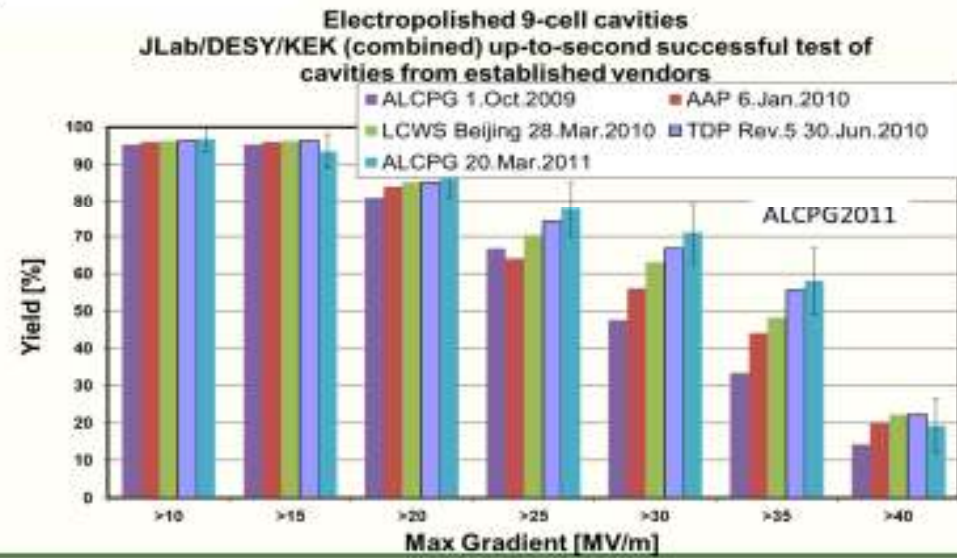
Over time, yield of cavities reaching  $> 30\text{MV/m}$  after 1<sup>st</sup> test improves markedly, reaching 50%; 30% reach the ILC spec.

When one considers the effect of a second process/test cycle, the yield of cavities reaching  $> 30\text{MV/m}$  now reaches 70%, and over 50% reach the ILC spec.

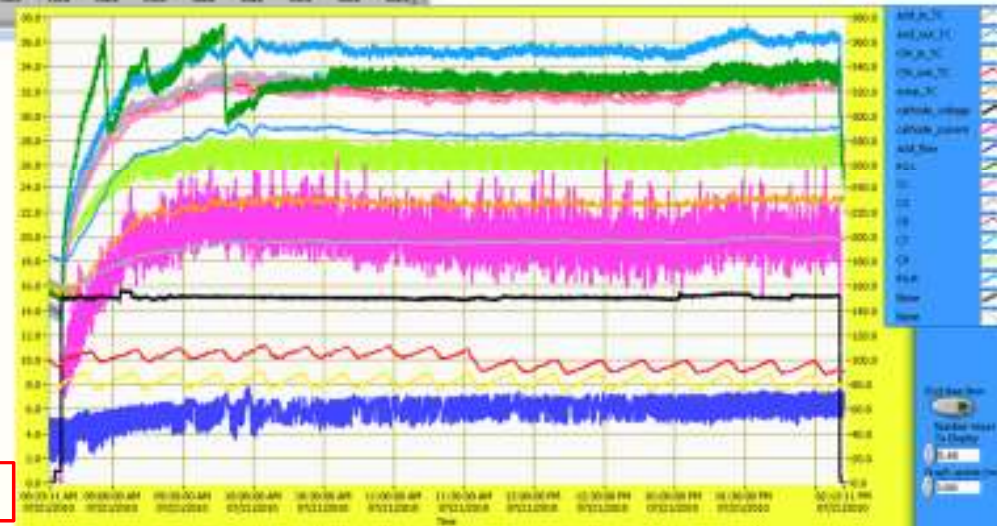
FNAL/ANL EP  
process monitoring

JLab EP process  
monitoring

EP parameters such as acid temperature, cavity temperature(s) and voltage and current are routinely monitored and controlled. The operation is reproducible and routine.

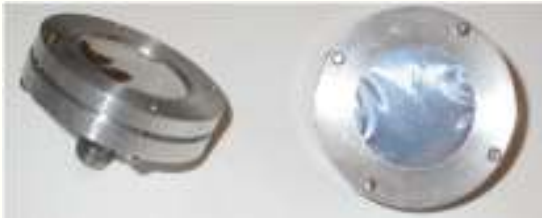
All labs are now using a combination of thermometry and second-sound detectors (OST) to localize quench origins.

Second sound detectors (OST's)

Fast Thermometry System (FTS) bands on equator at FNAL

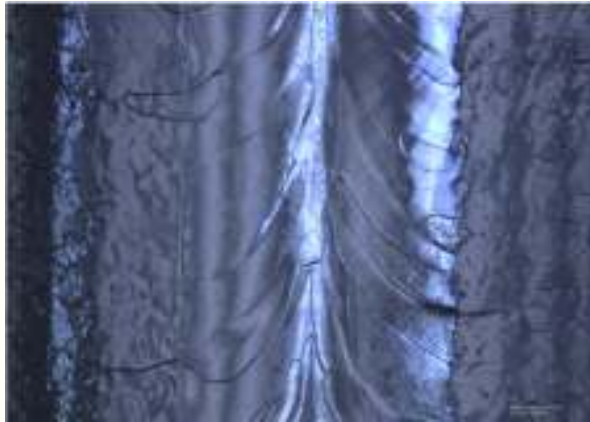
Cavity TB9RI024, quenched at 29 MV/m.

Cavity received additional (light) EP, then reached 36MV/m.

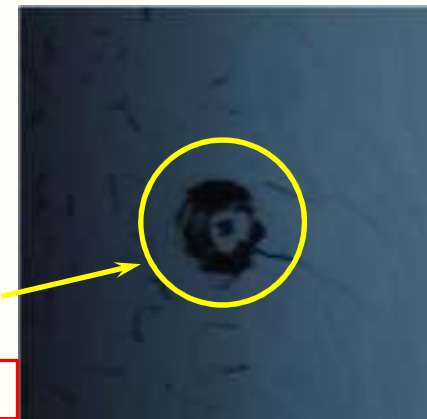
Cavity TE1AES004, quenched at 40 MV/m!

Defect is pit,  $\sim 1000\mu\text{m}$  (1mm!) in diameter.

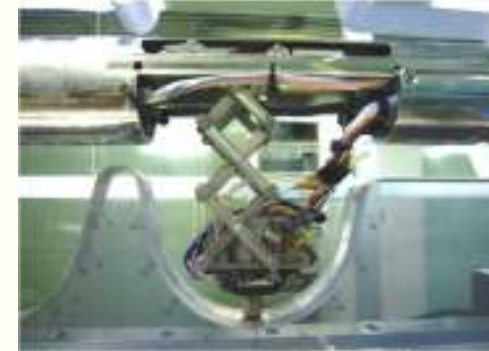
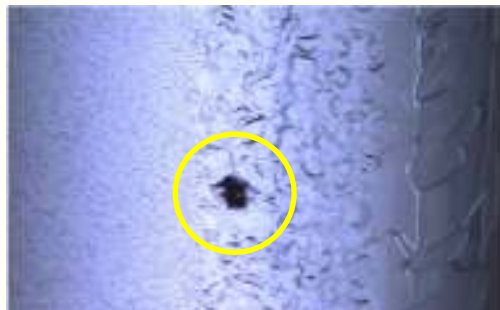
Technique developed at KEK; grinder is inserted into cavity and is directed at site of defect.

Bump, diameter  $\sim 200\text{-}300\mu\text{m}$

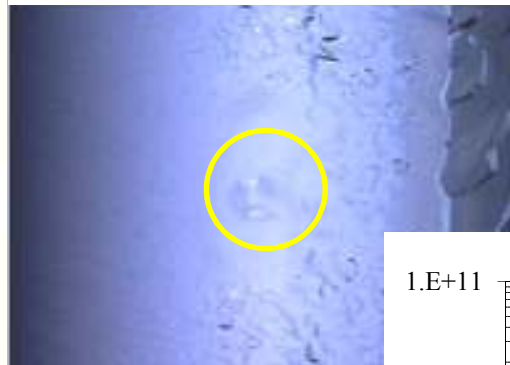
After grinding and  $50\mu\text{m}$  EP

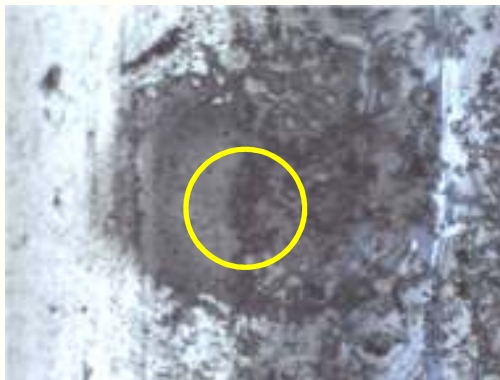
After repair and EP/HPR cavity now meets ILC gradient spec (quench limited, new location).

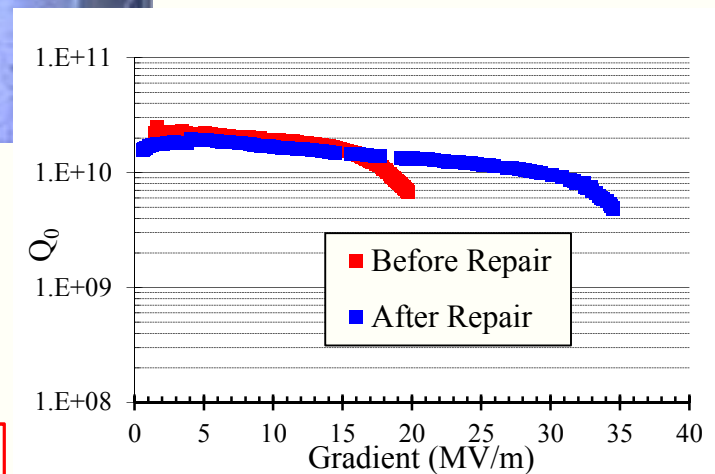
After grinding

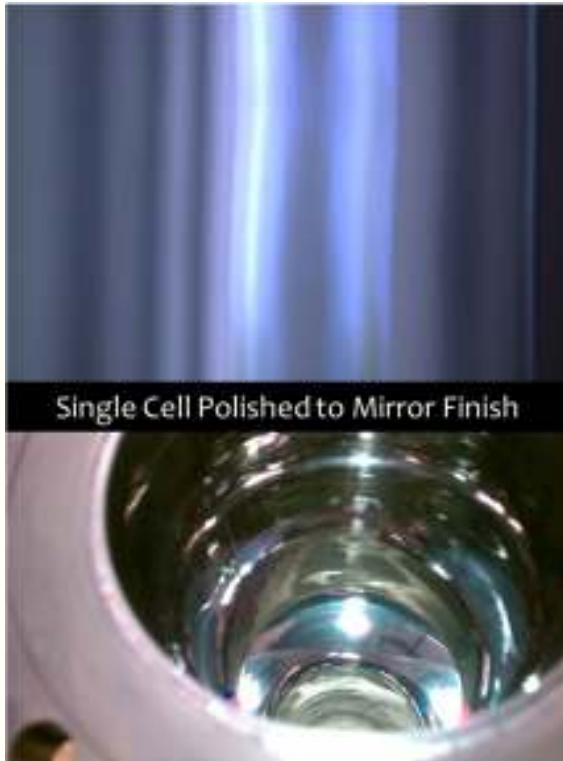
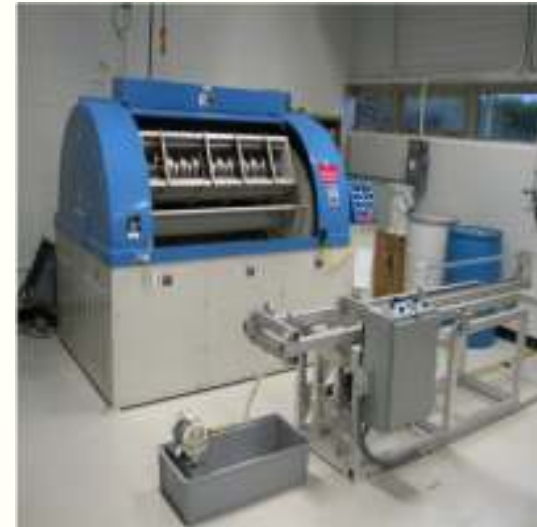
Like optical inspection and thermometry, all US labs now have CBP apparatus. These have been used for alternative process development and also as a “repair” tool.

Preliminary R&D on CBP has identified a process that can yield mirror like finishes, and can eliminate the need for bulk EP.

However, so far between 40 and 20 $\mu$ m of material still needs to be removed by chemistry processing (EP).

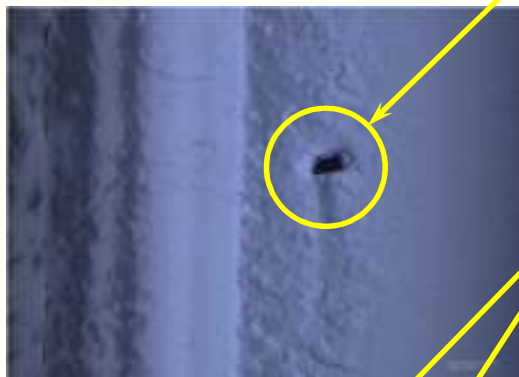
**Cavity TB9ACC015 tested at JLab, quench limited to 19MV/m. Thermometry identified a hot spot; optical inspection confirms defect at that location.**

After EP, 200 $\mu$ m diameter feature (pit) in cell 3 near equator

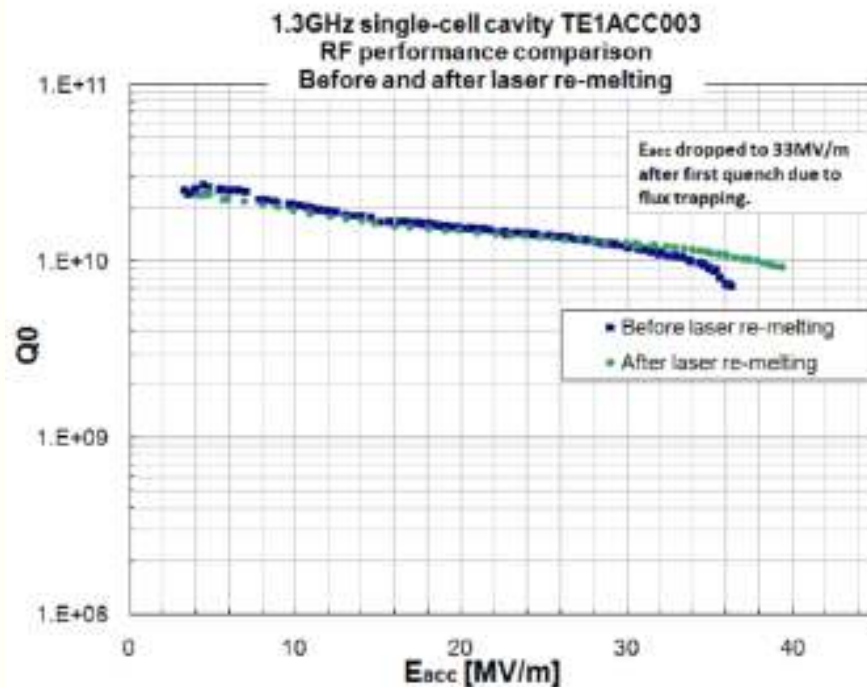
Re-melting (via E-beam or laser) has been successfully attempted on single-cell cavities at JLab (E-Beam) and FNAL (laser).

Laser re-melting example :

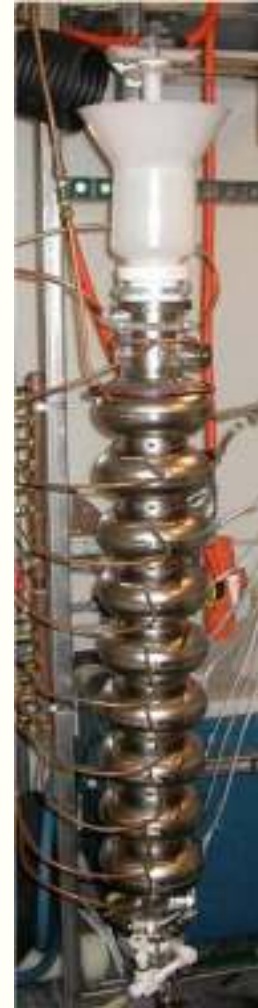
**Vertical electropolishing (VEP) is being studied at Cornell and JLab.**

- reduce temperature of acid to 20-25°C
- reduce agitation of electrolyte
- increase voltage during EP from 14 to 17 V

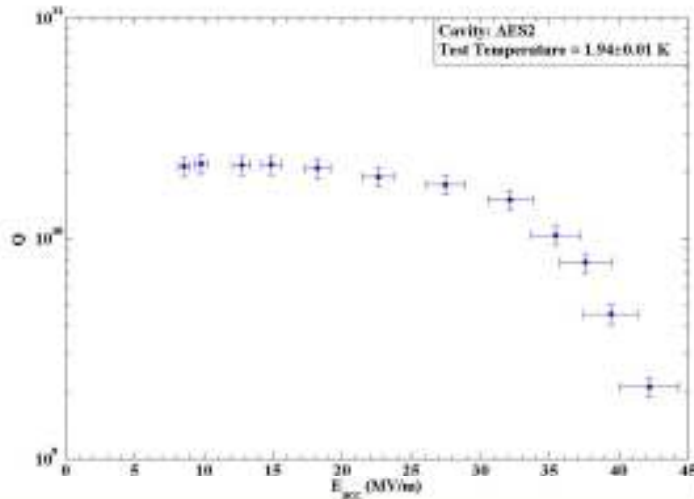
Single-cell cavity reaches  $> 40$  MV/m, meets ILC gradient and  $Q_0$  spec.

Also, extremely good  $r_{s0}$  measured in a SC cavity,  $\sim 1$  n $\Omega$ !

Nine-cell cavity reaches 36MV/m, meeting ILC gradient spec.  $Q_0$  value subsequently improved by higher-voltage VEP.

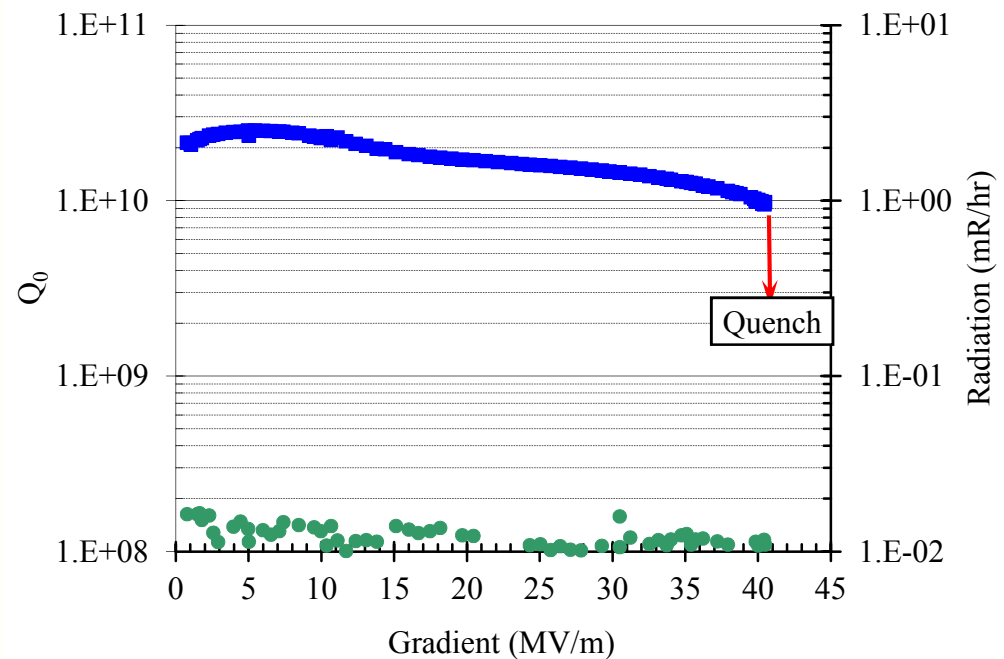
Example : single cell cavity TE1ACC004

- bulk CBP (120 $\mu$ m)
- light EP (40 $\mu$ m)
- 800°C HT (3hrs)
- light EP (20 $\mu$ m)
- HPR
- 120°C bake (40hrs)

Cavity reached > 40 MV/m, with excellent  $Q_0$ , and was quench limited.

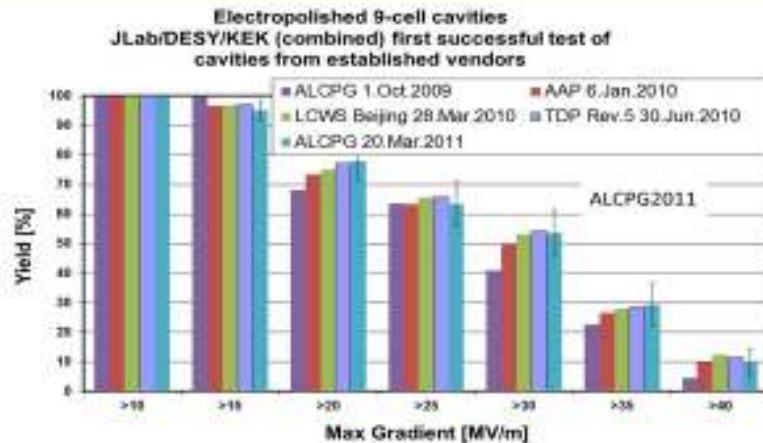
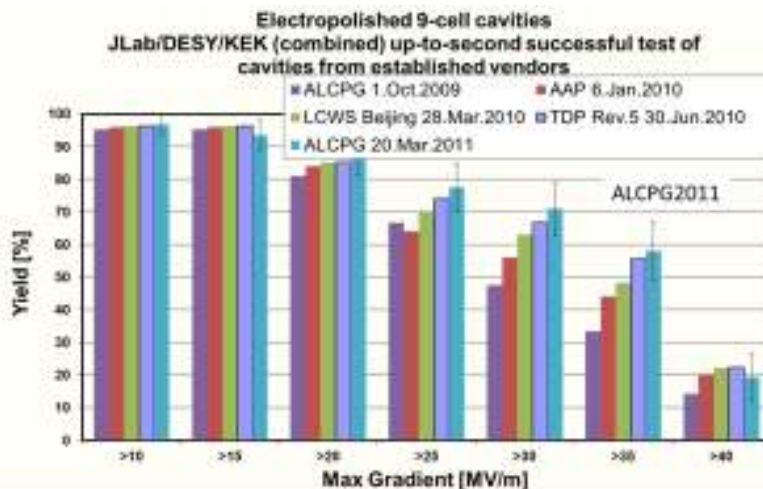
There has been sustained progress in achieved gradient and gradient yield :

The trend is positive... but the scatter is significant.
