NuMI Shutdown Summary

PMG Meeting

Conditions & Plan for 2020 Shutdown

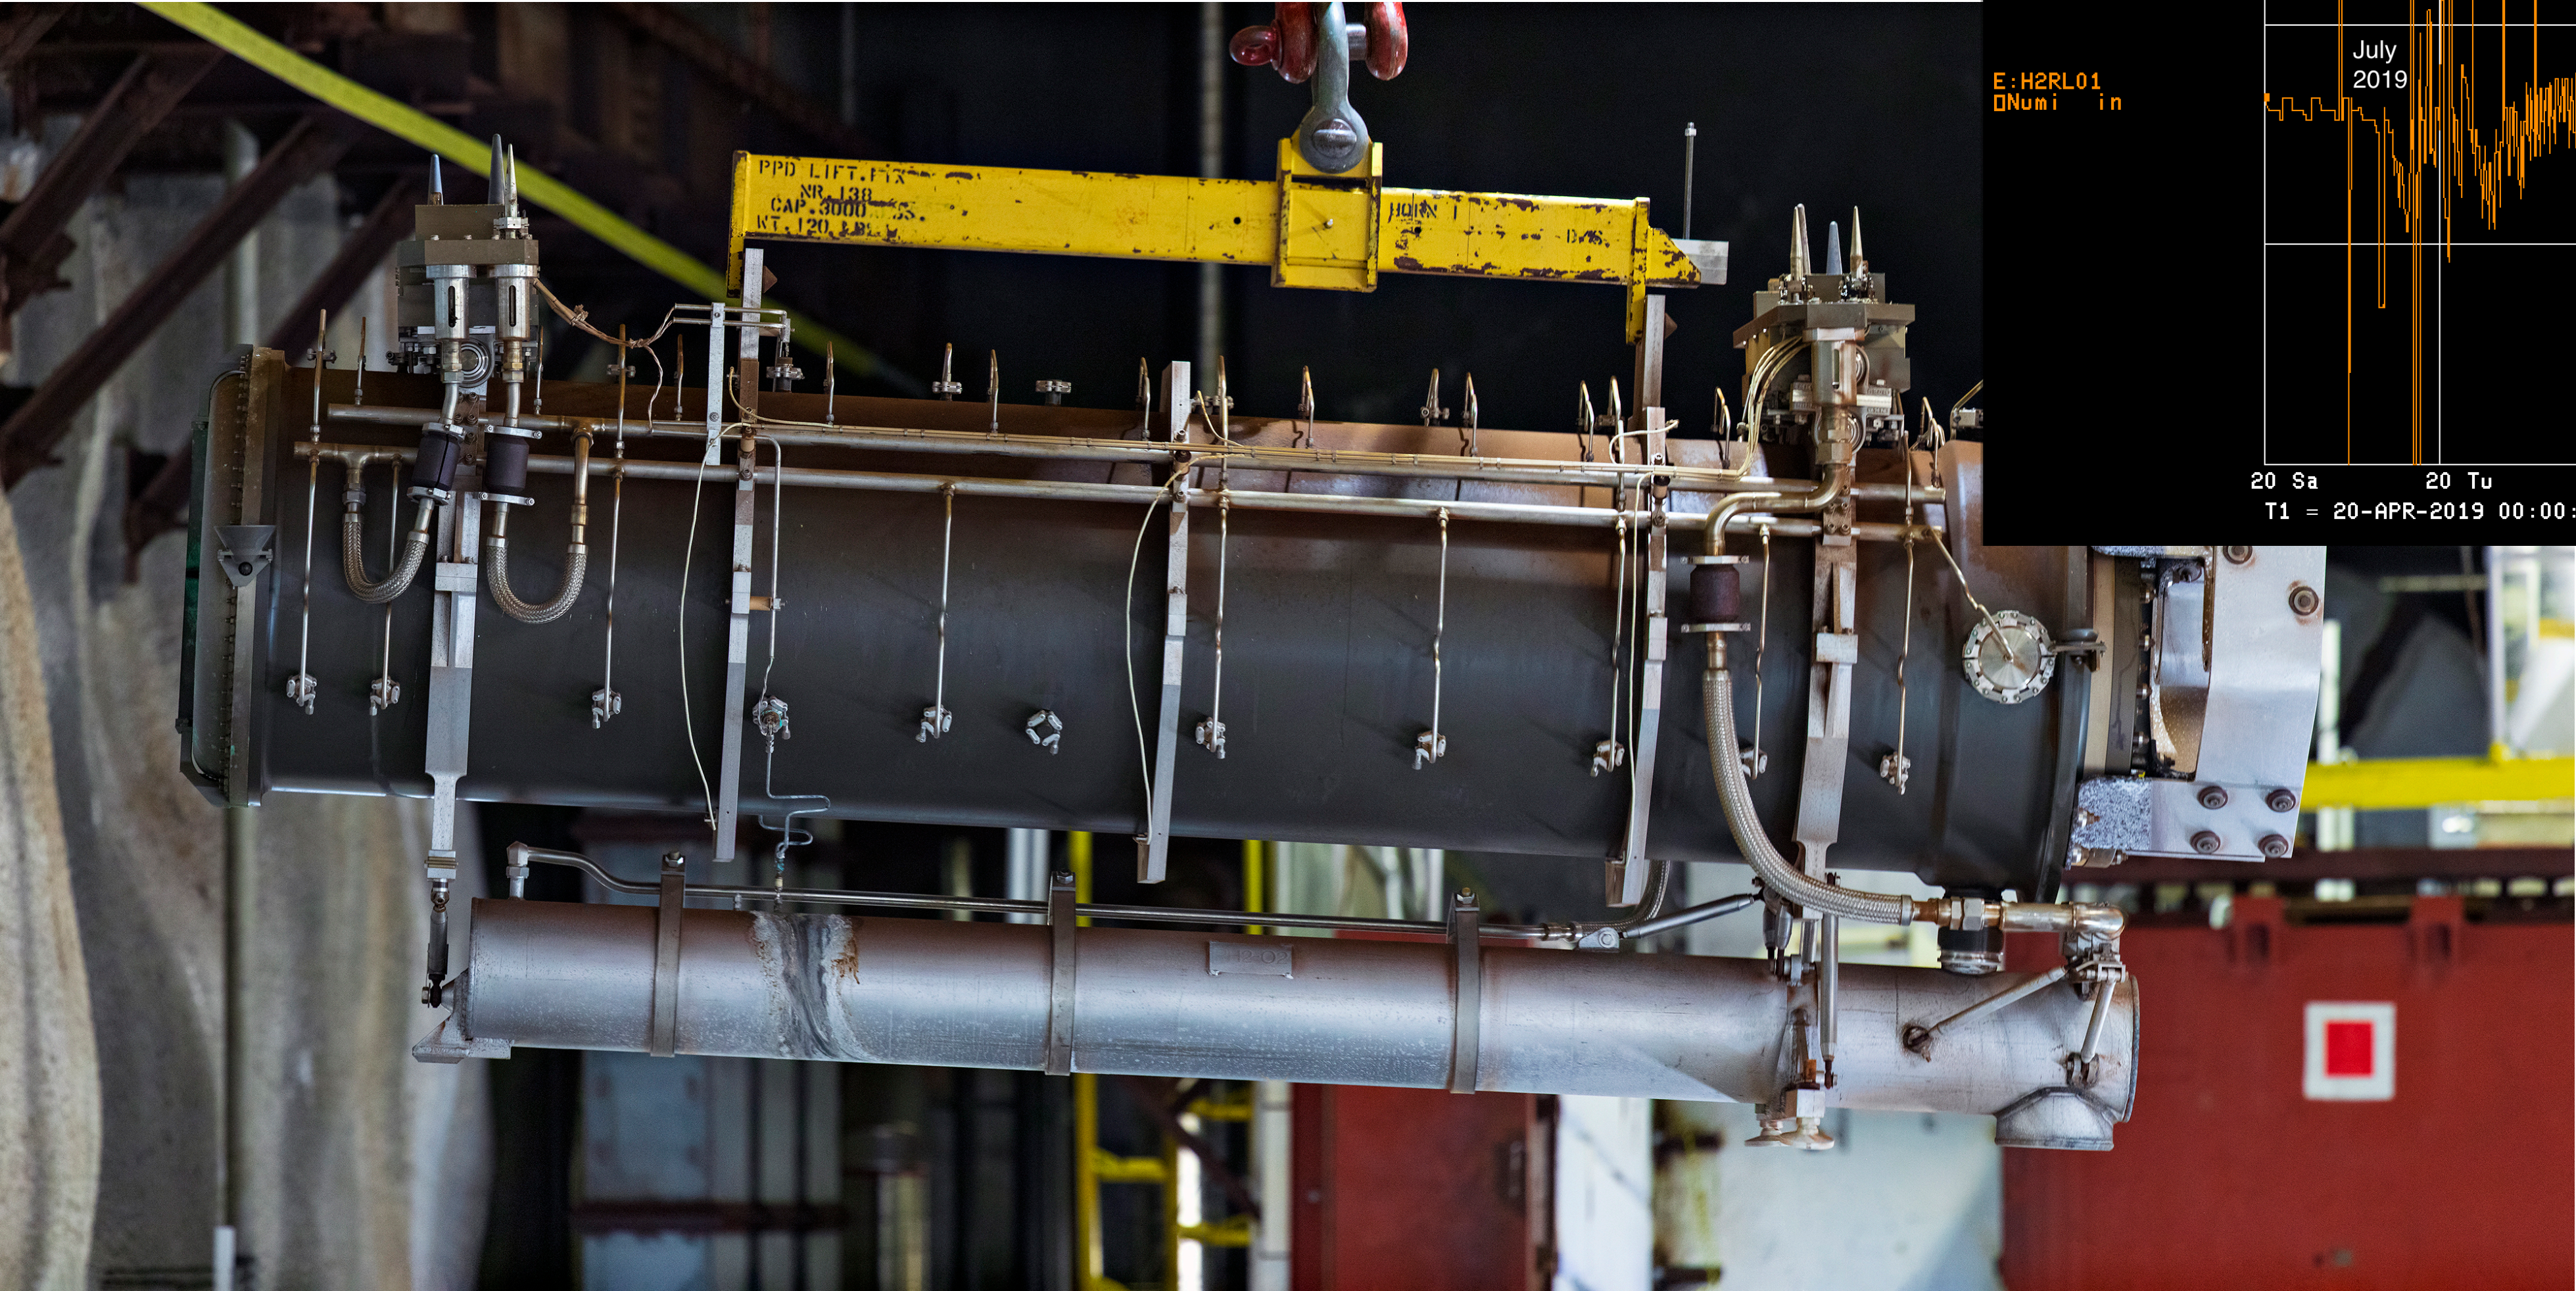
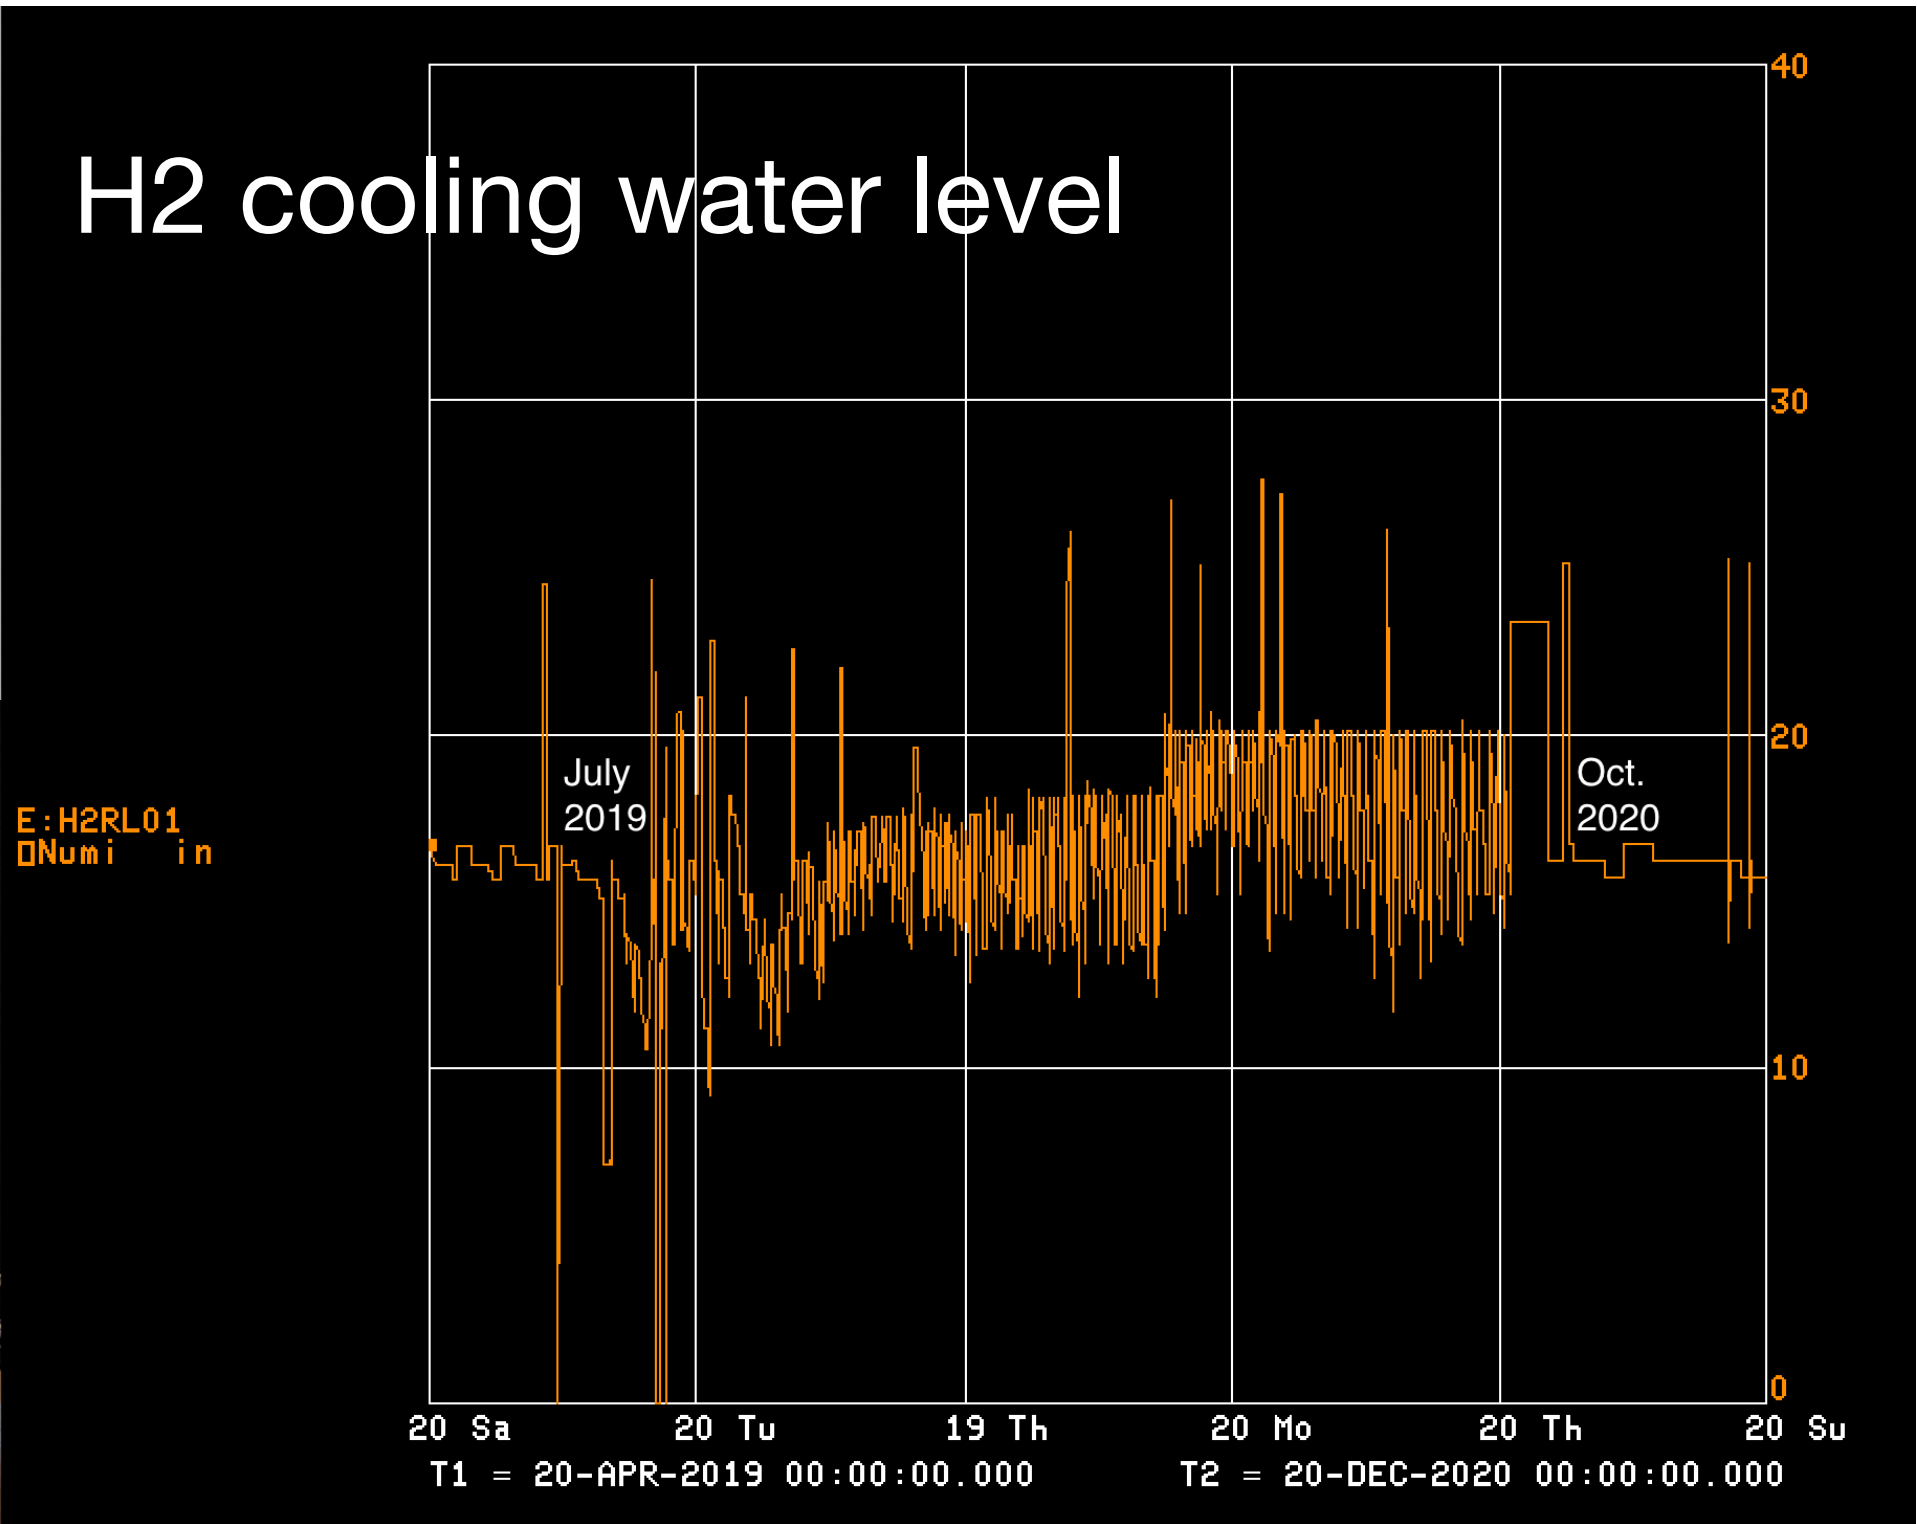
By end of May the likelihood of completing Plan-A was 50/50.
Given the uncertainty we decided to replace PH2-02 while H1 module
drive components were being fabricated.
RAW leak was on B-dot detector on the beam-right side of PH2-02.

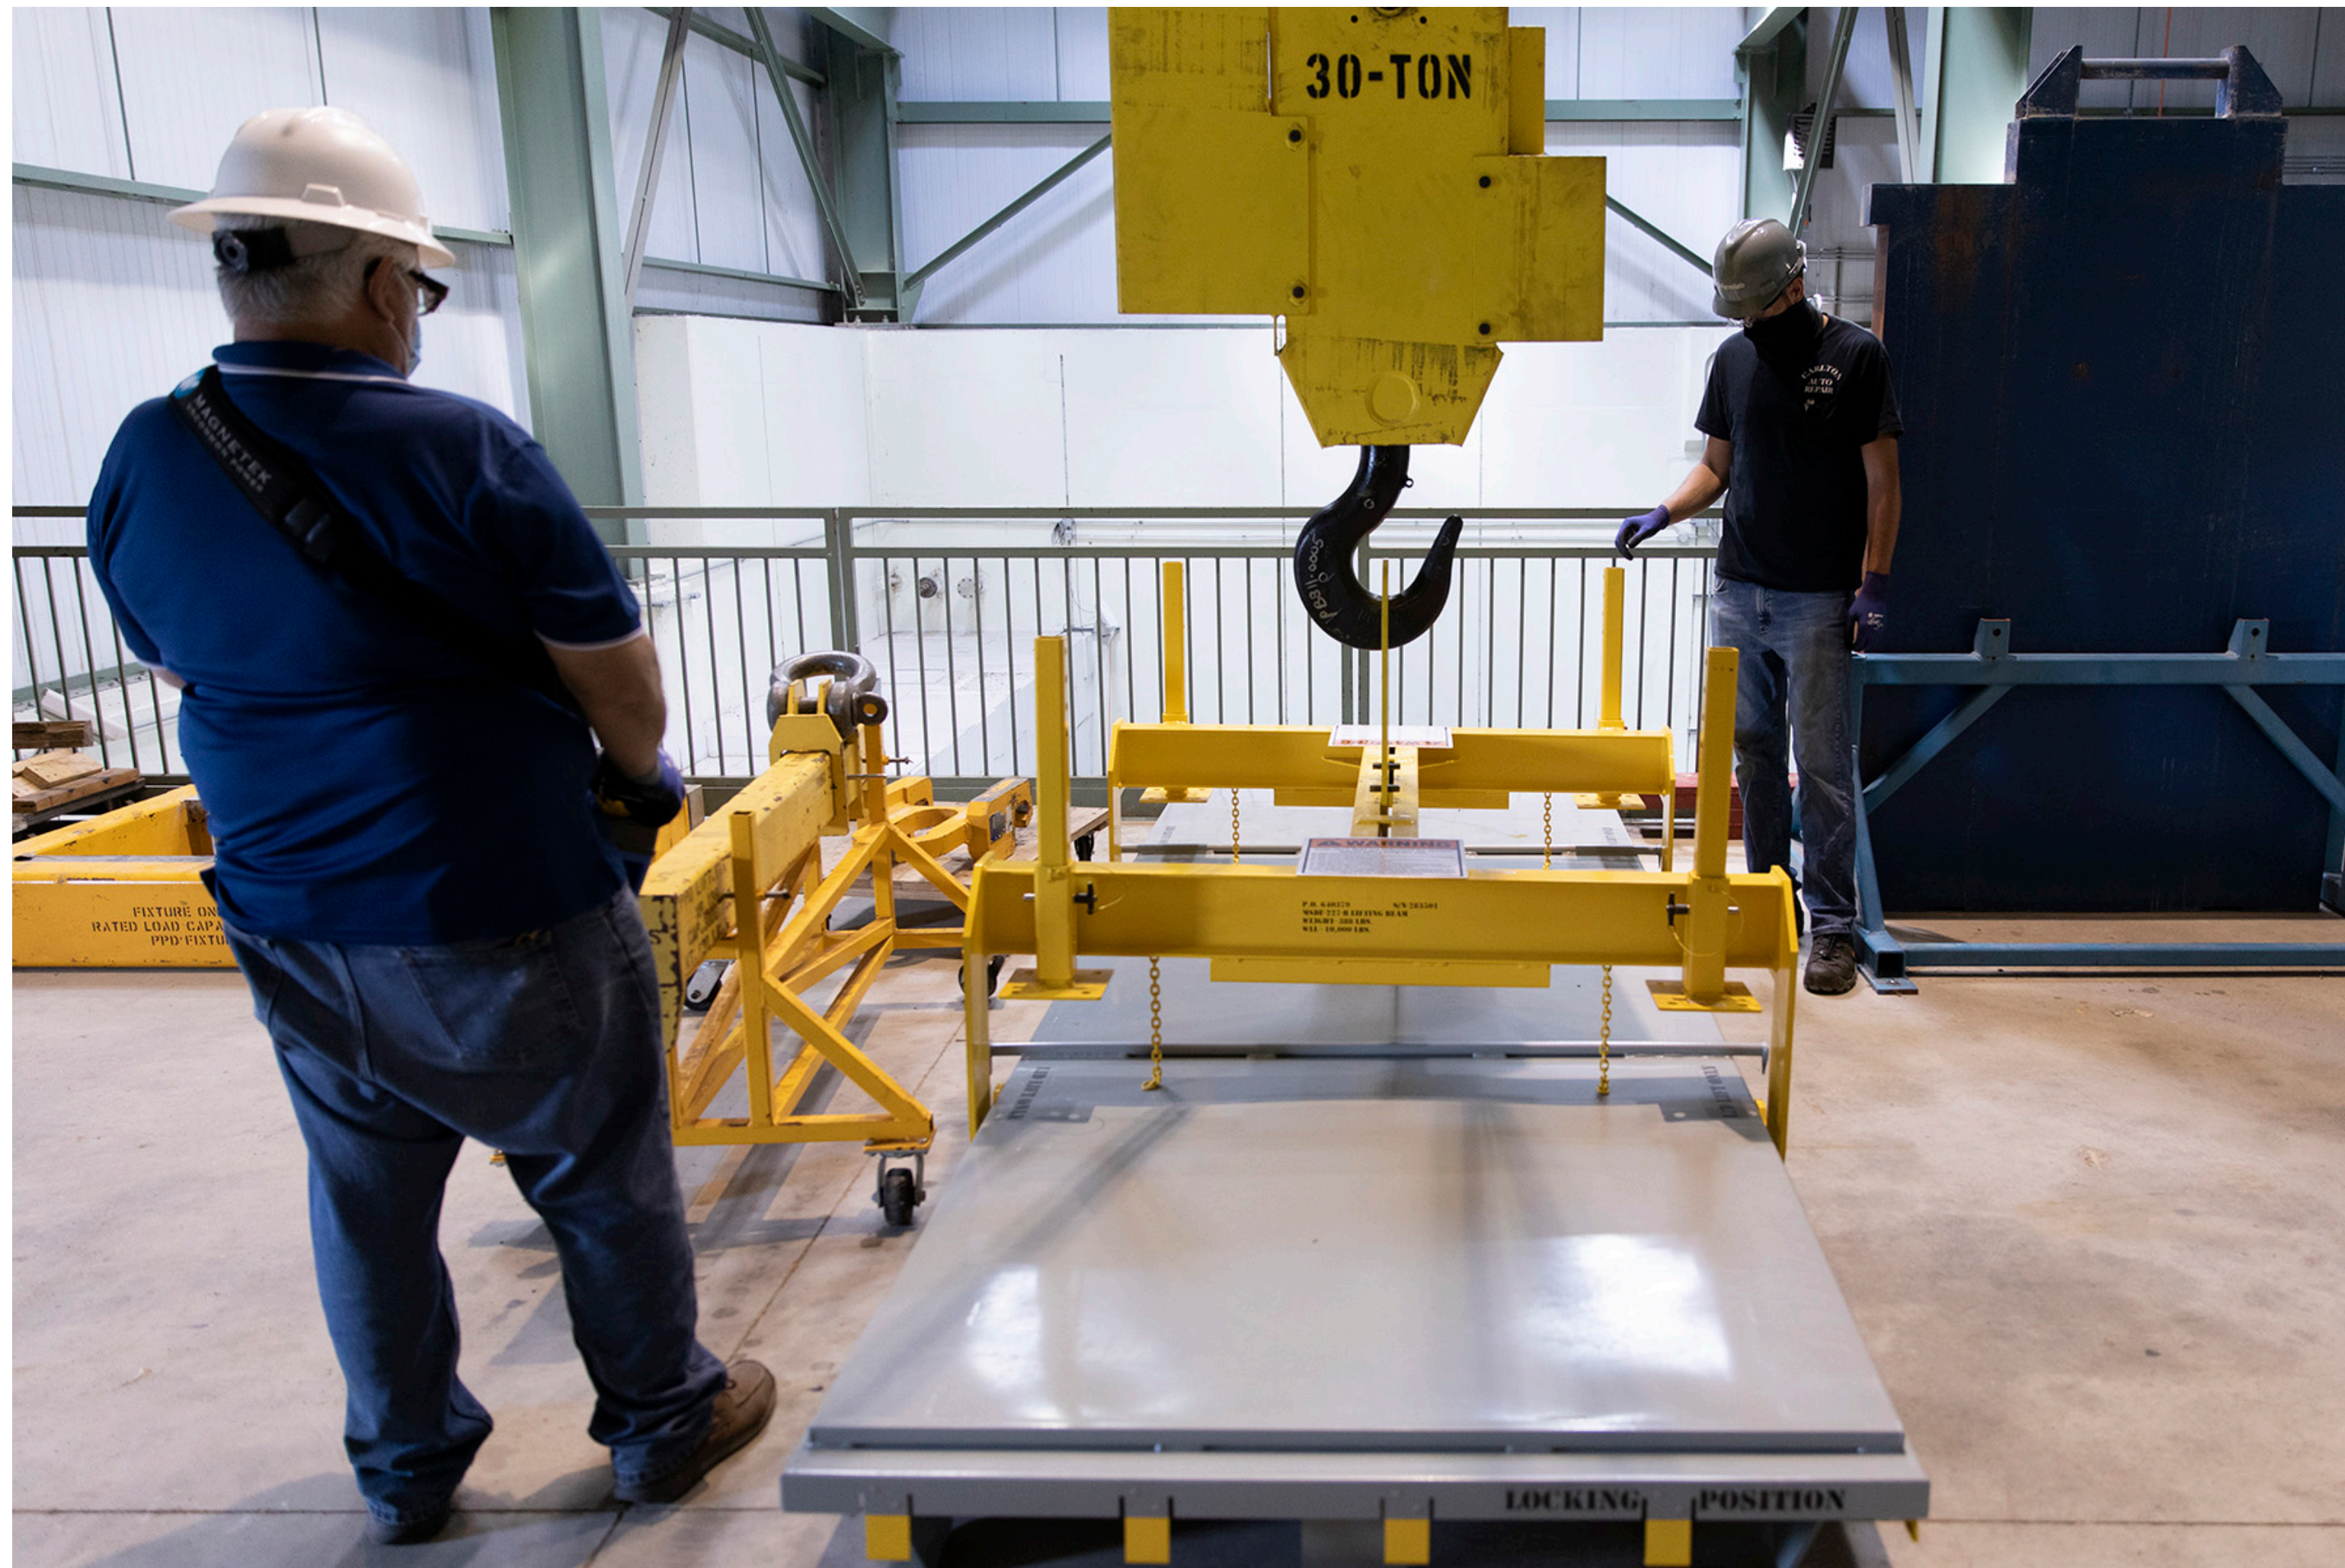
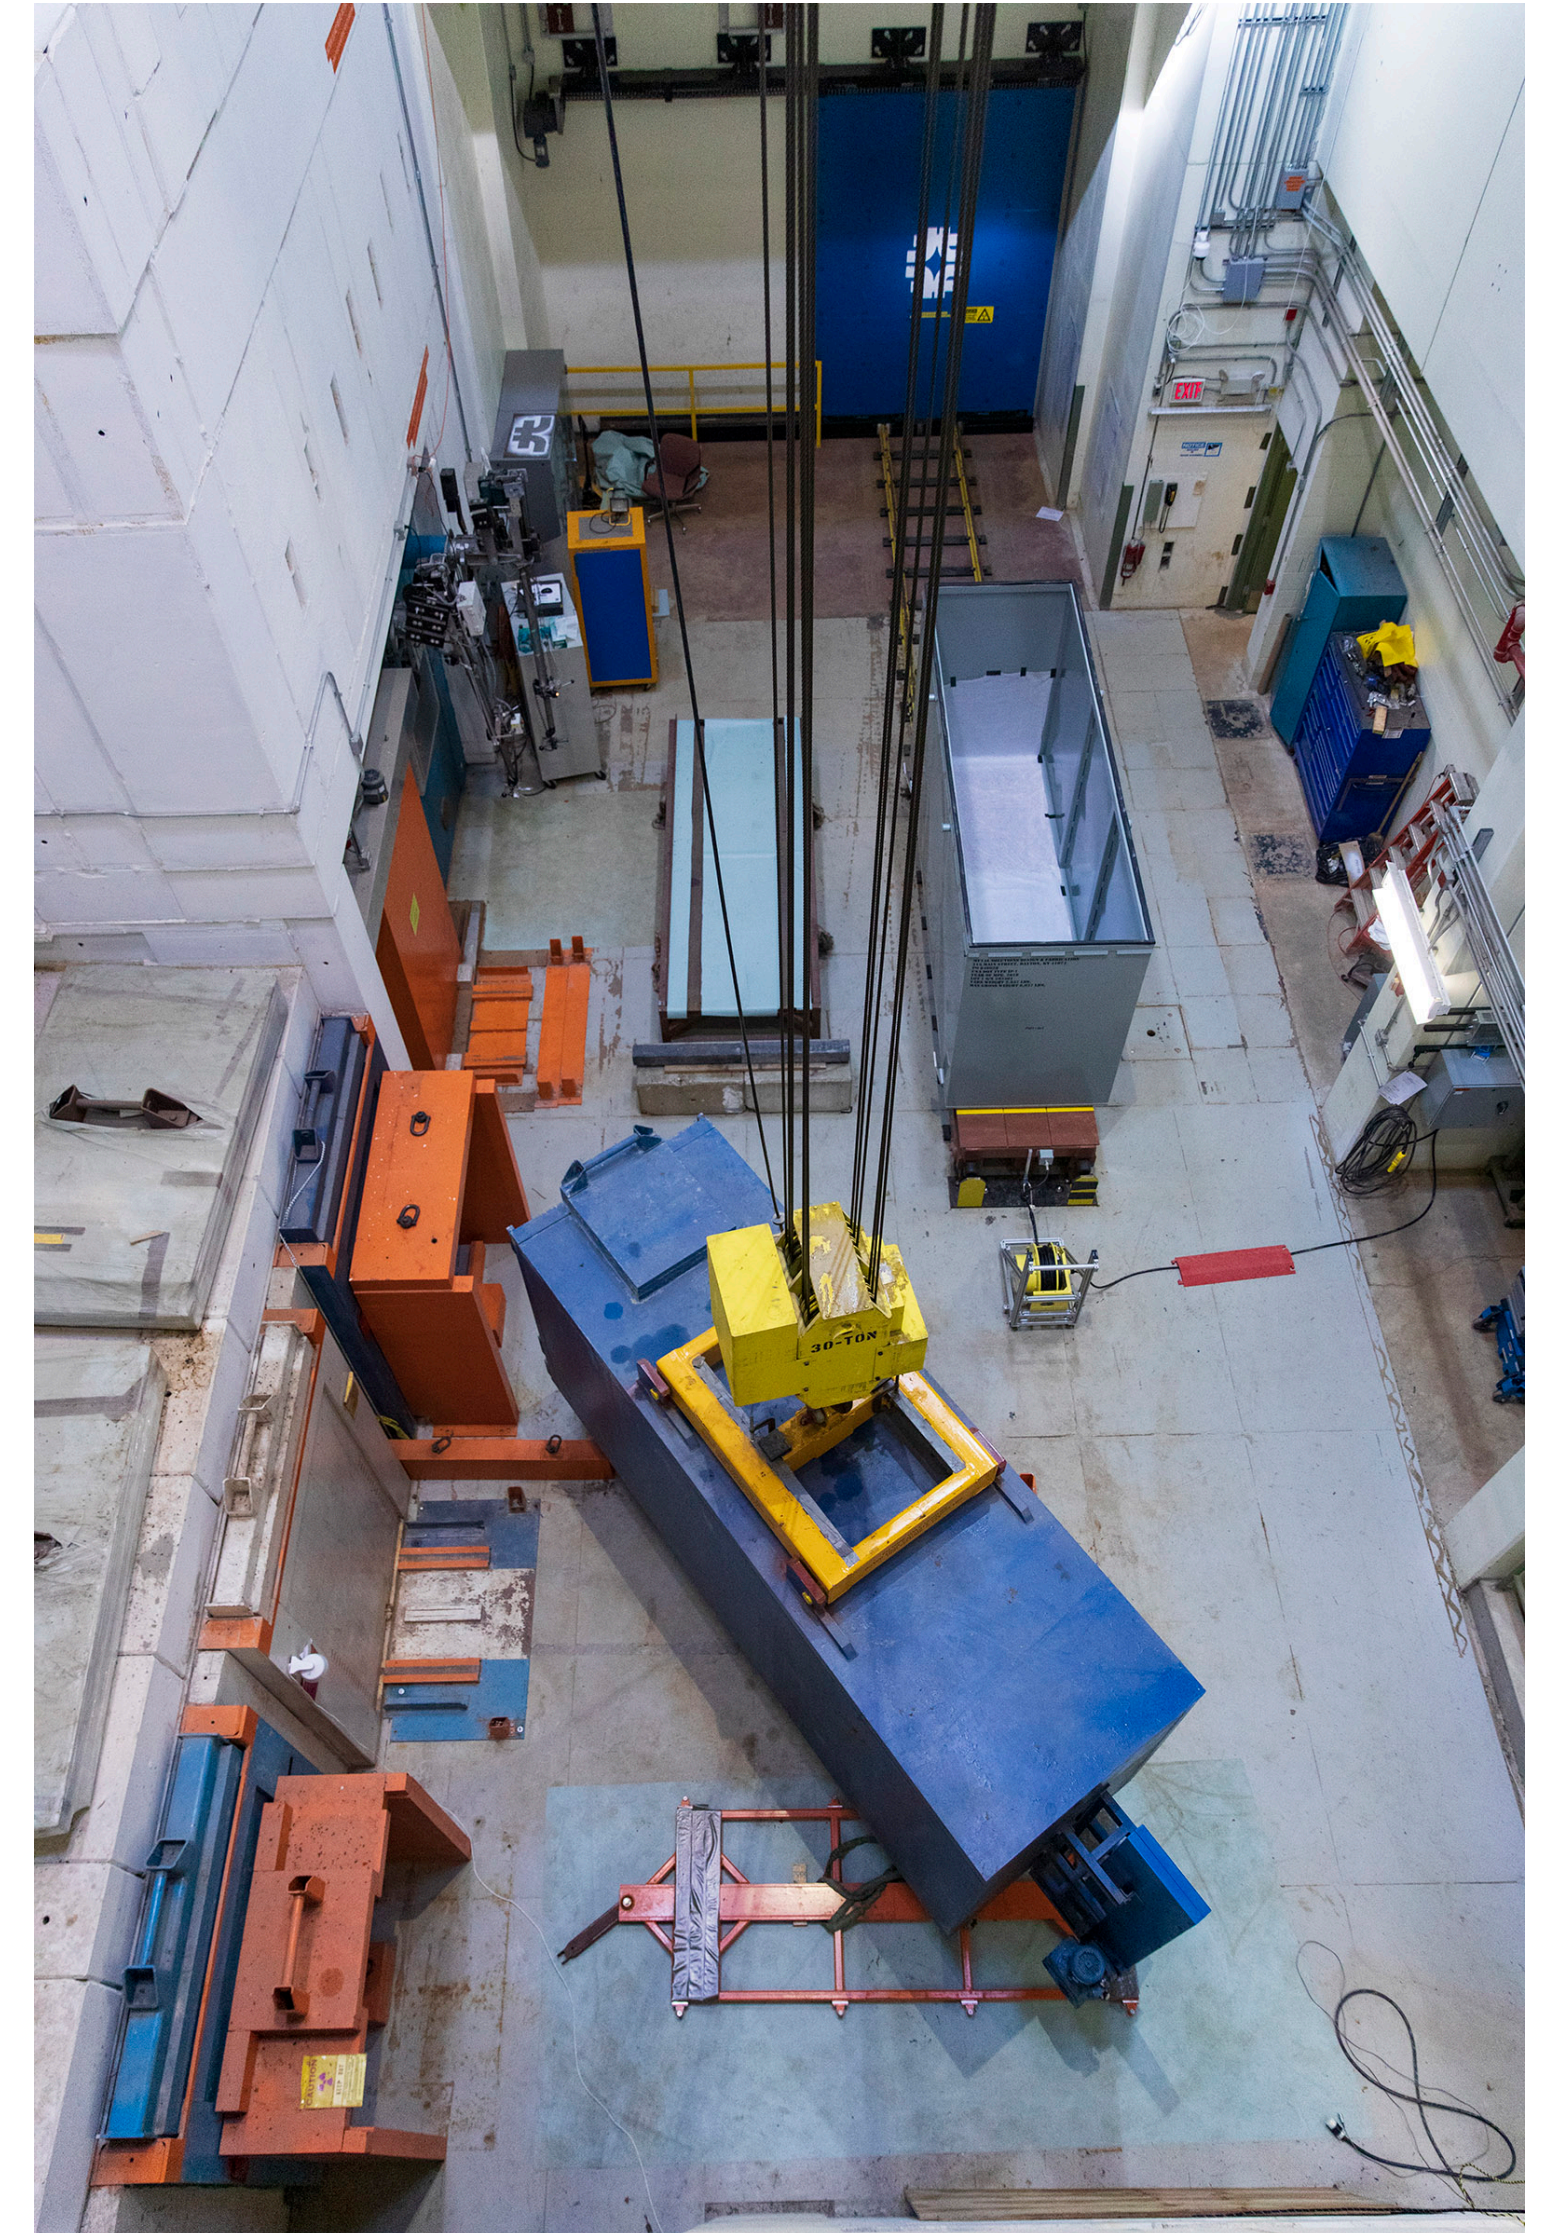
In order to complete component replacements we used components to C0. We completed two such moves: TA-03 and PH2-02 in July and August, respectively.

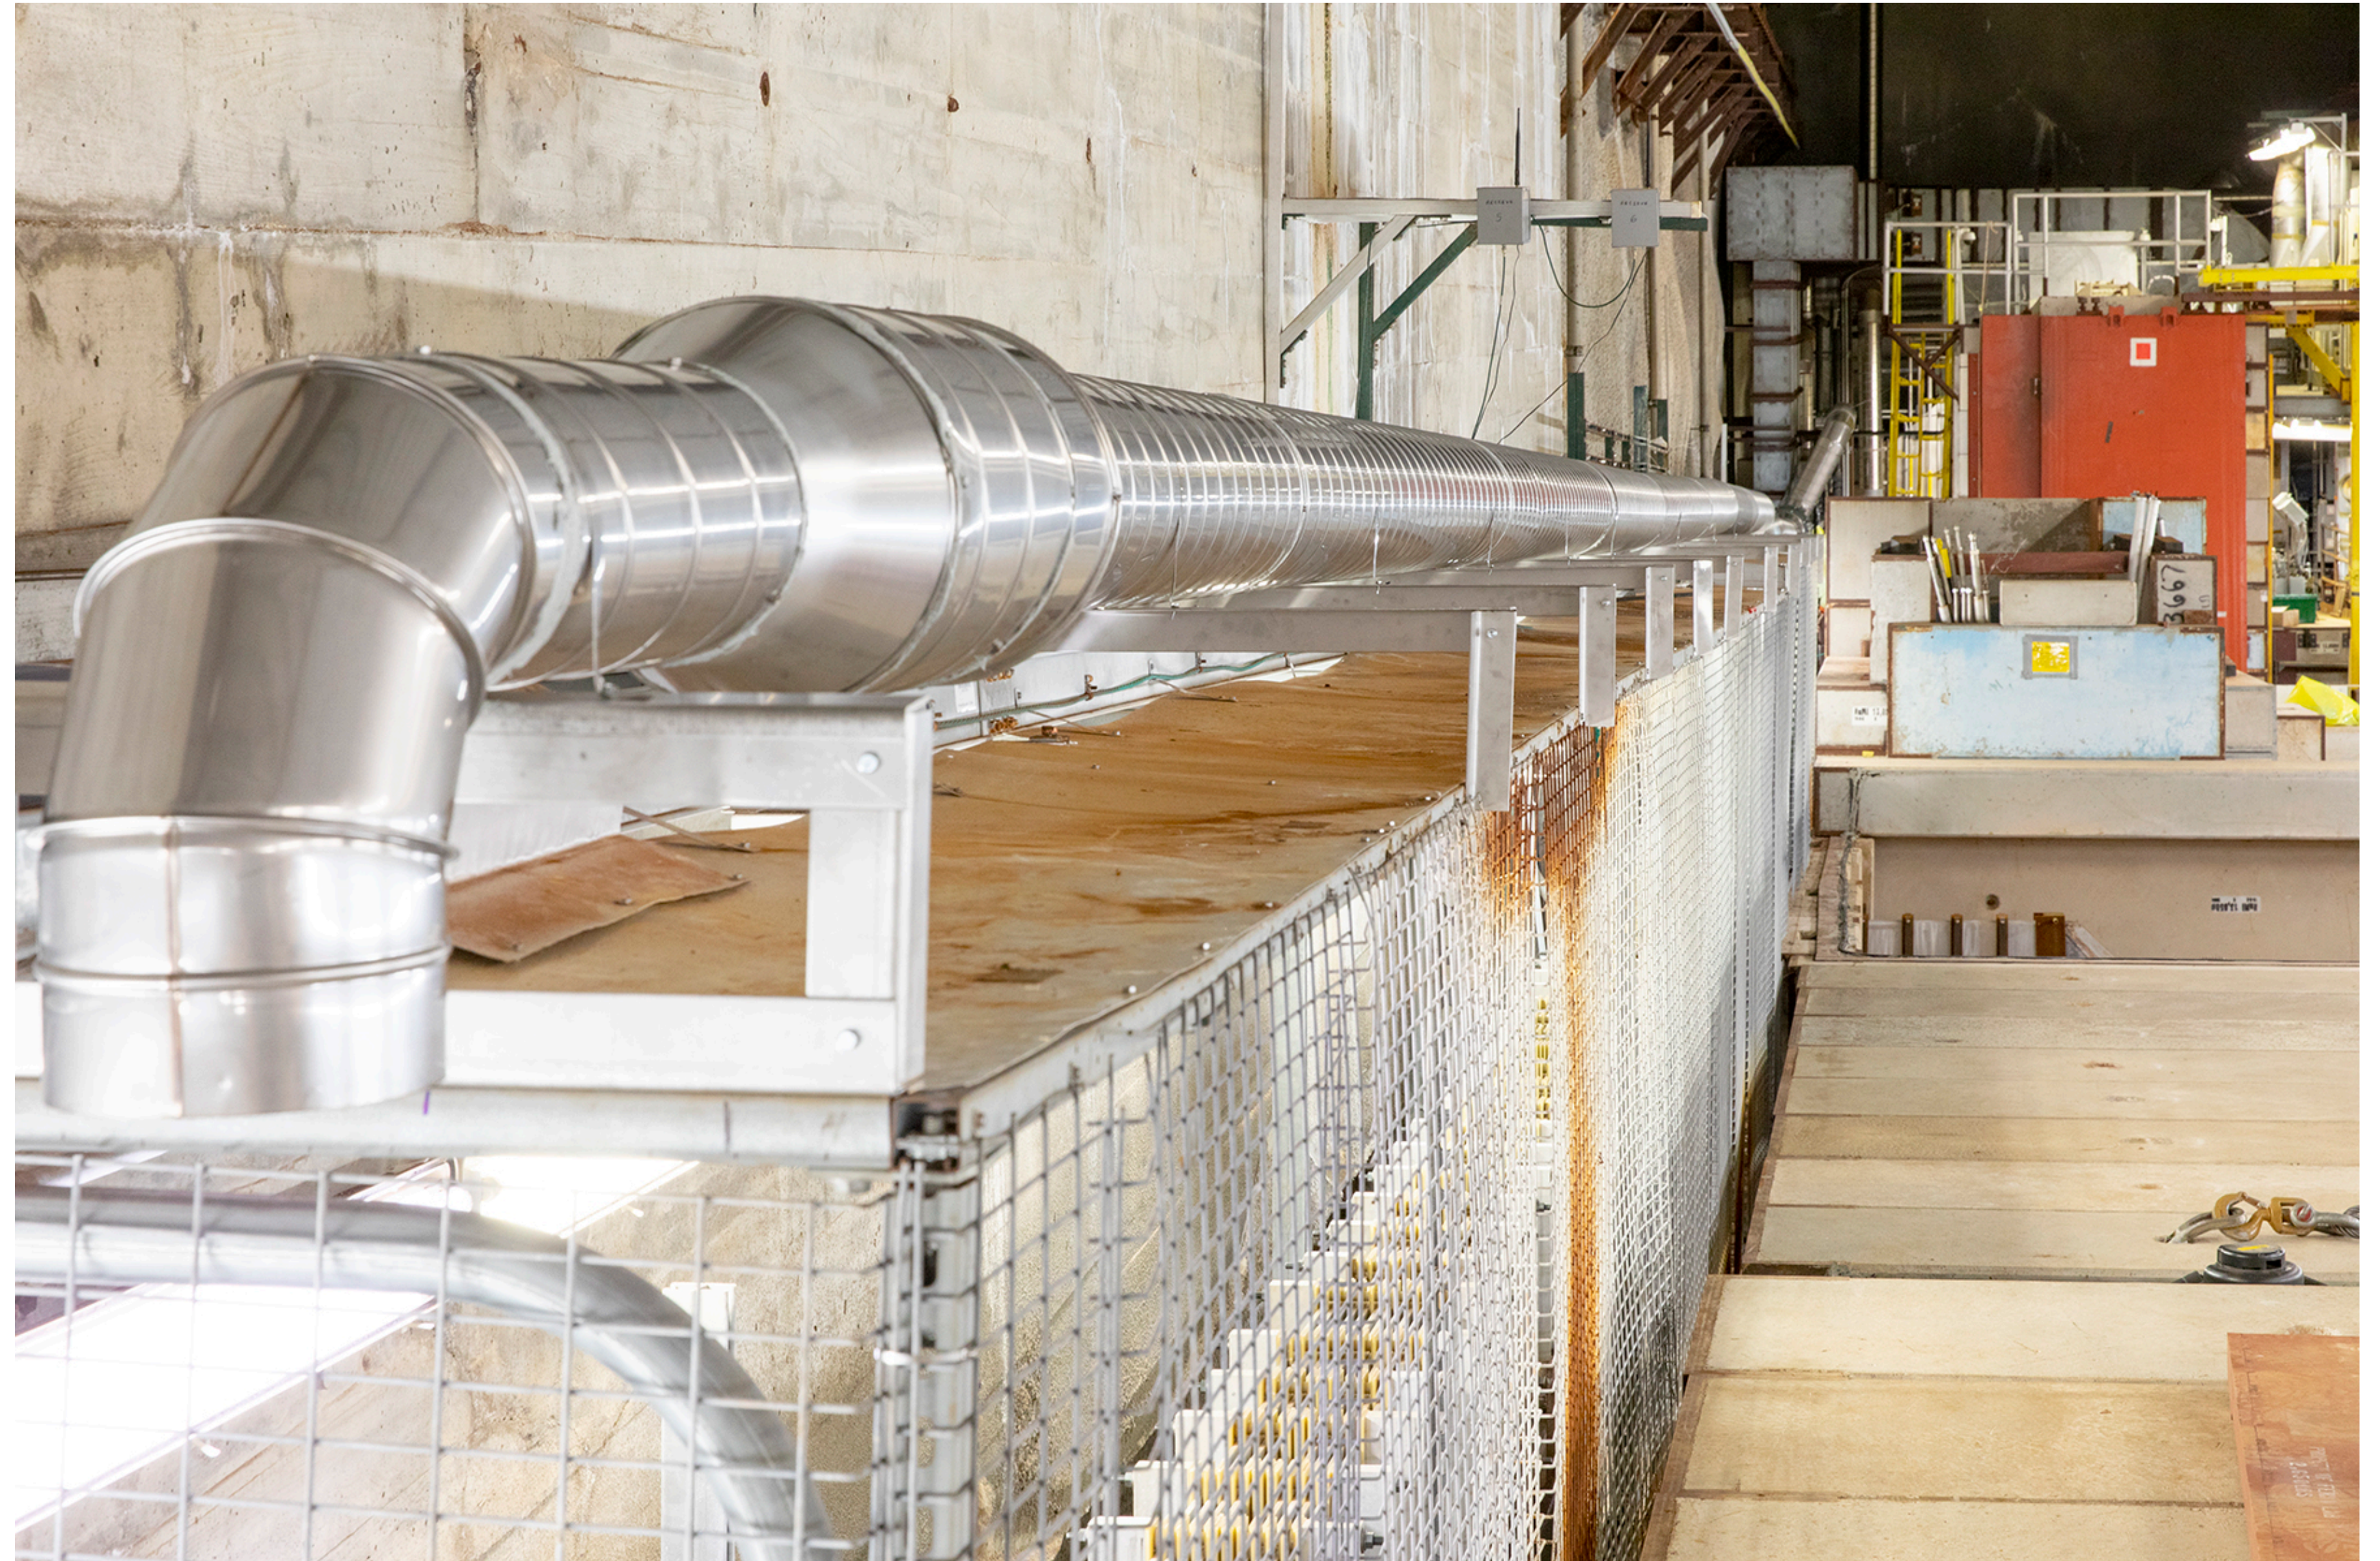
Horn-1 Strip-line Flag Cooling Installation

200 feet of 12" duct installed in Target Hall and Chase.

Installation was 80% complete by September 3.

The purpose of the cooling is to reject heat generated by beam interaction with Horn-1.
