NuMI Shutdown Summary

PMG Meeting

Conditions & Plan for 2020 Shutdown

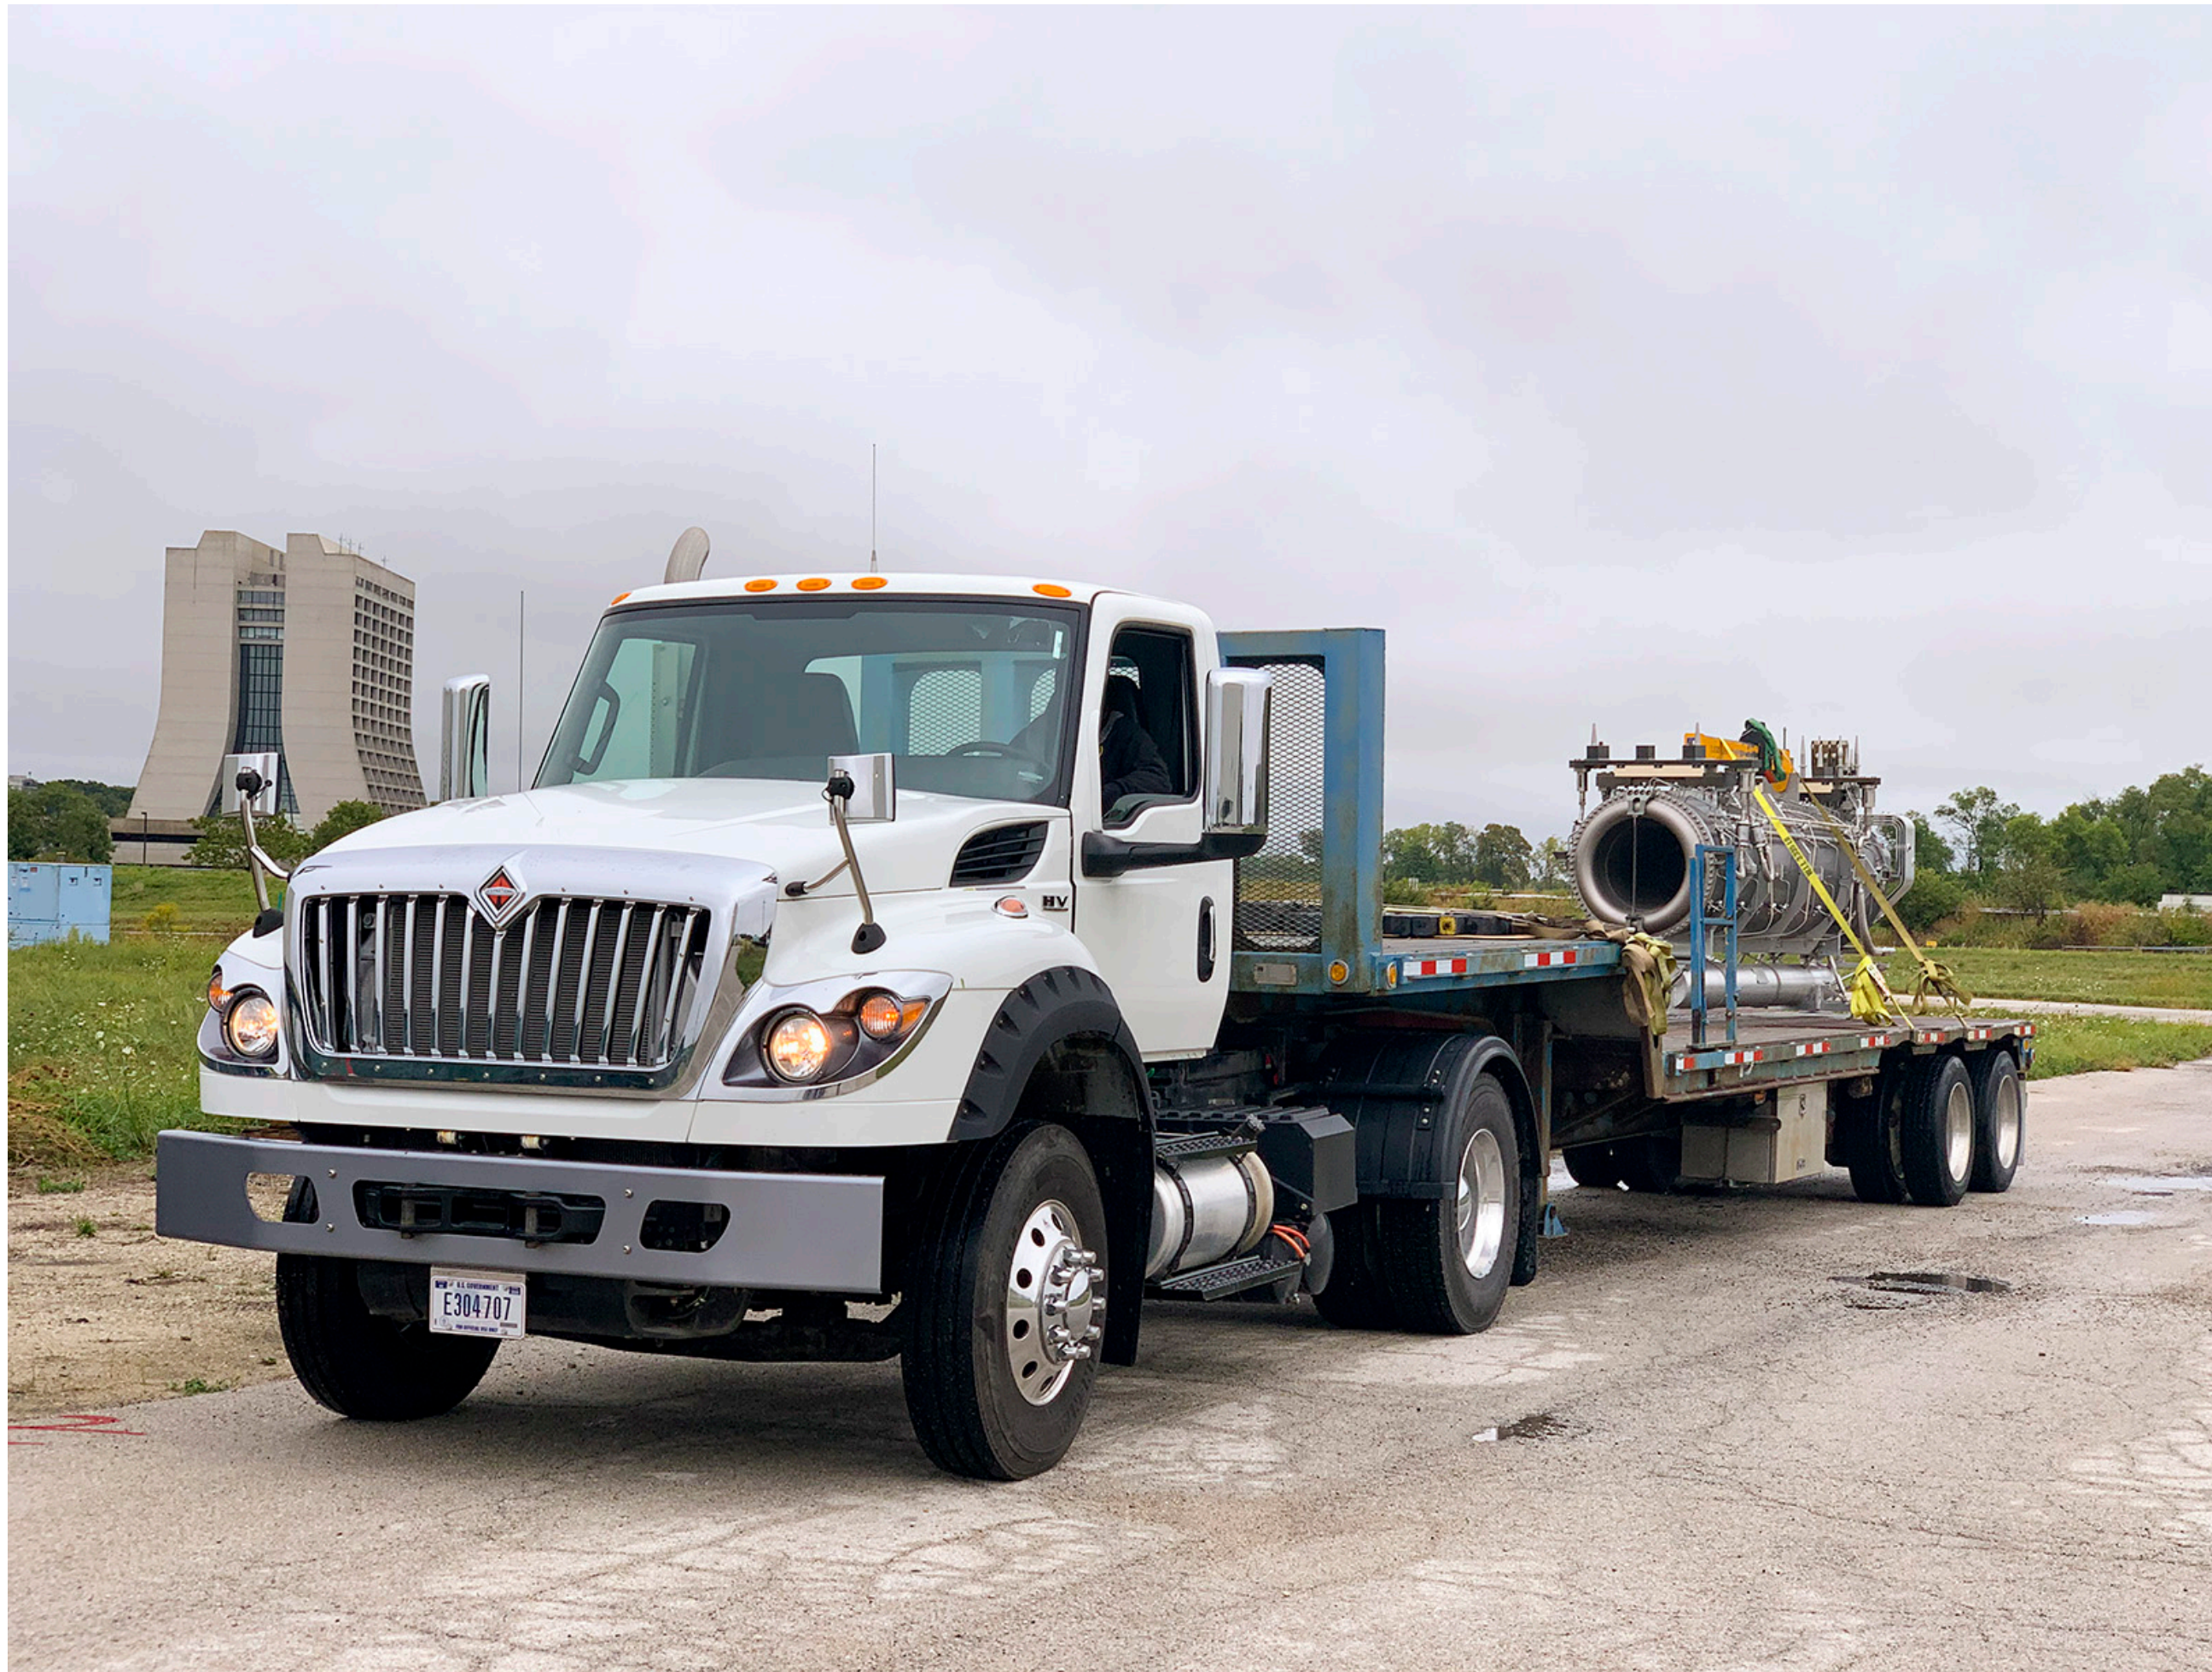
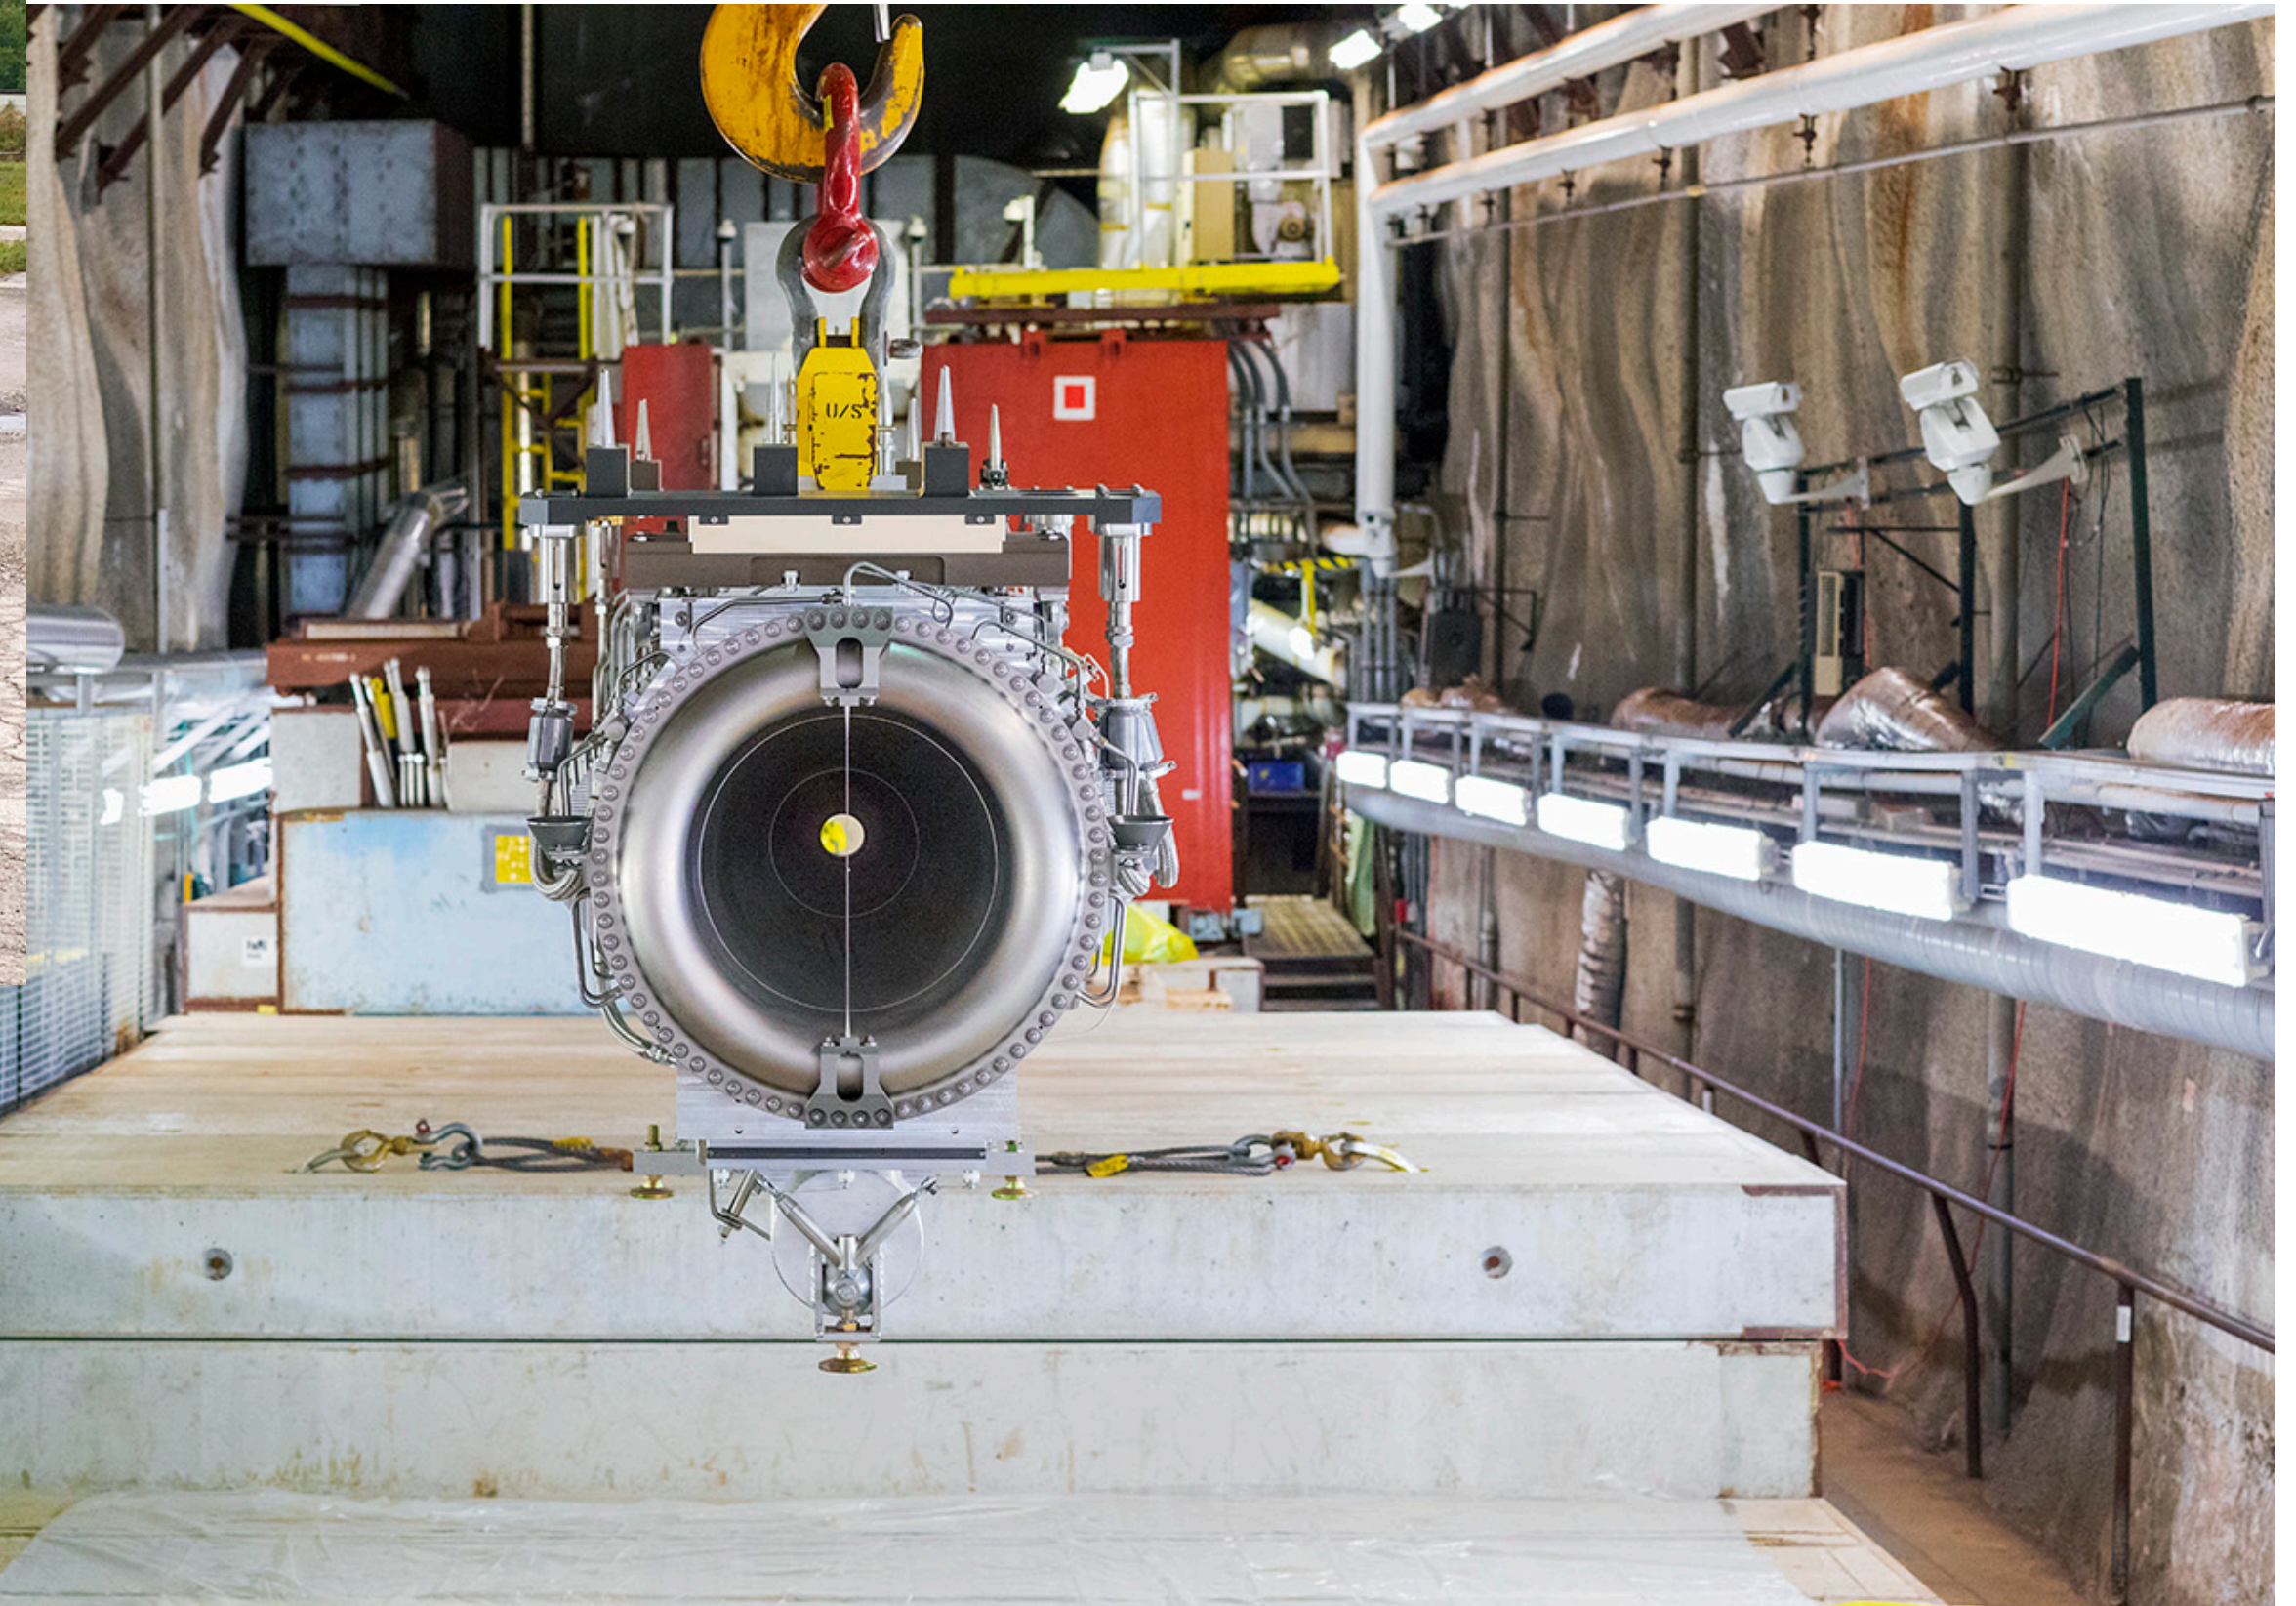
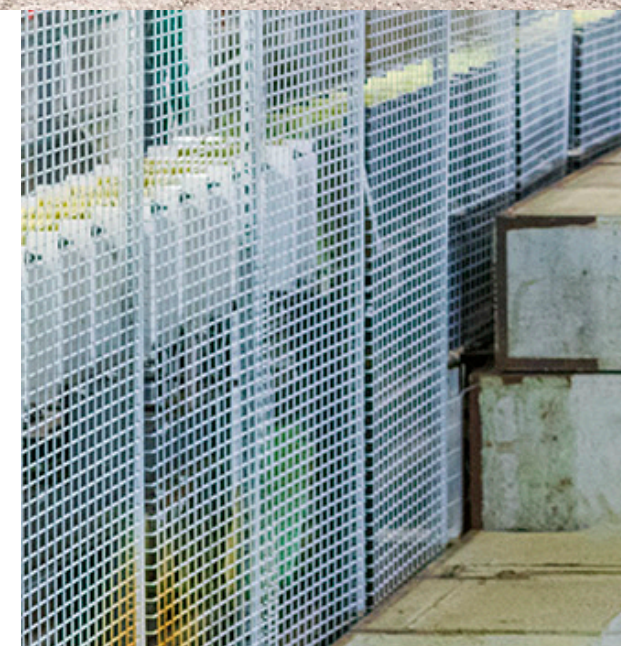
PH2-04 Installation

PH2-04 was identified as the preferred replacement H2. PH2-02 was prepared and installed in the chase on 10 September.

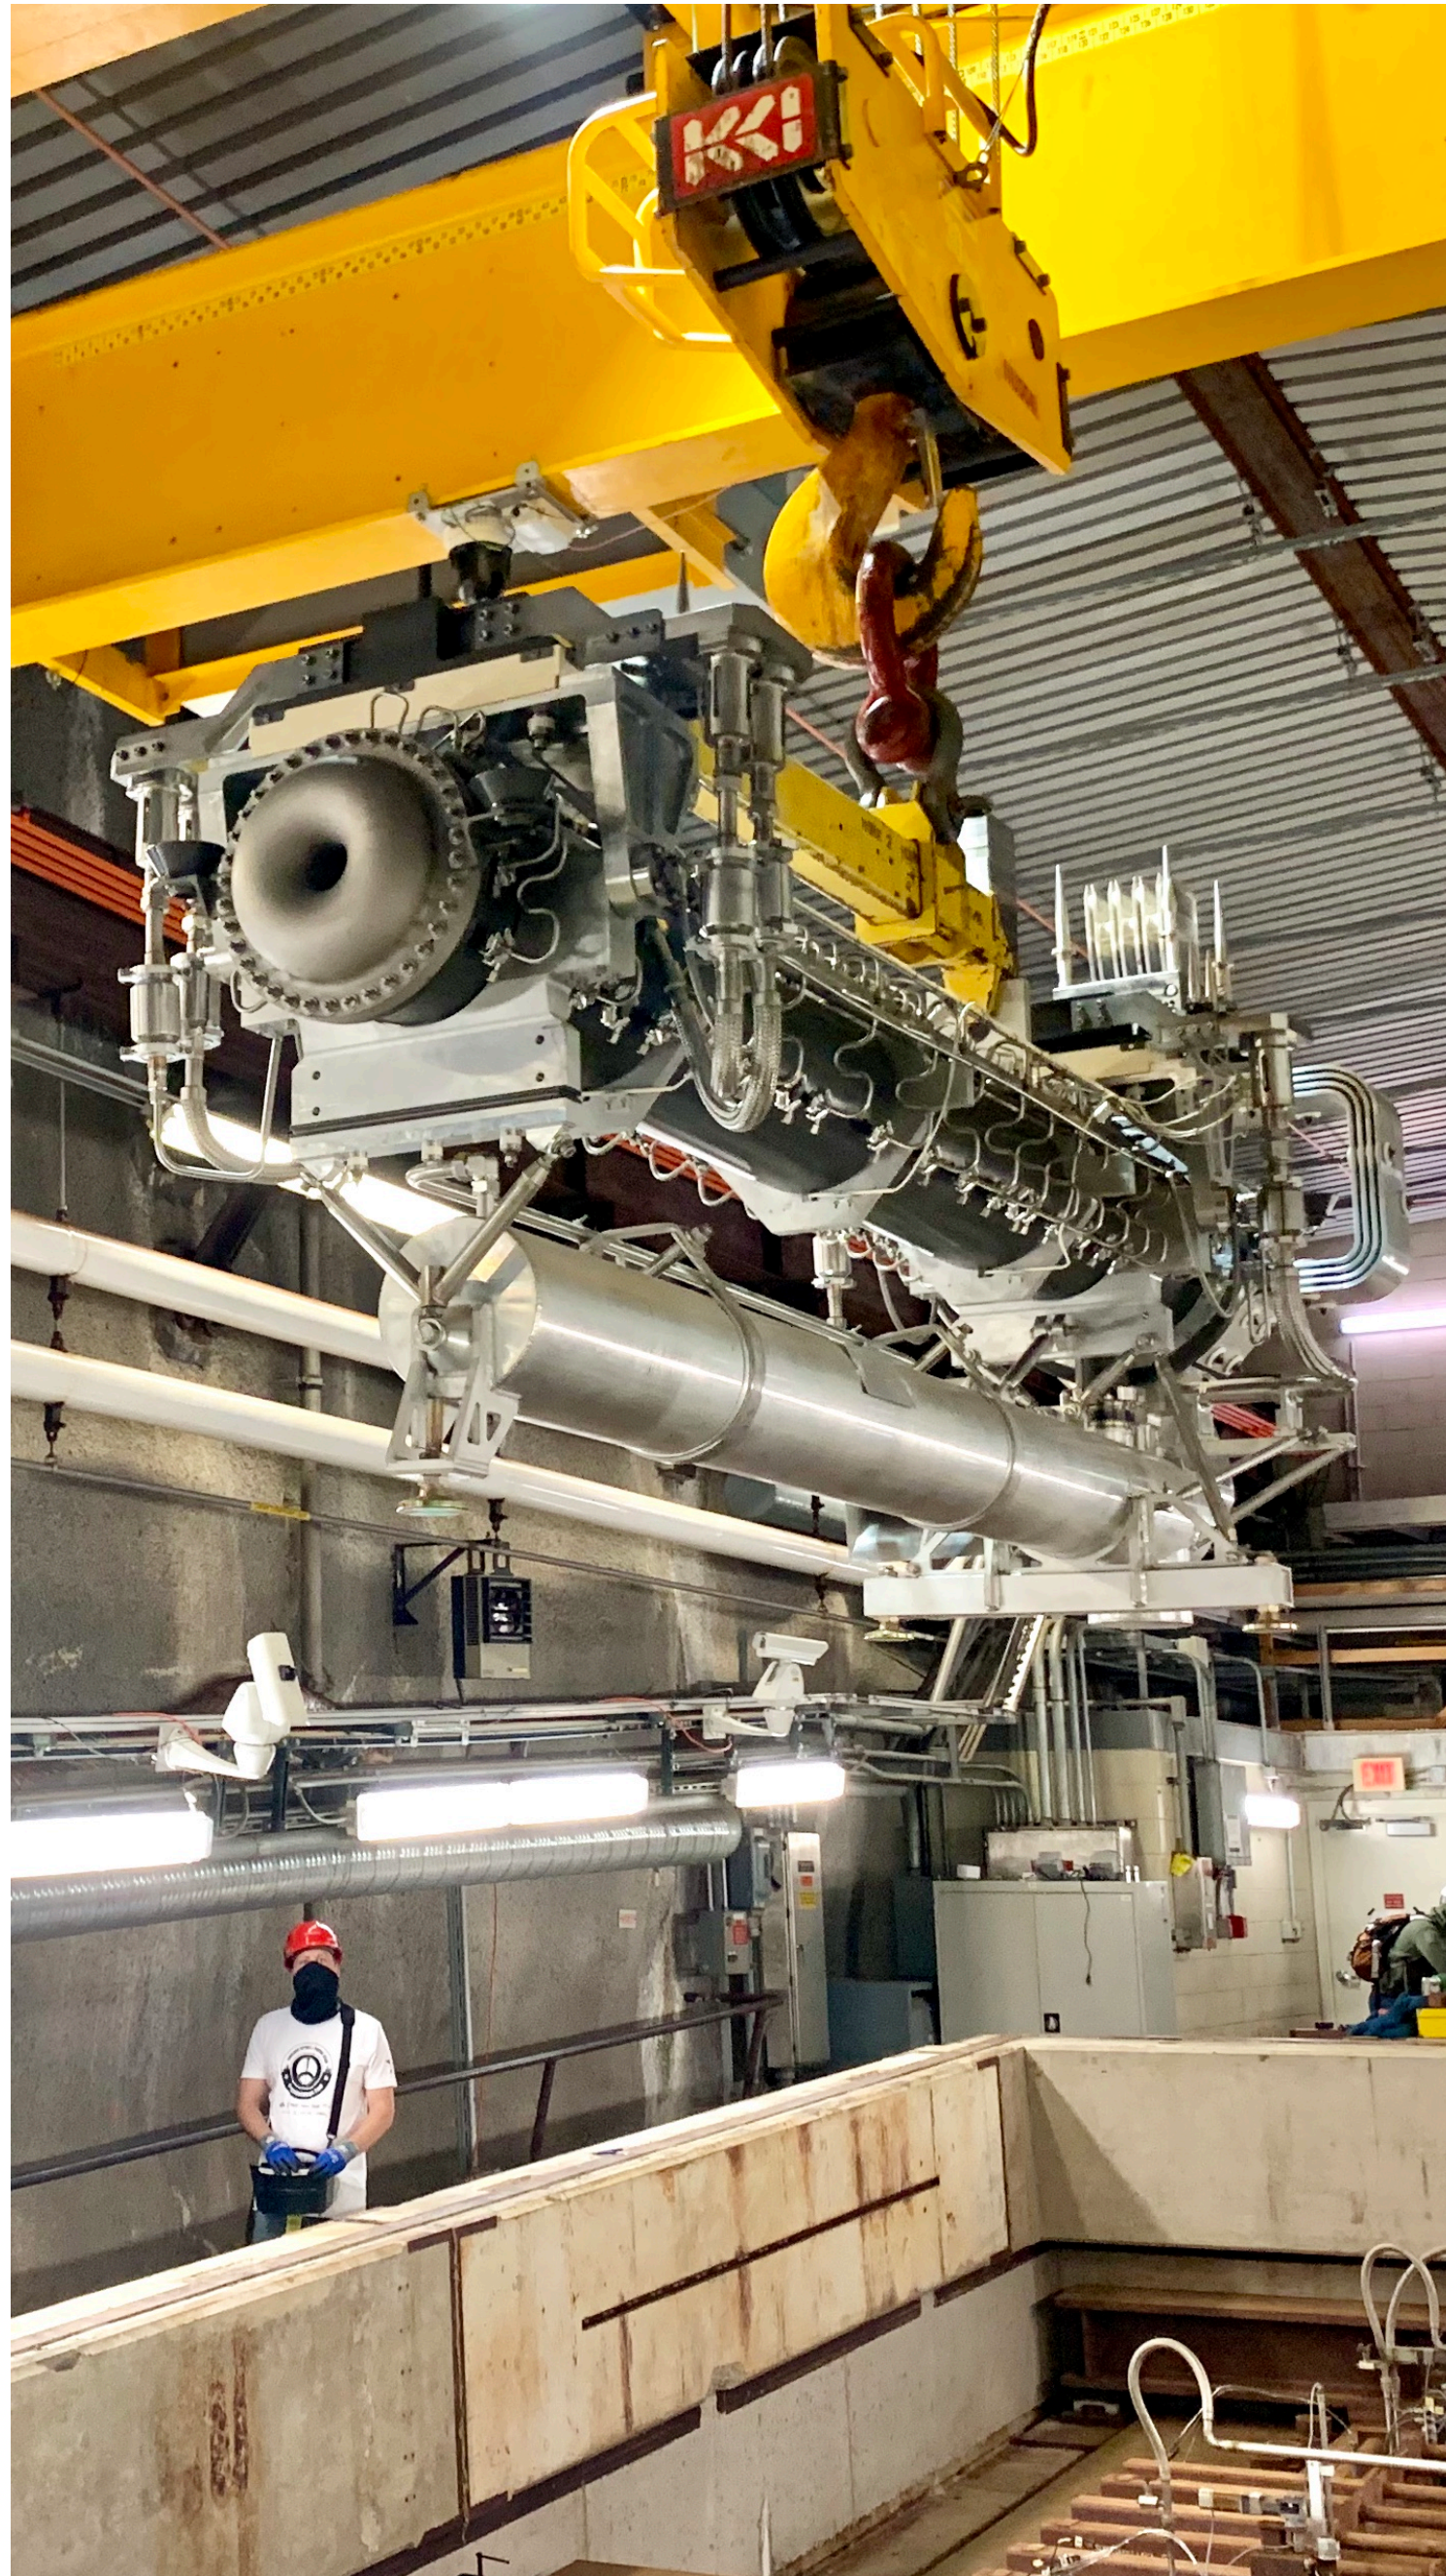
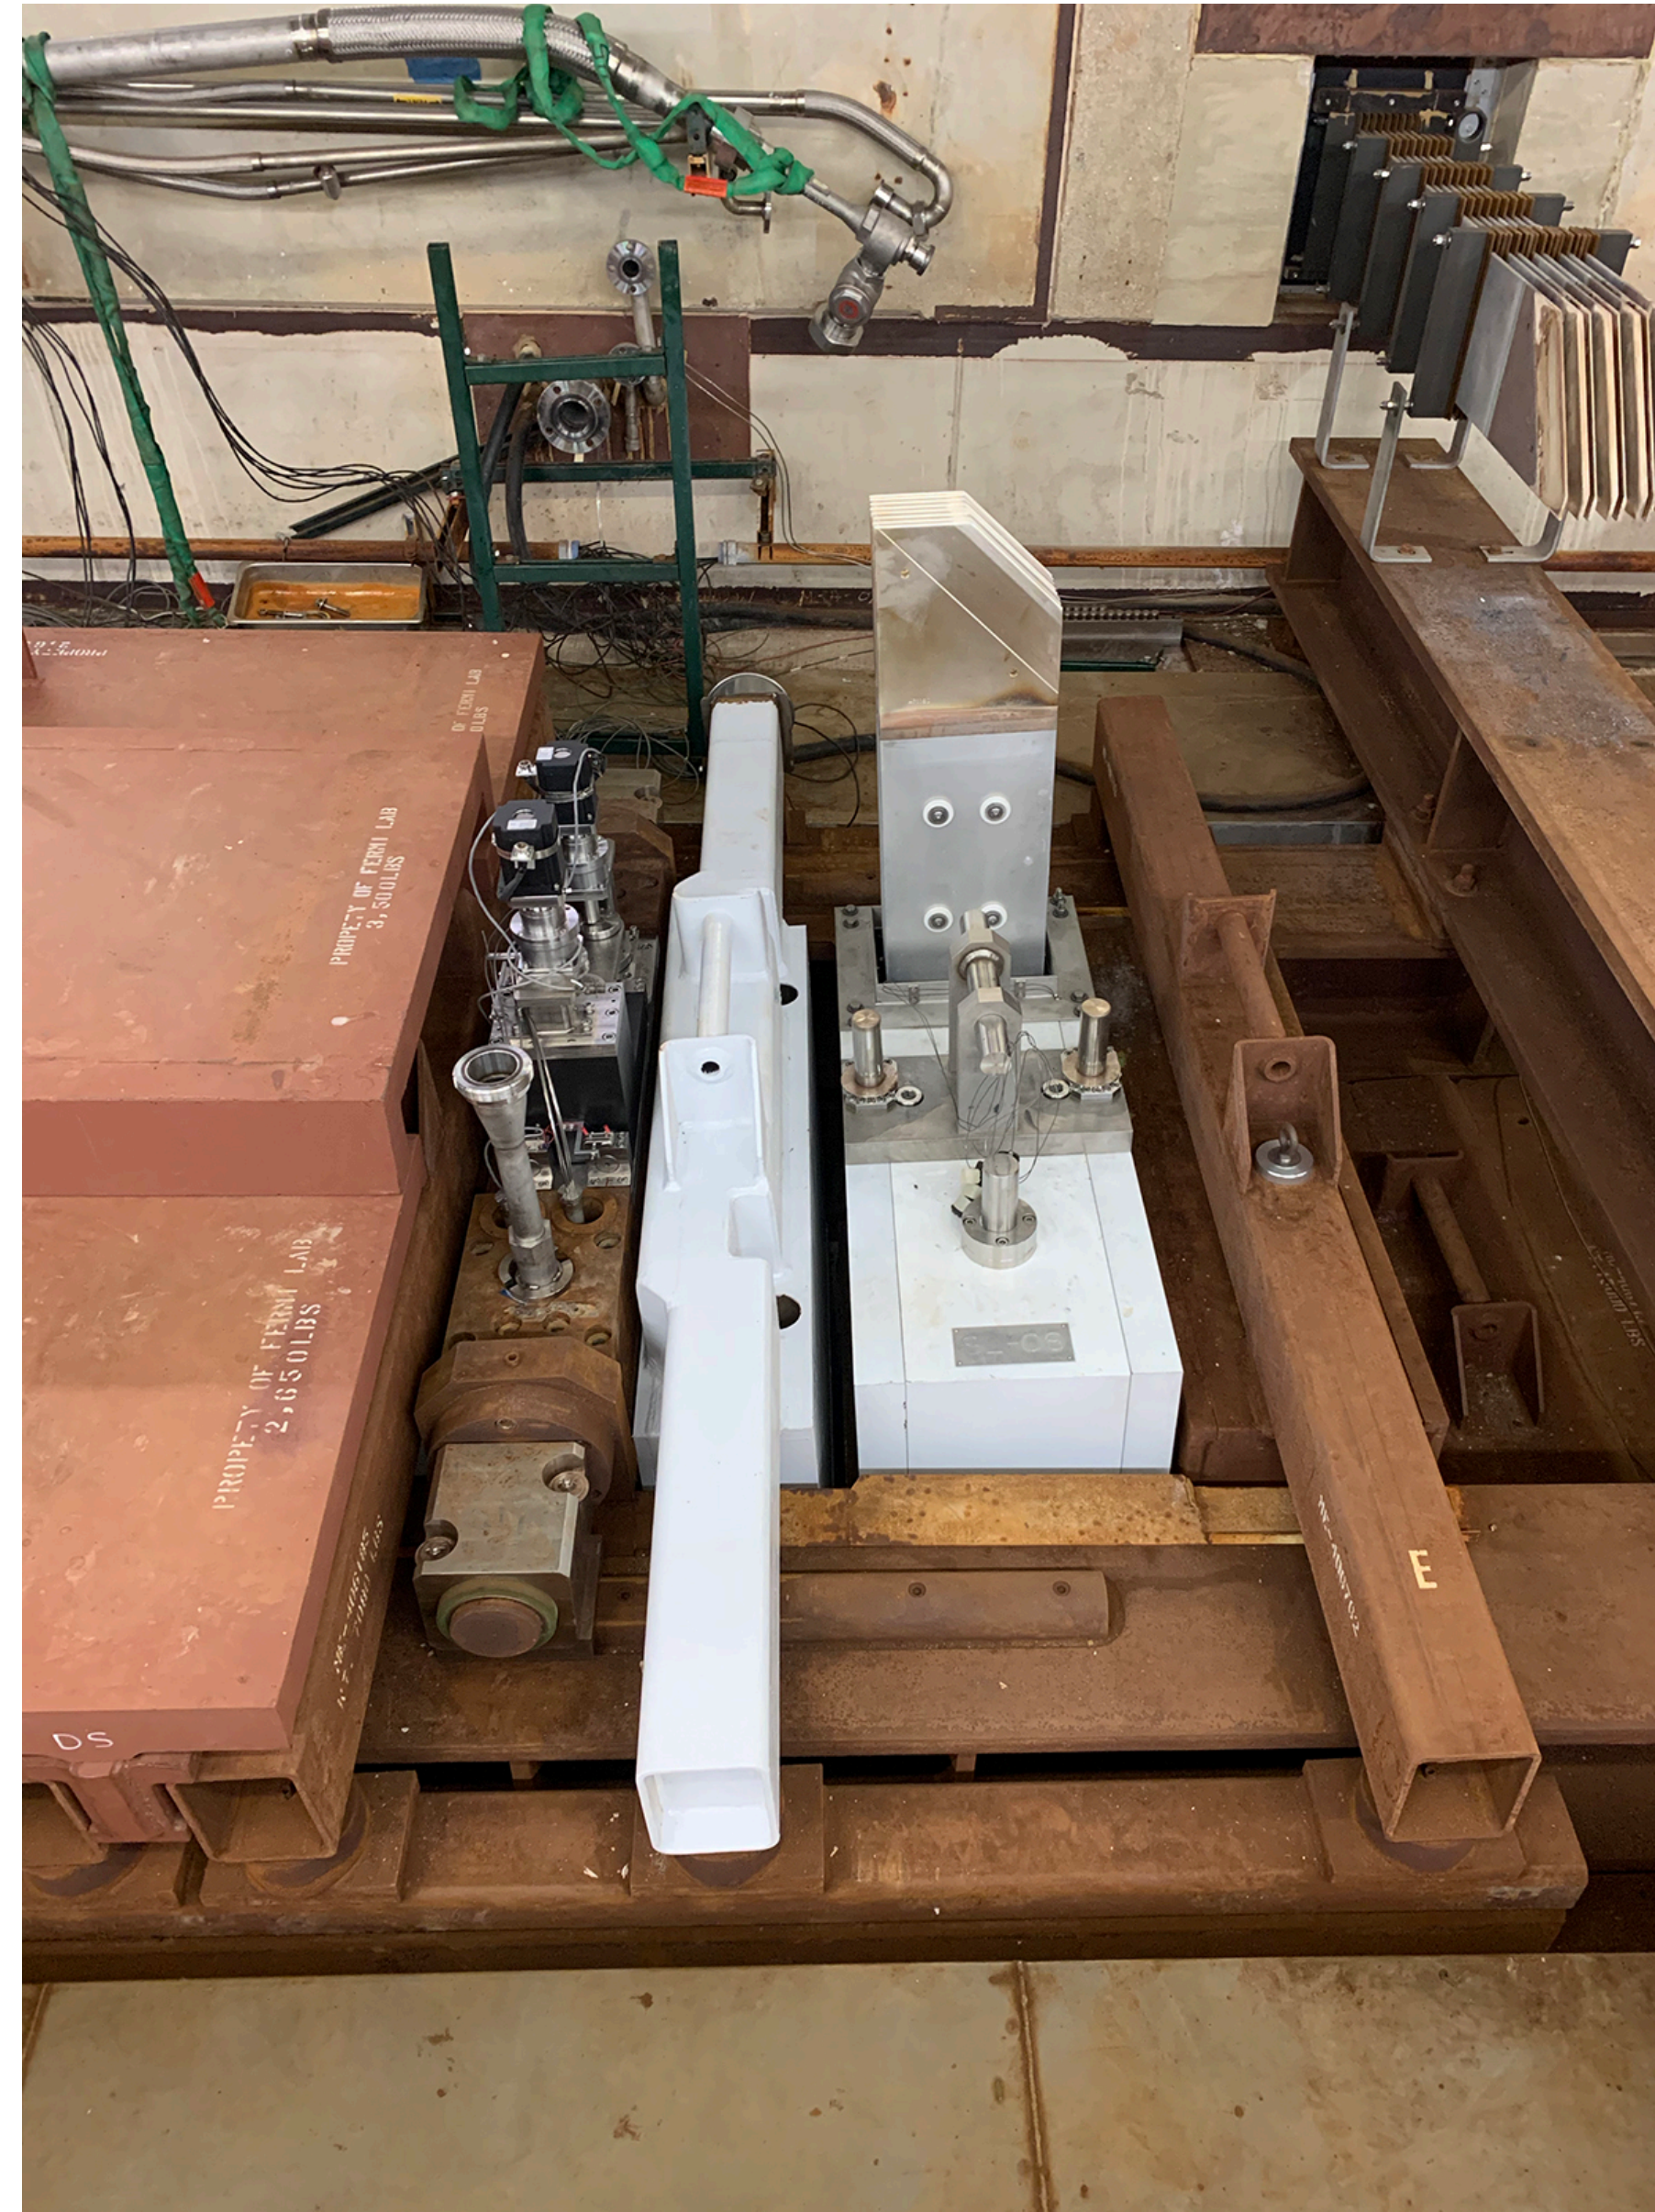
PH1-05 Installation

In order to get the air cooling to the horn strip-line flag a new T-block was fabricated and installed.

Pictured are PH1-05 (far left) and T-block and strip-line block.

Installation complete by 20 November.

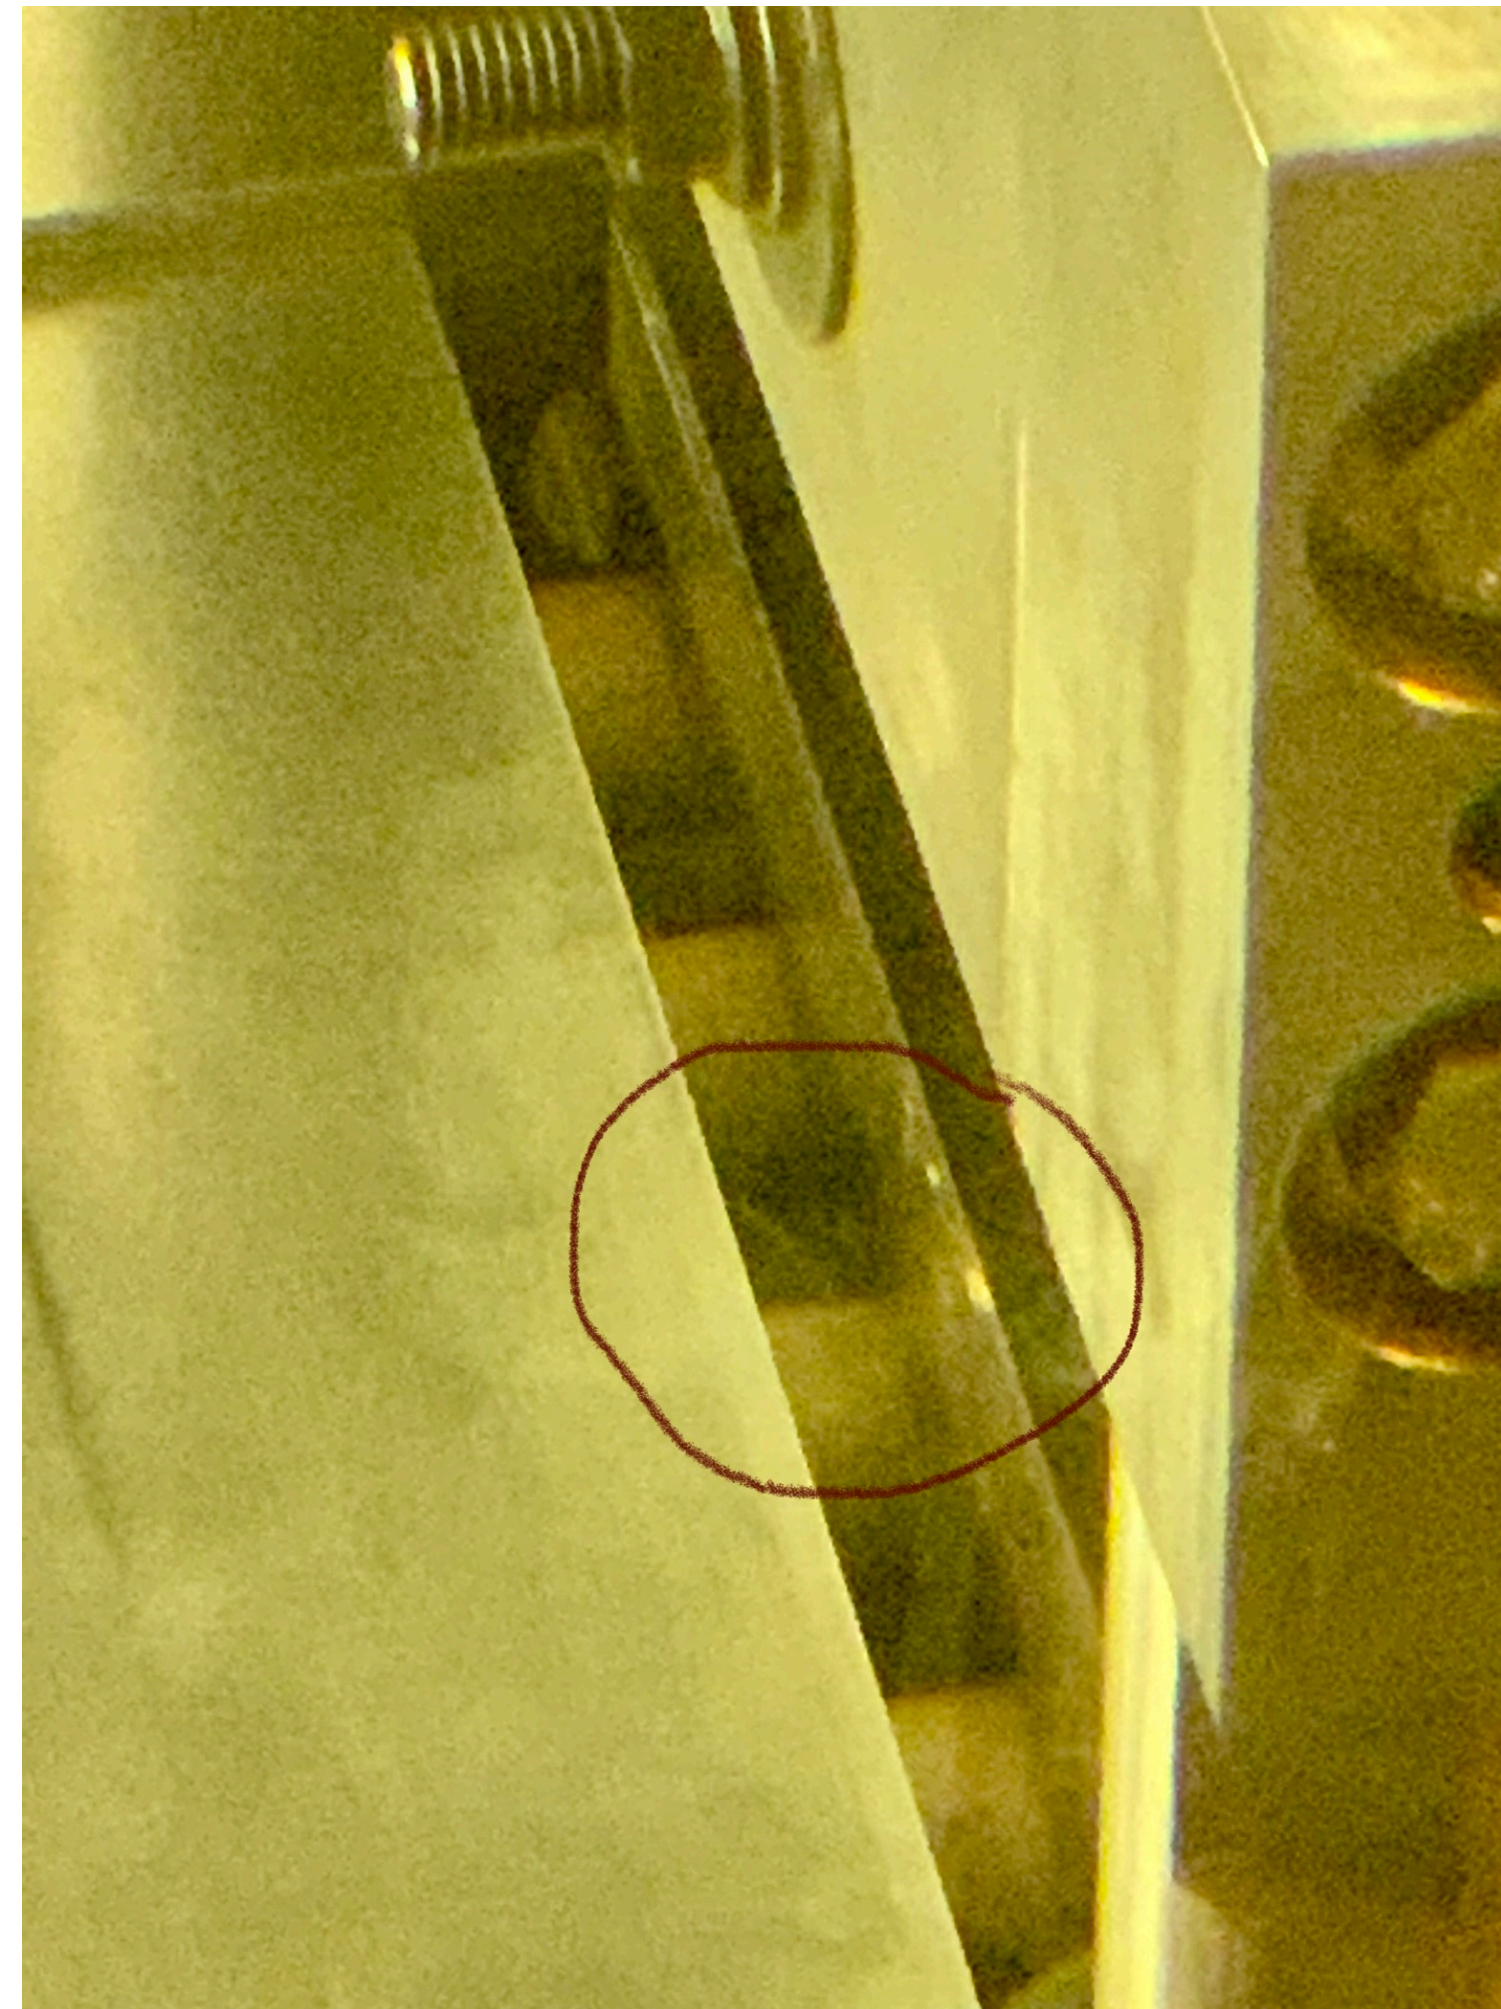
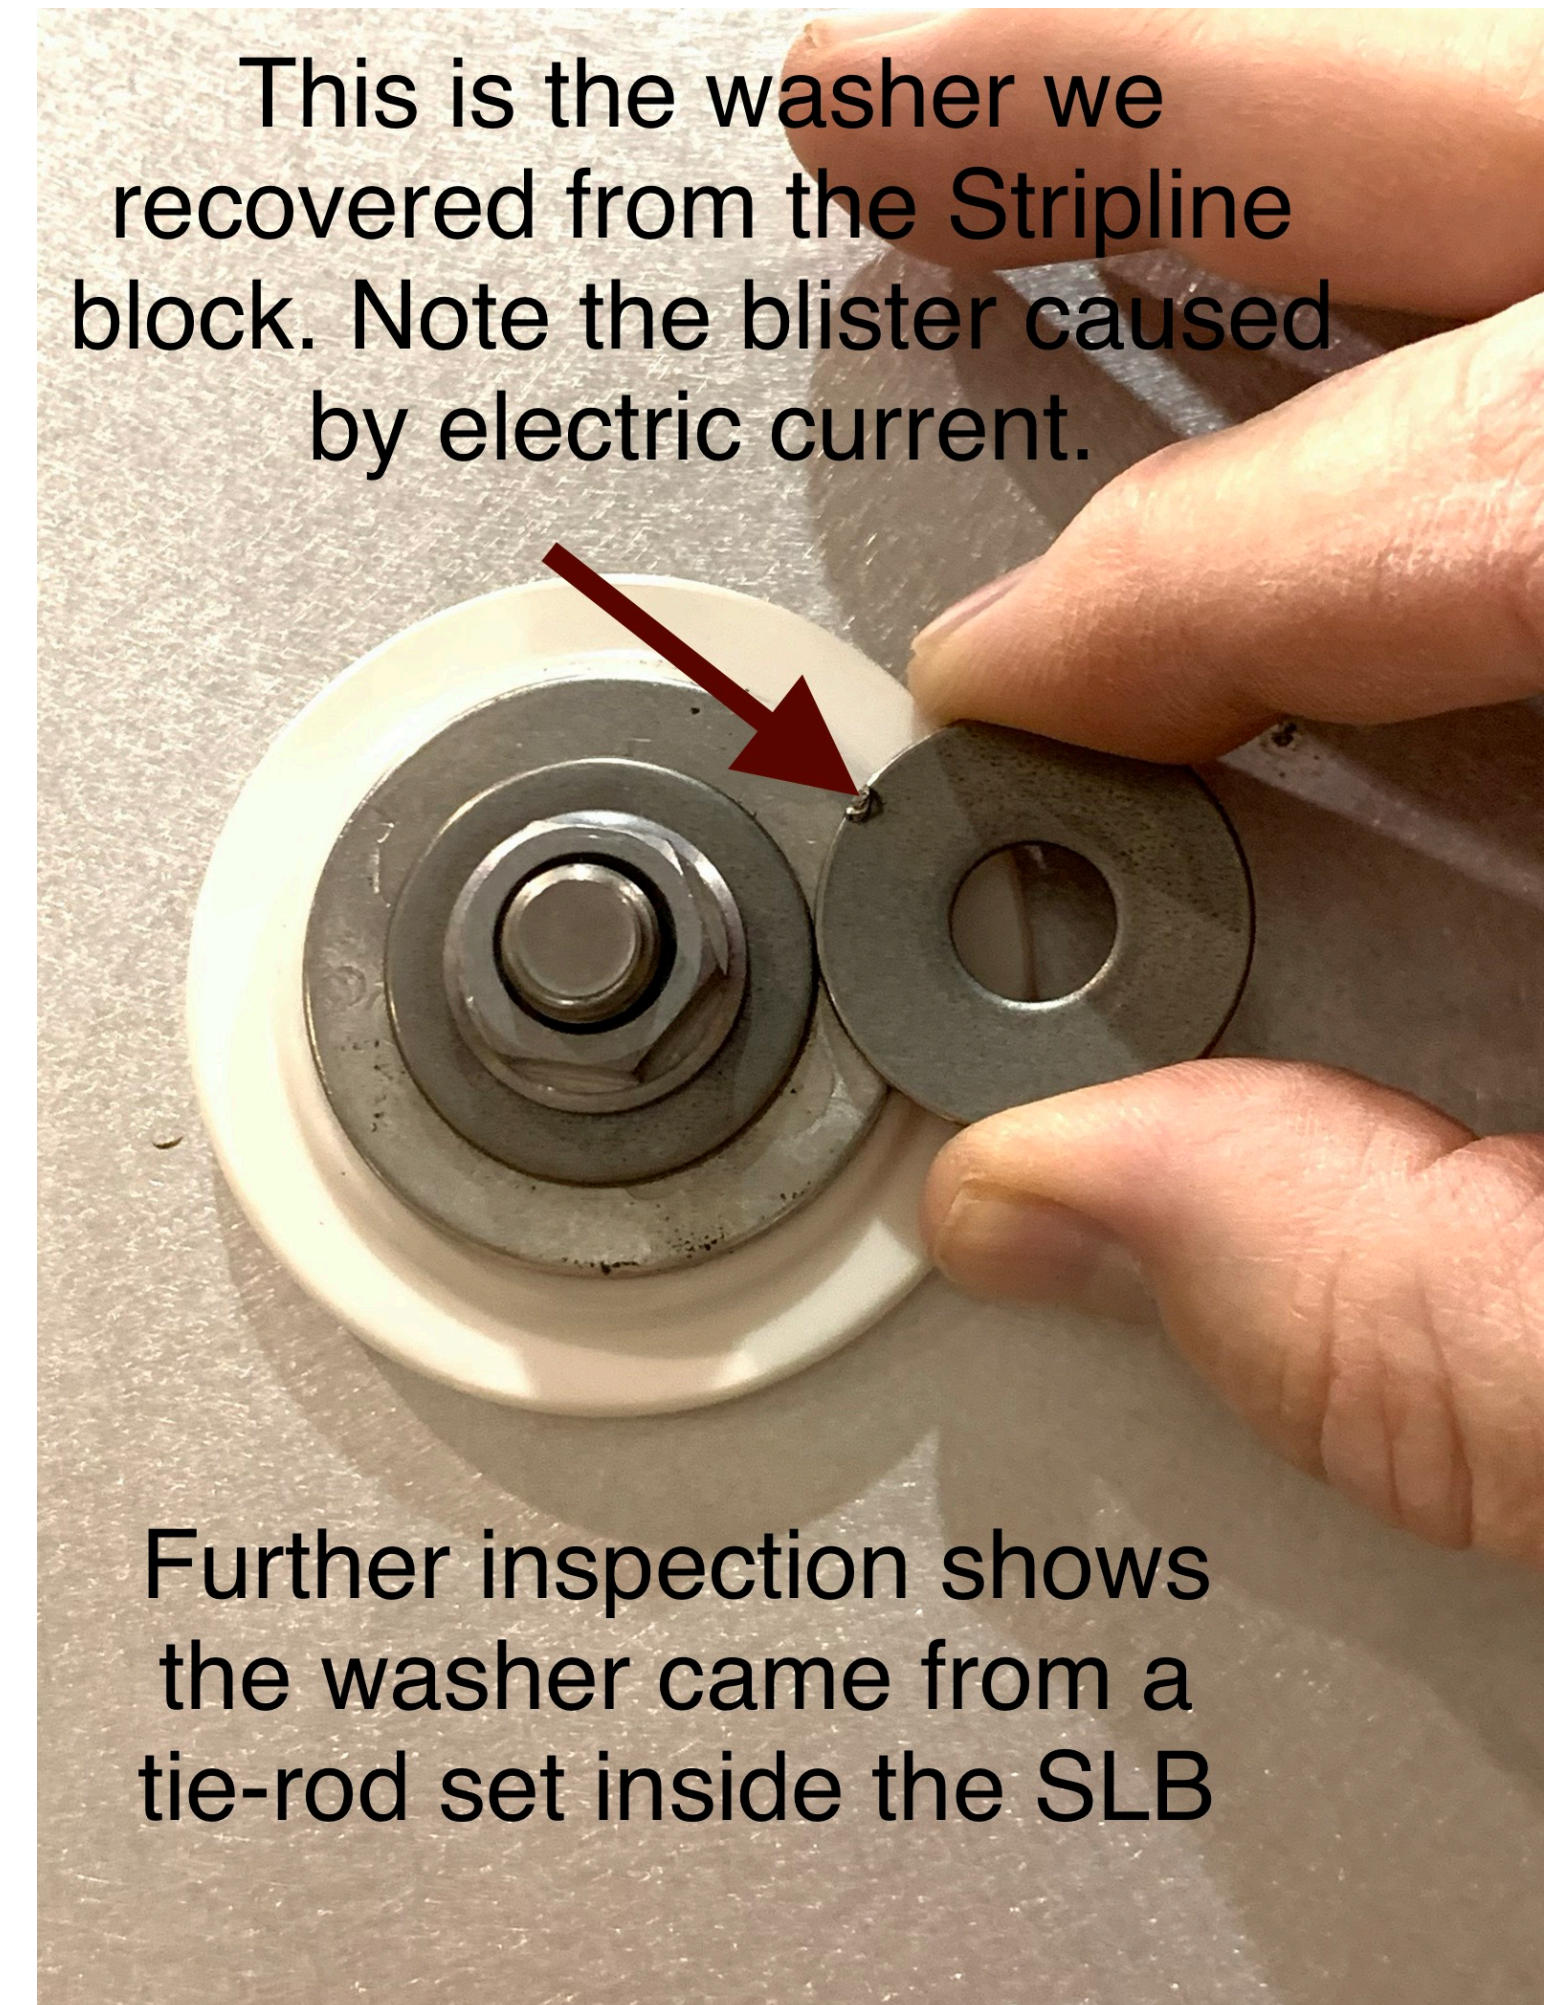
- Successful power-on access for thermal imaging.
- Horn scans & subsequent move complete before TG holiday.
- Horn PS tripped during pulsing exercise.
- Thorough investigation with AD EE-support and TSD departments pointed to the newly installed Strip-line block.
- A bolt assembly worked loose internally and a washer faulted to ground between the strip-line and the block.
- New SLB installed and another round of horn-scans/alignment were done. Target installation followed and **HEP beam was started by 12 December.**

This is the washer we recovered from the Stripline block. Note the blister caused by electric current.

Further inspection shows the washer came from a tie-rod set inside the SLB
