NuMI Shutdown Summary

PMG Meeting

Conditions & Plan for 2020 Shutdown

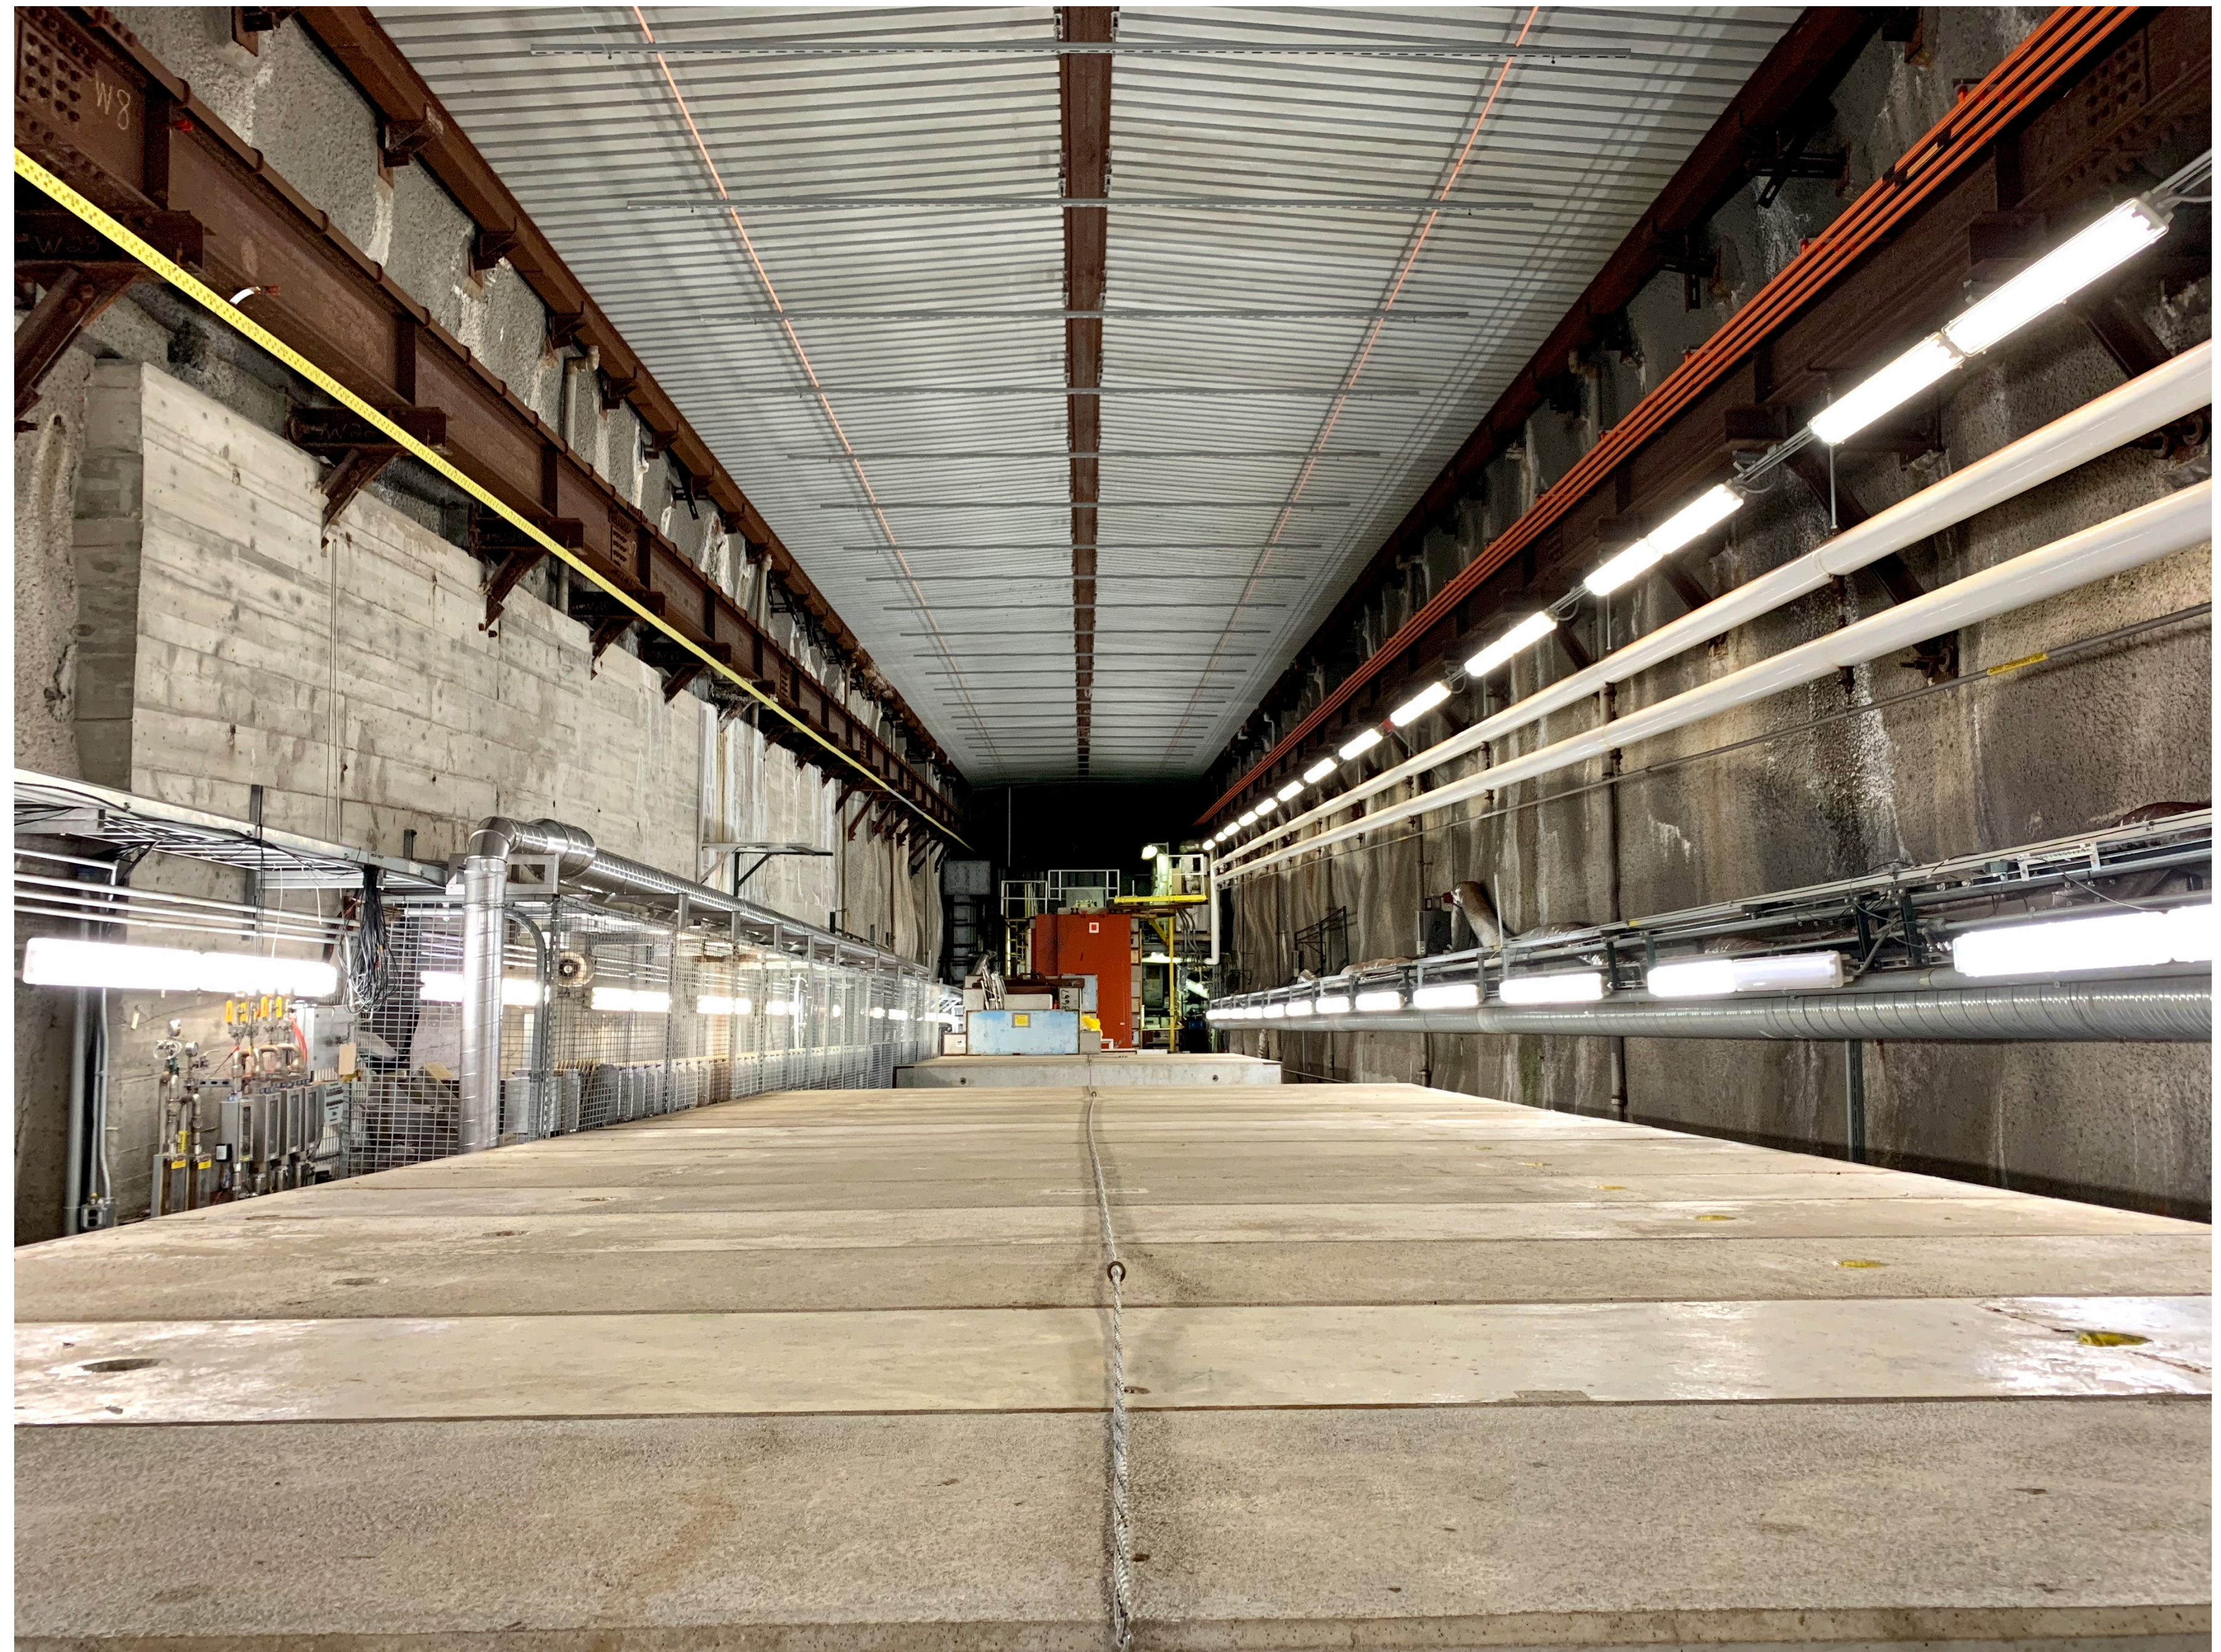
Looking down
stream inside
the beam-ready
NuMI Target Hall
on 12 December
