# Preparing for 50L test-II

16-18 December 2020

MO\_1140

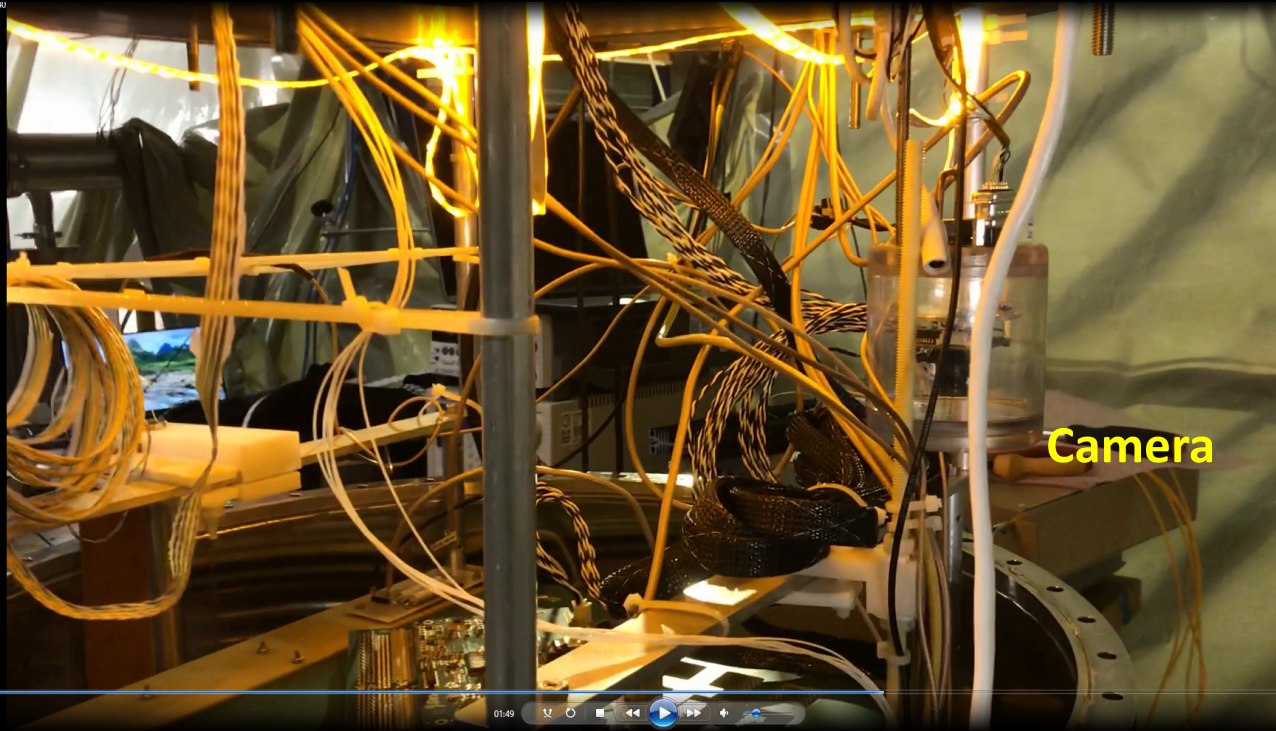
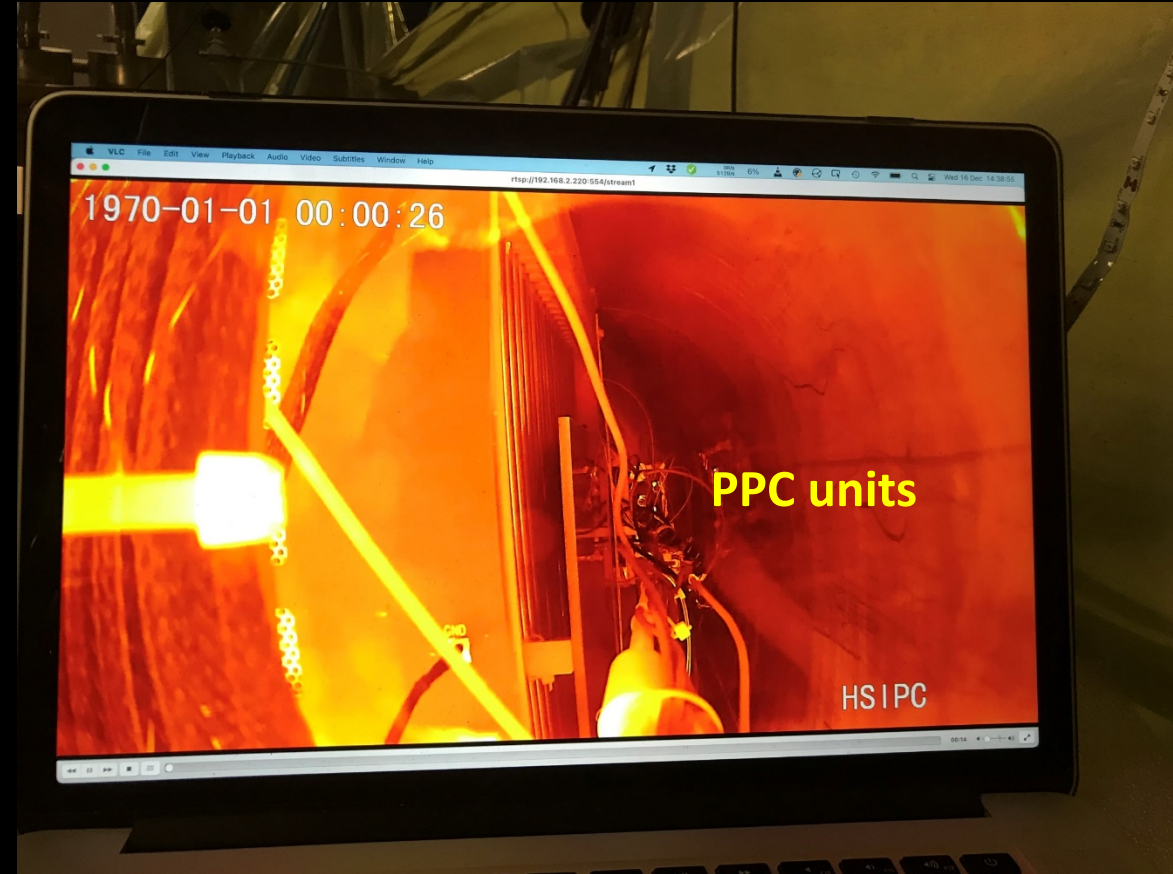
- UV-like LED strips replaced with yellow-LED strips
- Camera inserted inside the cryostat looking down to PPC units

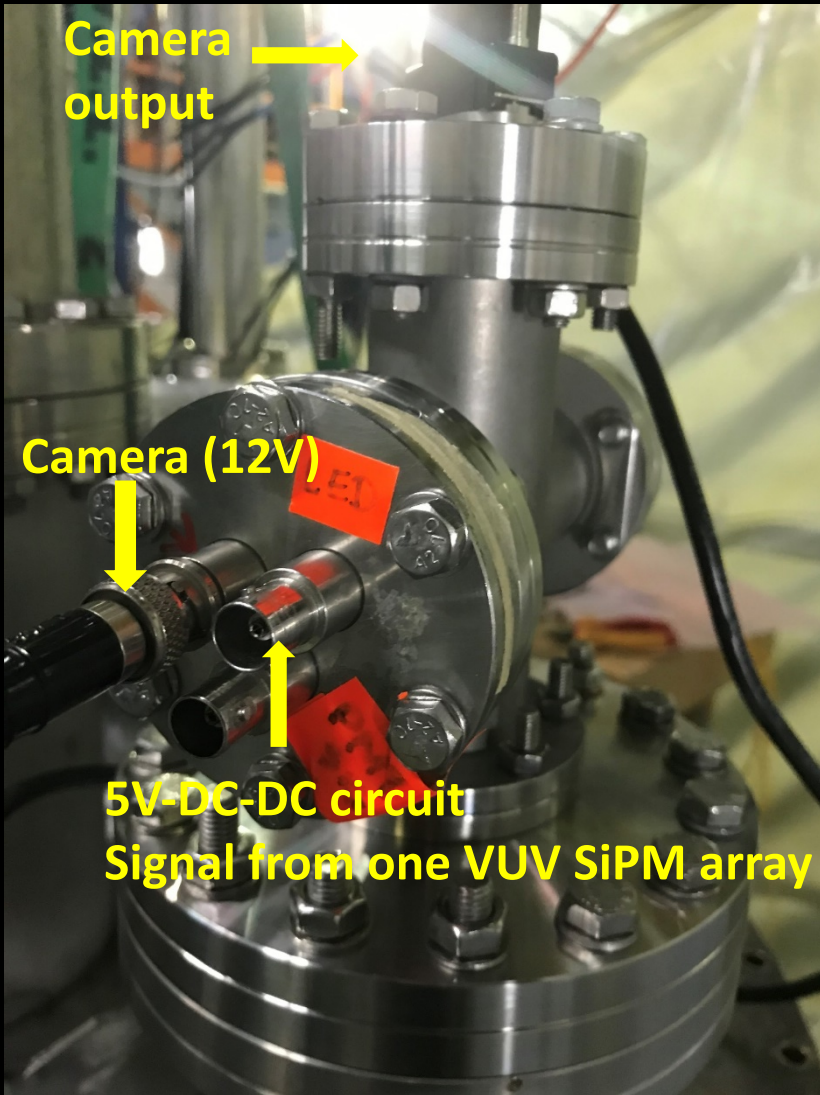
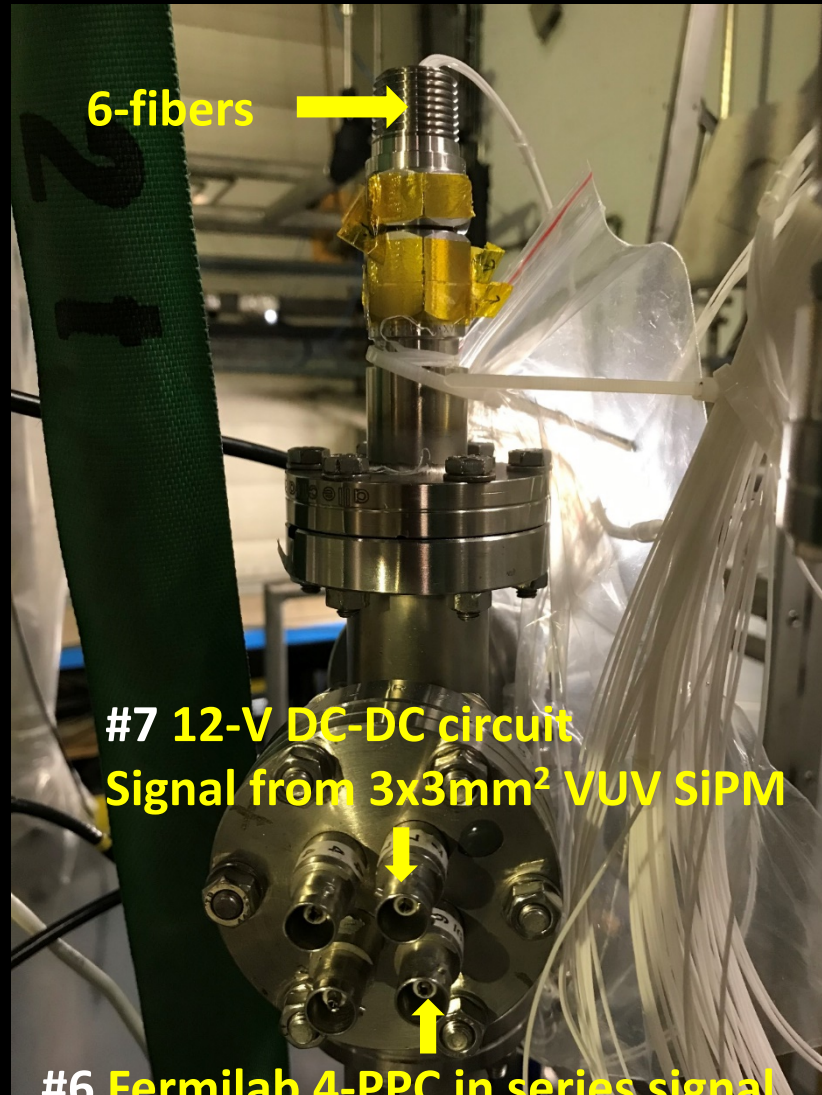
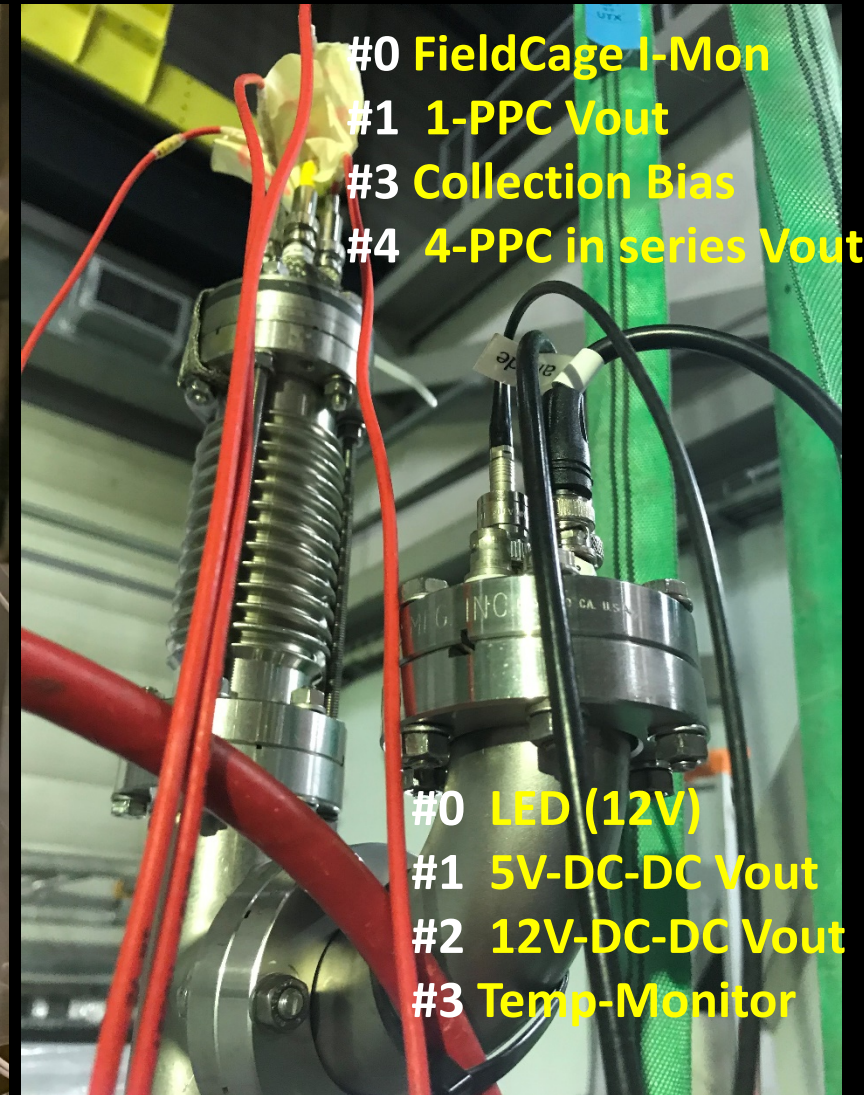
# Flanges:

- Found leaks on two flanges: fixed!
- Vacuum restarted at 13:00

- Leak test with He-Leak detectors
- All feedthroughs tight and no leaks
- Cabling done
- Electrical connection checks done

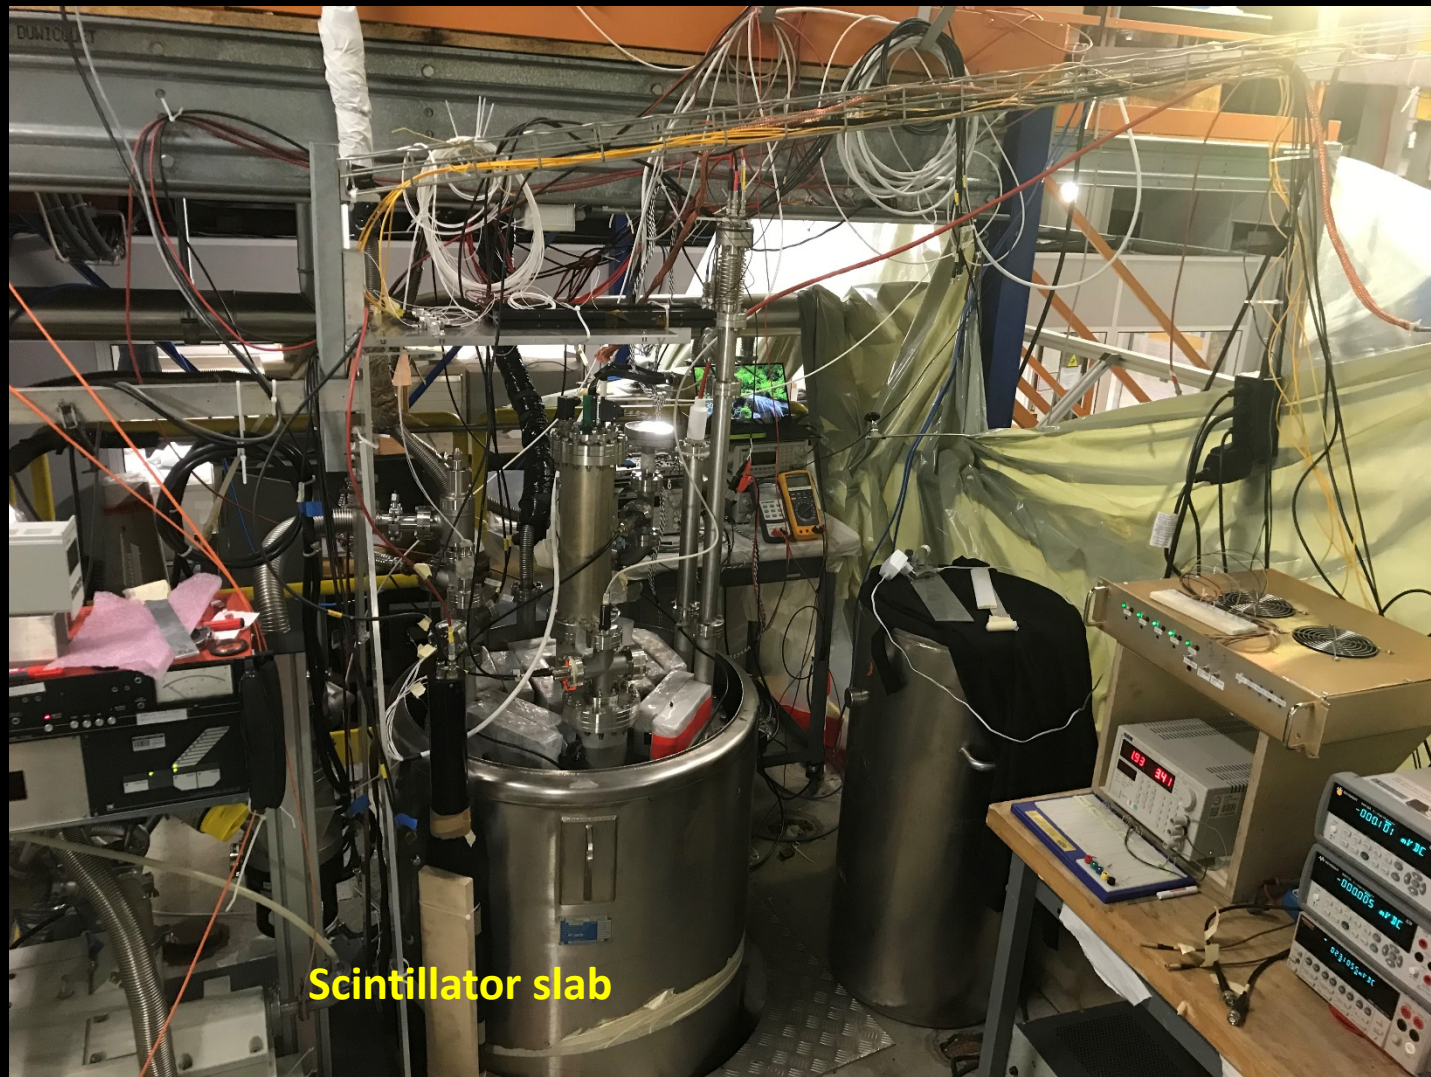
Scintillator slab

- **Detector is ready for liquid argon test**
- **We have placed couple of Raspberry-pi cameras around the detector**
- **We set-up a PC with labview to acquire voltage output data from PPC's and DC-DC converters**
- **Two scintillator slabs set for triggers (left and right side of the cryostat, inclined muons)**
- **TPC electronics checked for the noise, everything looks fine**
- **Temperature and pressure sensors are in place**
- **We keep vacuum running during the weekend**
- **Start argon filling on Sunday or Monday morning**

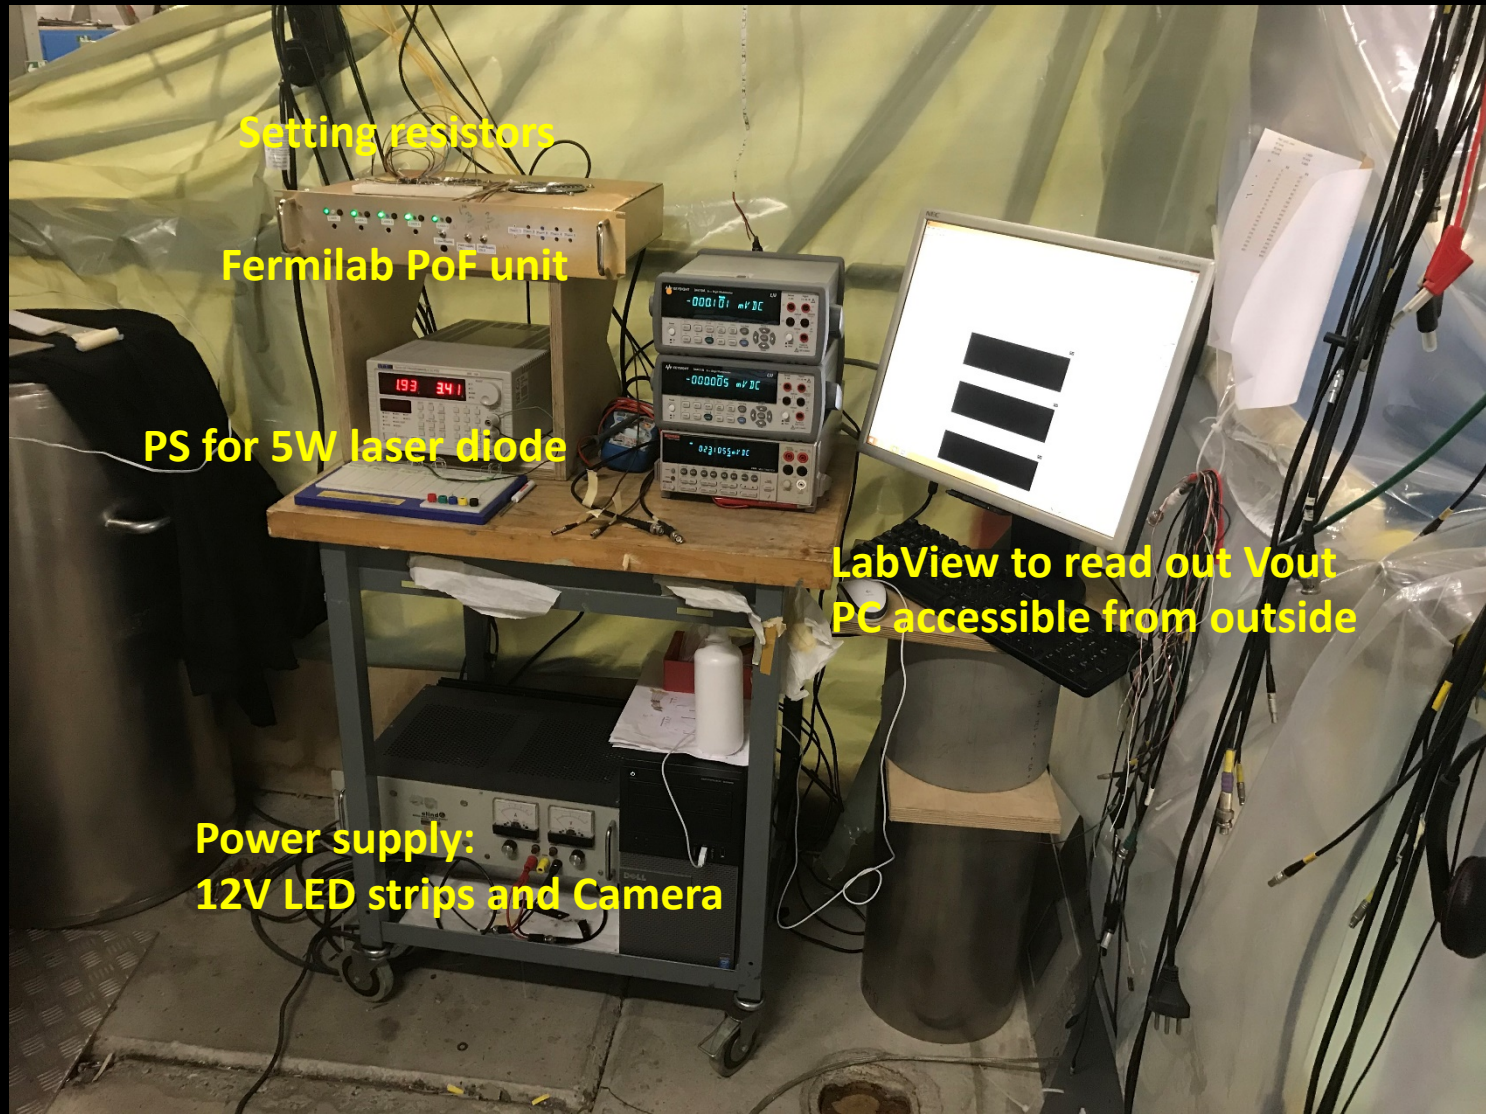
Setting resistors

Fermilab PoF unit

PS for 5W laser diode

LabView to read out  $V_{out}$   
PC accessible from outside

Power supply:  
12V LED strips and Camera
