Power over fiber in 50L cryostat

21-22 December 2020

U. Kose, F. Pietropaolo, P. Sala, S. Tufanli

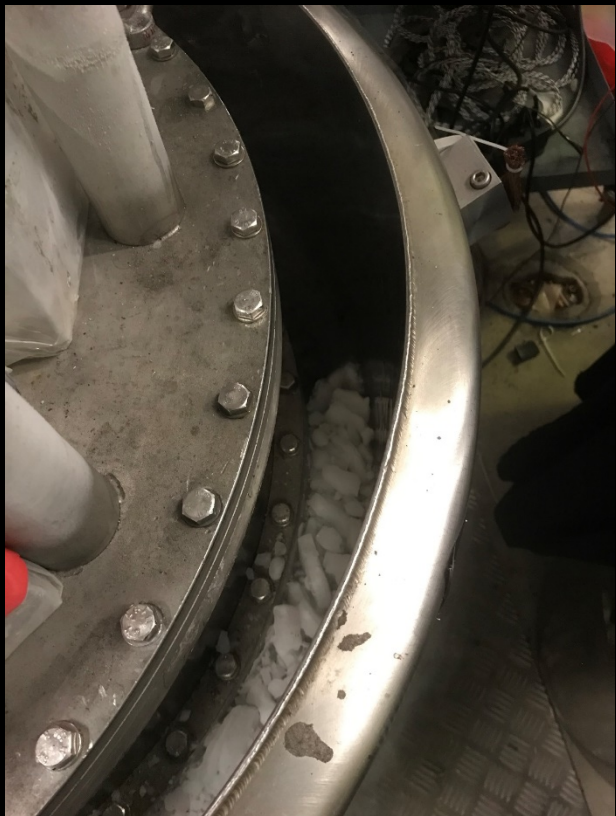
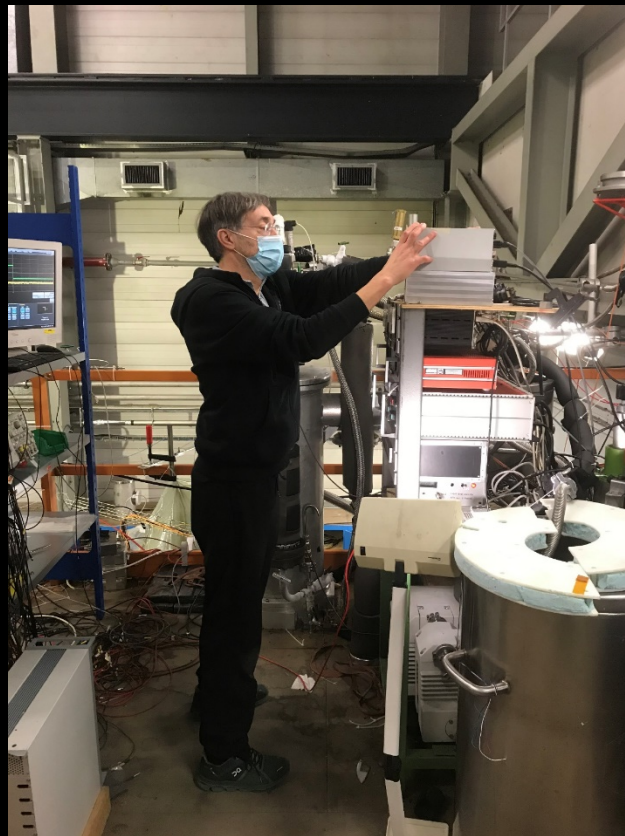
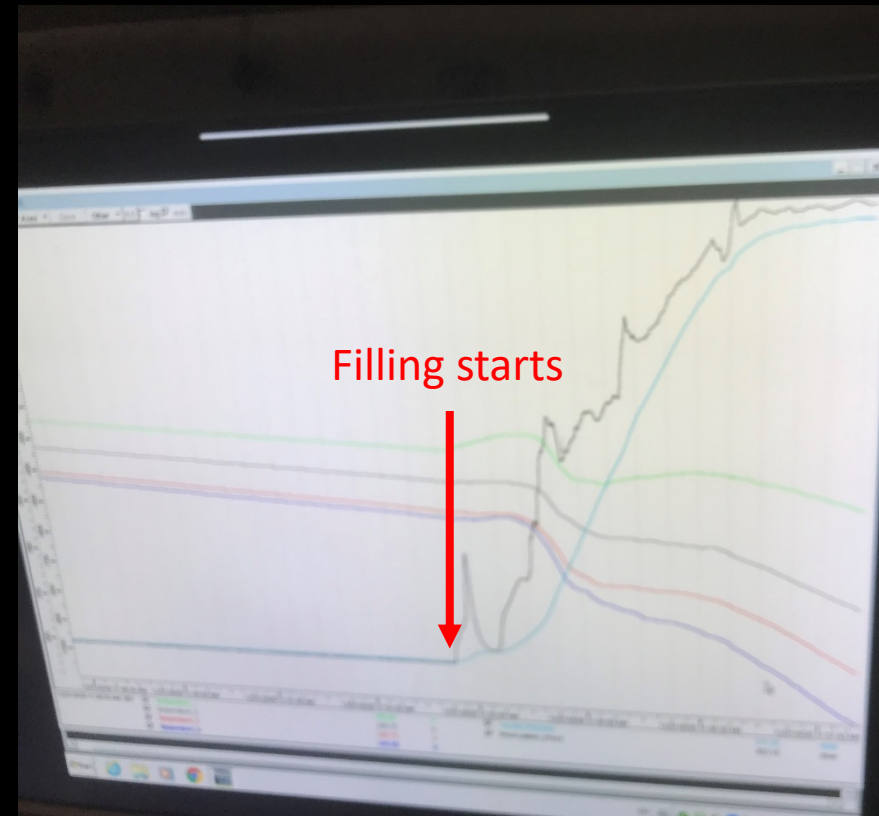
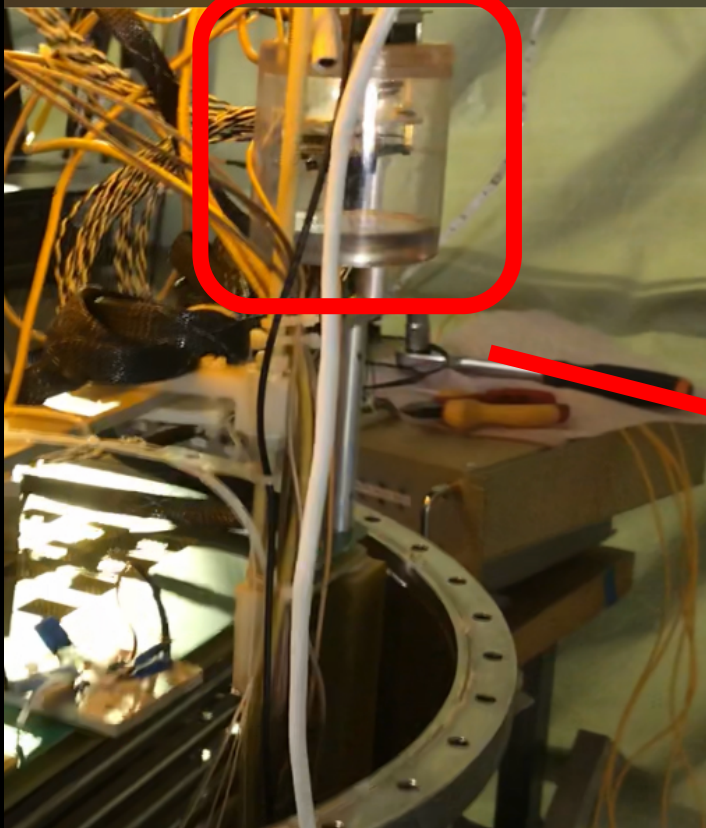
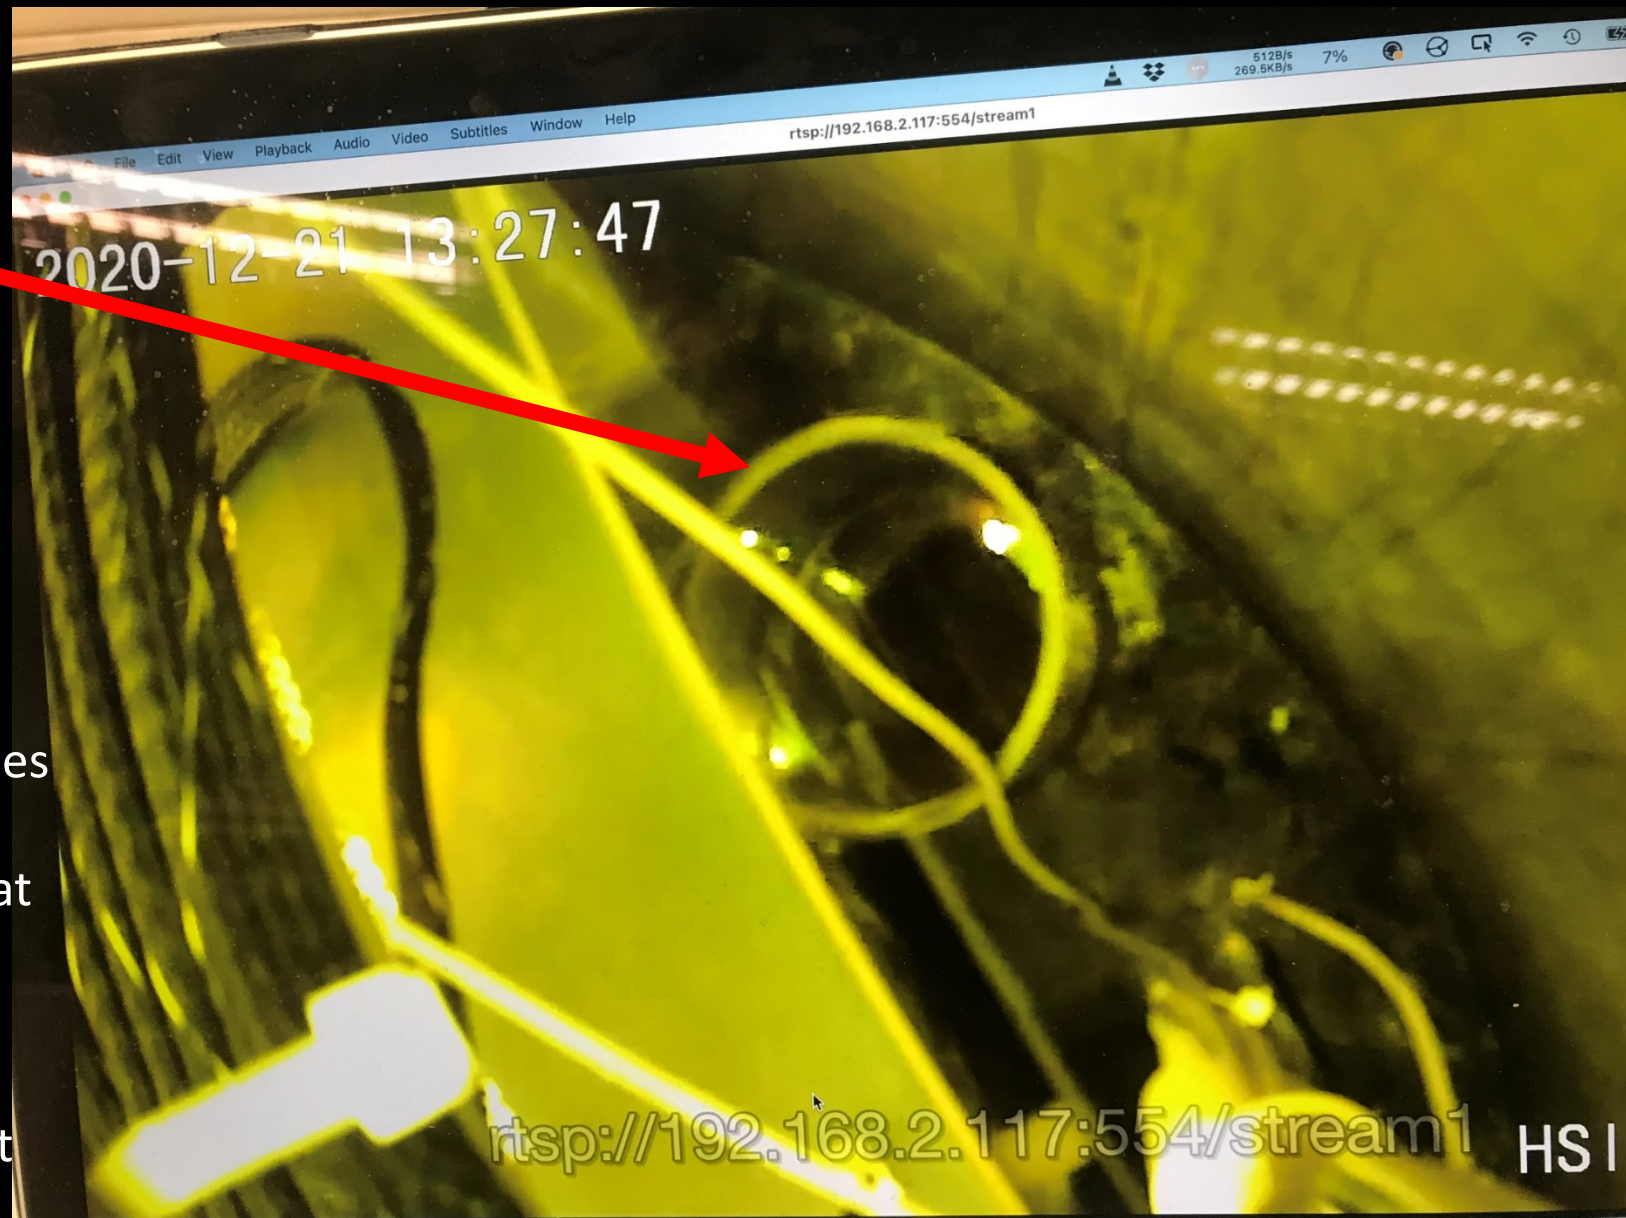
Cooling and filling the 50L-cryostat

- During cooling stage, some noise comes from the cryostat as if an object was moving and hitting hard to the cryostat wall.

- We found that plastic cover of the internal camera fell down and stuck at the top part of the field cage.

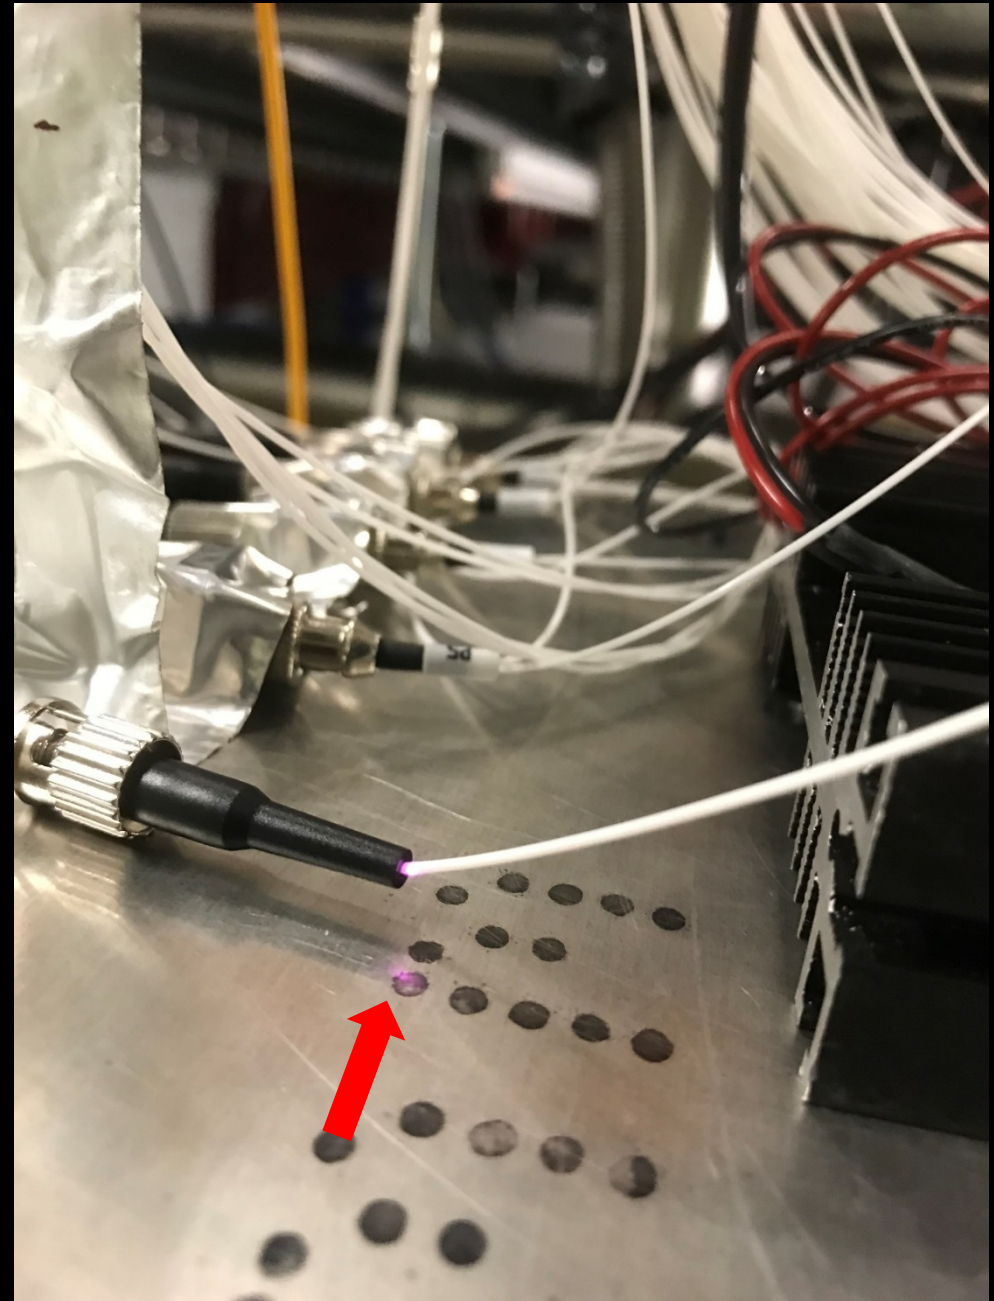
Checking the PoF units 1:

- We found the fiber of the 5W-laser diode got broken! (Friday was working without any problem)
- Replaced with spare one (thanks Xavier and CERN Fireman people)
- This laser diode is used together with 5V-DC-DC circuit. We read out ≥ 48 Volts from feedback cable.
- One VUV type SiPM array is used in SiPM board. We could not get any signals from the SiPM. We found that the signal cable malfunctioned (to be investigated once we open the dewar).

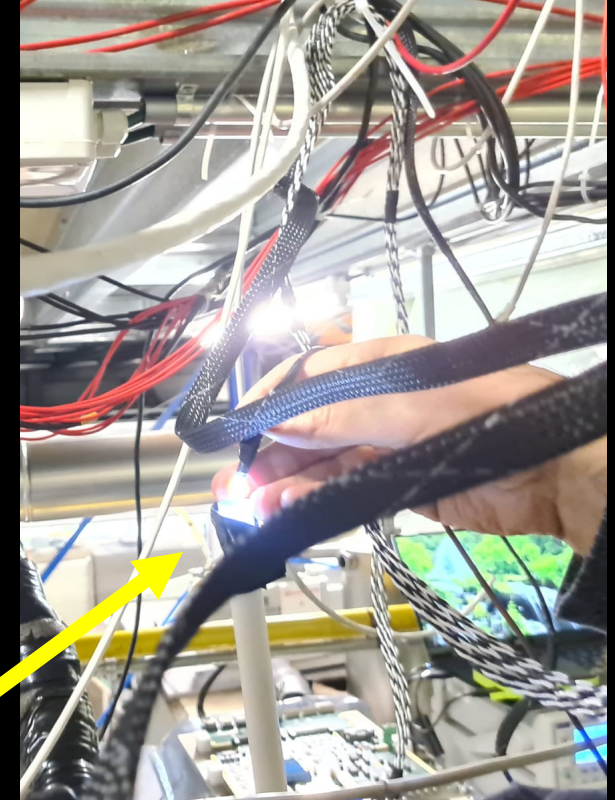
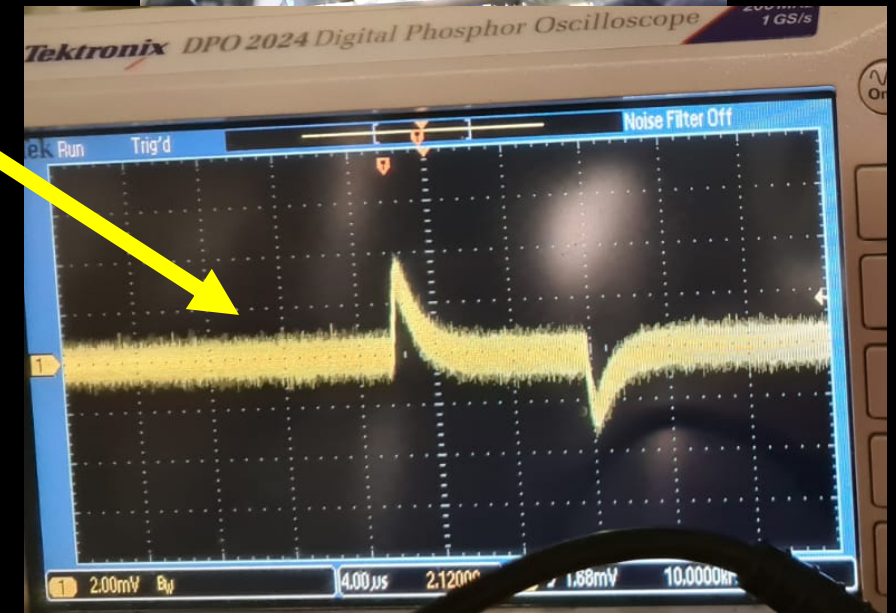
Checking the PoF units 2:

- Fermilab PoF units, **4-PPC in series** with **360 Ohm setting resistance**, we read out **48 Volts** from **feedback cable**.
- SiPM board has three VUV type SiPM arrays. We do not see any signal from SiPM both using self and external trigger (**coincidence of two scintillator slabs located on the left/right side of cryostat, they also move to the top of the cryostat to check with vertical muons**).
- We try to inject pulsed LED light via fiber installed on the cryostat. With high intensity we start to see signal from SiPM array!
- **Why do not we see argon scintillation light? (we will discuss this question in coming slides)**
 - VUV-SiPM has photon detection efficiency of **15% to LAr** and **23% to LXe** and **~40% to visible light**

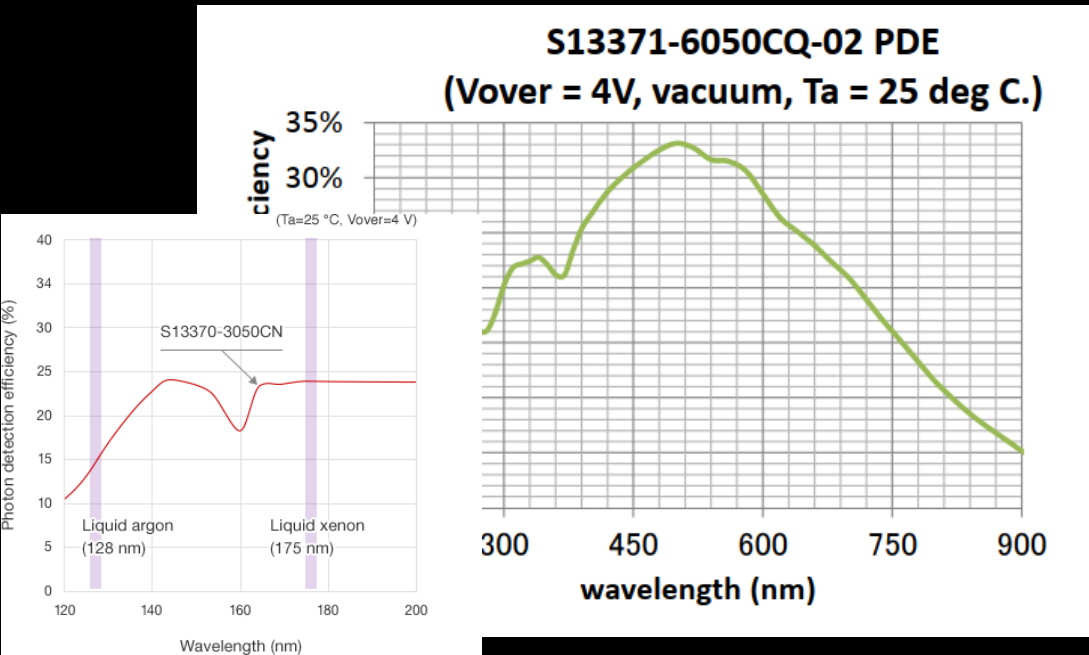
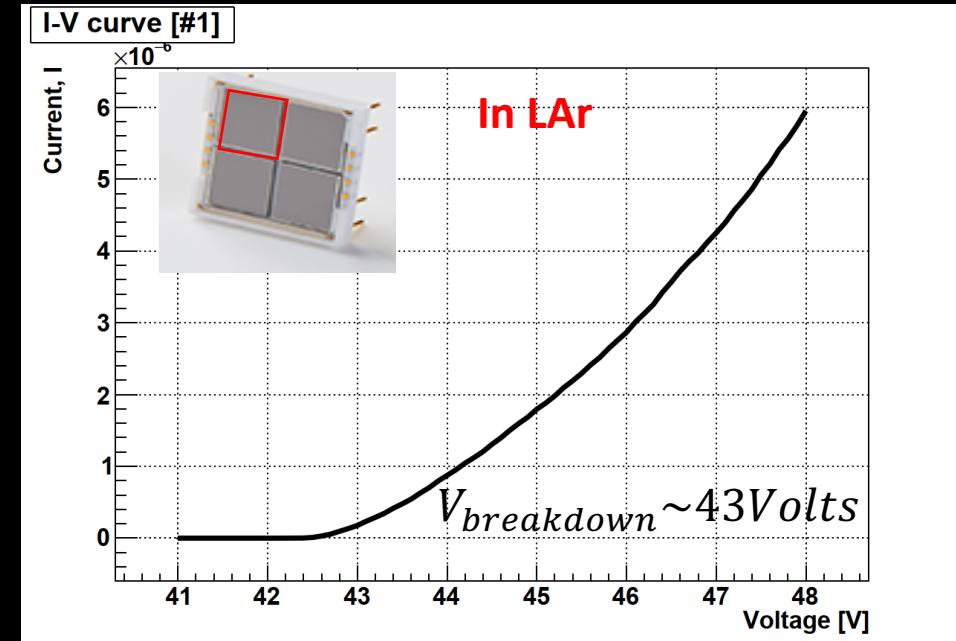
Photon detection efficiency

- We use LAr and LXe sensitive VUV4-SiPM arrays in the tests
- We have measured **break down voltage of ~ 43 Volts** in liquid argon
- We need to get an output voltage of 46 to 48 Volts from power over fiber units to bias the SiPM arrays $V_{operating} = V_{breakdown} + 5V \sim 48 \text{ Volts}$
- SiPM circuit board: signal pulse readout with 10nF capacitor
 - Grounded to the cryostat

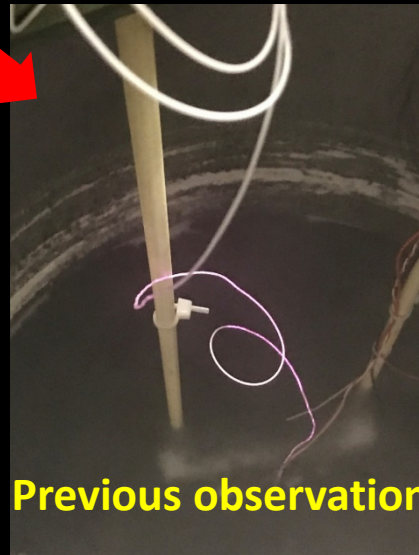
- We had the same test with extension fibers in open air dewar. It was only check by eye so no diffused light we have seen.

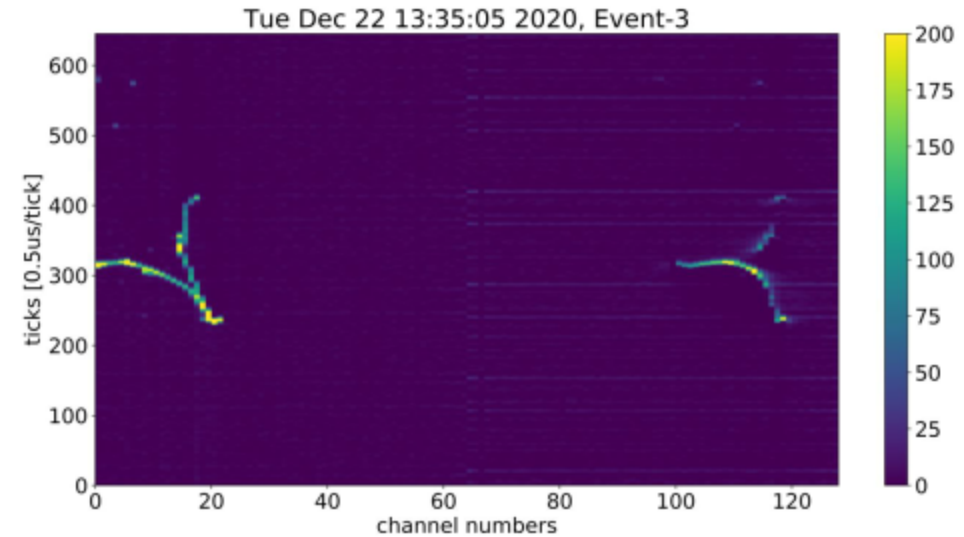
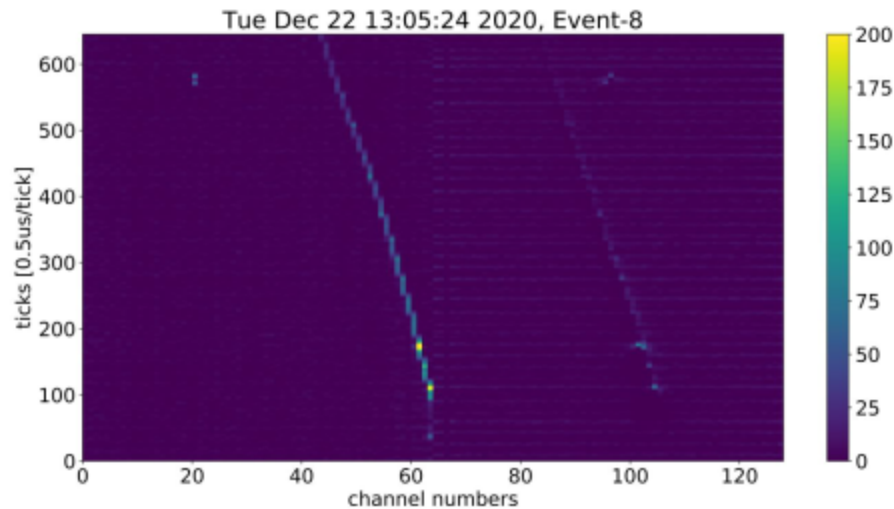
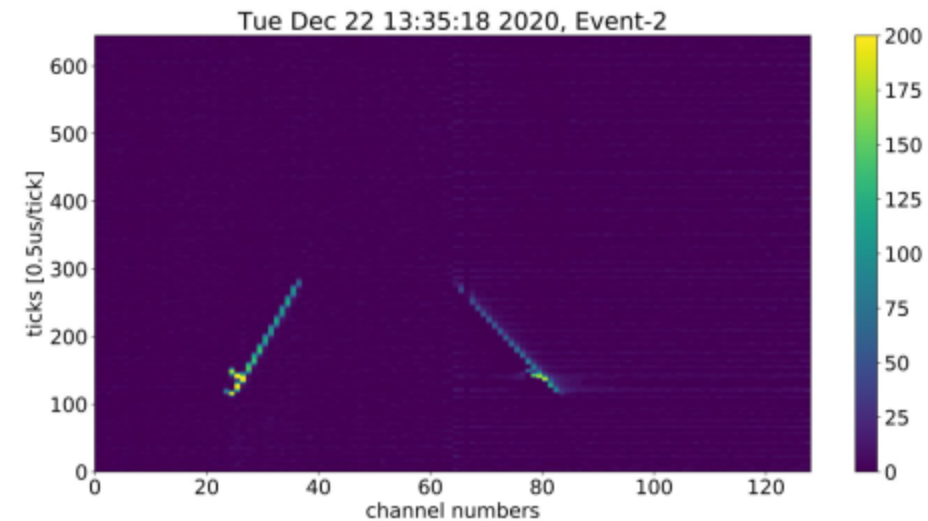
Overall summary on TPC

- Charge readout is working as expected
 - Took data with internal calibration pulse
 - Took data with external trigger using 2 scintillator pads coincidence
- Lower purity wrt previous data taking with 50L
- Higher noise levels wrt previous data taking
 - More visible on the induction plane

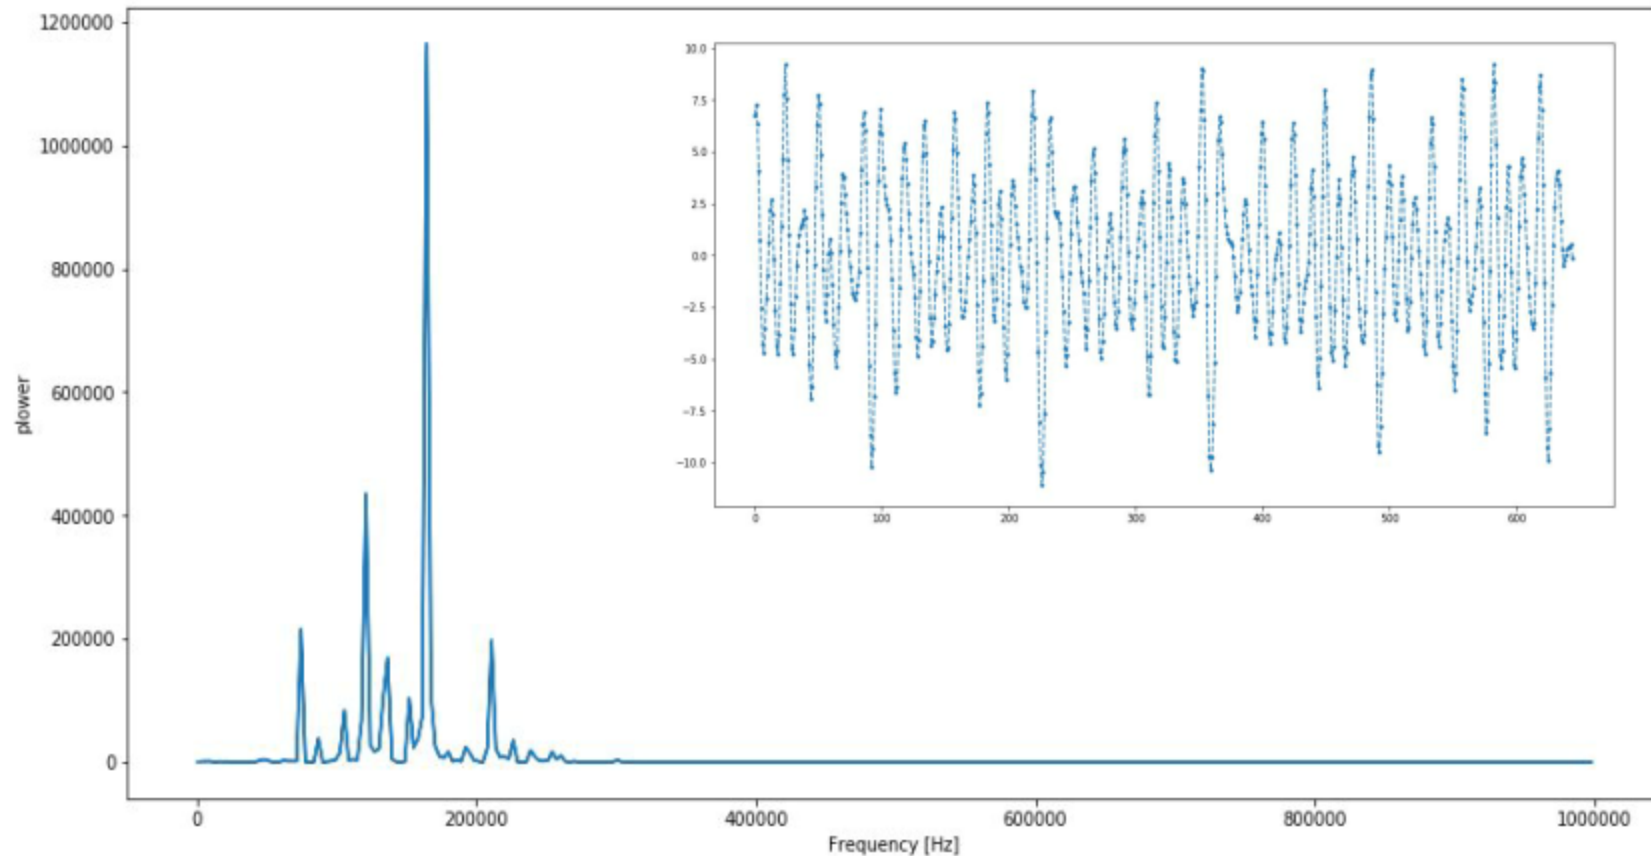
Noise levels

- Very quick and rough noise analysis..
 - Collection layer ~370e ENC
 - Induction layer ~700e ENC
- Most dominant noise at 17-18kHz

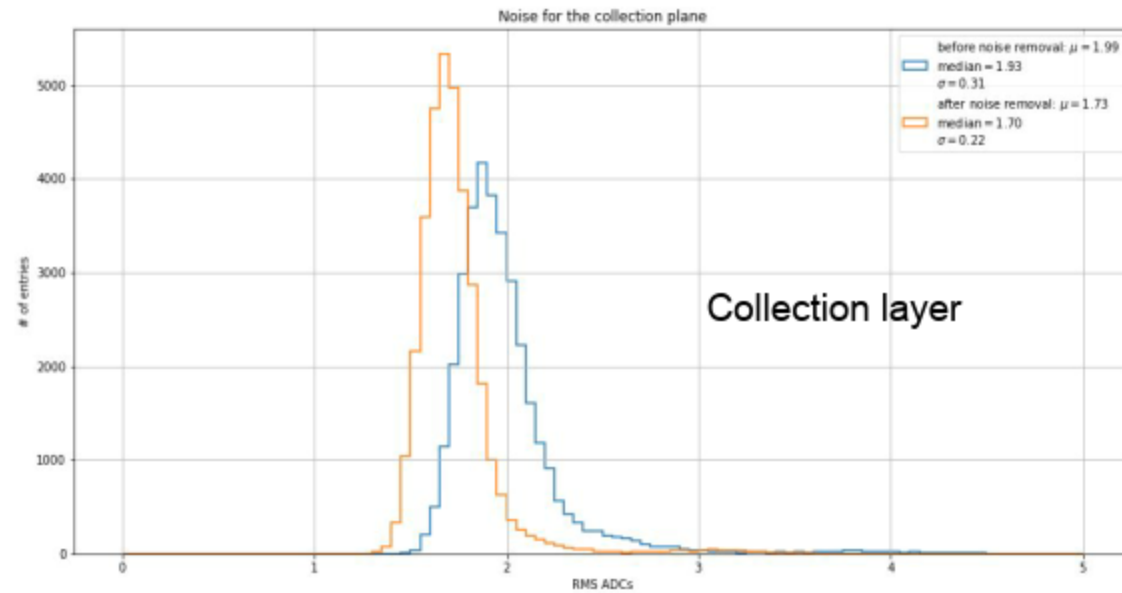
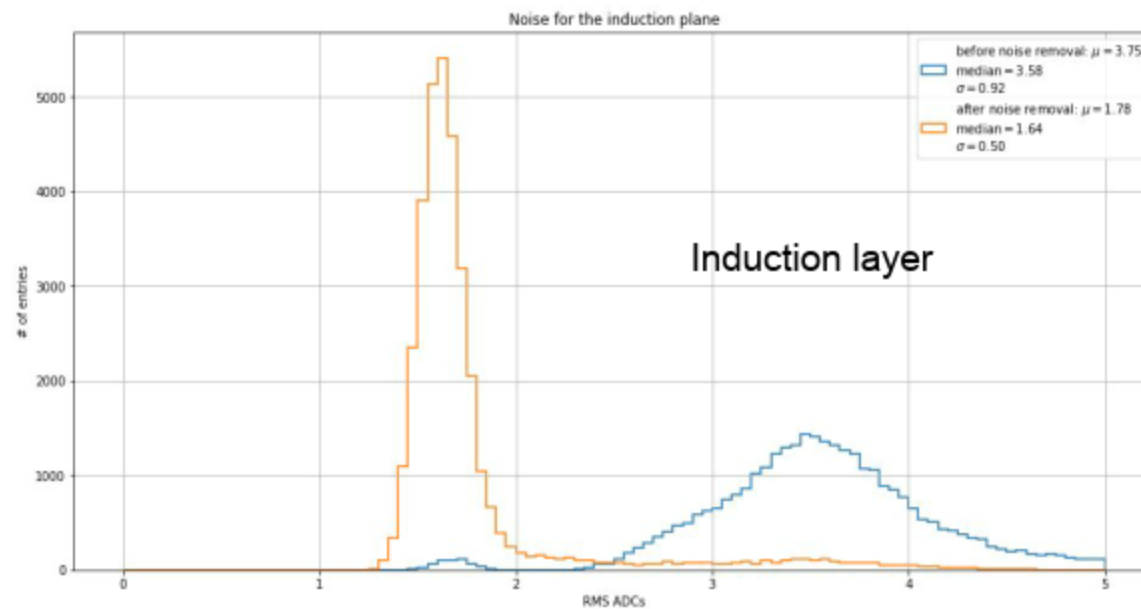
Coherent noise removal

- Most of the noise can be removed by coherent noise removal
- After noise removal
 - 320-330e ENC on collection and induction layers
 - Similar to the ones we measured in the previous runs
