“Improved RRCAT cavities Processing & 2K test result”

IIFC Meeting
110811

- RRCAT made two more single cell 1.3 GHz (2nd prototype) during 2011.
- TE1CAT003 arrived FNAL (May-11) & TE1CAT004 (August-11)

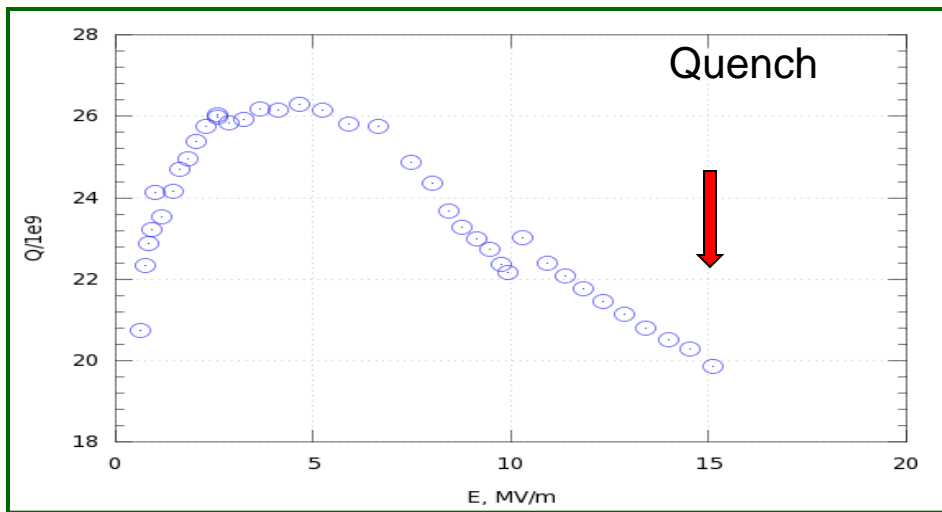
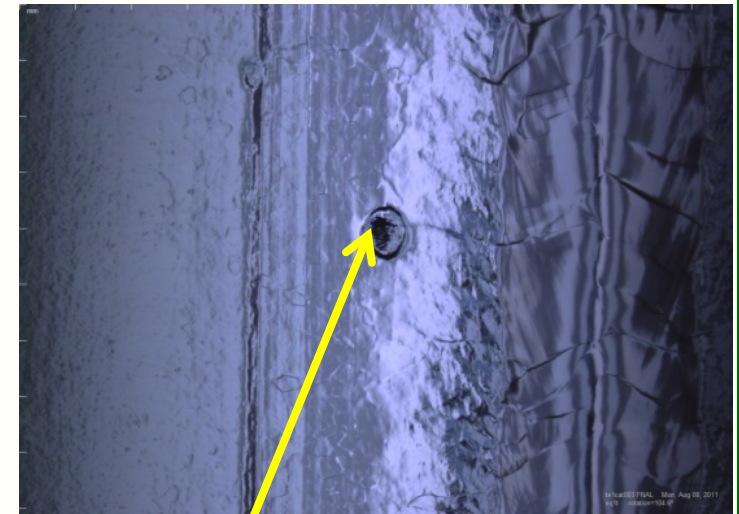
- Cavity initially tested after received the std ILC recipe- consisting of bulk EP,800c furnace treatment, light EP,HPR,assembly & 120 bake.

Bump was cause of quench

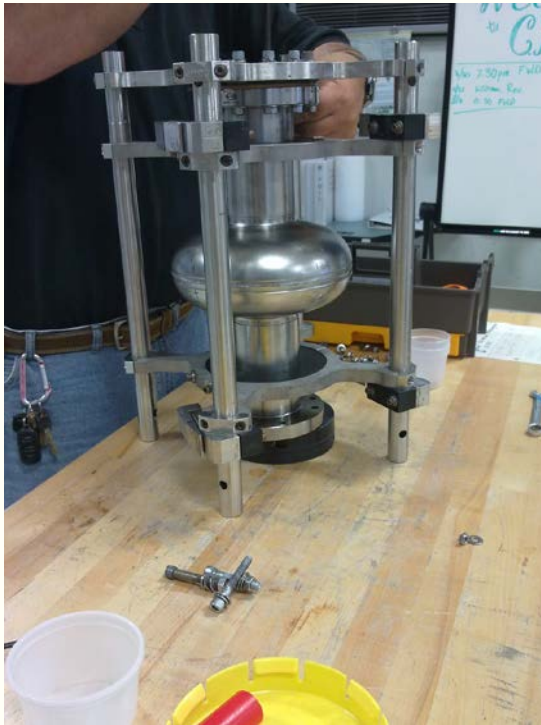
Machining marks

- It was decided to remove machining marks & features after scraped bump by Centrifugal barrel polishing with optical inspection between rounds.

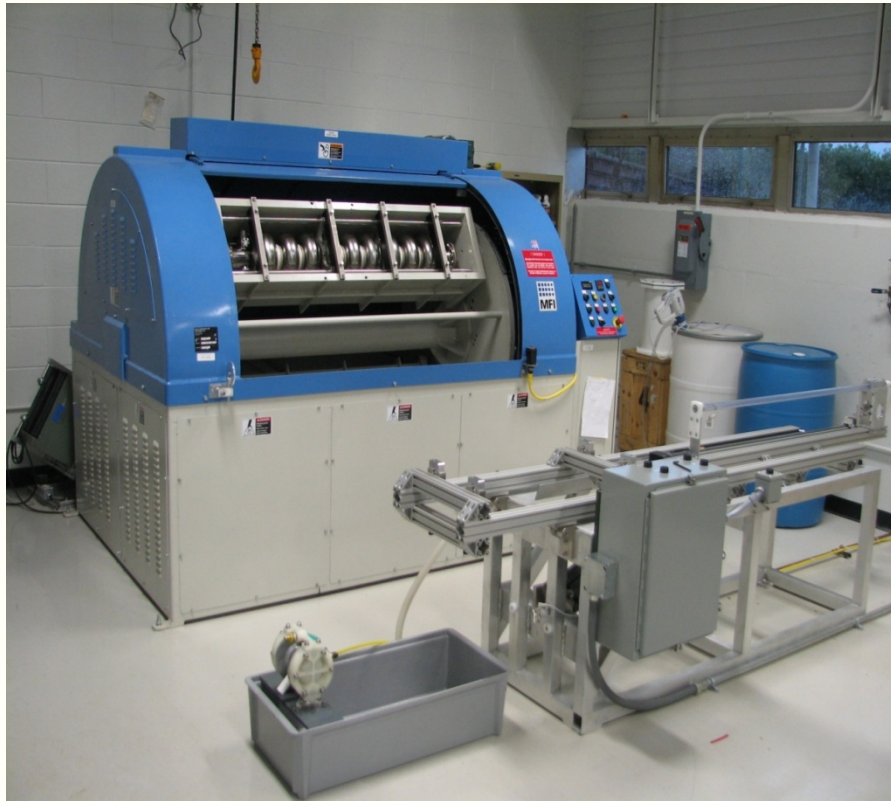
CBP is an alternative processing technique (Tumbling) that polishes the inside of superconducting RF cavities by rotating the cavities at high speed while filled with an abrasive media

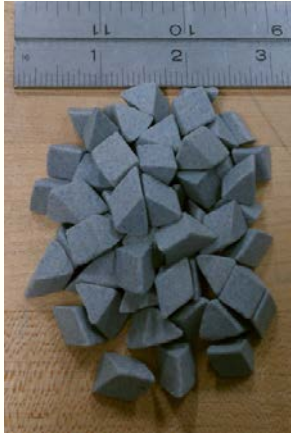
Step 1

Cutting, Time as needed

+ Soap & Ultrapur e Water

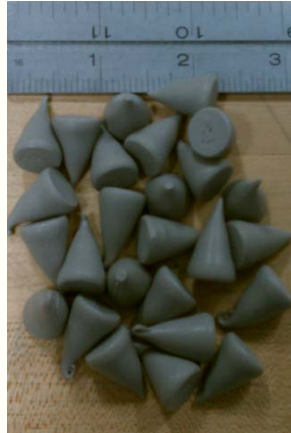
Step 2

Intermediate Polishing, 12 hours

+ Soap & Ultrapur e Water

– 3 um / hr

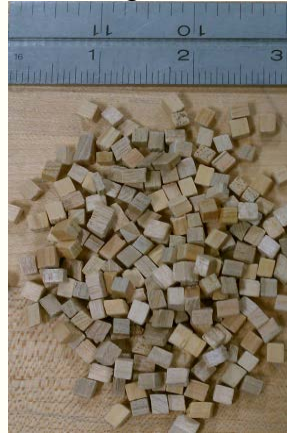
Step 3

Intermediate Polishing, 15 hours

Water + 400 Mesh Alumin

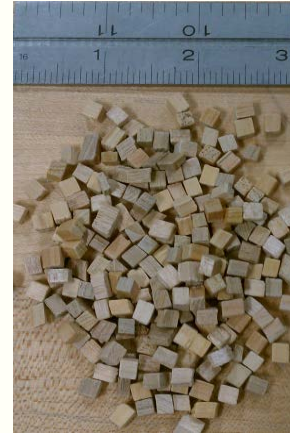
Step 4

Intermediate Polishing, 20 hours

Water + 800 Mesh Alumina

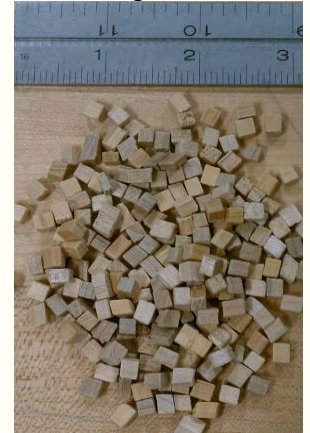
Step 5

Final Polishing, 40 hours

Colloidal Silica

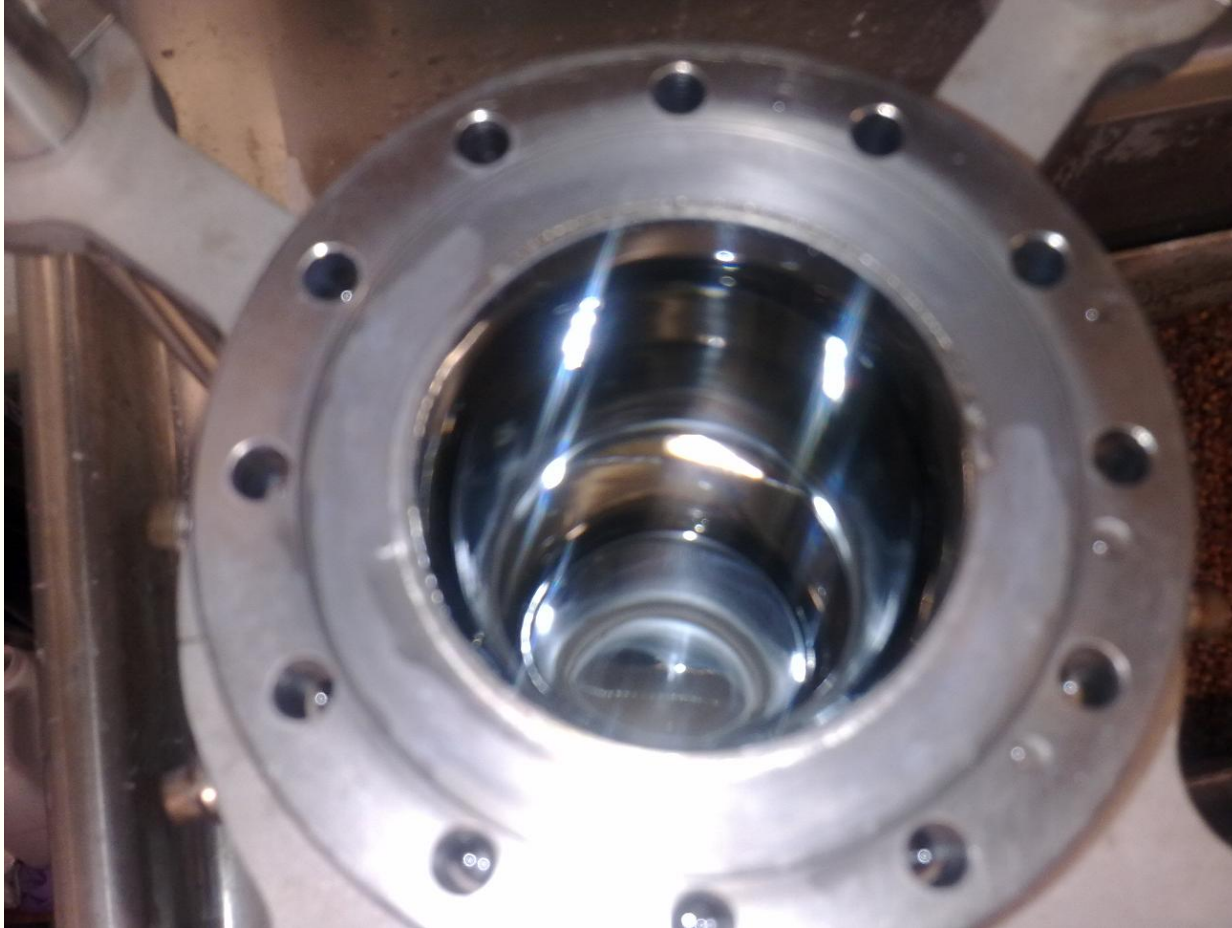
Mirror finish due to CBP before EP

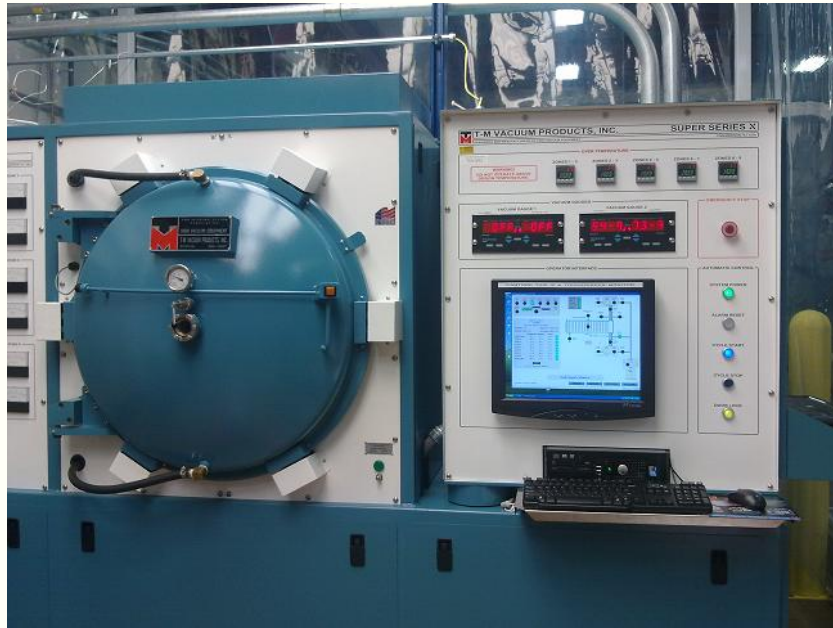
Vacuum furnace in IB4 (Max temp 1000°C)

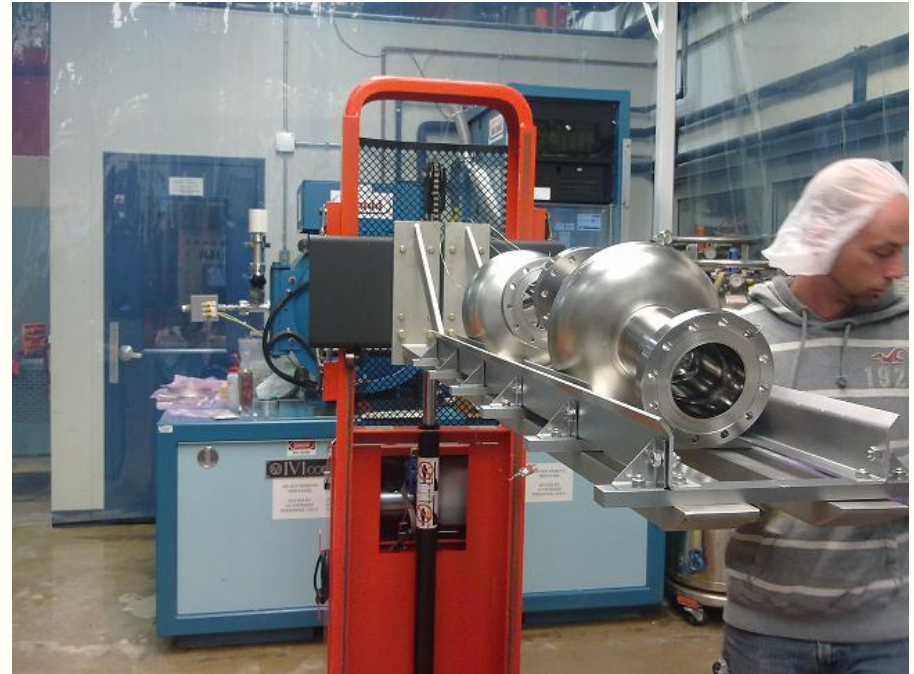
Cavity moving inside the vacuum furnace

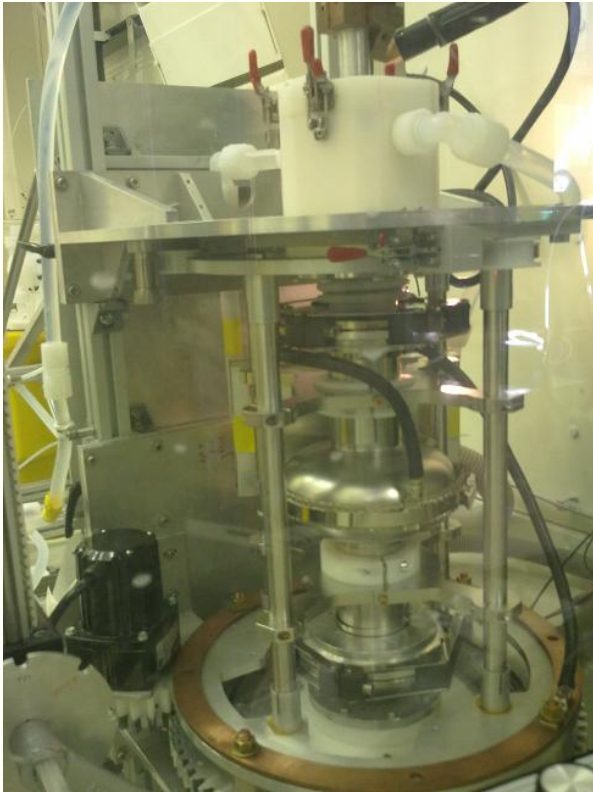
**Draining of acid & rinsing after
EP**

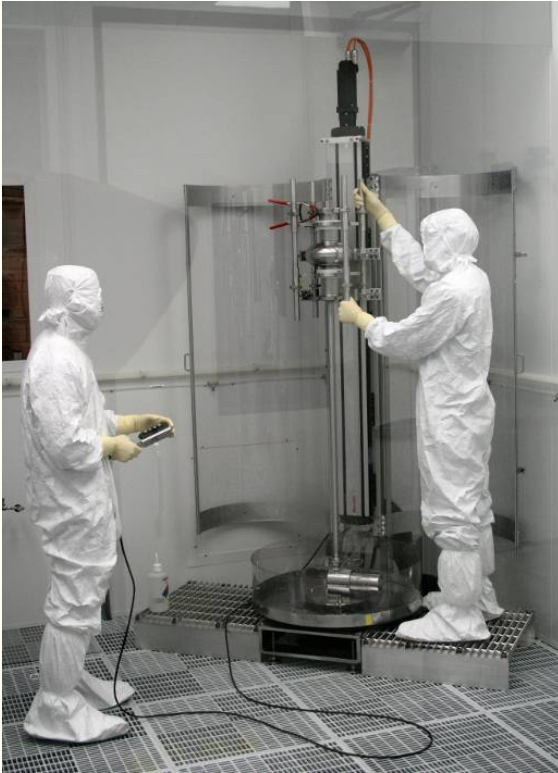
HPR station

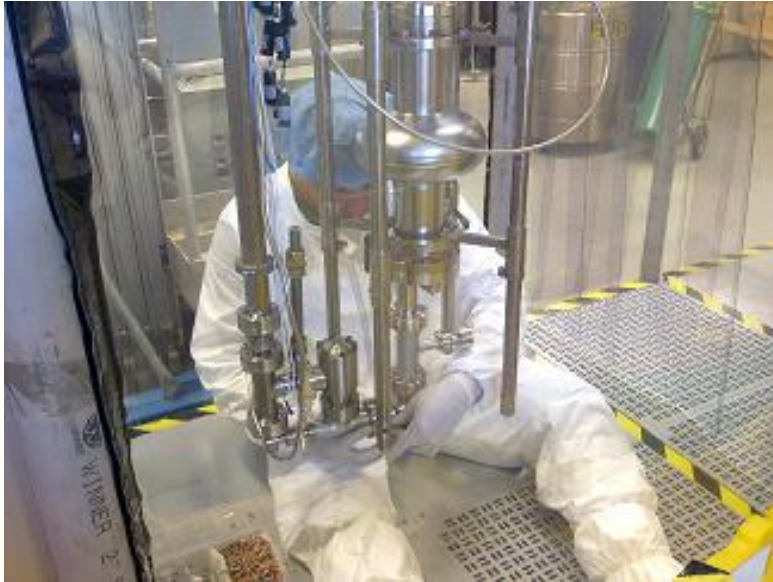
Assembly of cavity with VTS insert

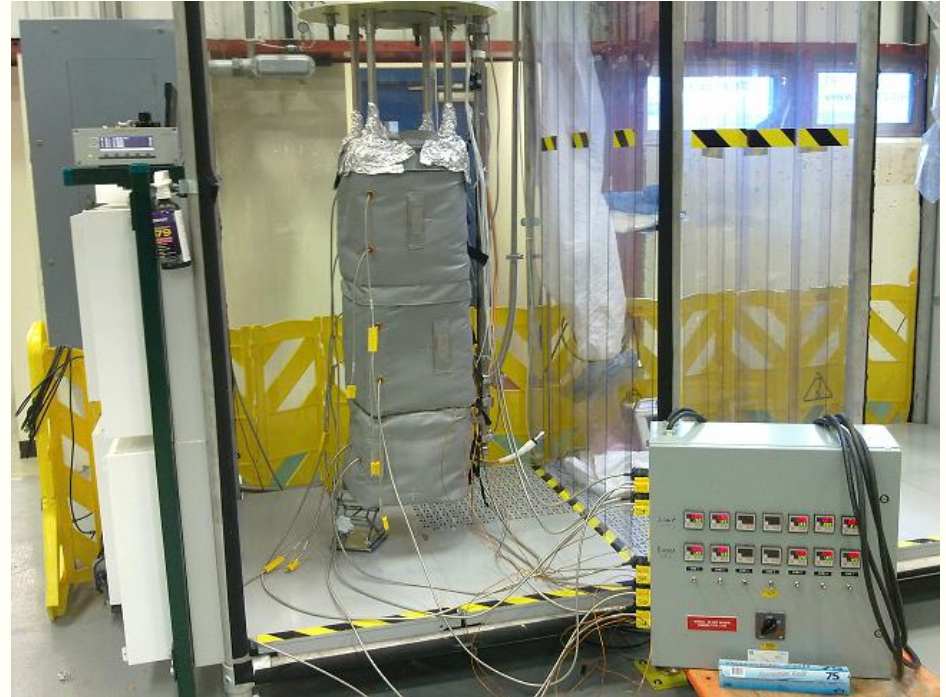
Heating Jackets around the cavity with temp monitor for 120 °C bake,

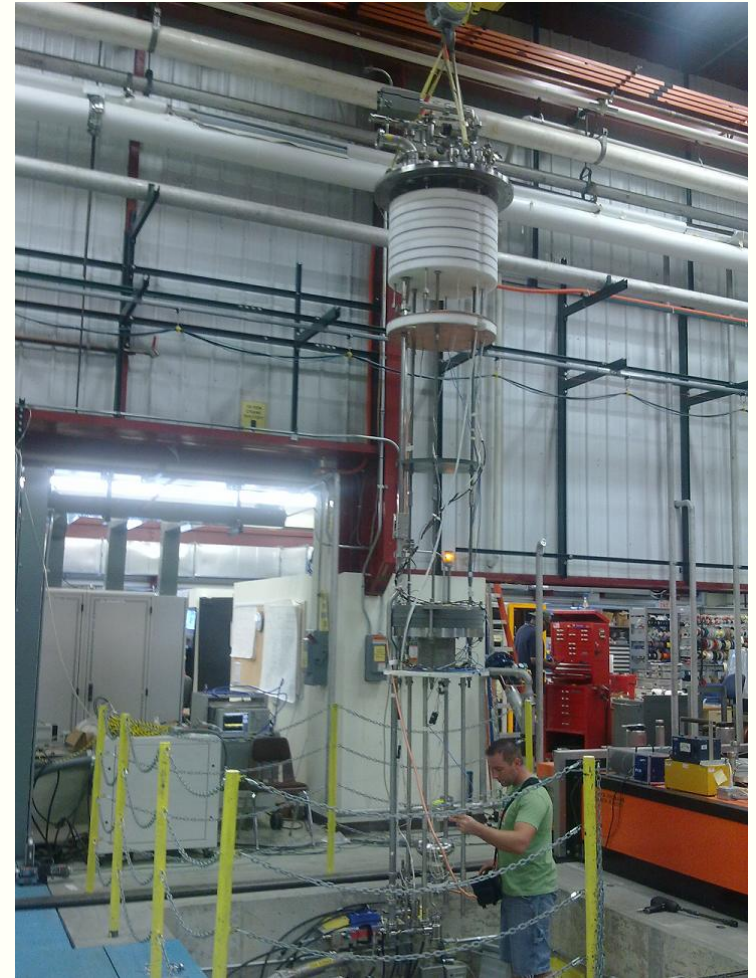
Cavity insert mounted inside the VTS cryostat

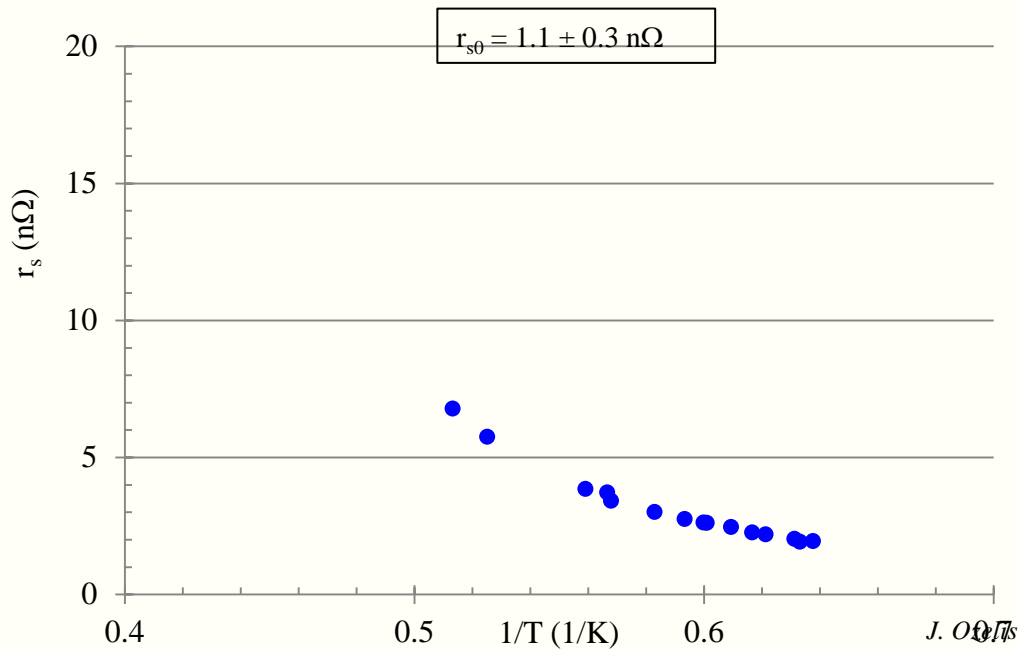
ILC-TE1CAT003 - Surface Resistance

Tested 10/11/11- CBP then EP/HPR/Assy @ ANL, then 120°C Bake @ IB1

The residual surface resistance of $1.1 \pm 0.3 \text{ n}\Omega$ – among the lowest e measured at Fermilab. Surface resistance in general is very low for this cavity (as evidenced by high Q0 values throughout).
