PIP-II 2nd Technical Workshop
Fermilab
2022.07.12-14

ppSSR2 Coupler Production
Experience and Lessons
Learned - IJCLab

David Longuevergne, Sandry Wallon - IJCLab

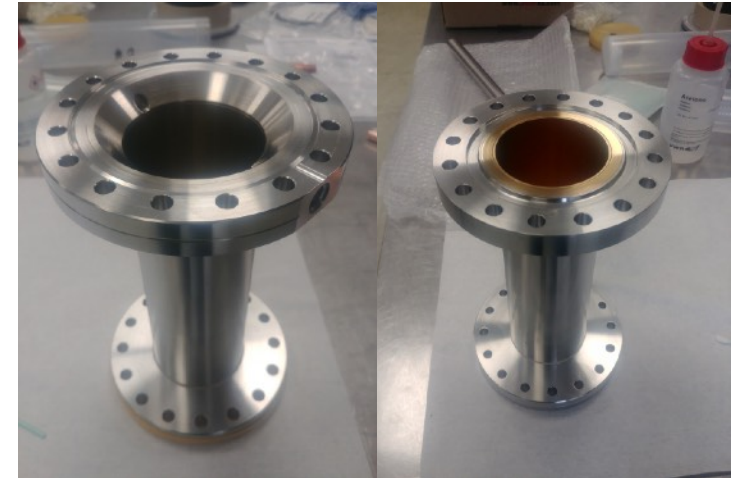
Vacuum side outer cond. test parts
Nickel wood coating (L) / Cu coating (R)

- 2 pieces shipped for Cu plating
- 3 other waiting for IJCLab Cu RRR measurement (Aug.)
- Two 2K flanges with slightly tight groove for Al diamond seal (investigation in progress)

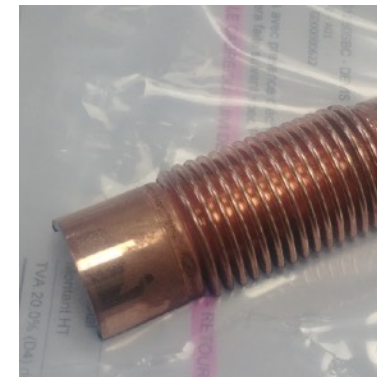
Bubbles under Cu coating
(no bubbles where penetrant compound applied)

- 3 test parts done
- Production parts ready for Cu plating (waiting test parts qualification)
- Some mishaps on test parts :
 - bubbles under the Cu coating during 400 °C stabilisation baking (due to laser welding, PMB did not perform usual baking for brazed parts)
 - Corrosion attack after bathing (leads : corrosion sensitivity of titanium [310 Ti] ; shared bath)

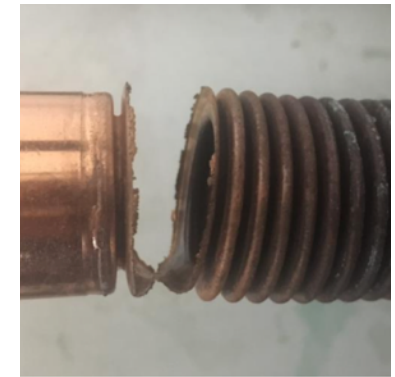
Corrosion attack

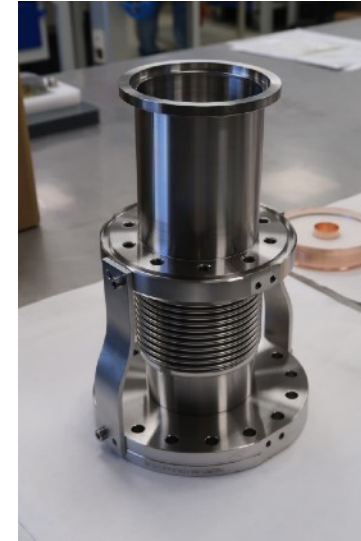
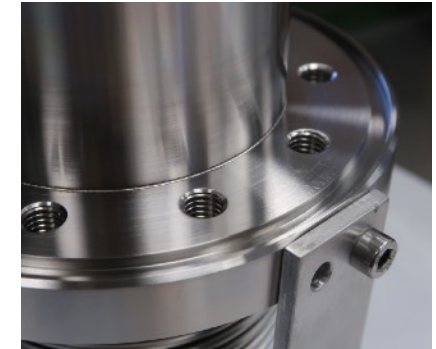
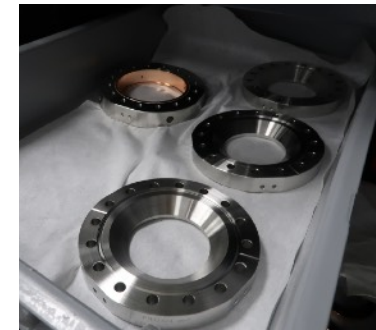
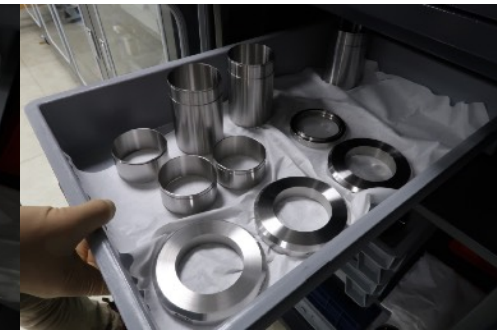
All pics : air side outer cond. test piece and parts

- 3 test parts done - in a row with no intermediate analysis ; laser welding issue solved (deformation after 1st welding) ; production parts would have an improved design to reduced the number of welding operations to 3 to 2 and deformation
- Production parts ready for welding (waiting results of welding trail with alternative solution 2 [light machining on “cryomodule flange”] on 1st production parts)
