ESS COUPLERS: MANUFACTURING AND CONDITIONING

Optimus+

C. Arcambal

CEA Paris-Saclay, 91 191 Gif-sur-Yvette, France

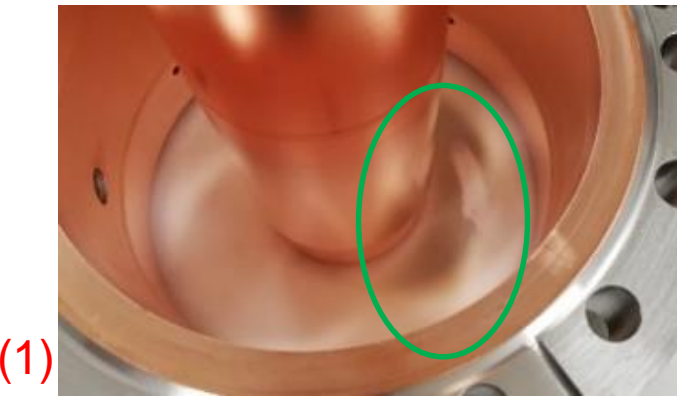
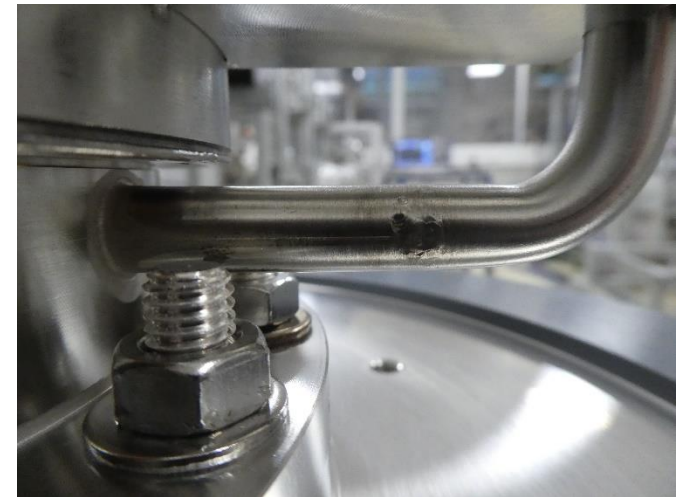
- **Pollution of the ceramic:** Bad positioning of the ceramic protection during the electron beam welding (1)
- **Flow of the filler metal on the copper** during the brazing (2)
- **Weakness of the weld** close to the vacuum gauge flange (3) (2 windows with leak). As we can tilt the tube when we screw the gauge on the window flange, we can weaken the weld.

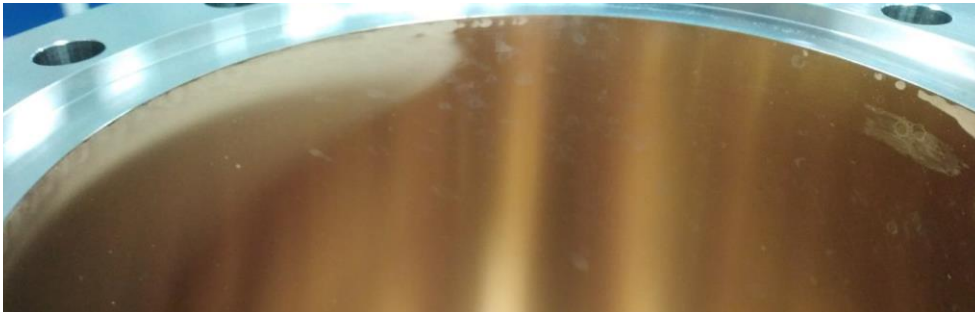
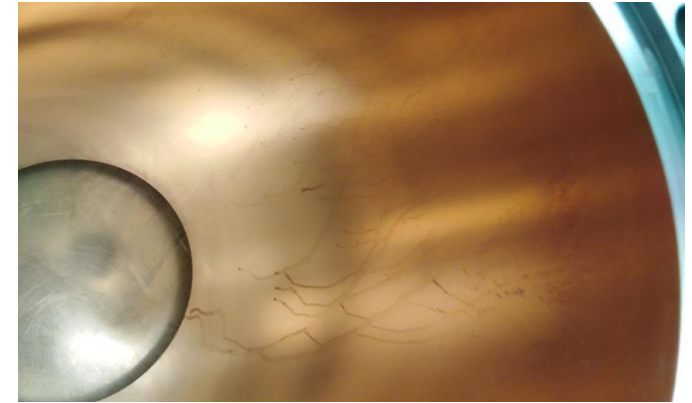
- **Aspect:** coating is operator dependent. Last year, obligation de remove copper coat on 12 tubes (scratch, stain, mark...)

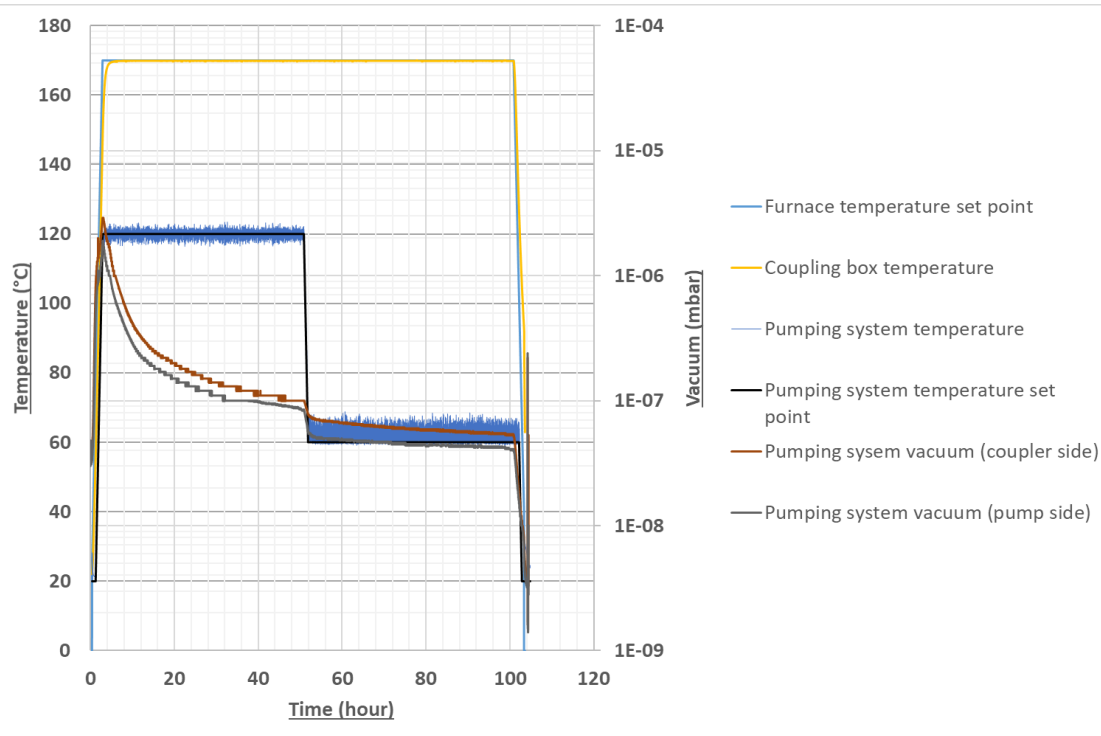
Baking (temperature and vacuum)

- Baking in an oven (couplers 170°C for 4-5 days, pumping system 120°C for 2 days then 60°C)
- Oven filled with nitrogen to limit the oxidation of the copper in the window air side.
- Pumping group is heated with heating tapes
- Residual gas analysis during the baking

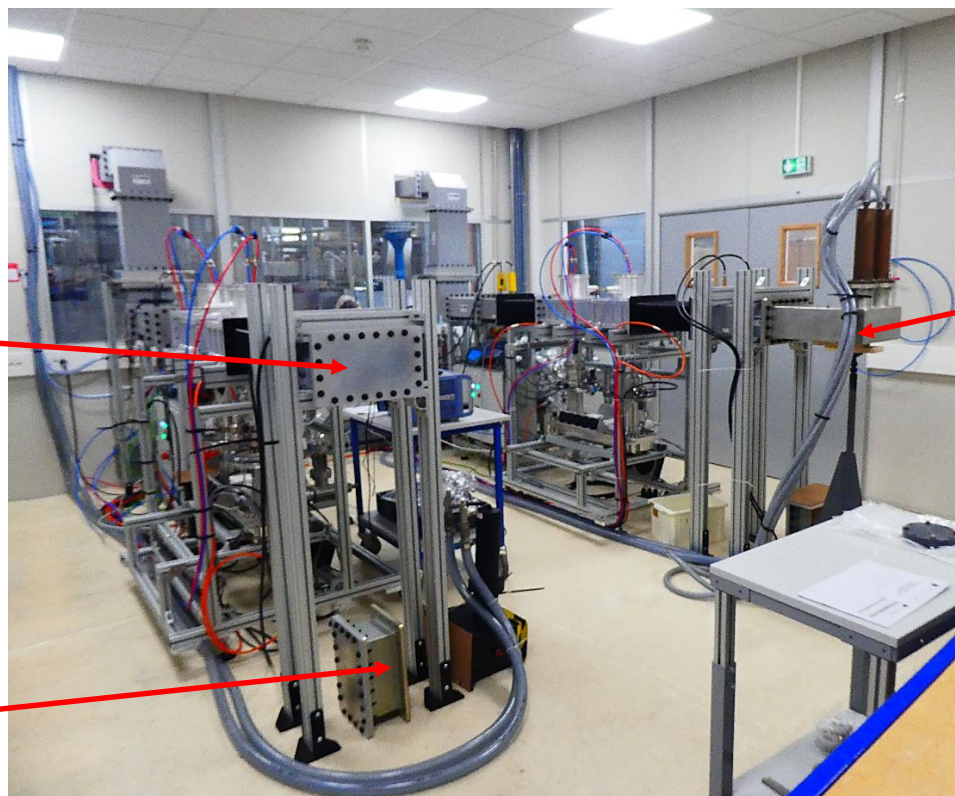
- 2 klystrons to perform conditioning of 2 couplers pairs in parallel.
- Couplers conditioned by pair on a coupling box in travelling waves (at 1 Hz then 14Hz) and standing waves (at 1 Hz then 14Hz) for 2 positions of the short circuit (minimum then maximum electric field close to the ceramic).
- Pumping system: effective speed $\approx 20\text{l/s}$, whole conductance $\approx 24\text{l/s}$. Turbo pump: 300l/s .

Short circuit
(E min)

Short circuit
(E max)

Load

Zoom on the couplers

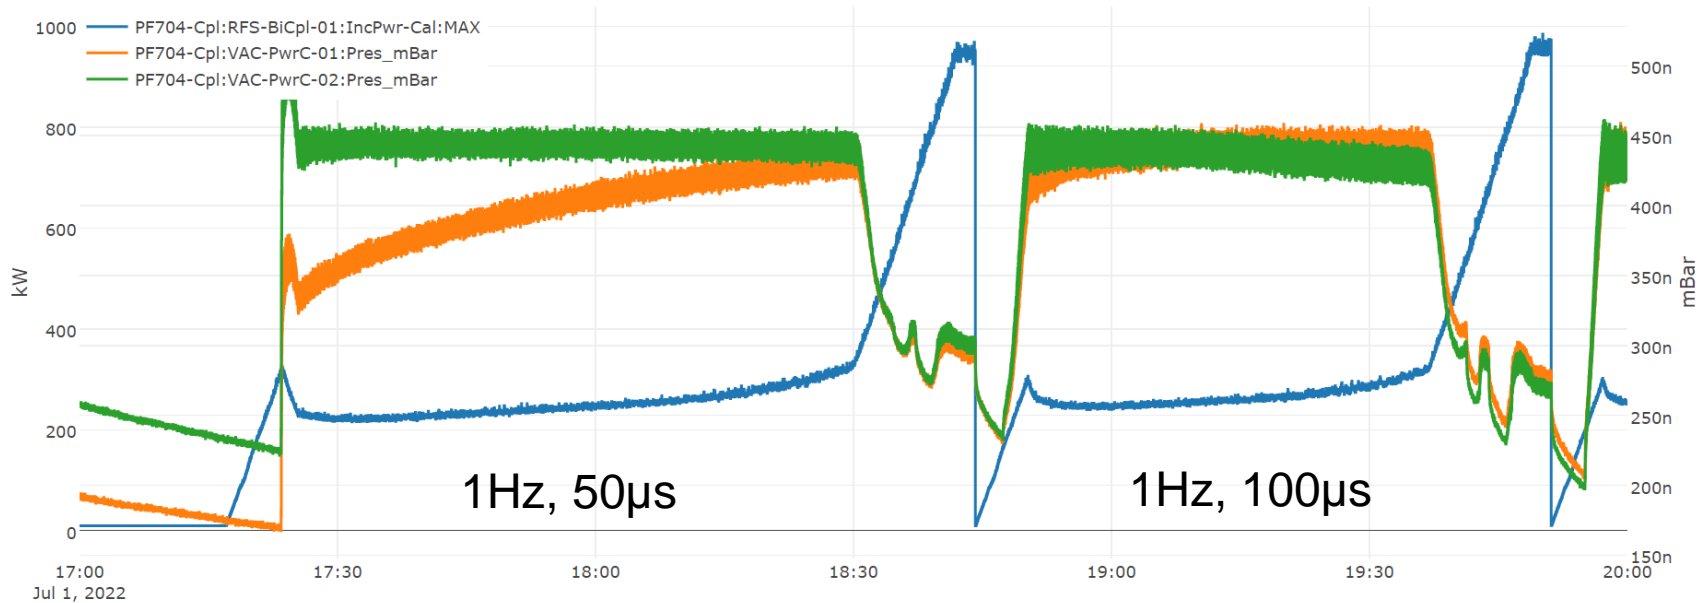
- Beginning of the conditioning: 1Hz, travelling waves. Vacuum threshold fixed at 4.5×10^{-7} mbar

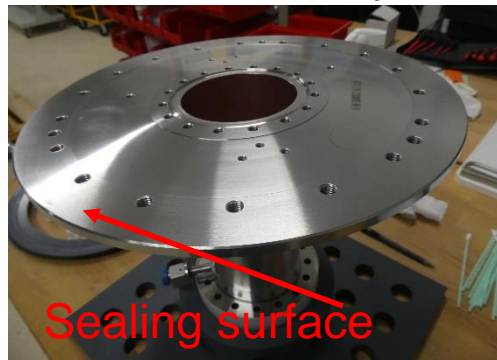
Bellow bell

- Difficulties to obtain vacuum tightness on some interfaces

- VCR connector
- Coupler bellow bell
