Measurement of the gas gain and understanding the gas flow in the Mu2e Tracker

Student: Giovanni Celotto

Midterm presentaiton

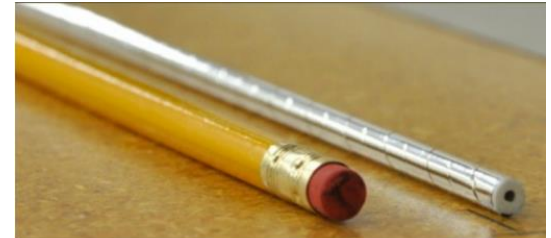
- 96 Mylar straws
- 5 mm diameter and 15 μm walls
- 25 μm gold plated tungsten sense wire

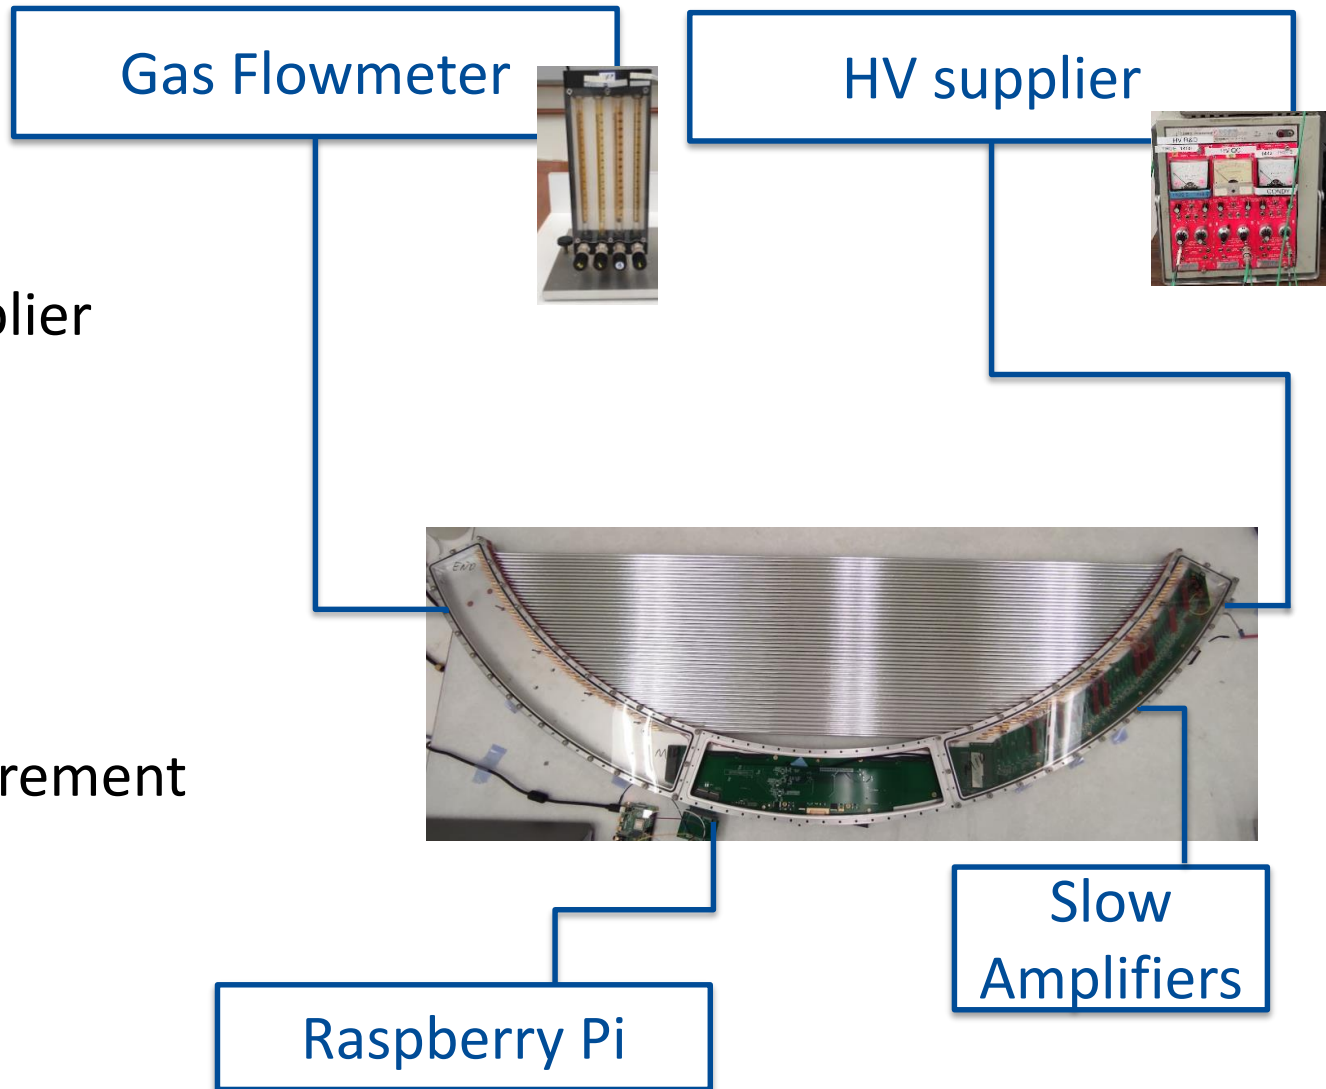
- Gas flowmeter
 - Panel MN084
 - Droege HV supplier
 - Slow amplifiers
 - Raspberry Pi
-
- $V = 1450\text{ V}$
 - Pedestal measurement

- Gas flowmeter
 - Panel MN084
 - Droege HV supplier
 - Slow amplifiers
 - Raspberry PI
-
- $V = 1450 \text{ V}$
 - Pedestal measurement

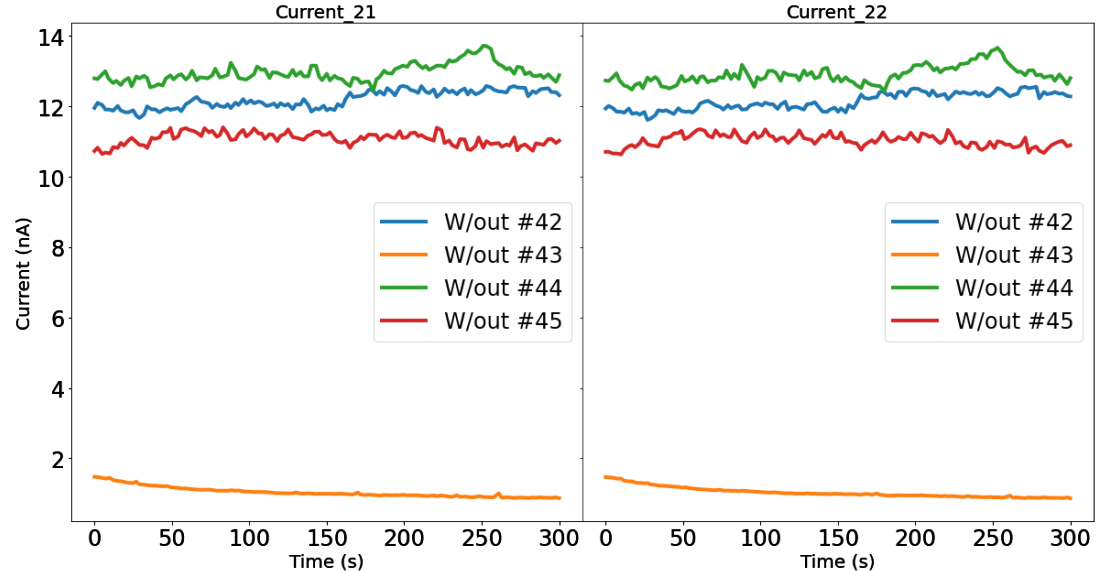
Disconnecting
#42, #43, #44, #45
one by one

Straw #43 draw high
current

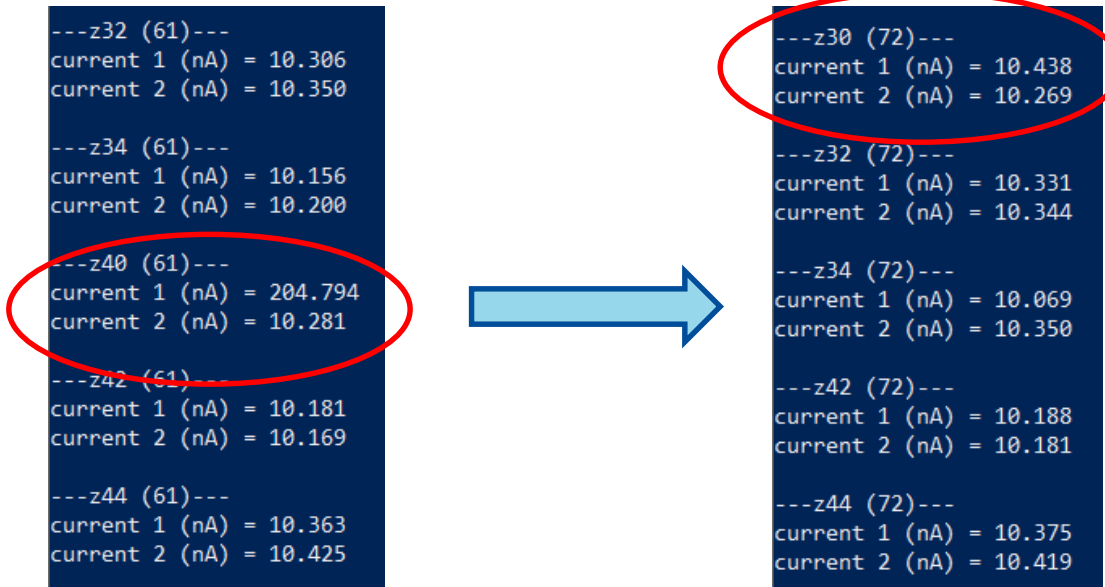
- The problem is not in the slow amplifier. Moving the same slow amplifier to another slot it works. Using different slow amplifiers in Z40 they have the same issue.

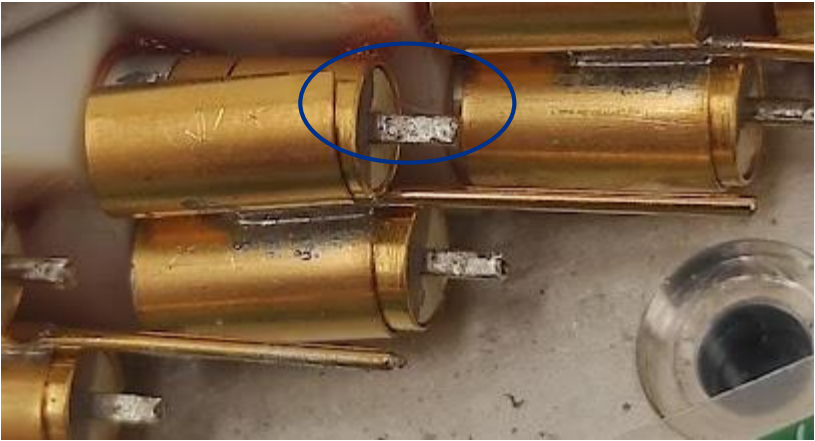
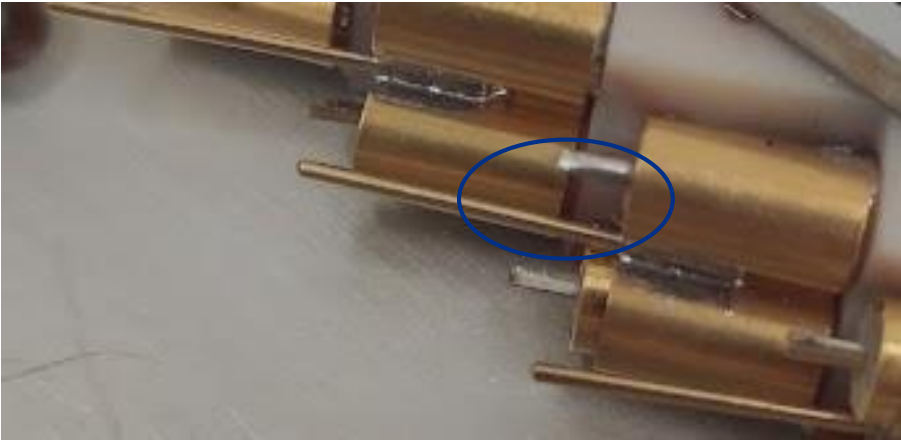
- Pigtail caused the **short** on wire #80 in panel MN084

Panel No	Plane No	Cleaned/Prepped	Air test	Blocked straws	Missing wires	Missing wires confirmed	PNF epoxy	DMB Id	Standy off	Leak install	Leak test
MN084		✓	✓	None ✓			✓			Leak install ✓	Leak test ✓
Repairs	DMB connector holes cleared.										
HV issues	wire 80 shorted wires 39, 43, 78 draw back cavities orange piece 32 (cal wire) falls off + 33 brassing 33										
Notes	didn't do air test, deemed unnecessary Air test for blocked straws ✓ 2/22/22 PNF ✓ = OK epoxy on DMB connector - yes - cleared
