Status of SBND Construction

Anne Schukraft
ND All Hands Meeting
Oct 18, 2022

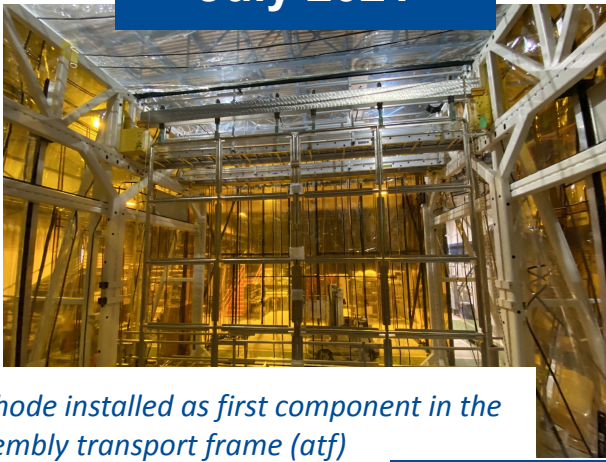
July 2021

Cathode installed as first component in the assembly transport frame (atf)

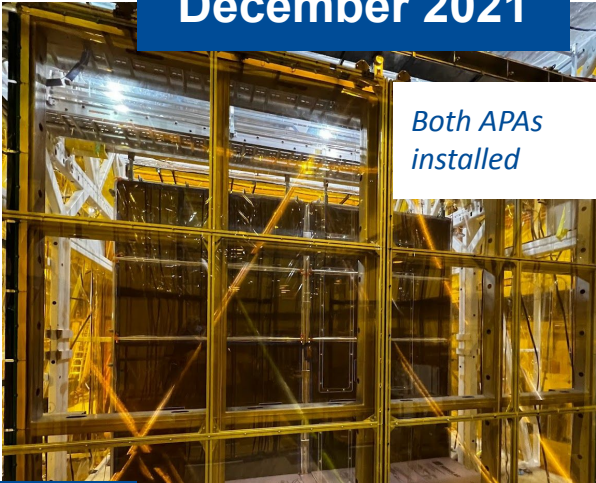
December 2021

Both APAs installed

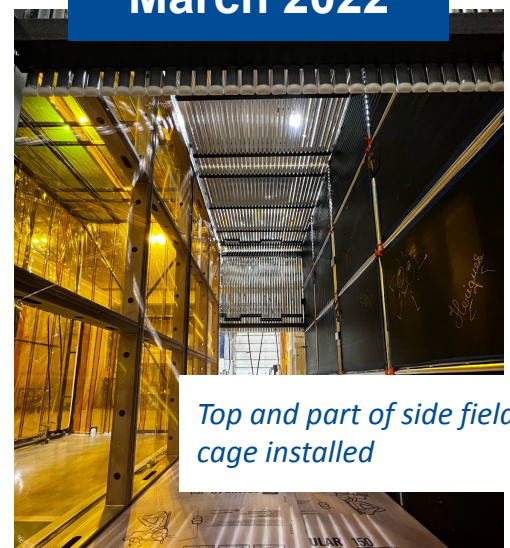
March 2022

Top and part of side field cage installed

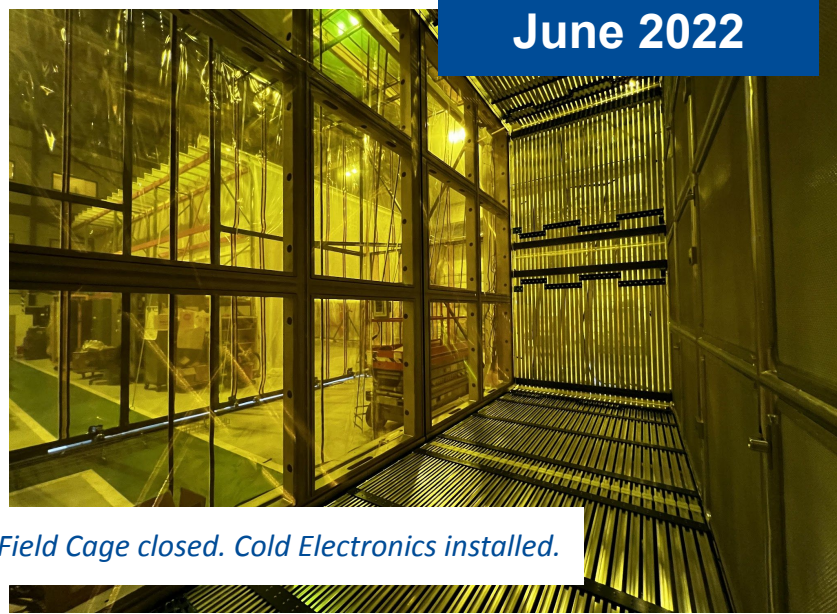
June 2022

Field Cage closed. Cold Electronics installed.

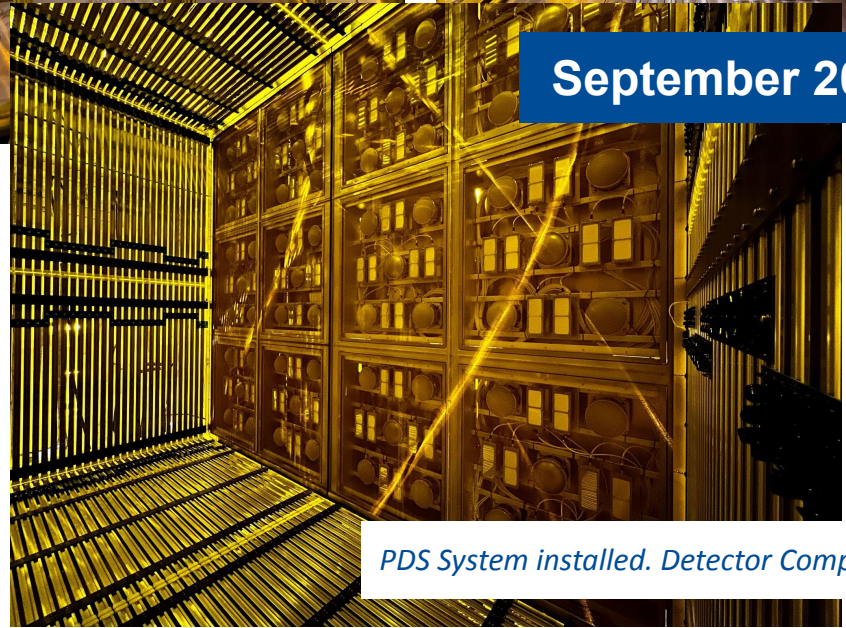
September 2022

PDS System installed. Detector Complete.

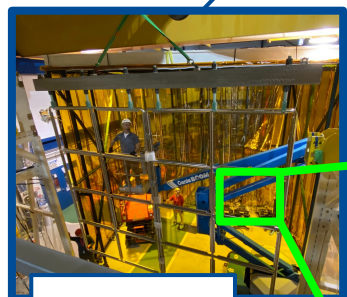
24 Photon Detection System Modules

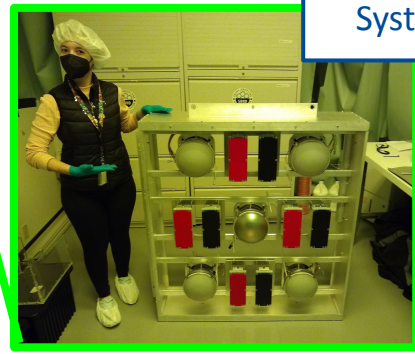
16 TPB coated reflective panels

120 8" PMTs & 192 X-ARAPUCA modules

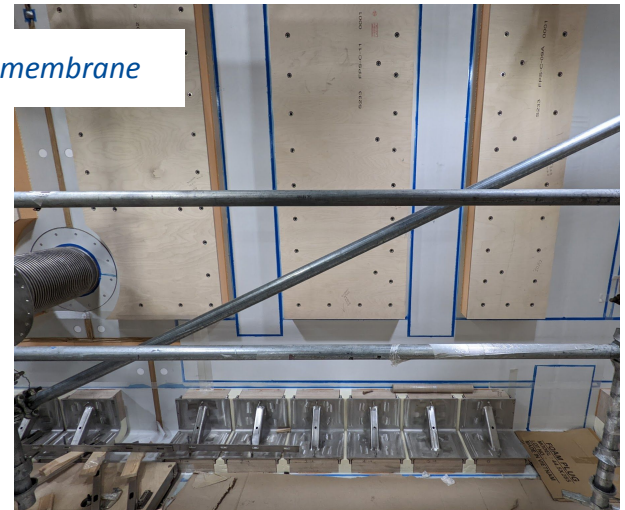
Glueing of strips to seal secondary membrane

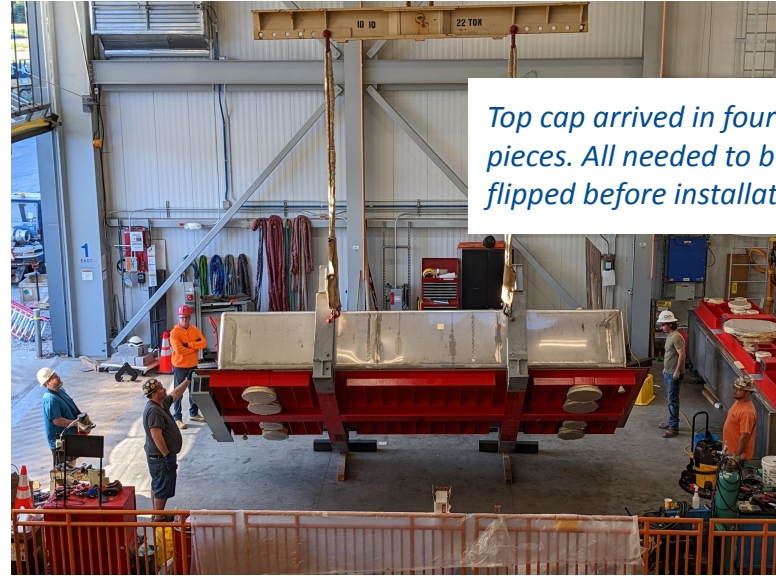
Cryogenic top cap installed & welded to the cryostat

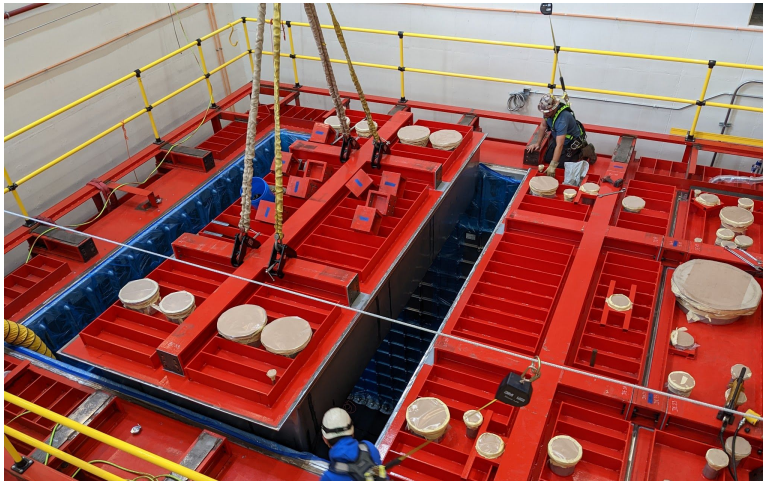
Top cap arrived in four pieces. All needed to be flipped before installation.

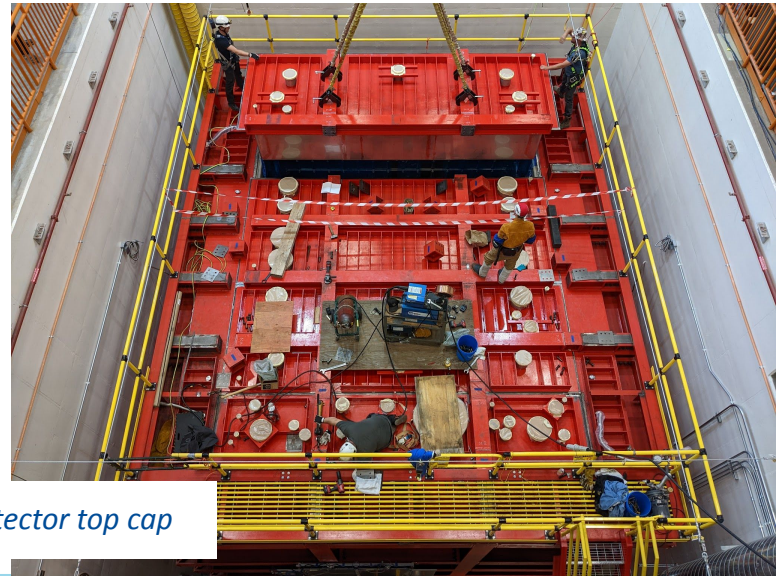
Alignment of top cap pieces, before assembly of 3 pieces into one detector top cap

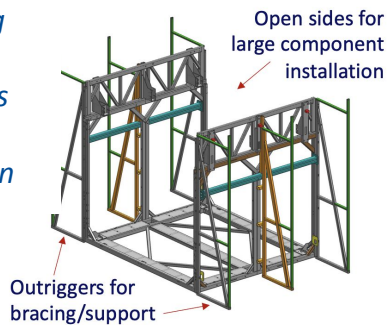
Assembly configuration of atf

Reconfiguring the atf in the coming weeks for transportation

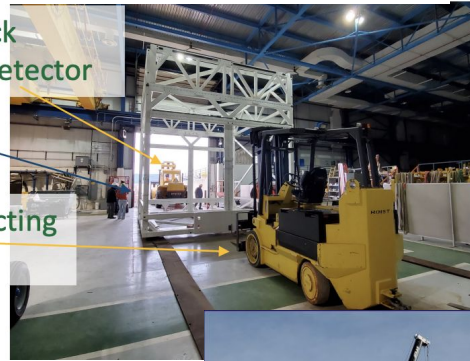
We practiced the move out of DAB with an empty atf in December 2019

Fork truck pulling detector

atf

Fork truck acting as a brake

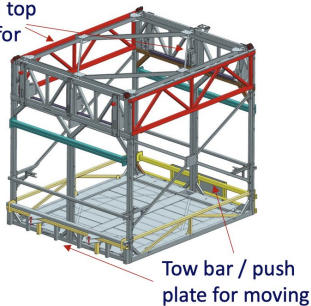
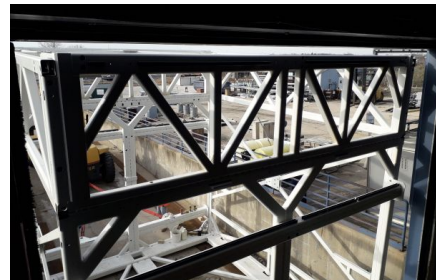
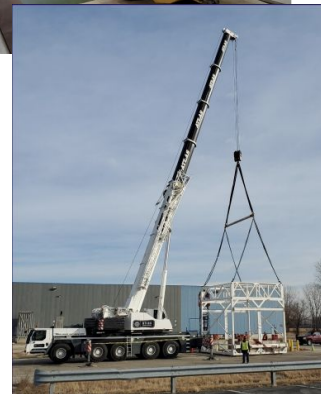
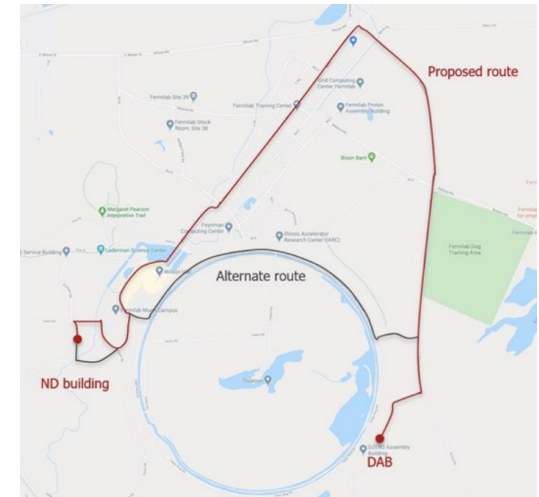
Transportation configuration of atf

We did three practice runs with empty and loaded trailers for two potential routes on site during the past two months

Side and top bracing for rigidity
