APA3 and CRP5b at CERN updates

Hanjie Liu, Cheng-Ju Lin, Manhong Zhao, Herilala Razafinime, Miriama Rajaoalisoa
12/20/2022

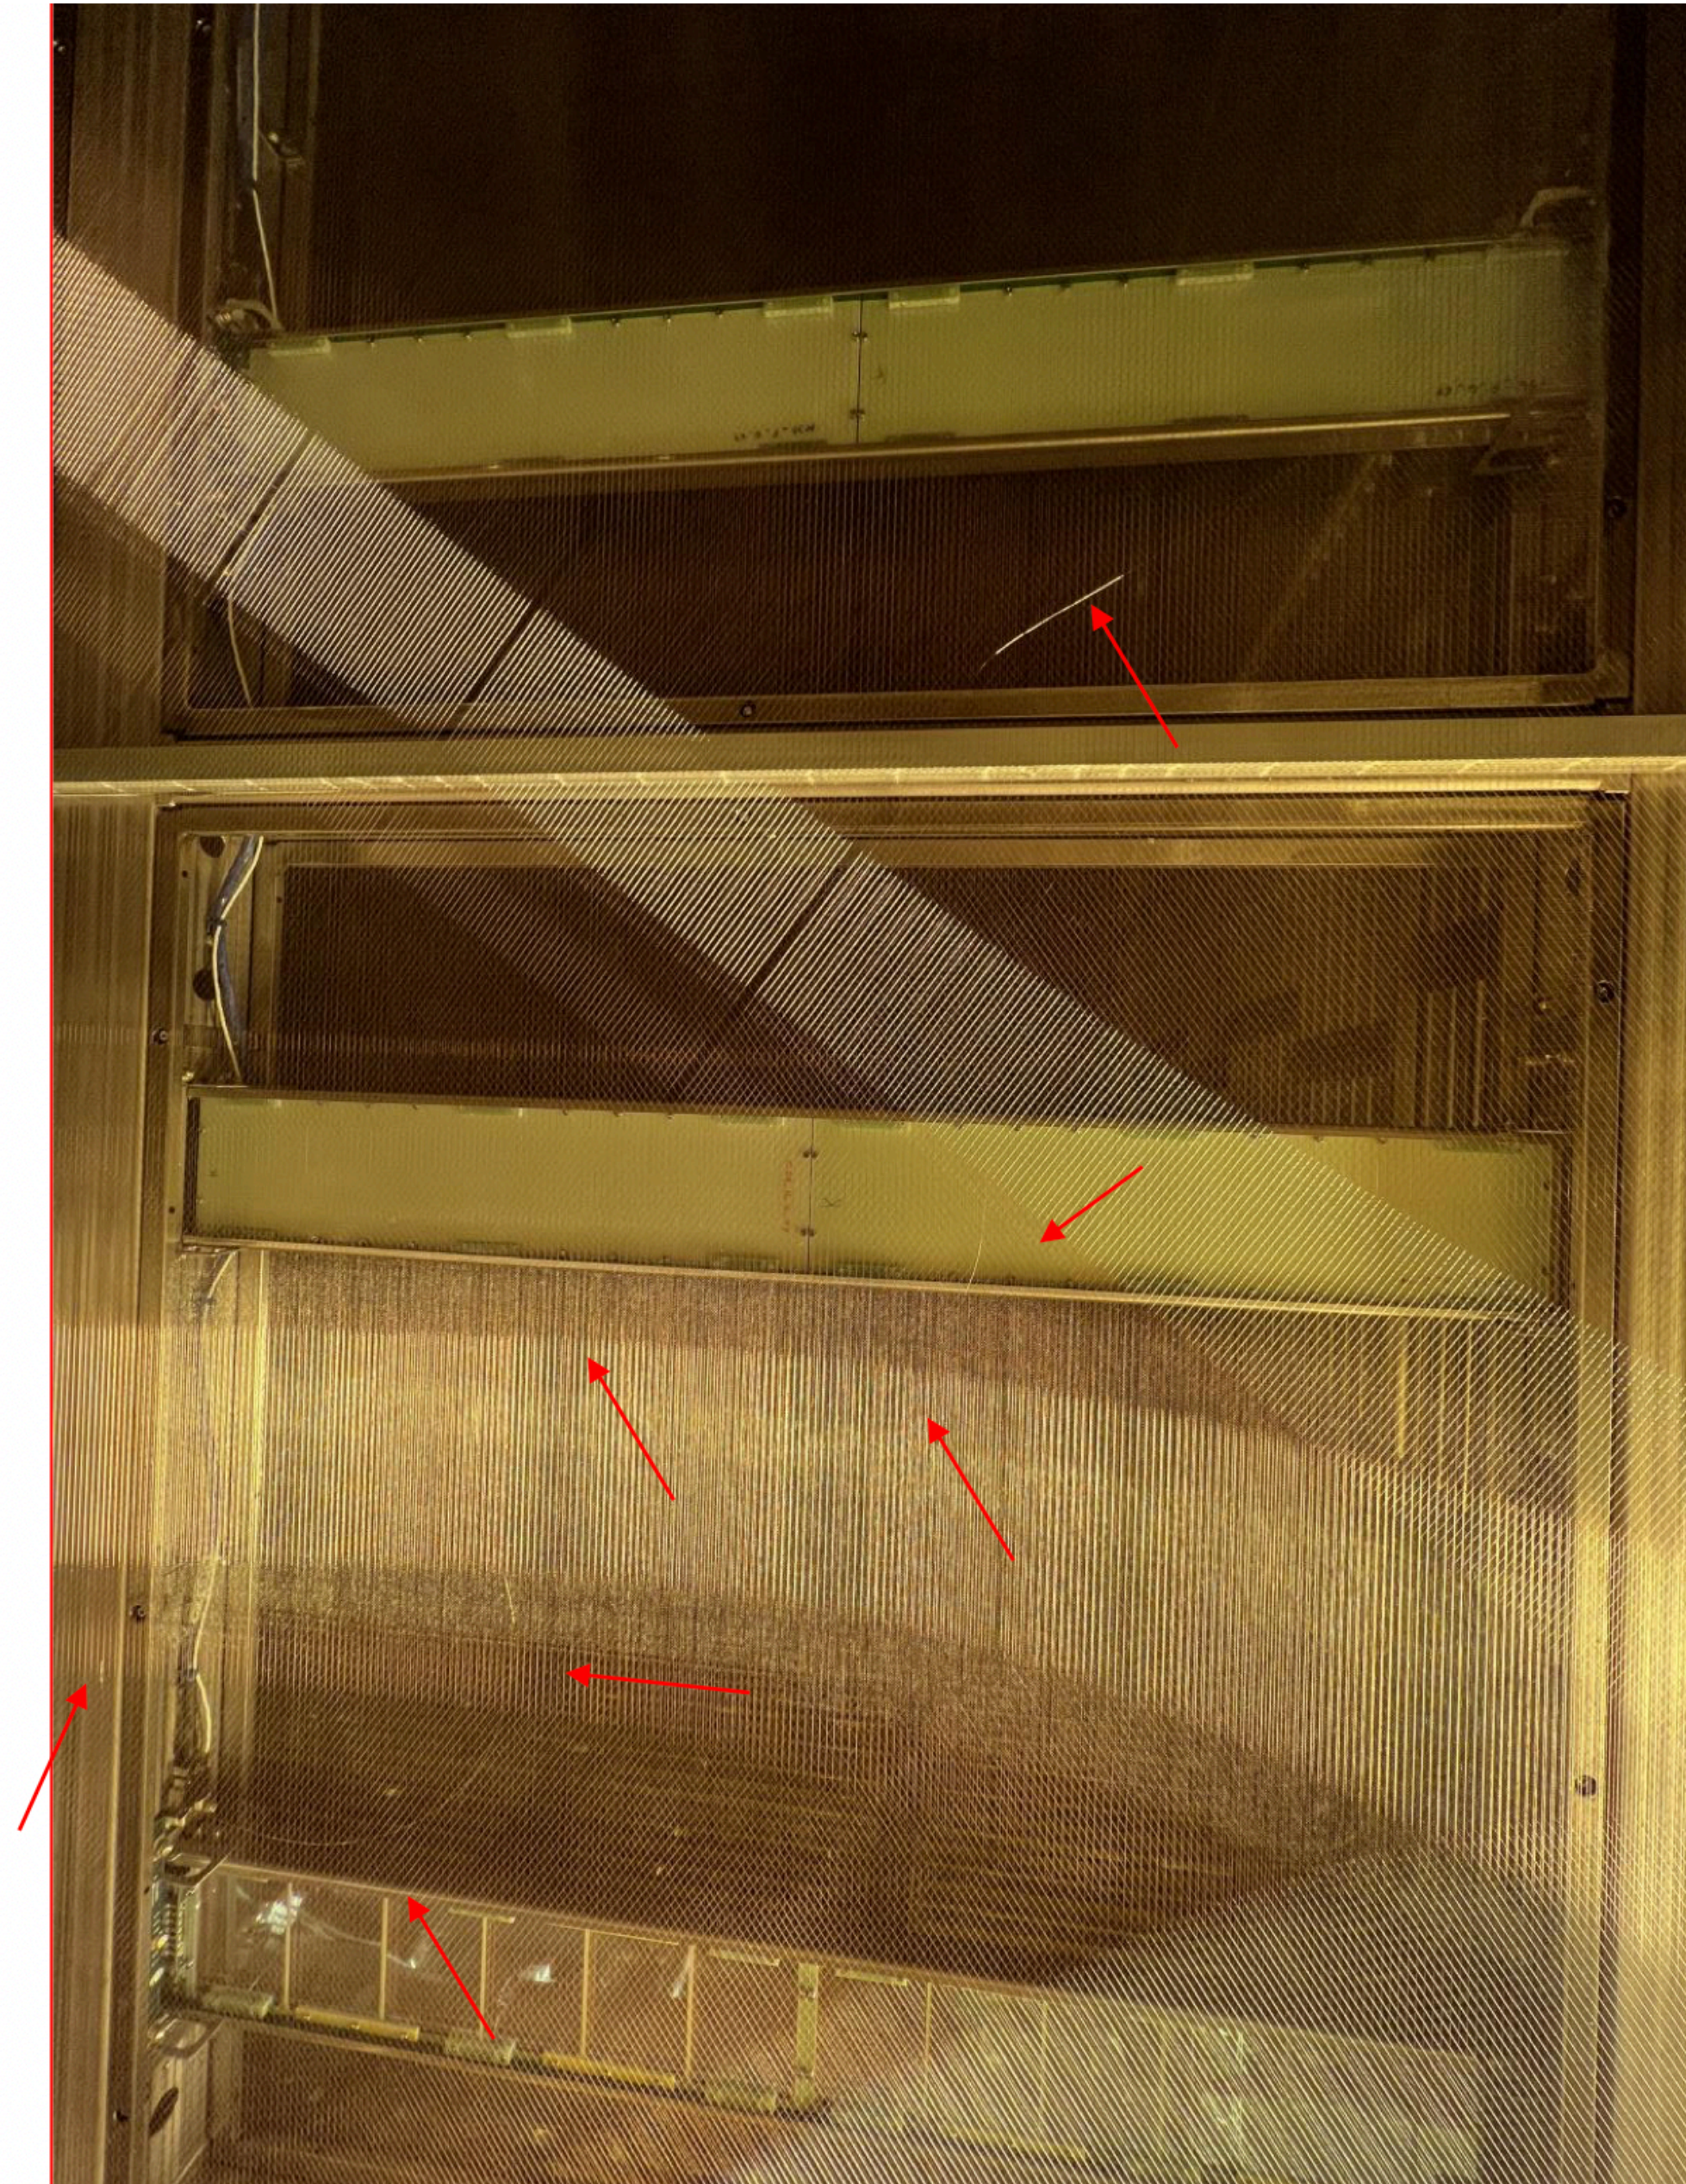
APA3 newly broken wire found on Dec 7th

- The open channel caused by the new broken wire shows up in the first Cryostat run
- The location of the broken wire is on the B side, adapter board 7, V2
- It seems that the broken wire causes random high noise channels in APA3
- Noise runs are taken regularly to keep track of the APAs performance

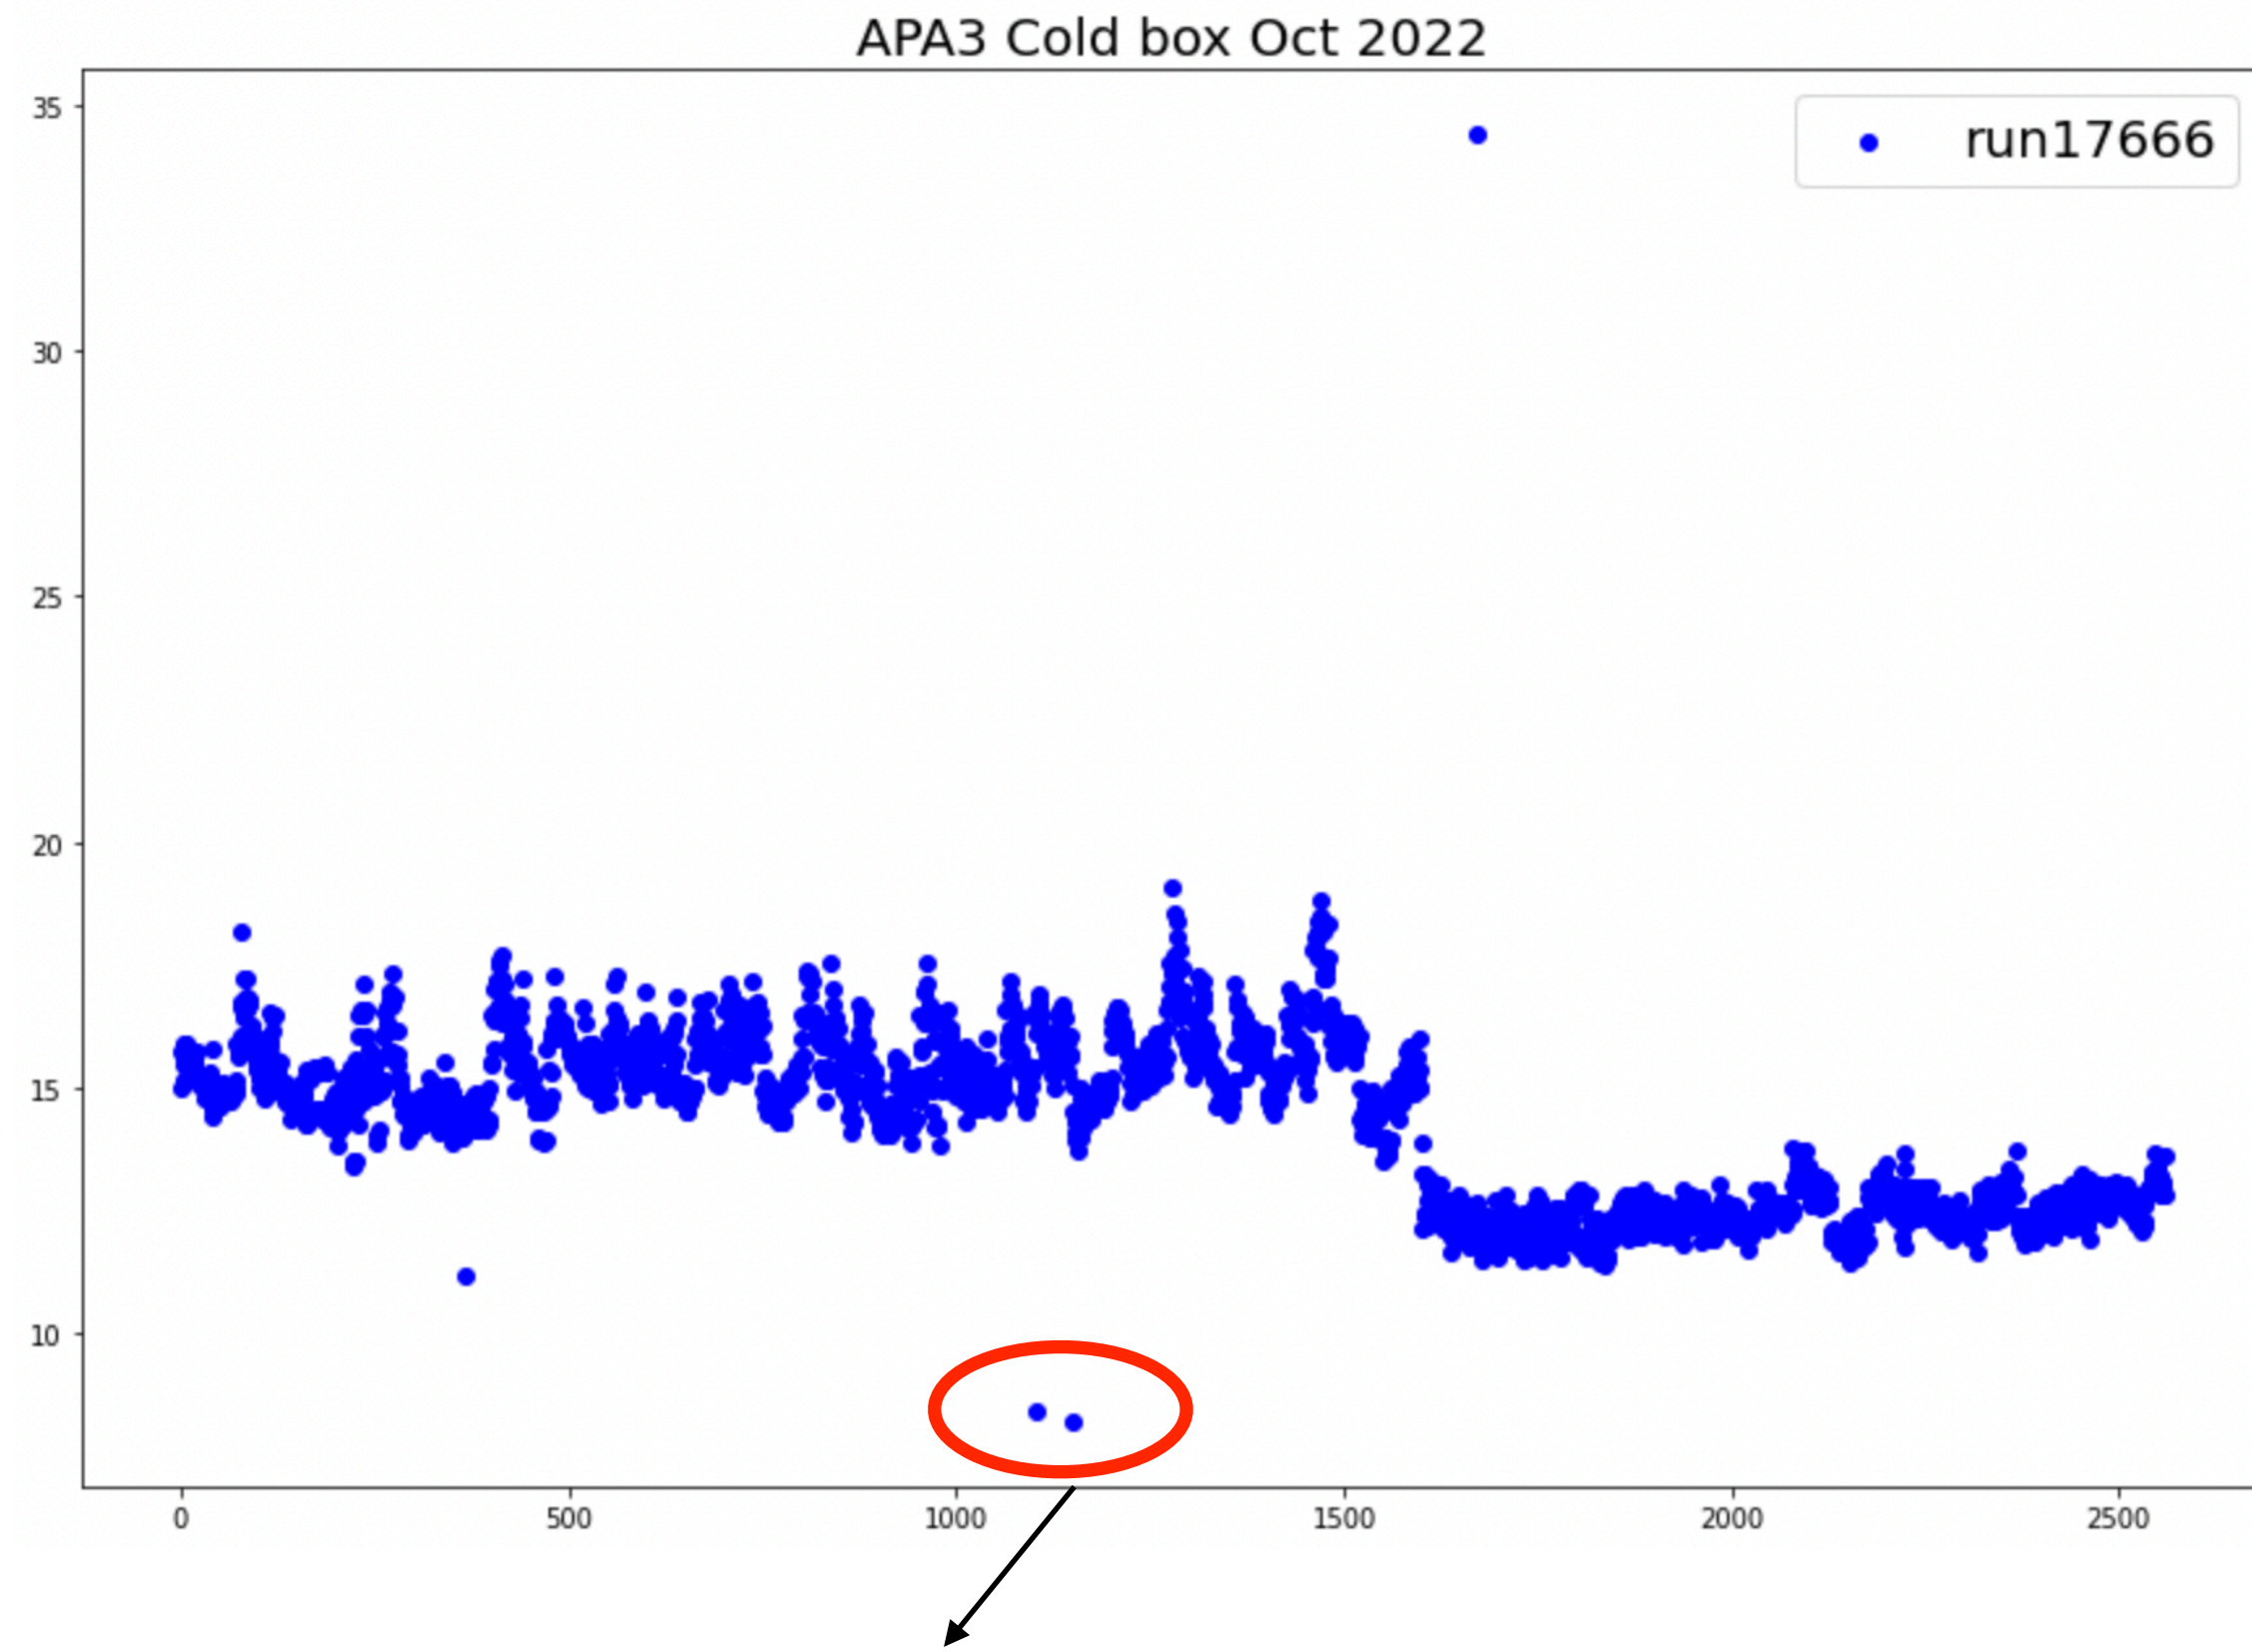
One of the last APA3 cold box on Oct 2022

Offline Channels

FEMBs

1102	—>	FEMB 8, ch 72
1149	—>	FEMB 9, ch 106

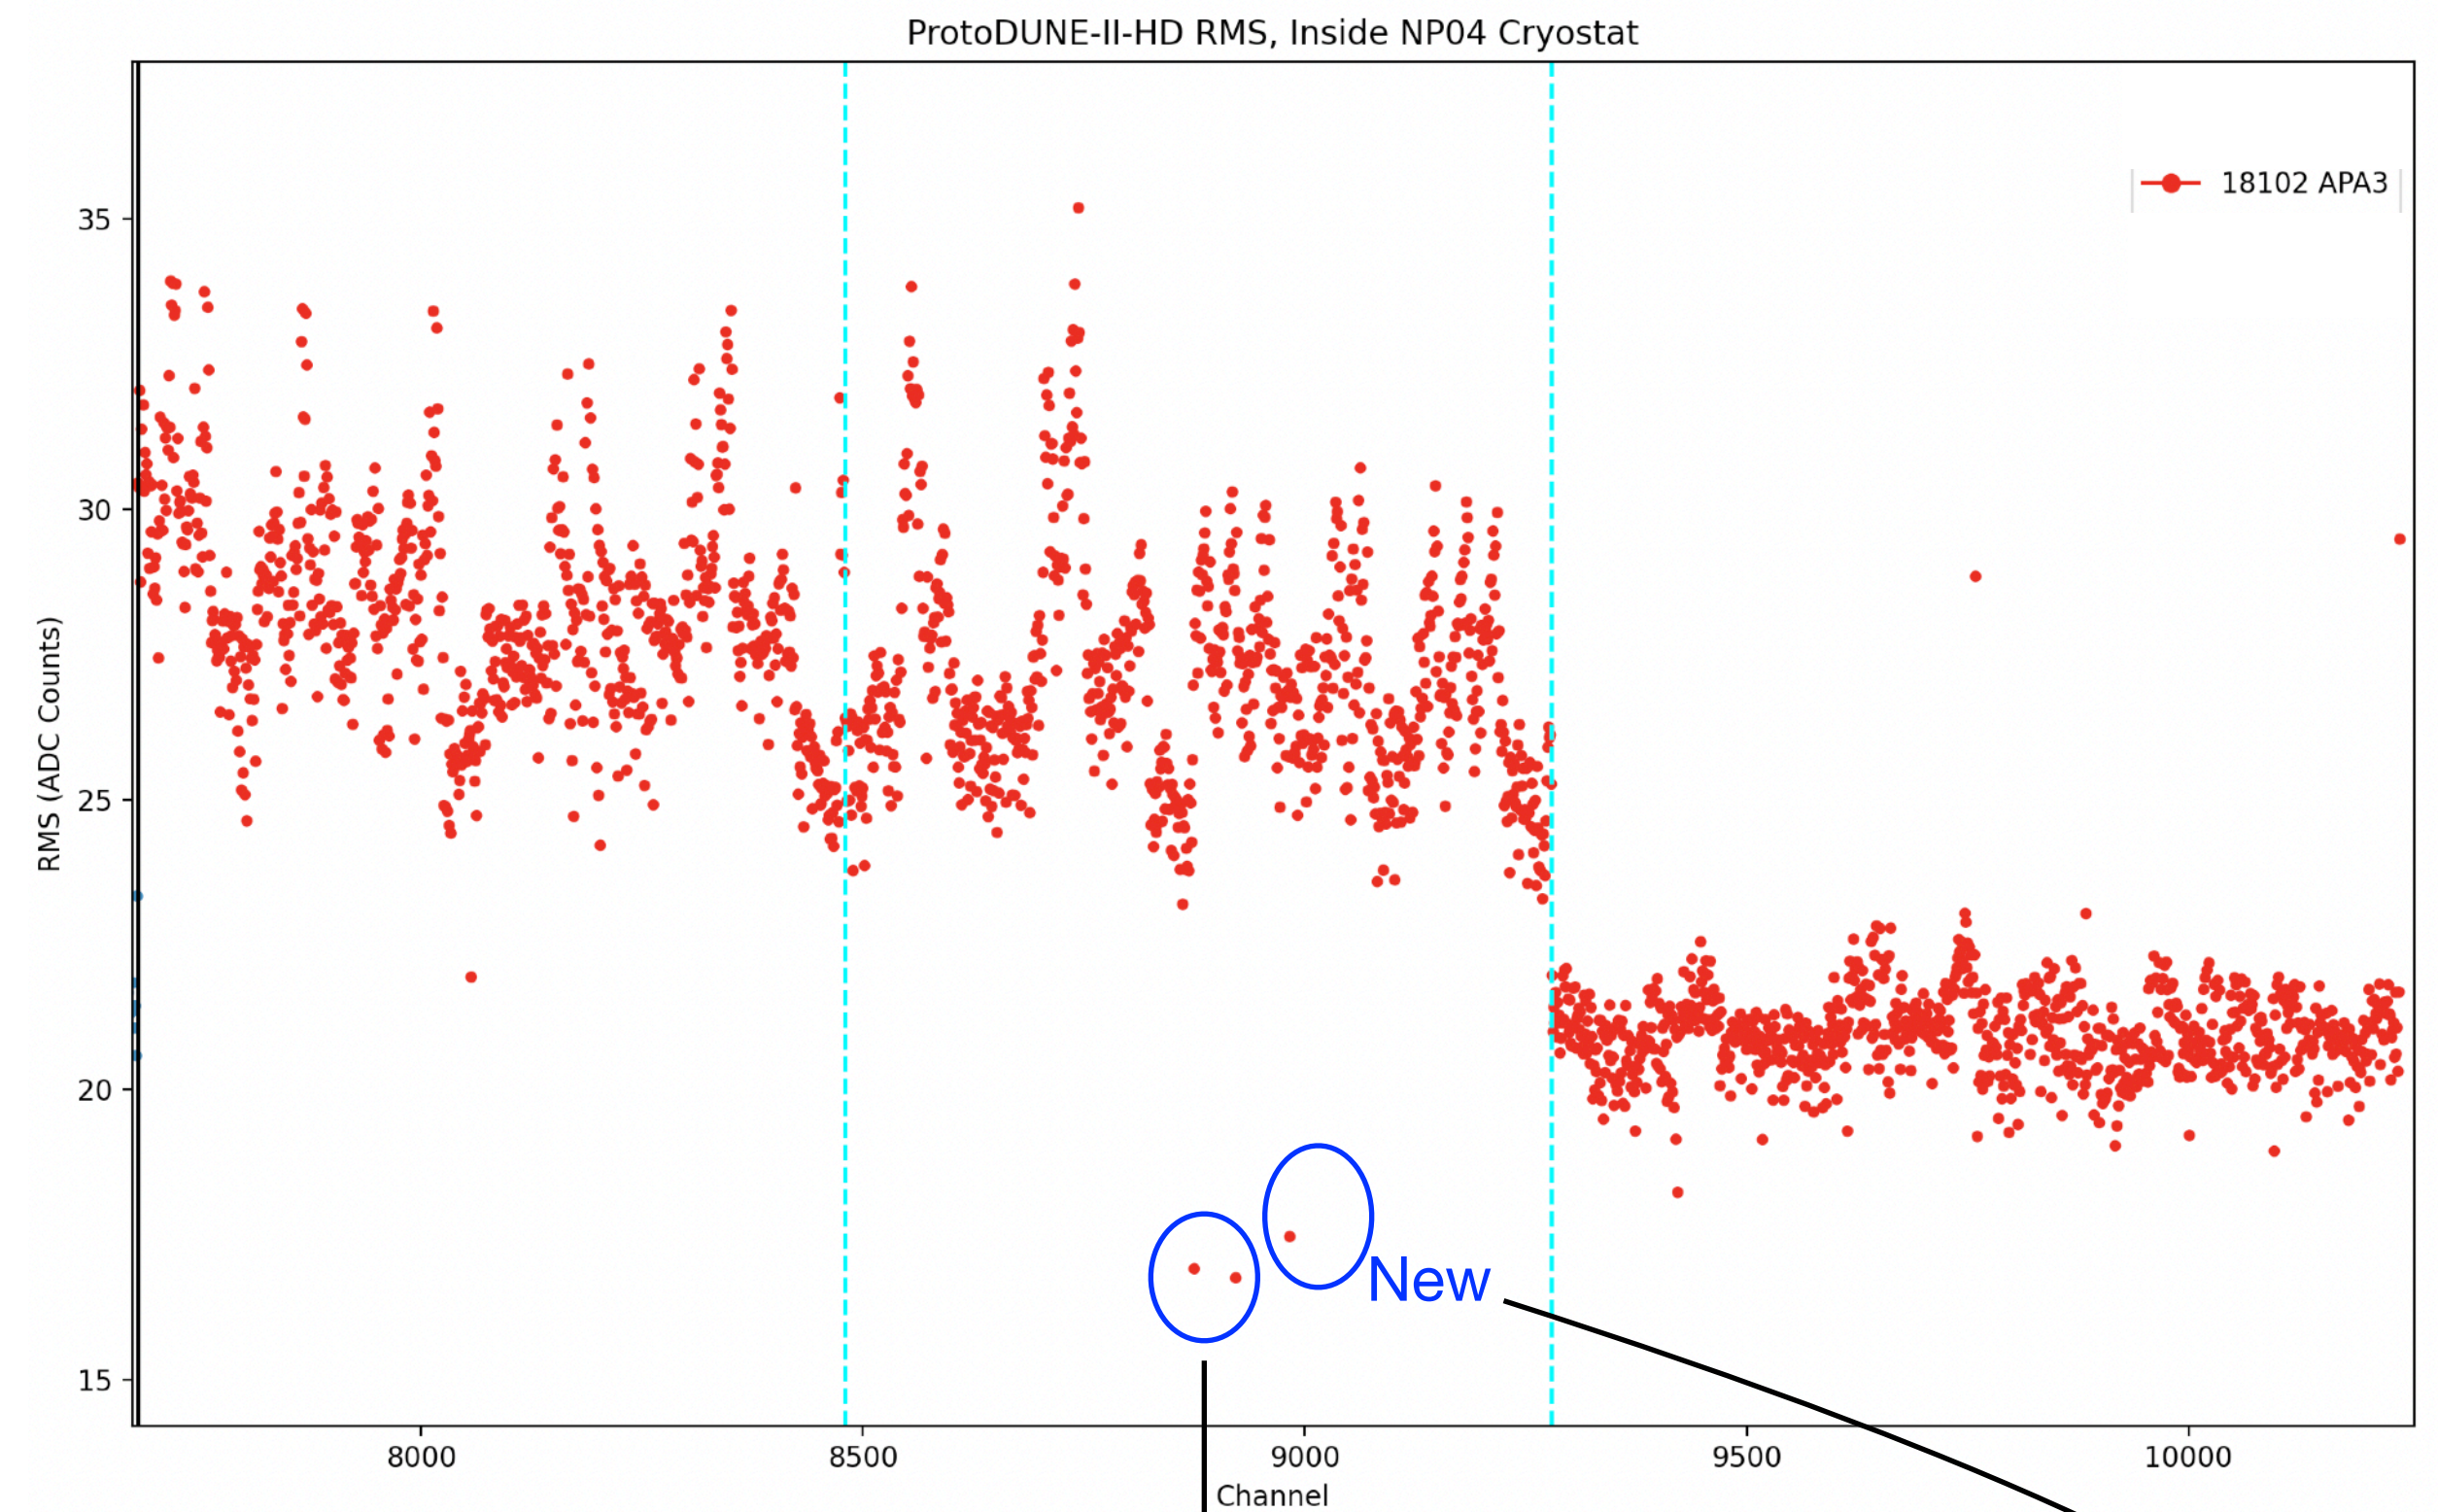
First cryostat run, Nov. 23 2022

Offline Channels

FEMBs

8922	—>	FEMB 8, ch 72
8875	—>	FEMB 9, ch 106
8983	—>	FEMB 7, ch 54

V2 wire on adapter board 7

*FEMB channels are raw data channels not U, V, X channels

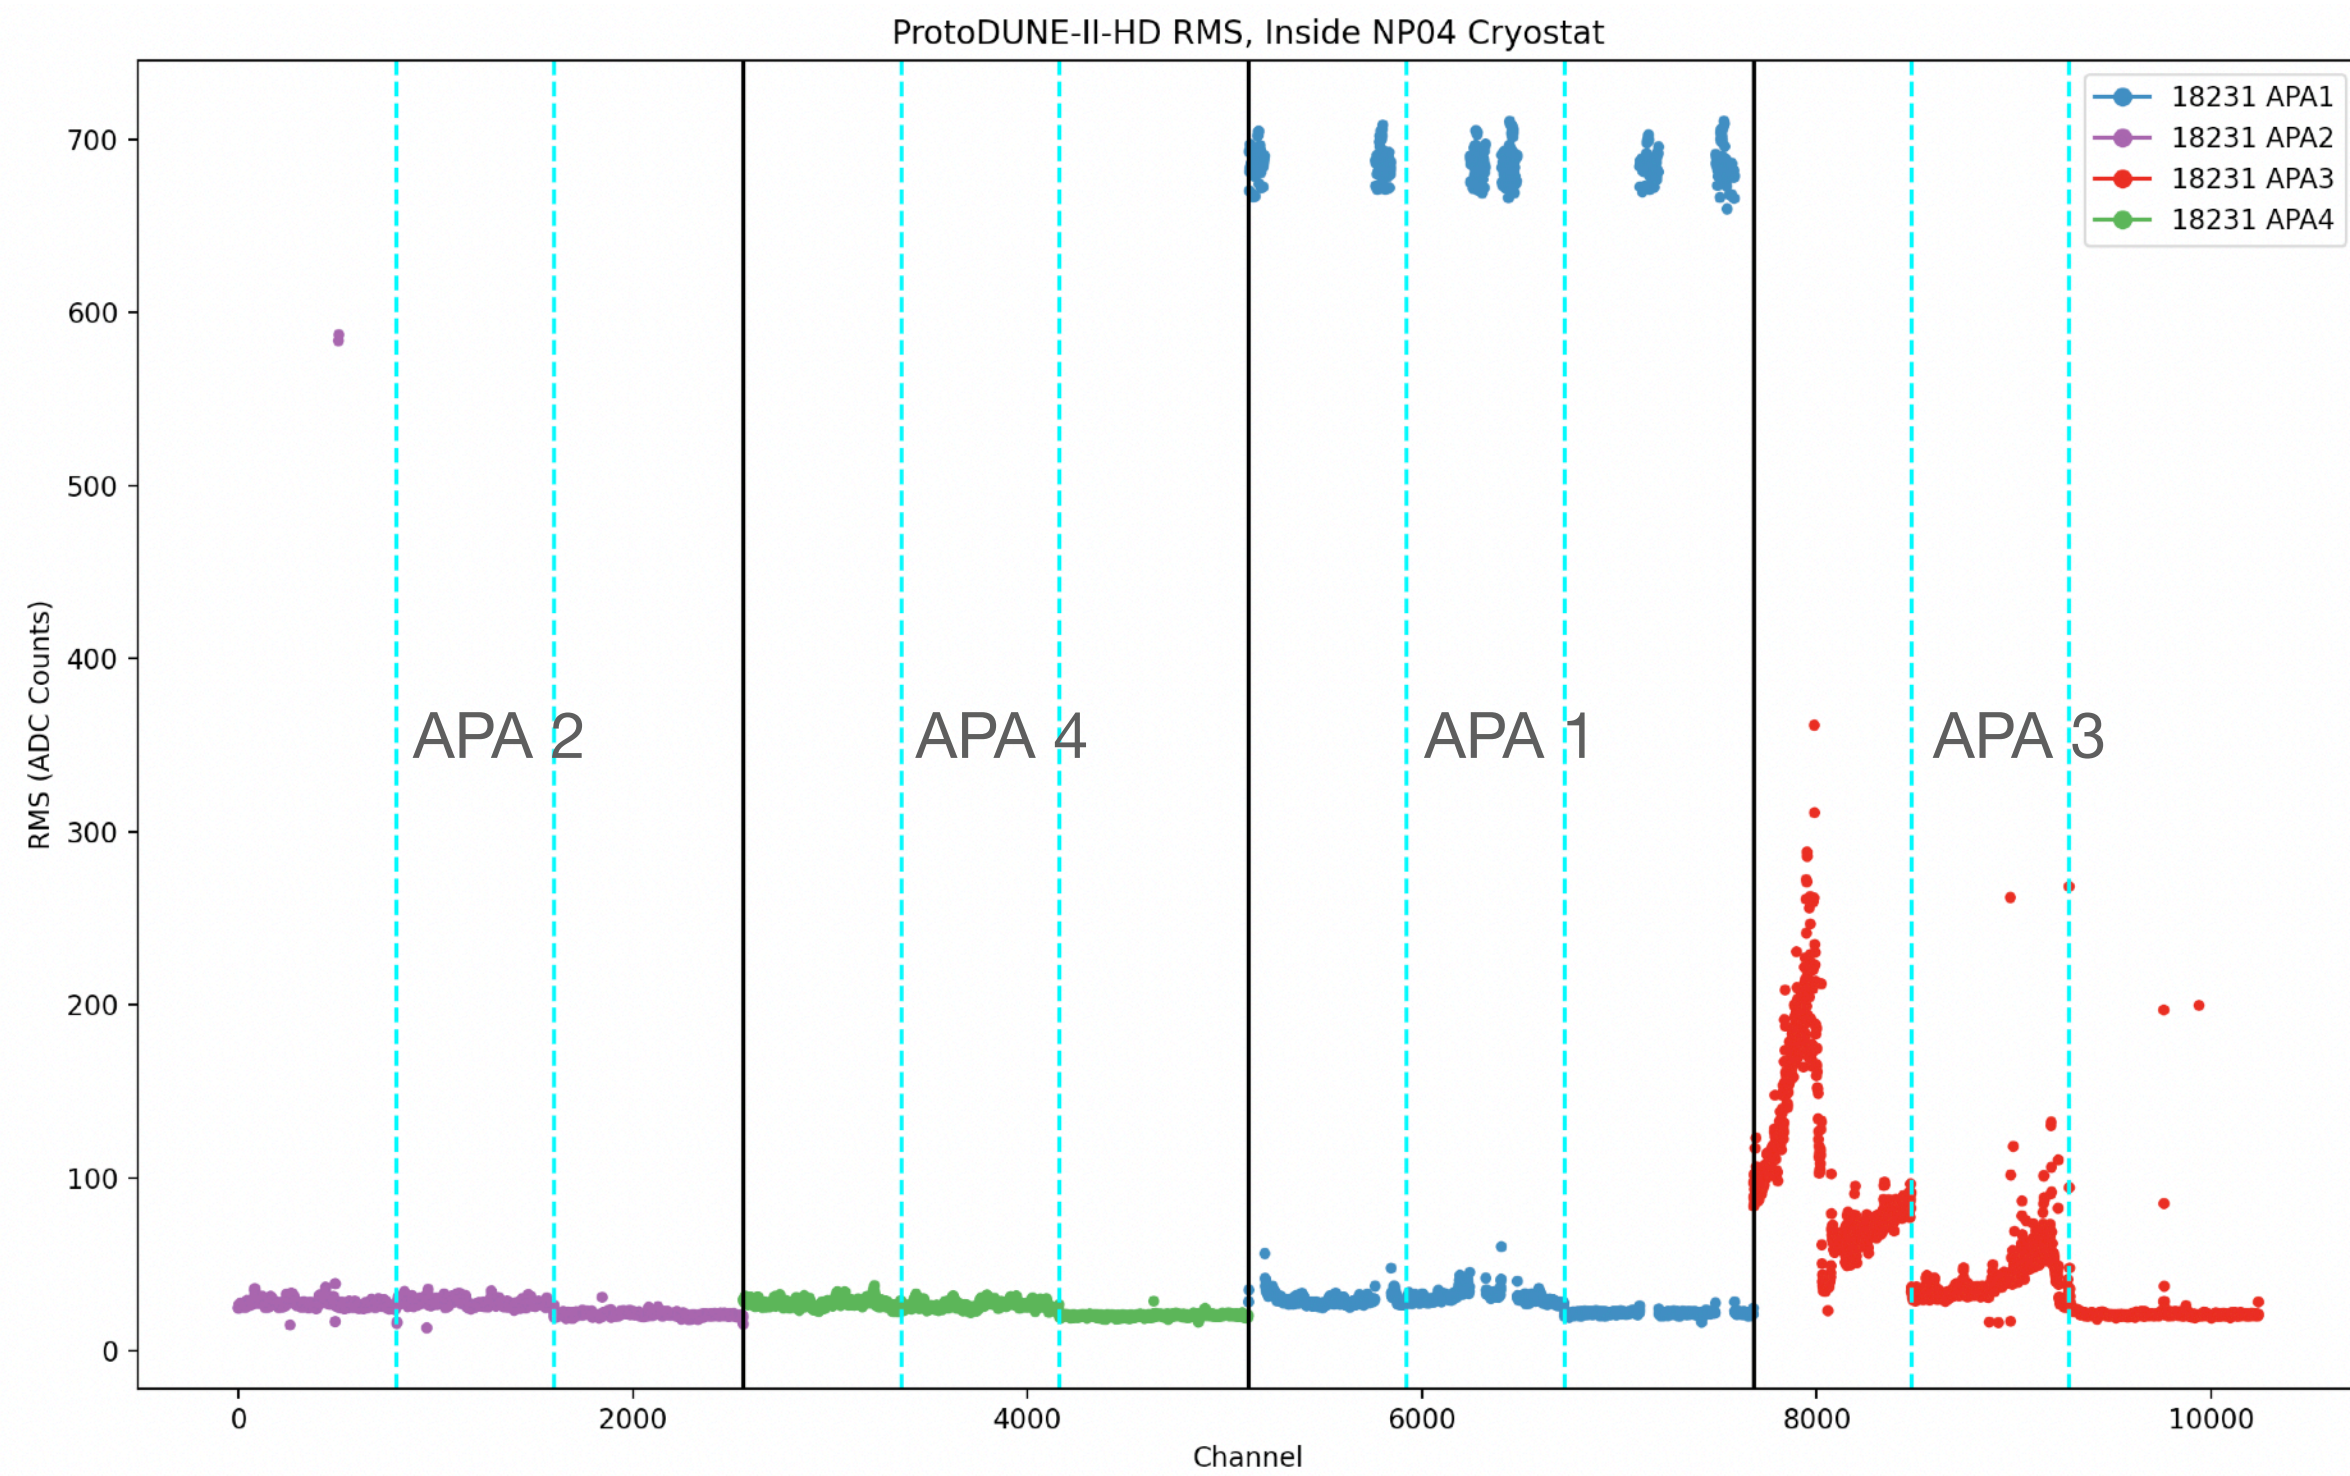
Noise runs in Cryostat

Noticed the newly broken wire

- Two high noise channels on APA 2
- WIB3 on APA 1 are all high noises
- Lots of high noises on APA 3

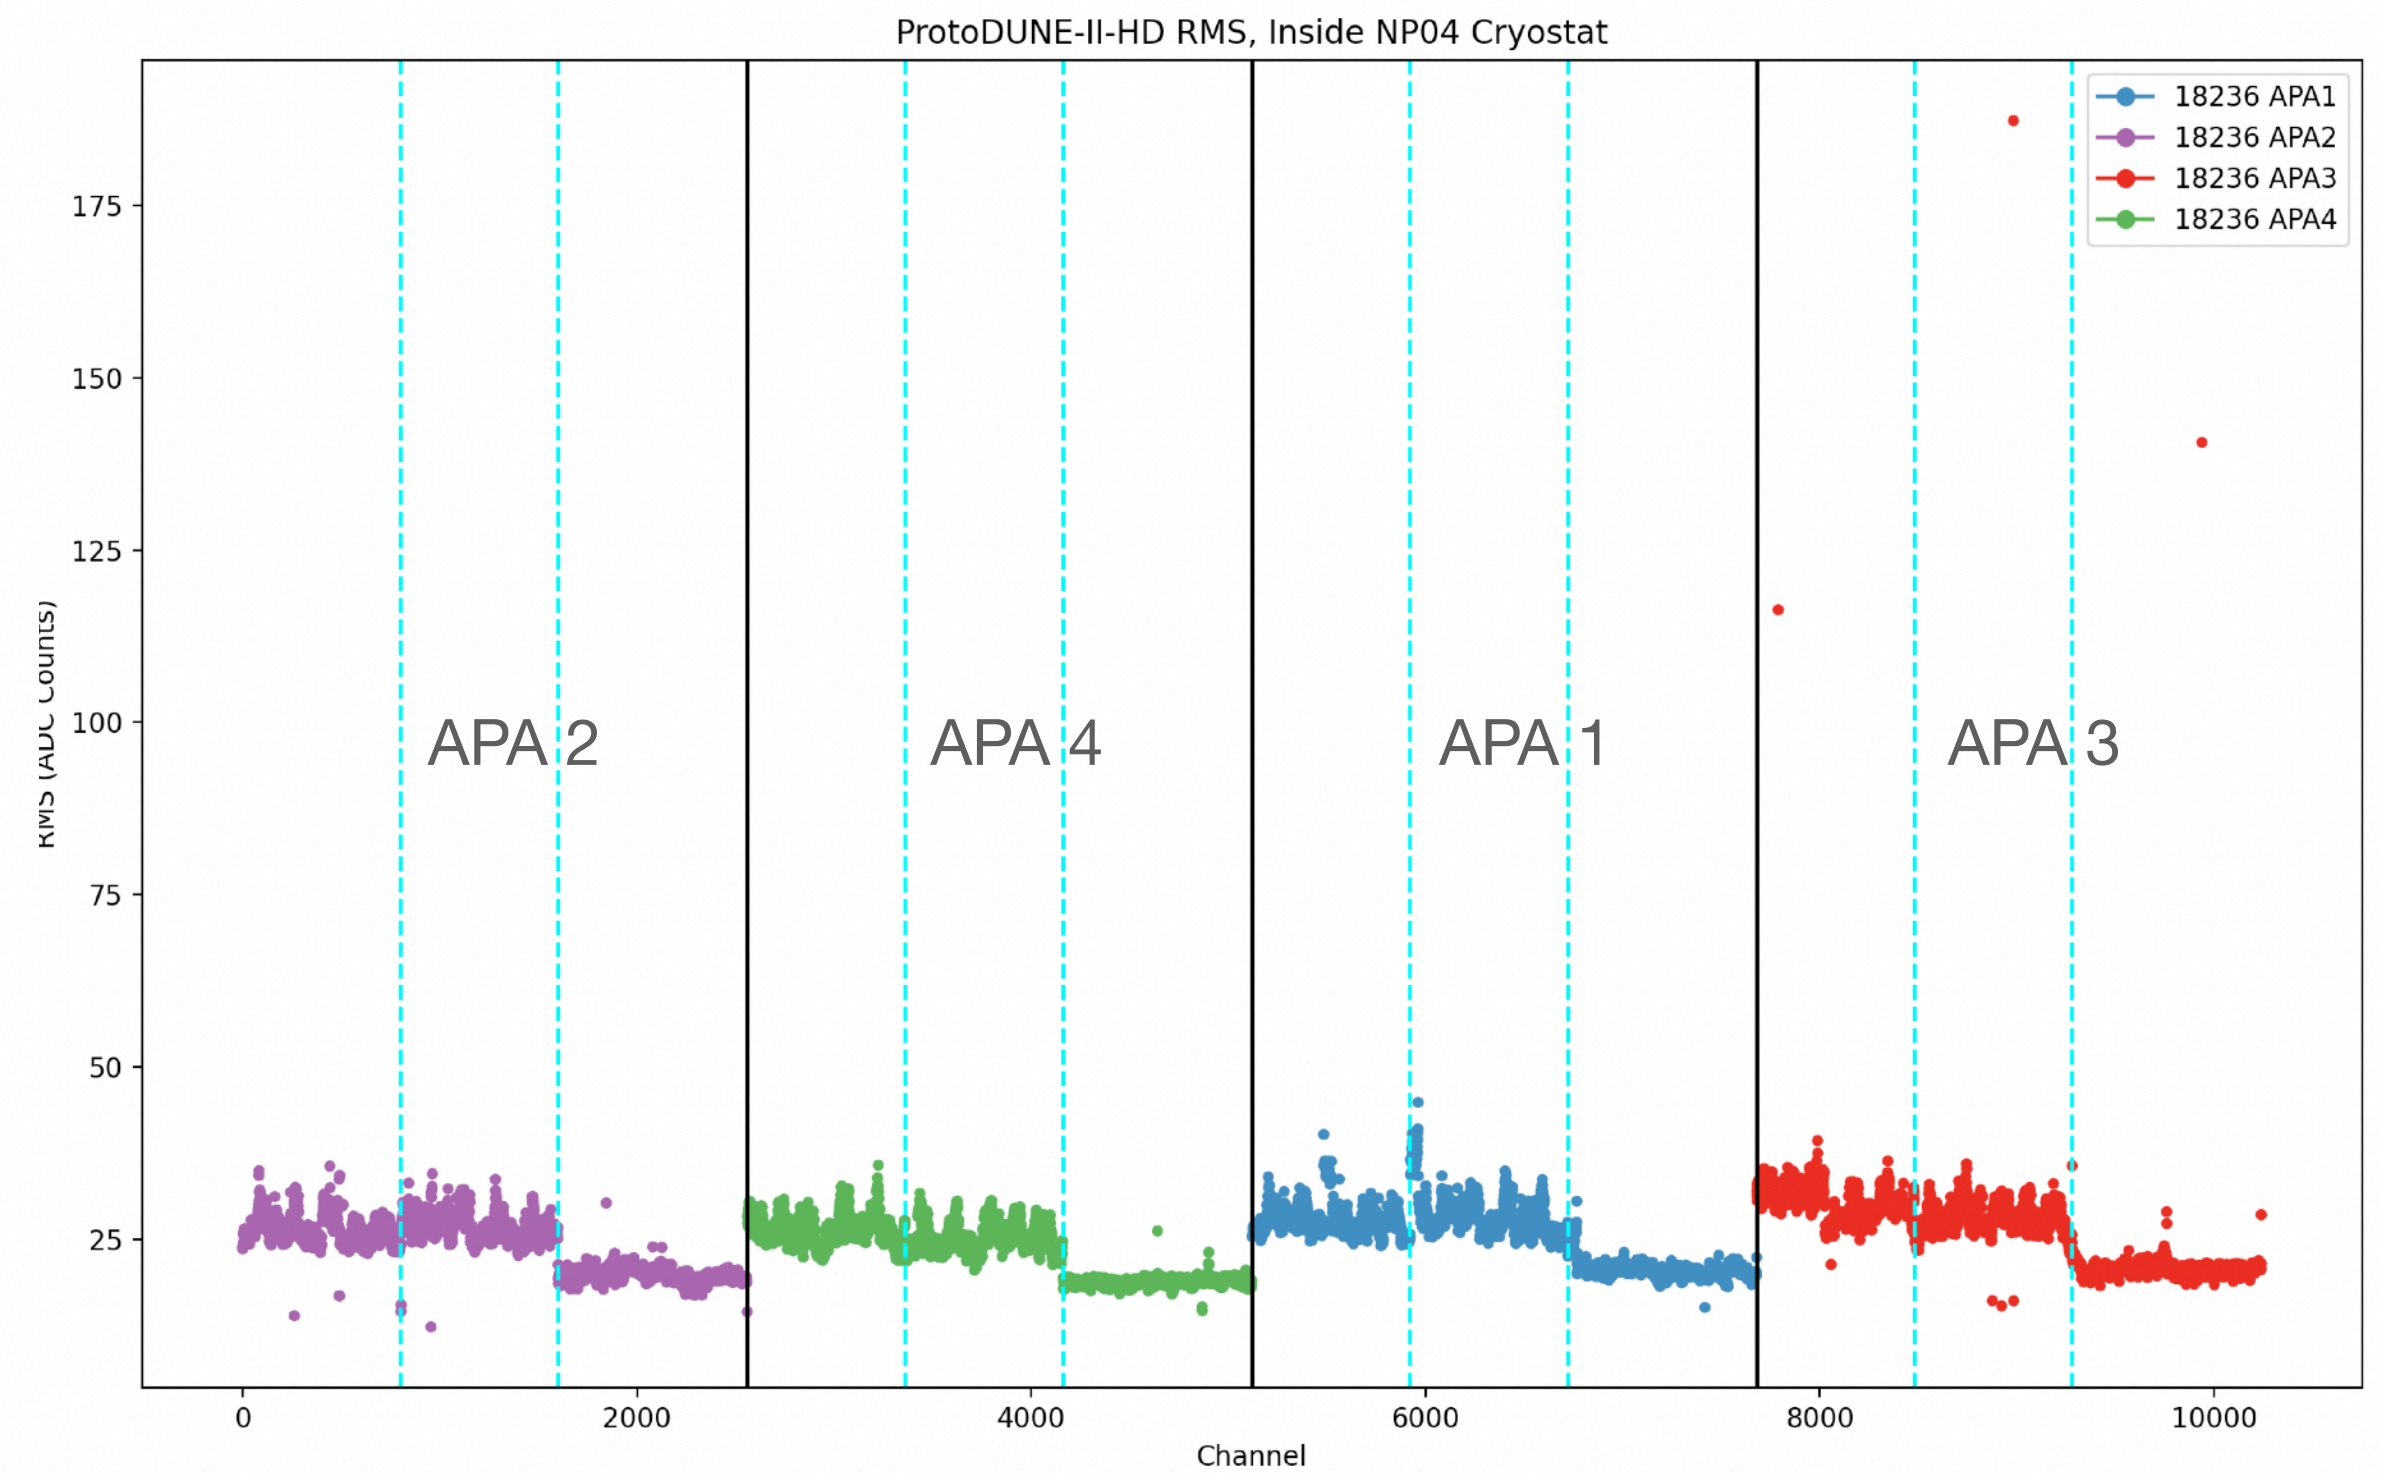
Reboot APA1, APA2, APA4

- APA 1 and APA 2 high noise channels disappeared
- APA 3 high noise channel:
 - 7789 —> FEMB 15, U4
 - 8982 —> FEMB 7, V3
 - 9938 —> FEMB 4, X35

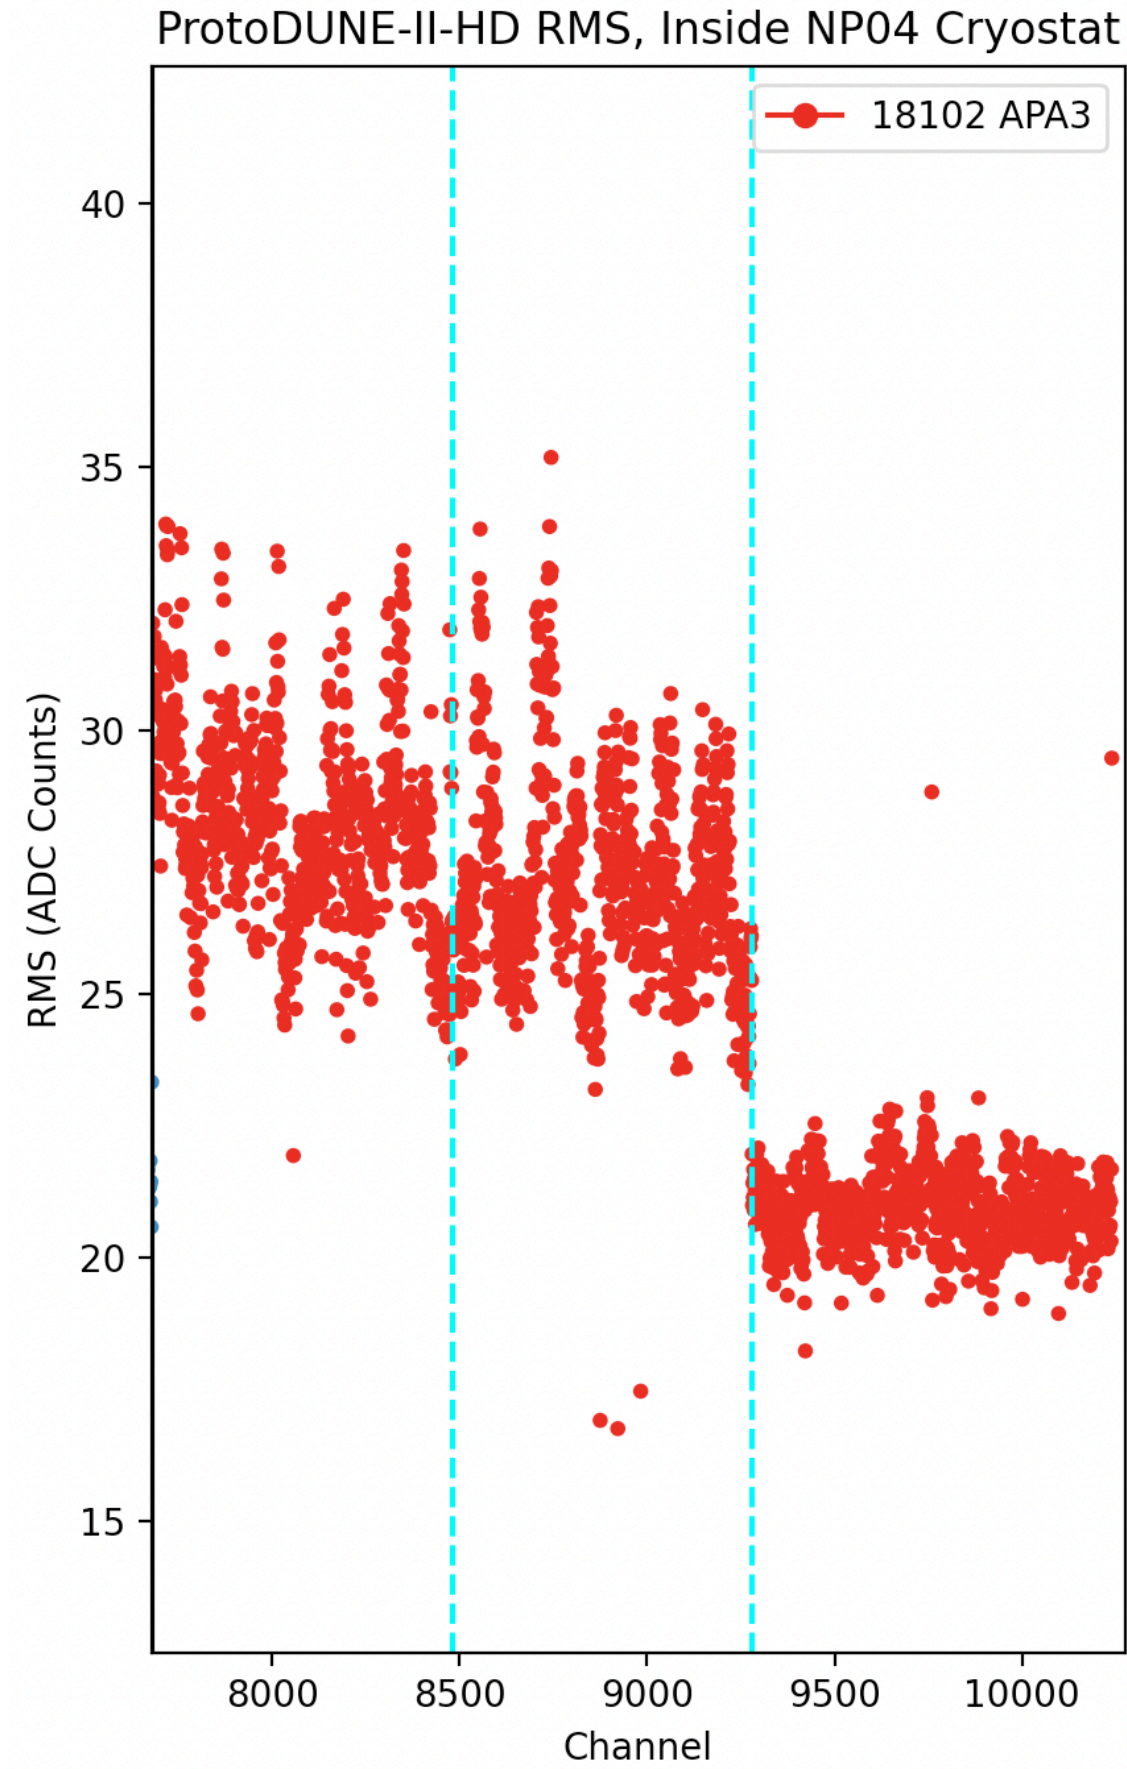
Nov. 23

High noise channels in APA3 in Cryostat

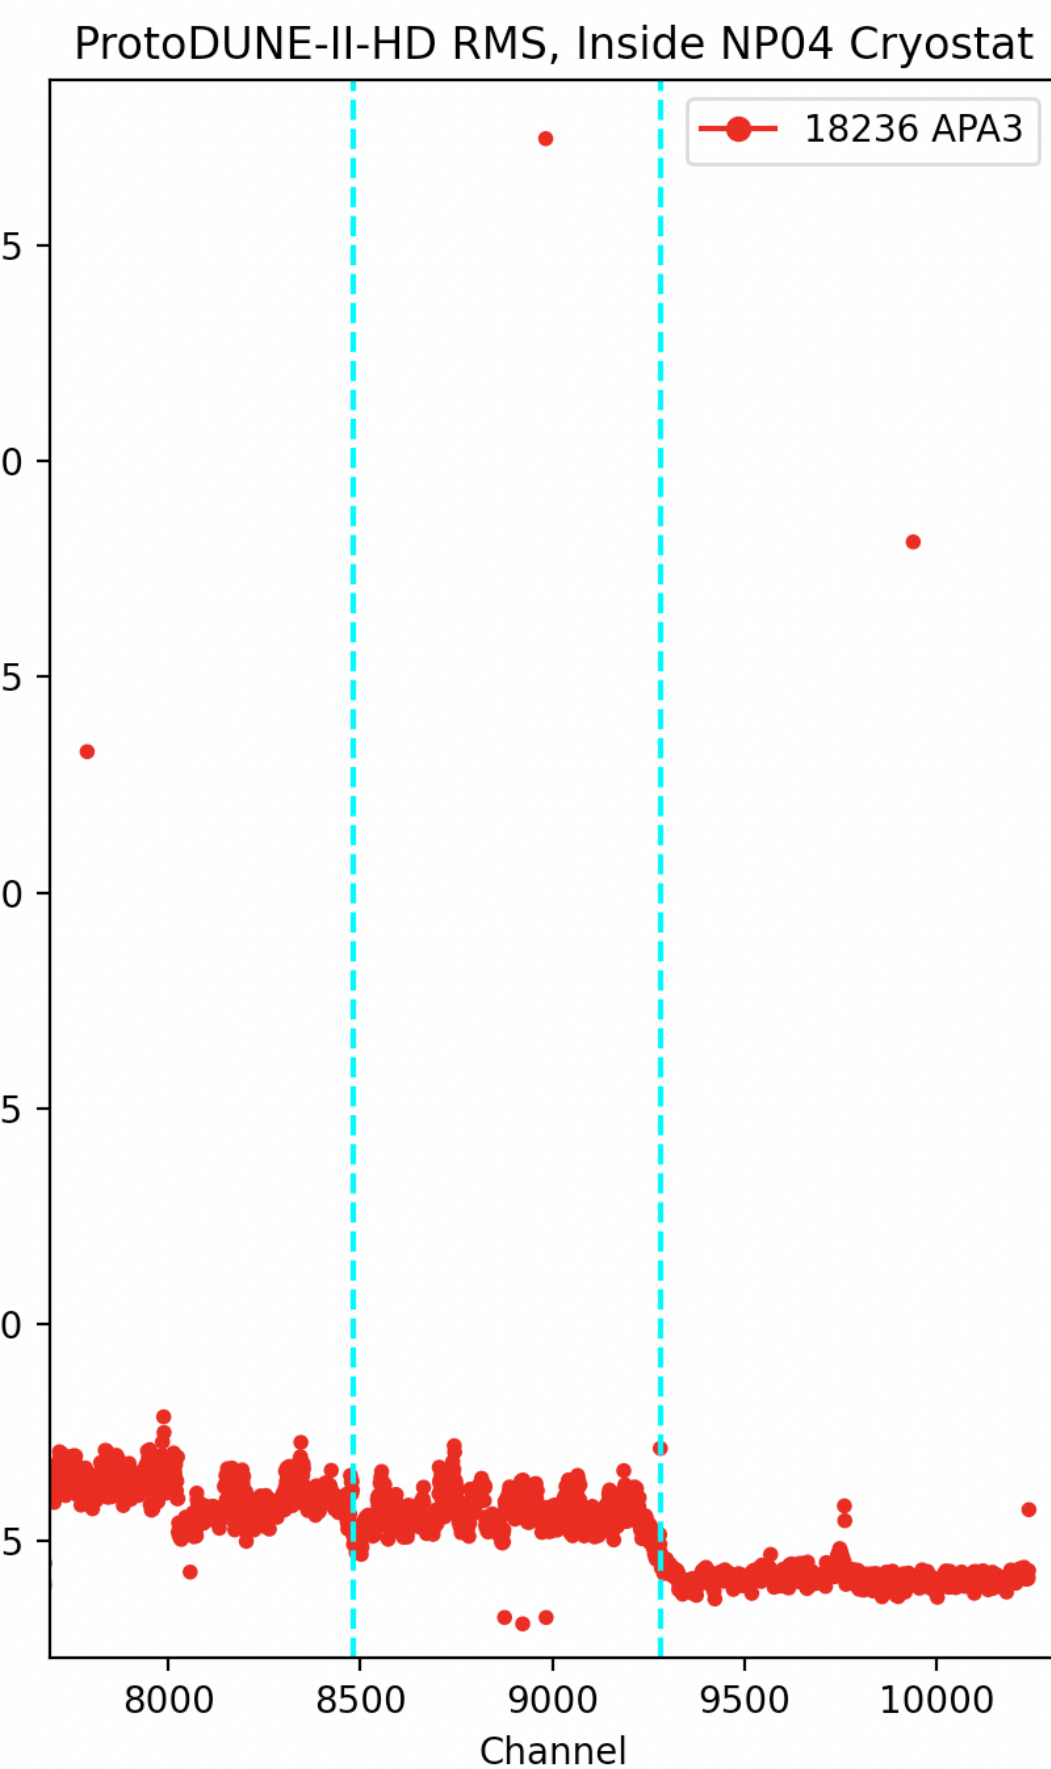
Dec. 9

High noise channels:

- 7789 —> FEMB 15, U4
- 8982 —> FEMB 7, V3
- 9938 —> FEMB 4, X35
