APA3 and CRP5b at CERN updates

Hanjie Liu, Cheng-Ju Lin, Manhong Zhao, Herilala Razafinime, Miriama Rajaoalisoa
12/20/2022

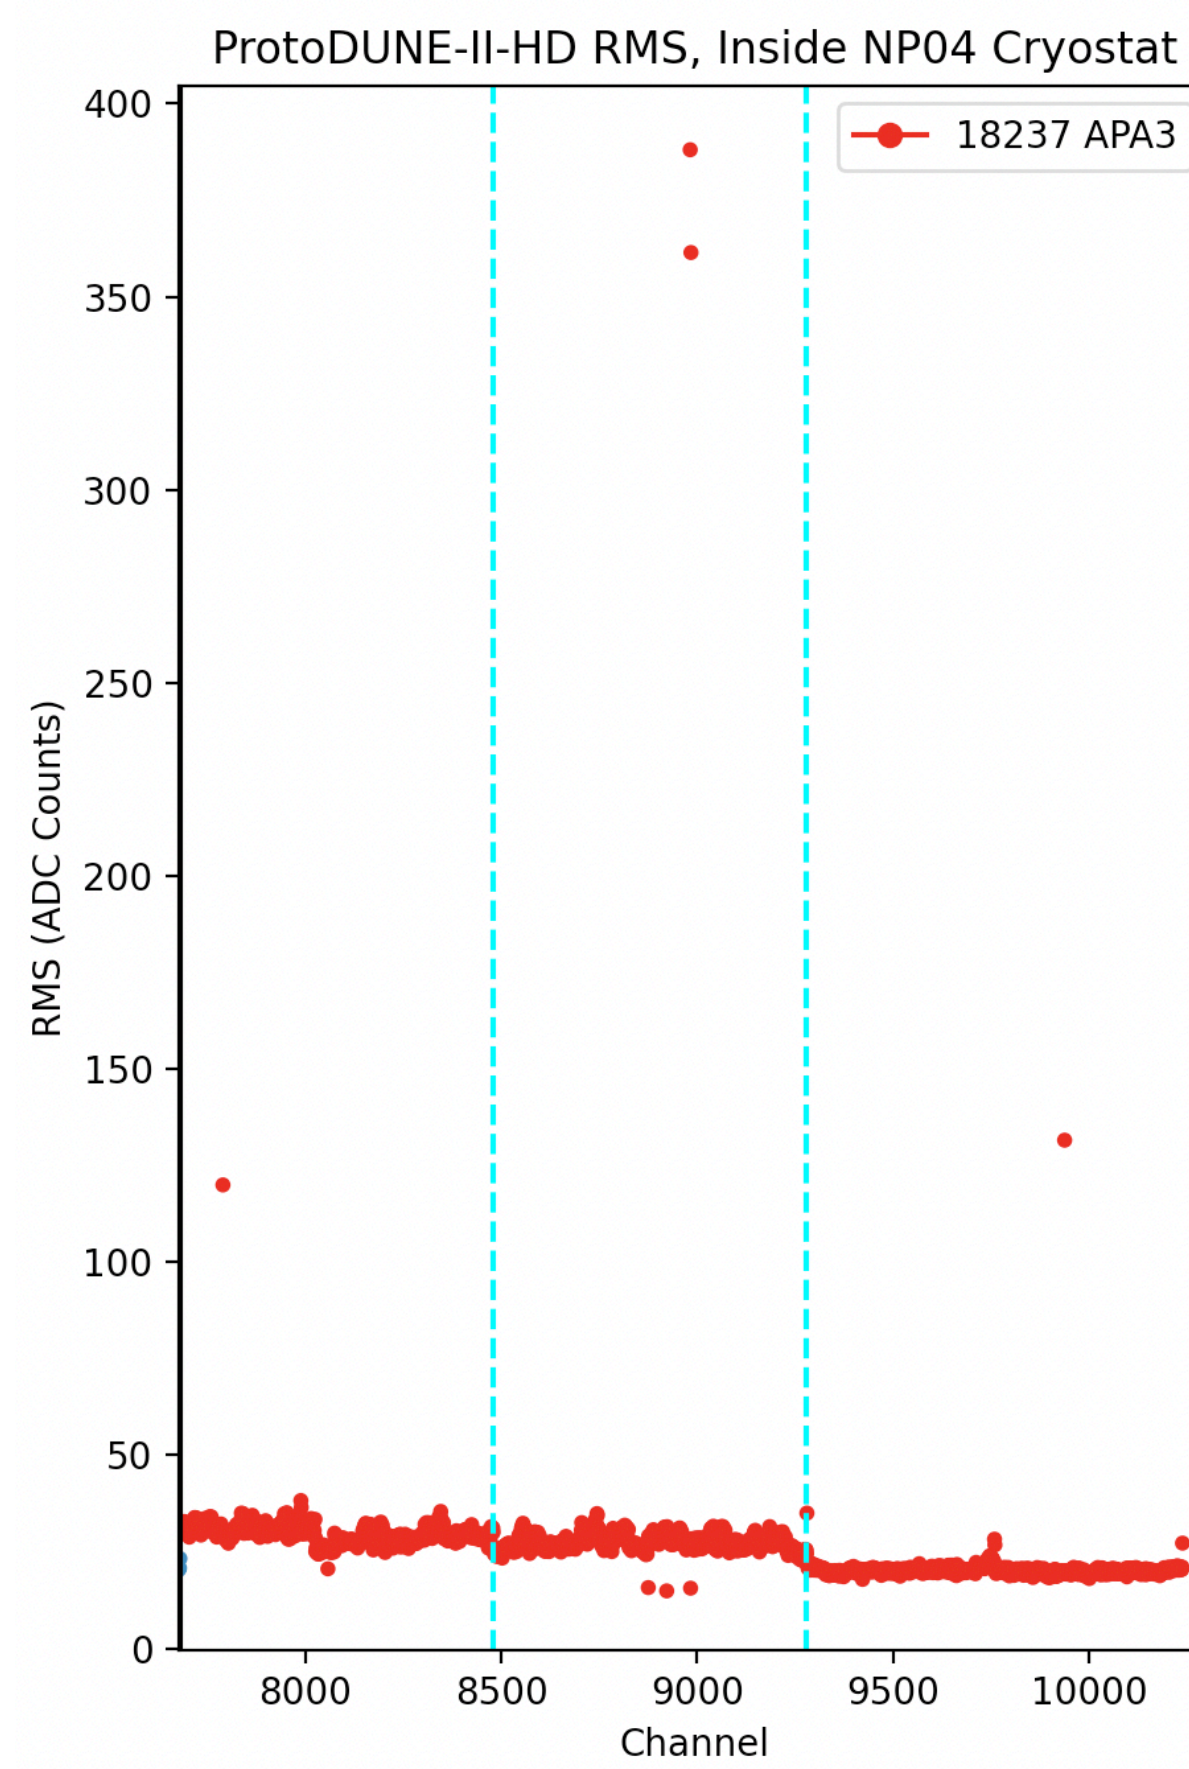
Dec. 11

High noise channels:

- 7789 —> FEMB 15, U4
- 8982 —> FEMB 7, V3
- 9938 —> FEMB 4, X35
- 8984 —> FEMB 7, V1

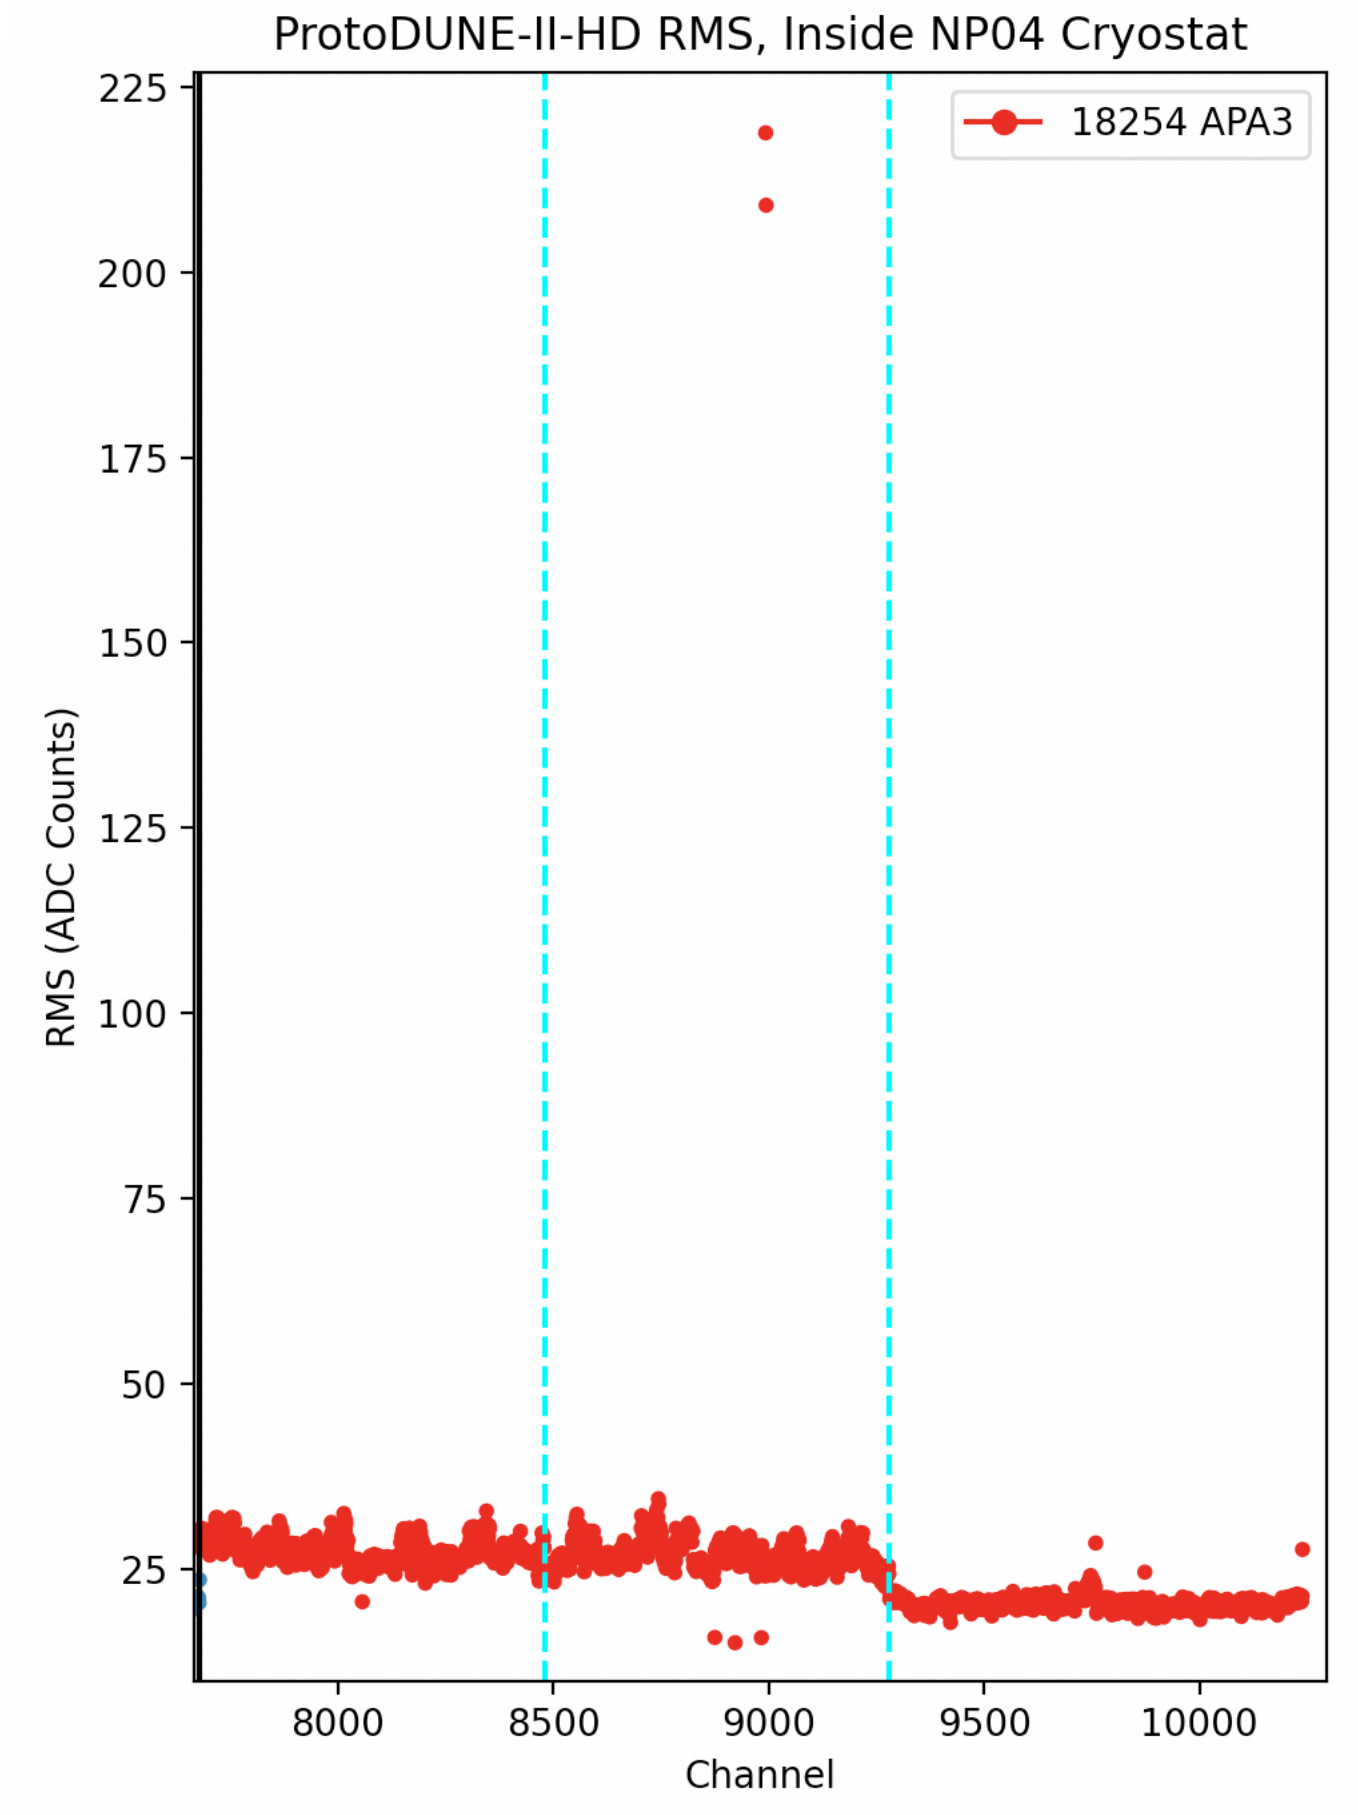
Dec. 12

High noise channels:

- 8993 —> FEMB 6, V32
- 8994 —> FEMB 6, V31

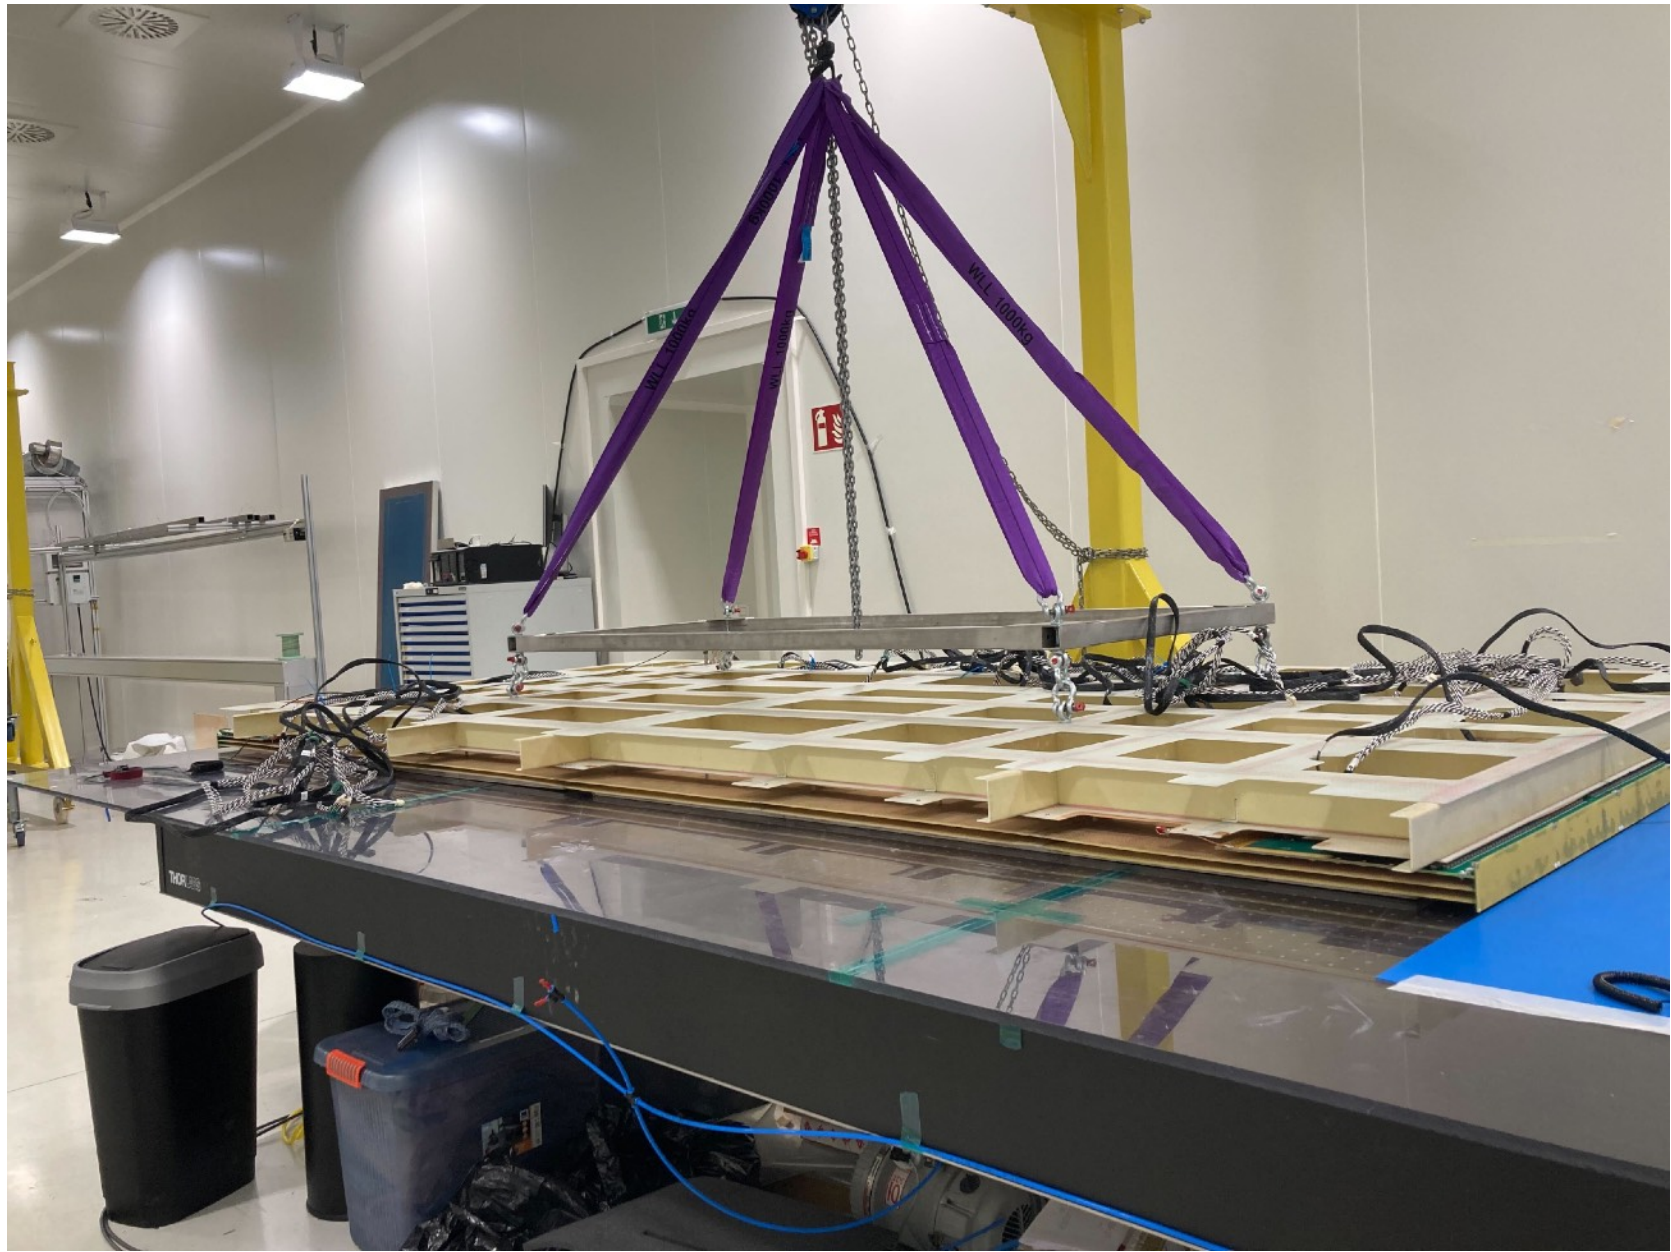
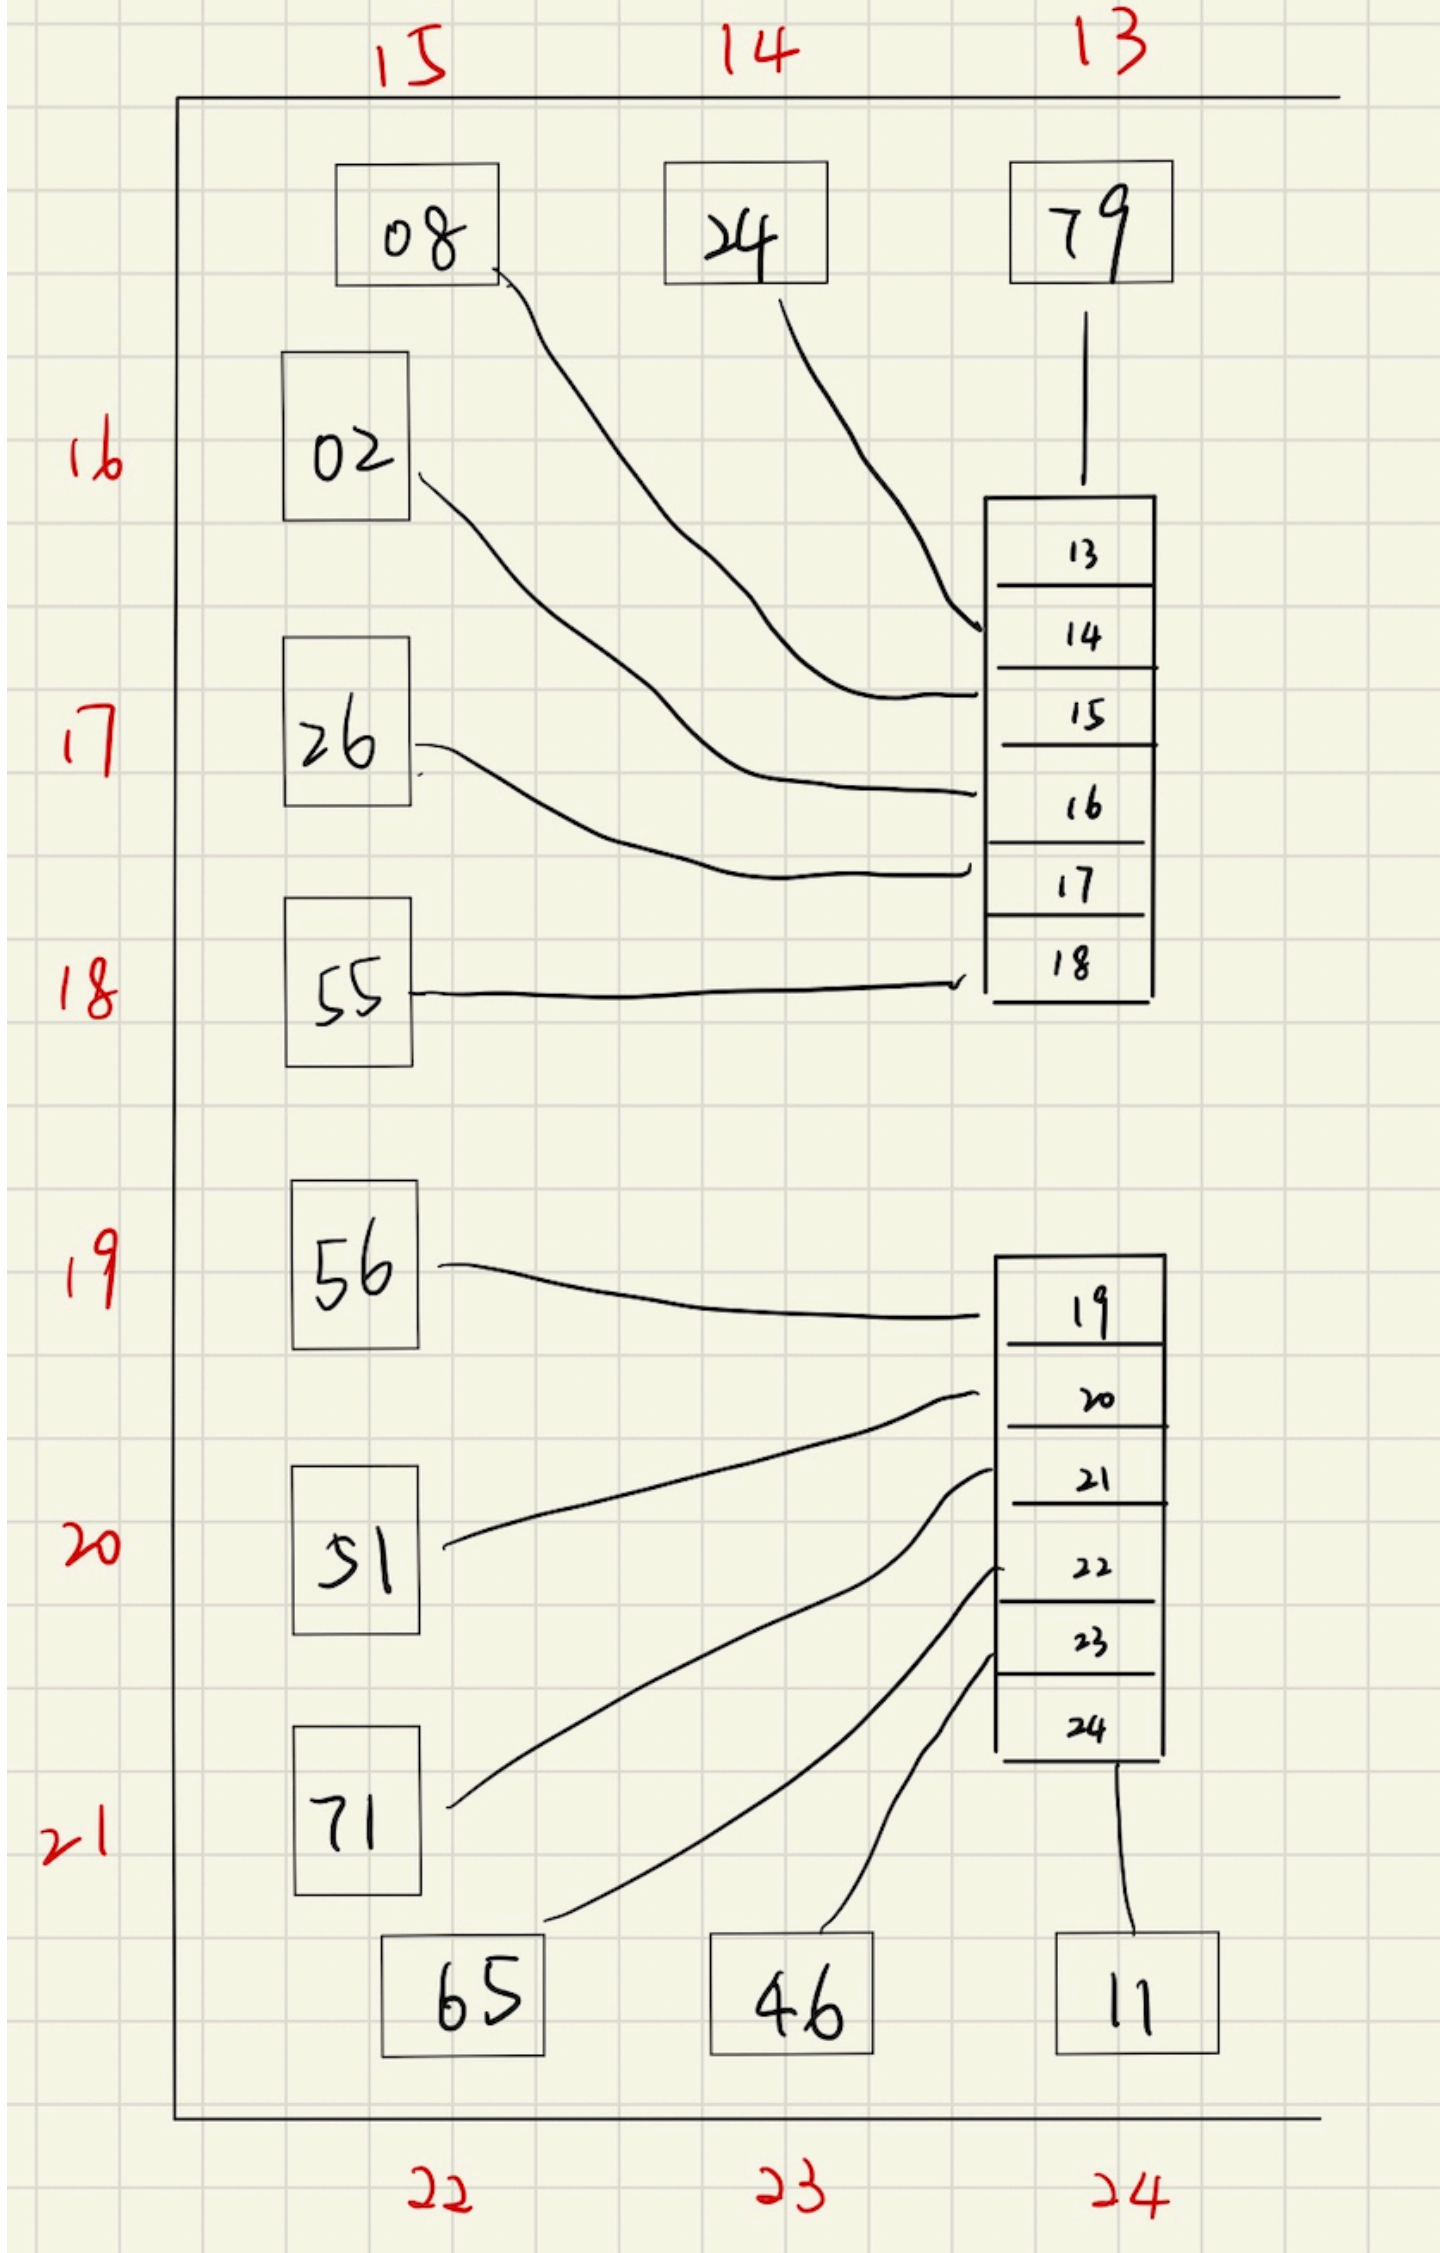
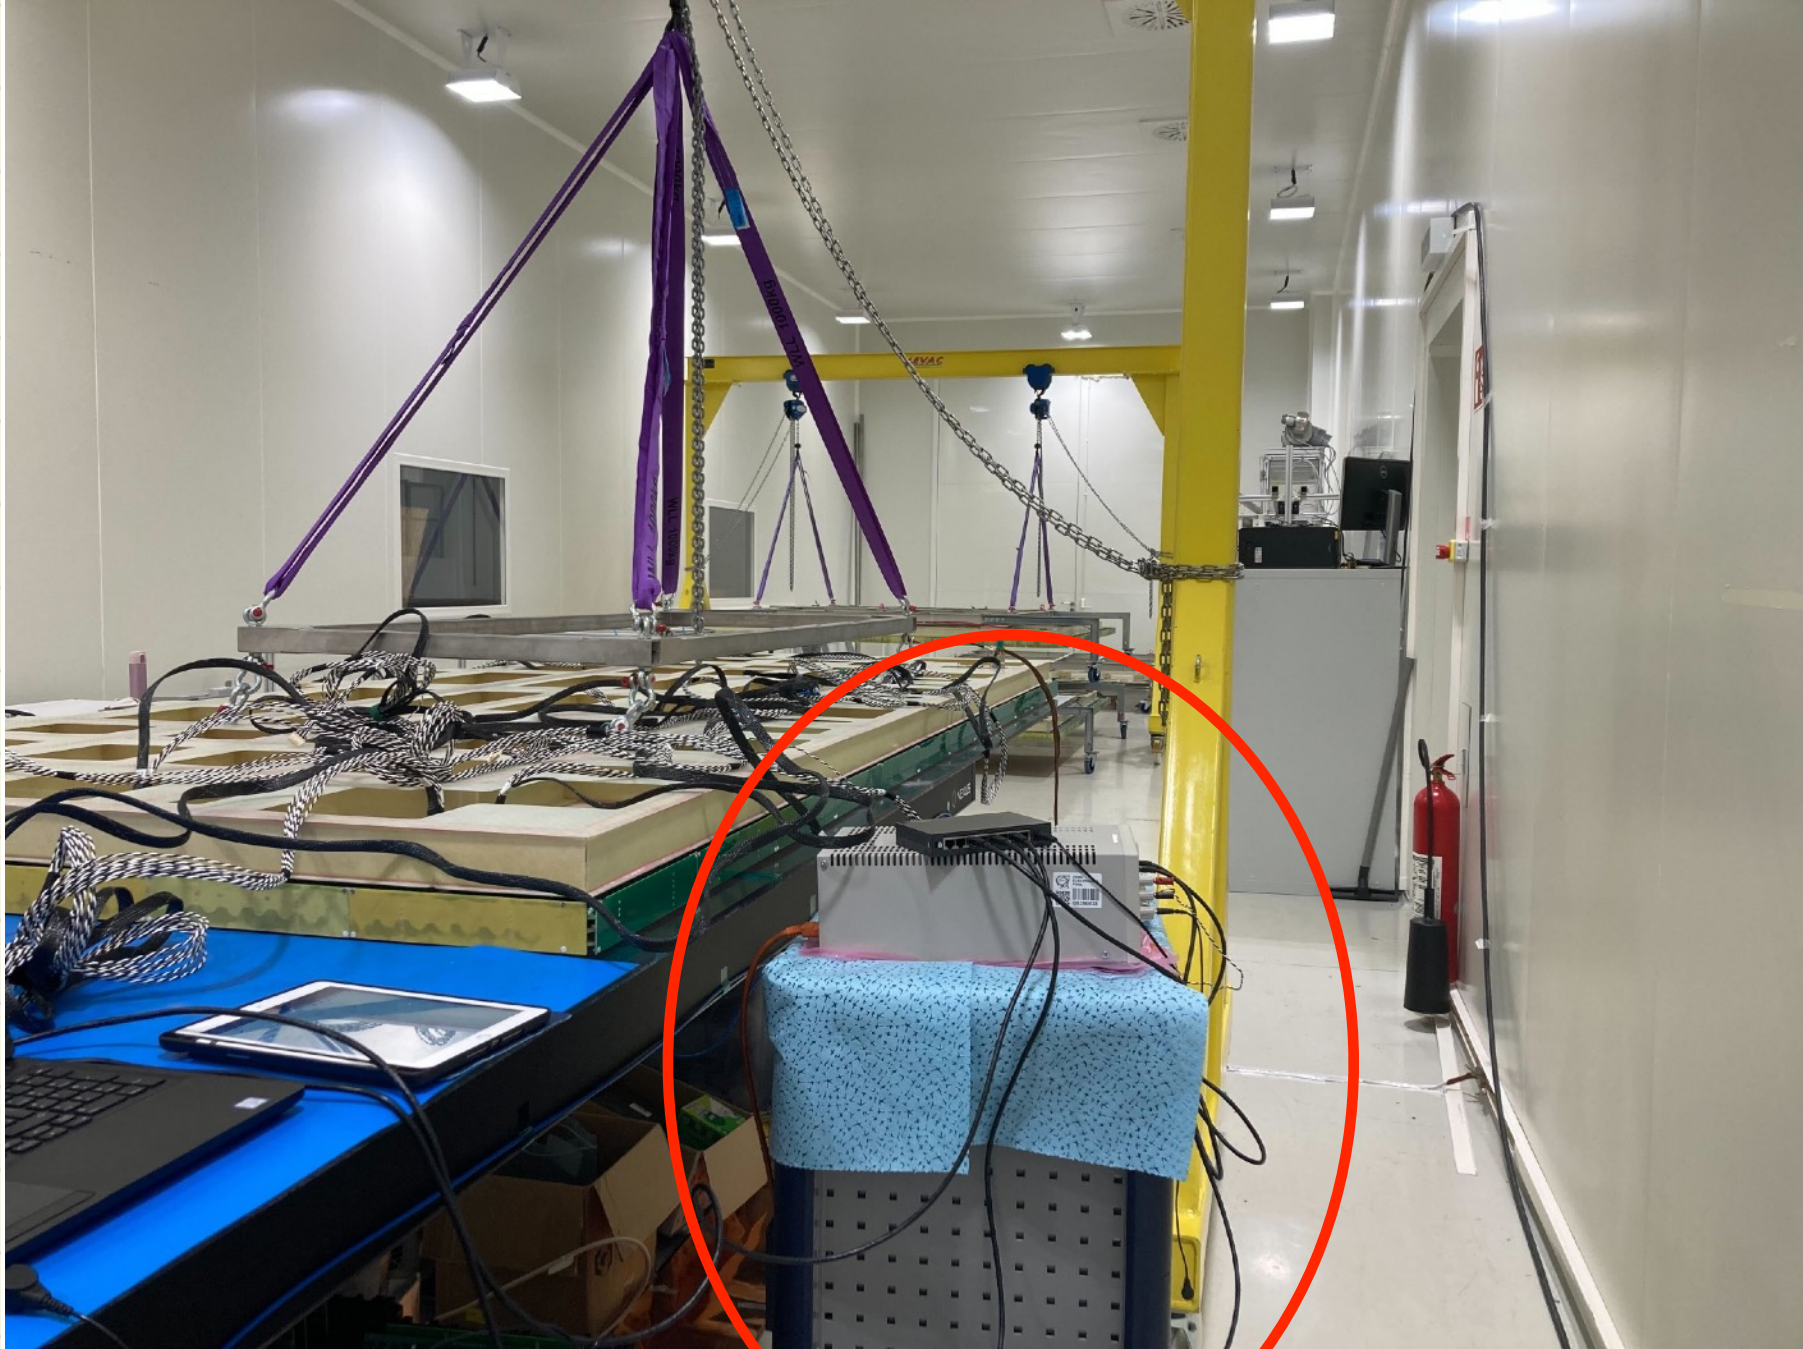
CRP5b CE installation

- Installed 12 FEMBs and two patch panels

FEMB checkout test setup

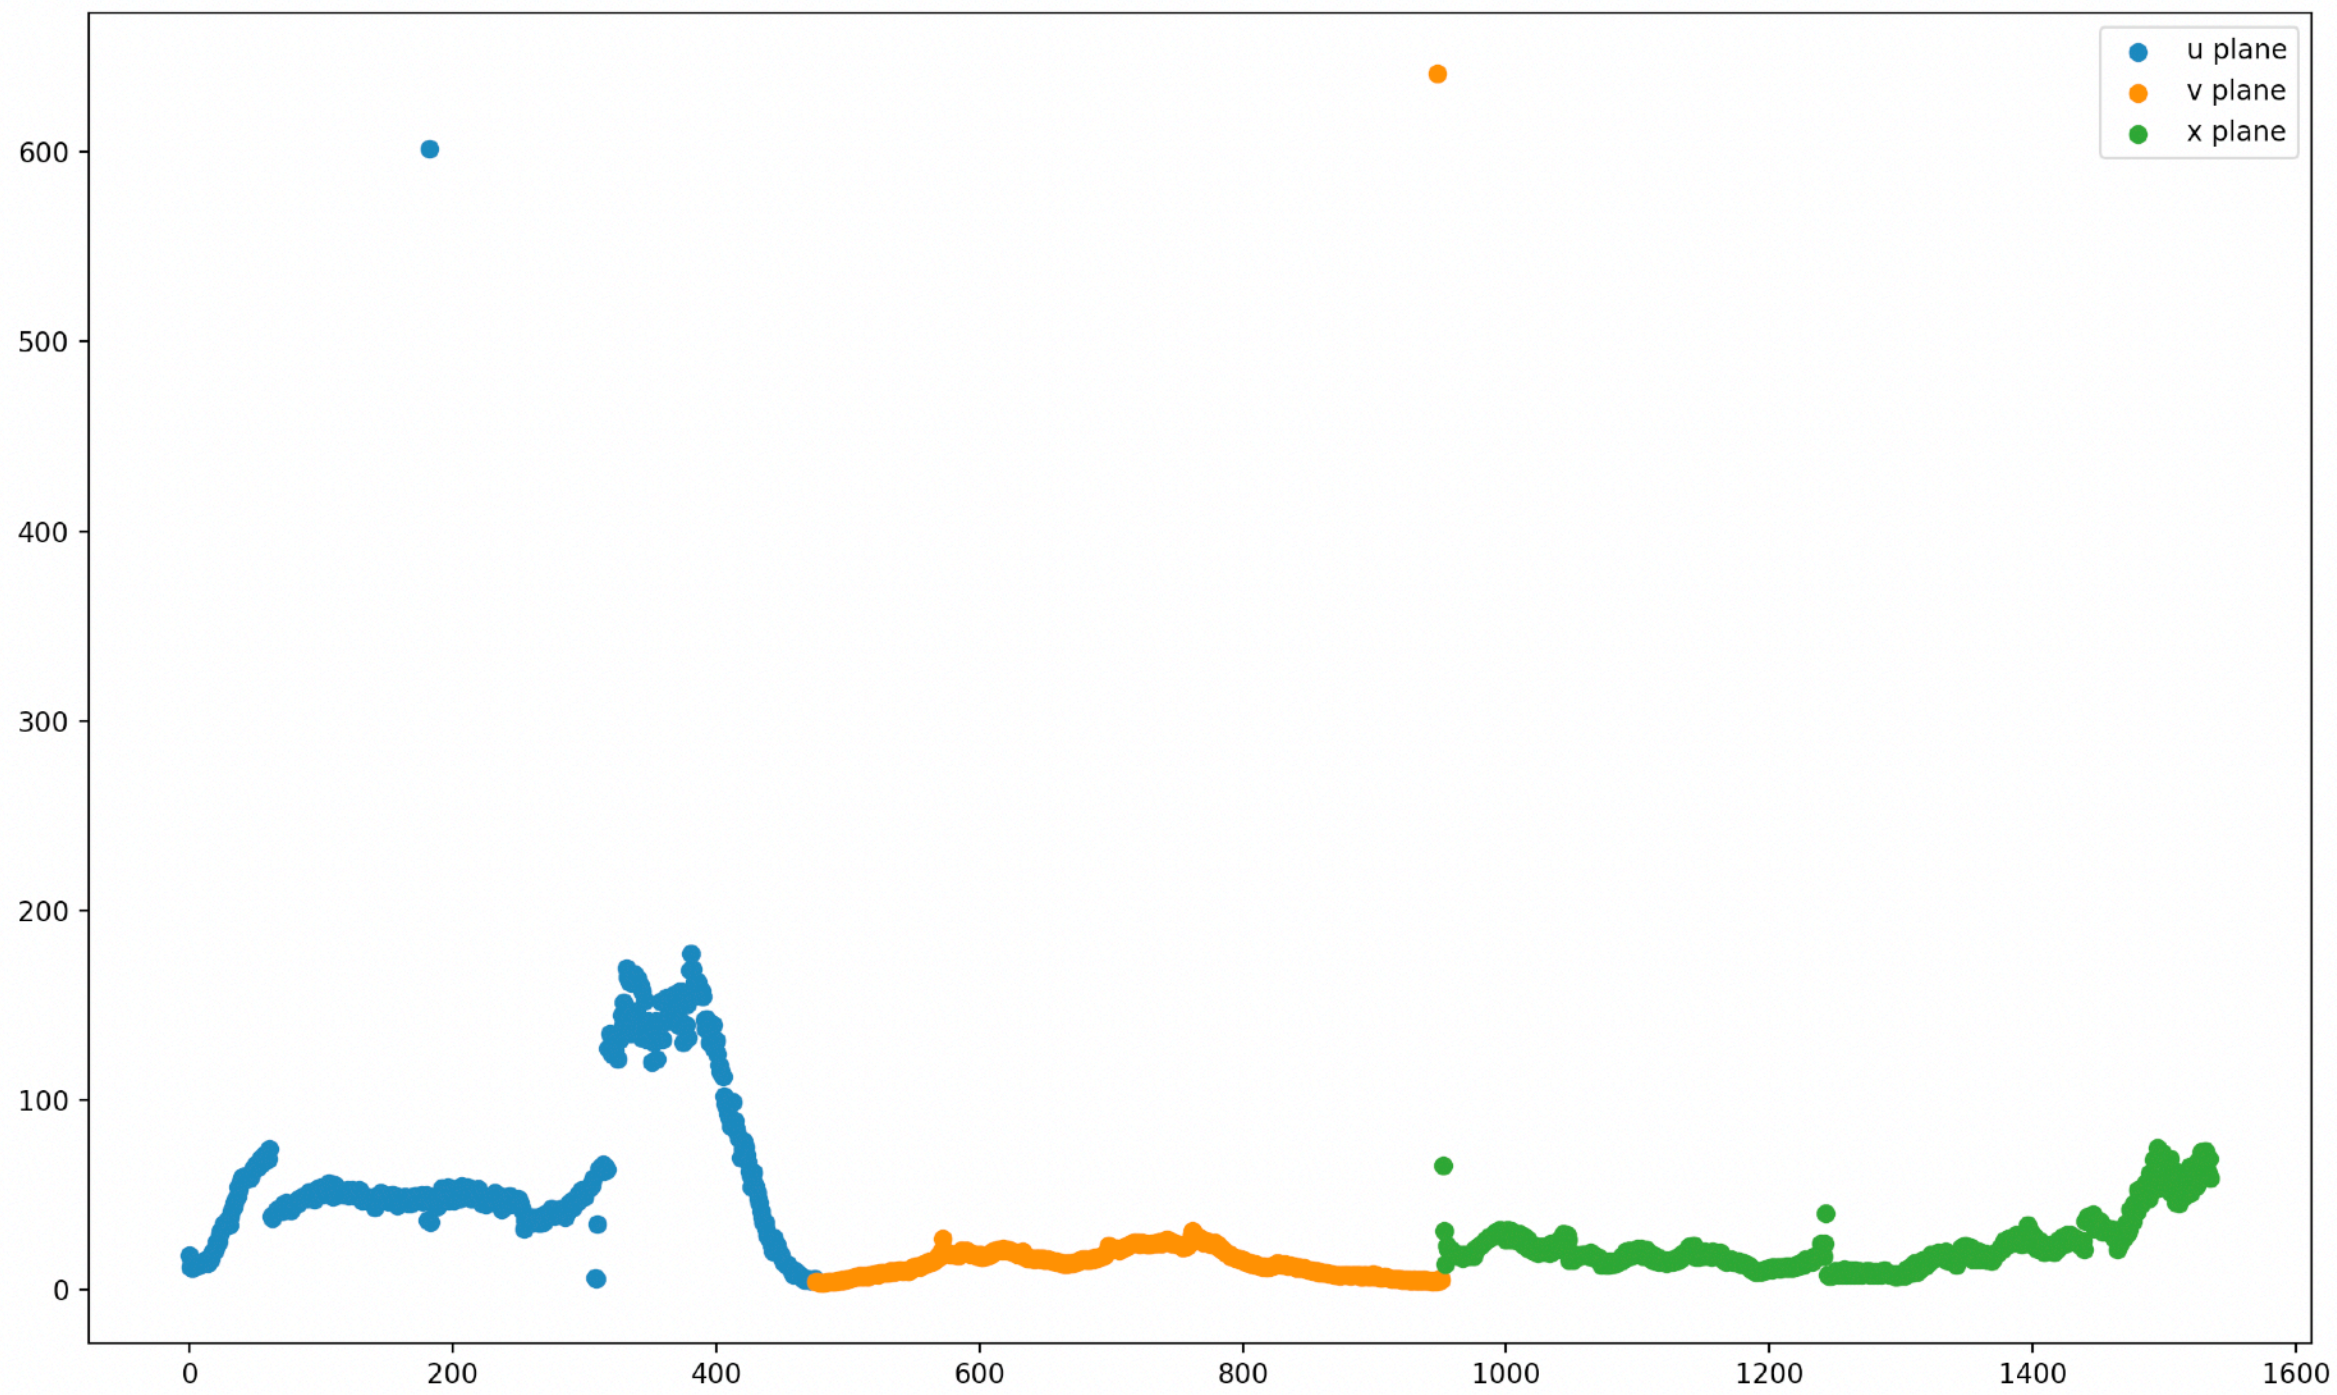
RMS vs. Strips

Before Patch Panel installation

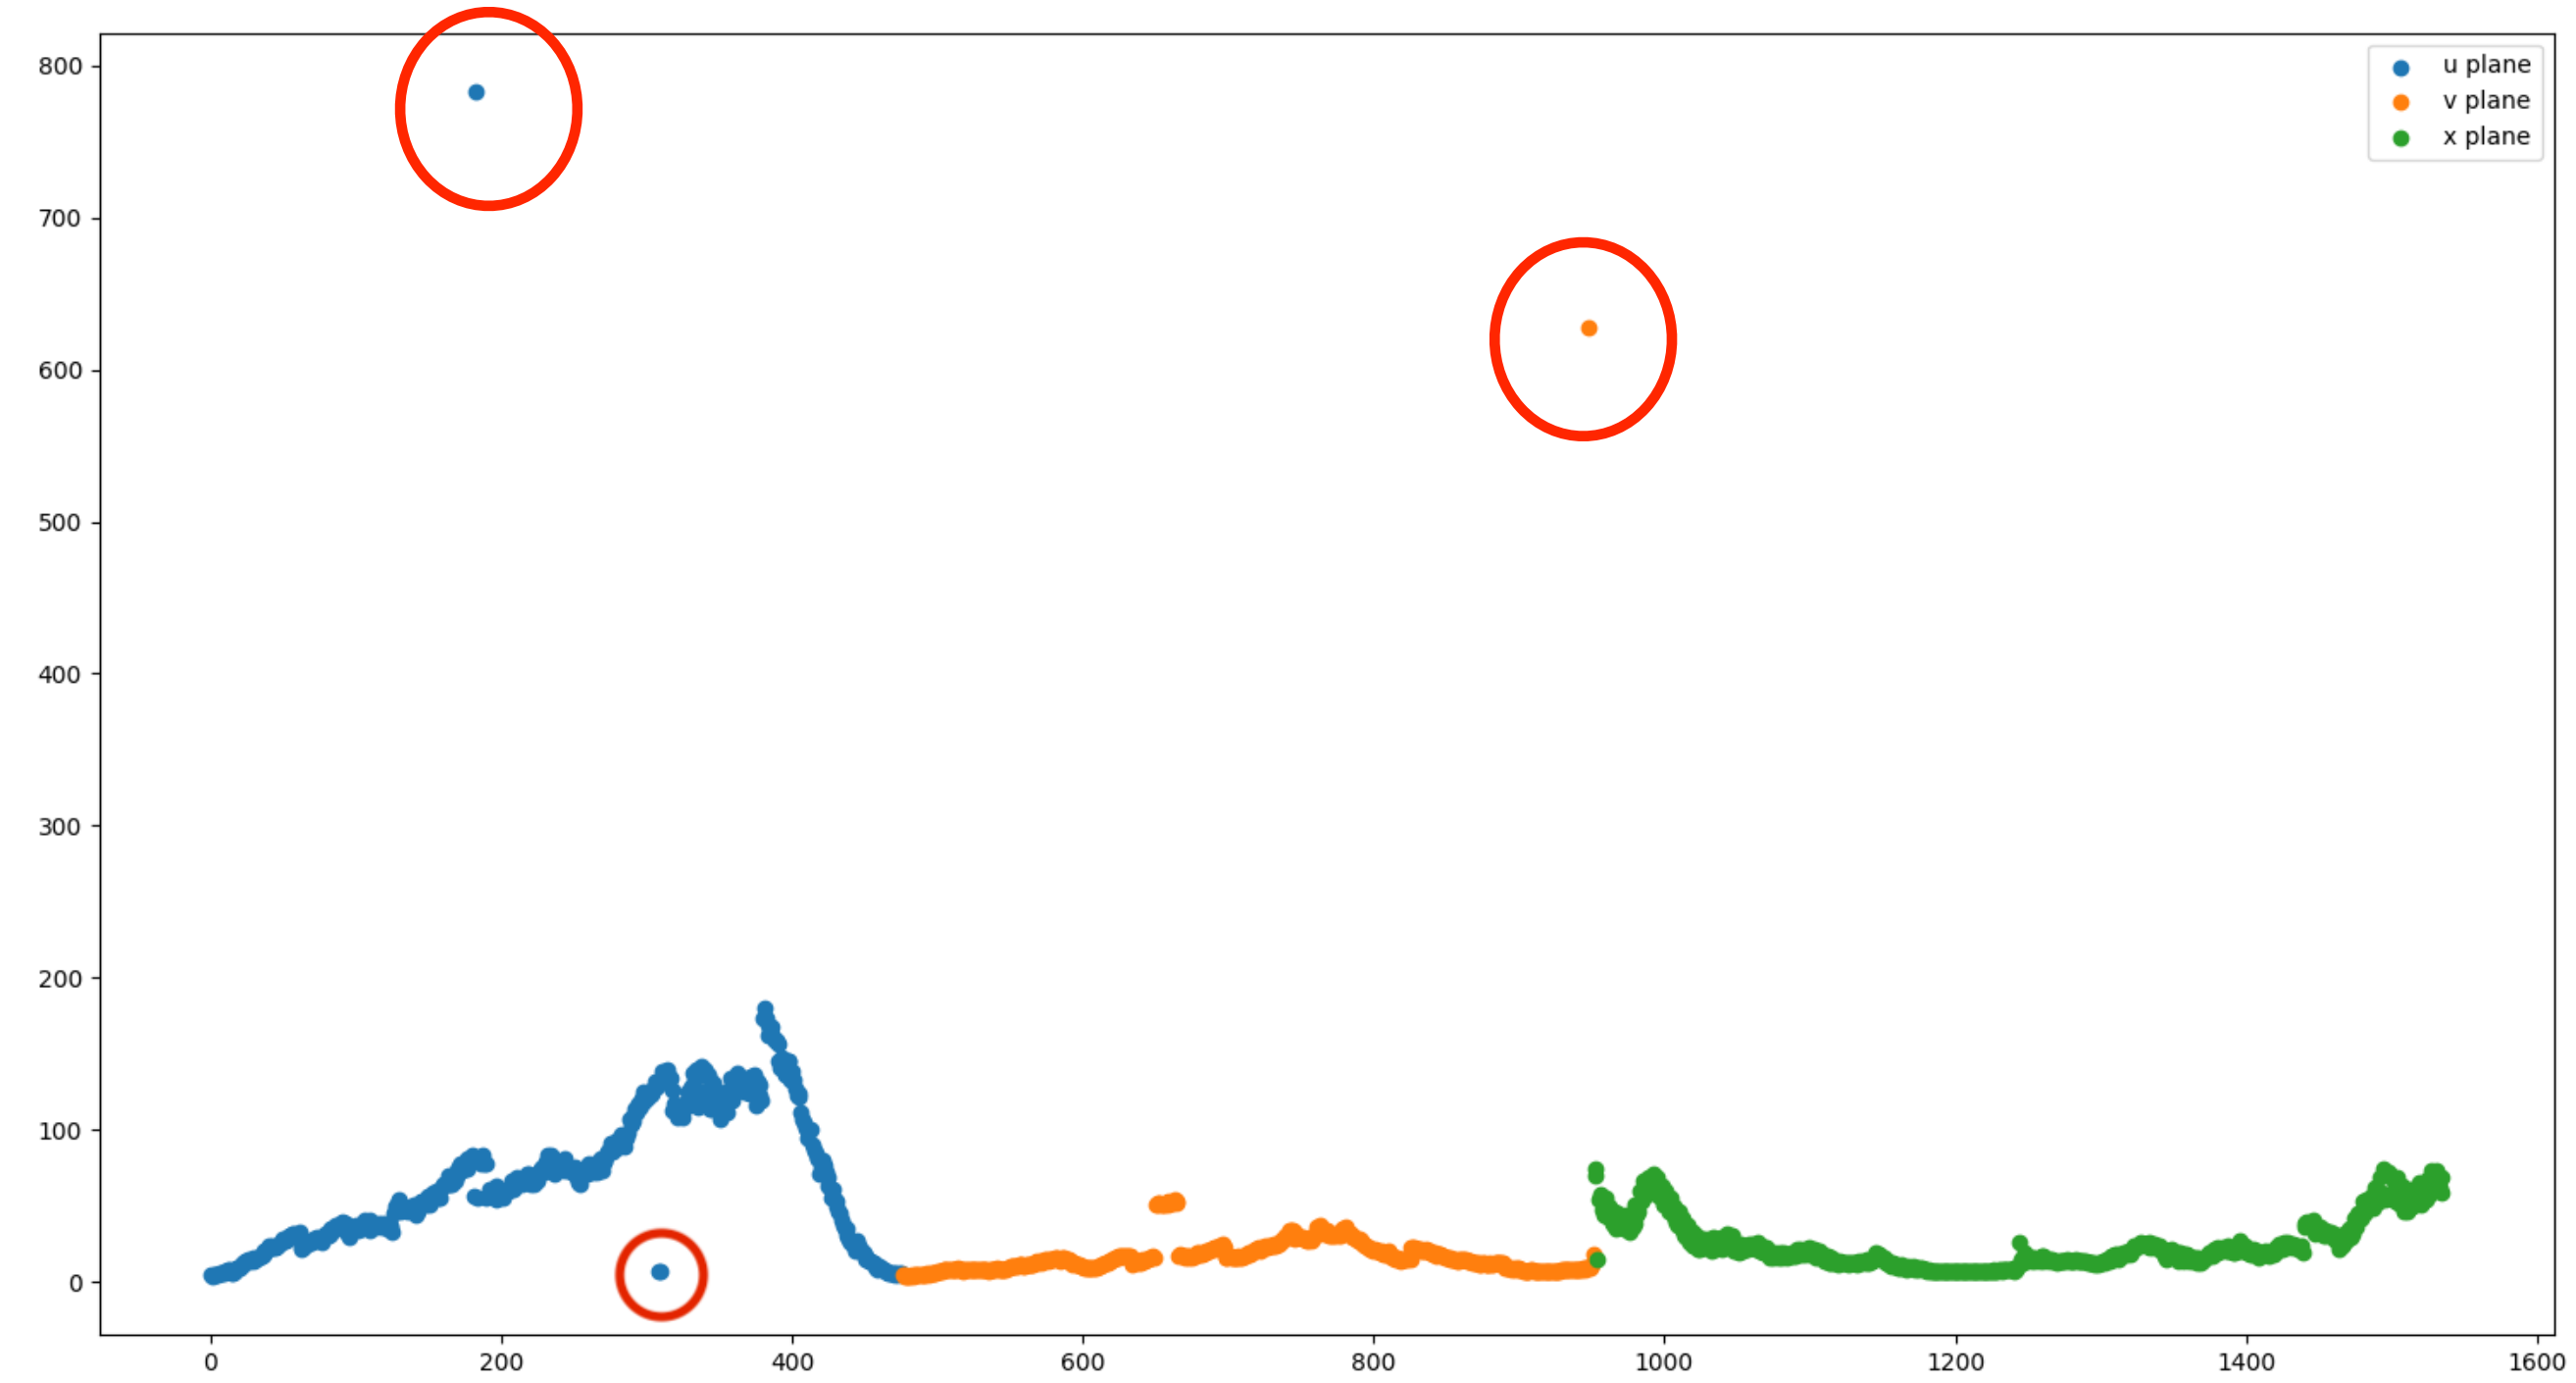
RMS vs. Strips

After Patch Panel installation

- Two high noise channels:
1st Induction plane, strip 182;
2nd Induction plane, strip 472

- Two open channels:
1st Induction plane, strip 308, 309

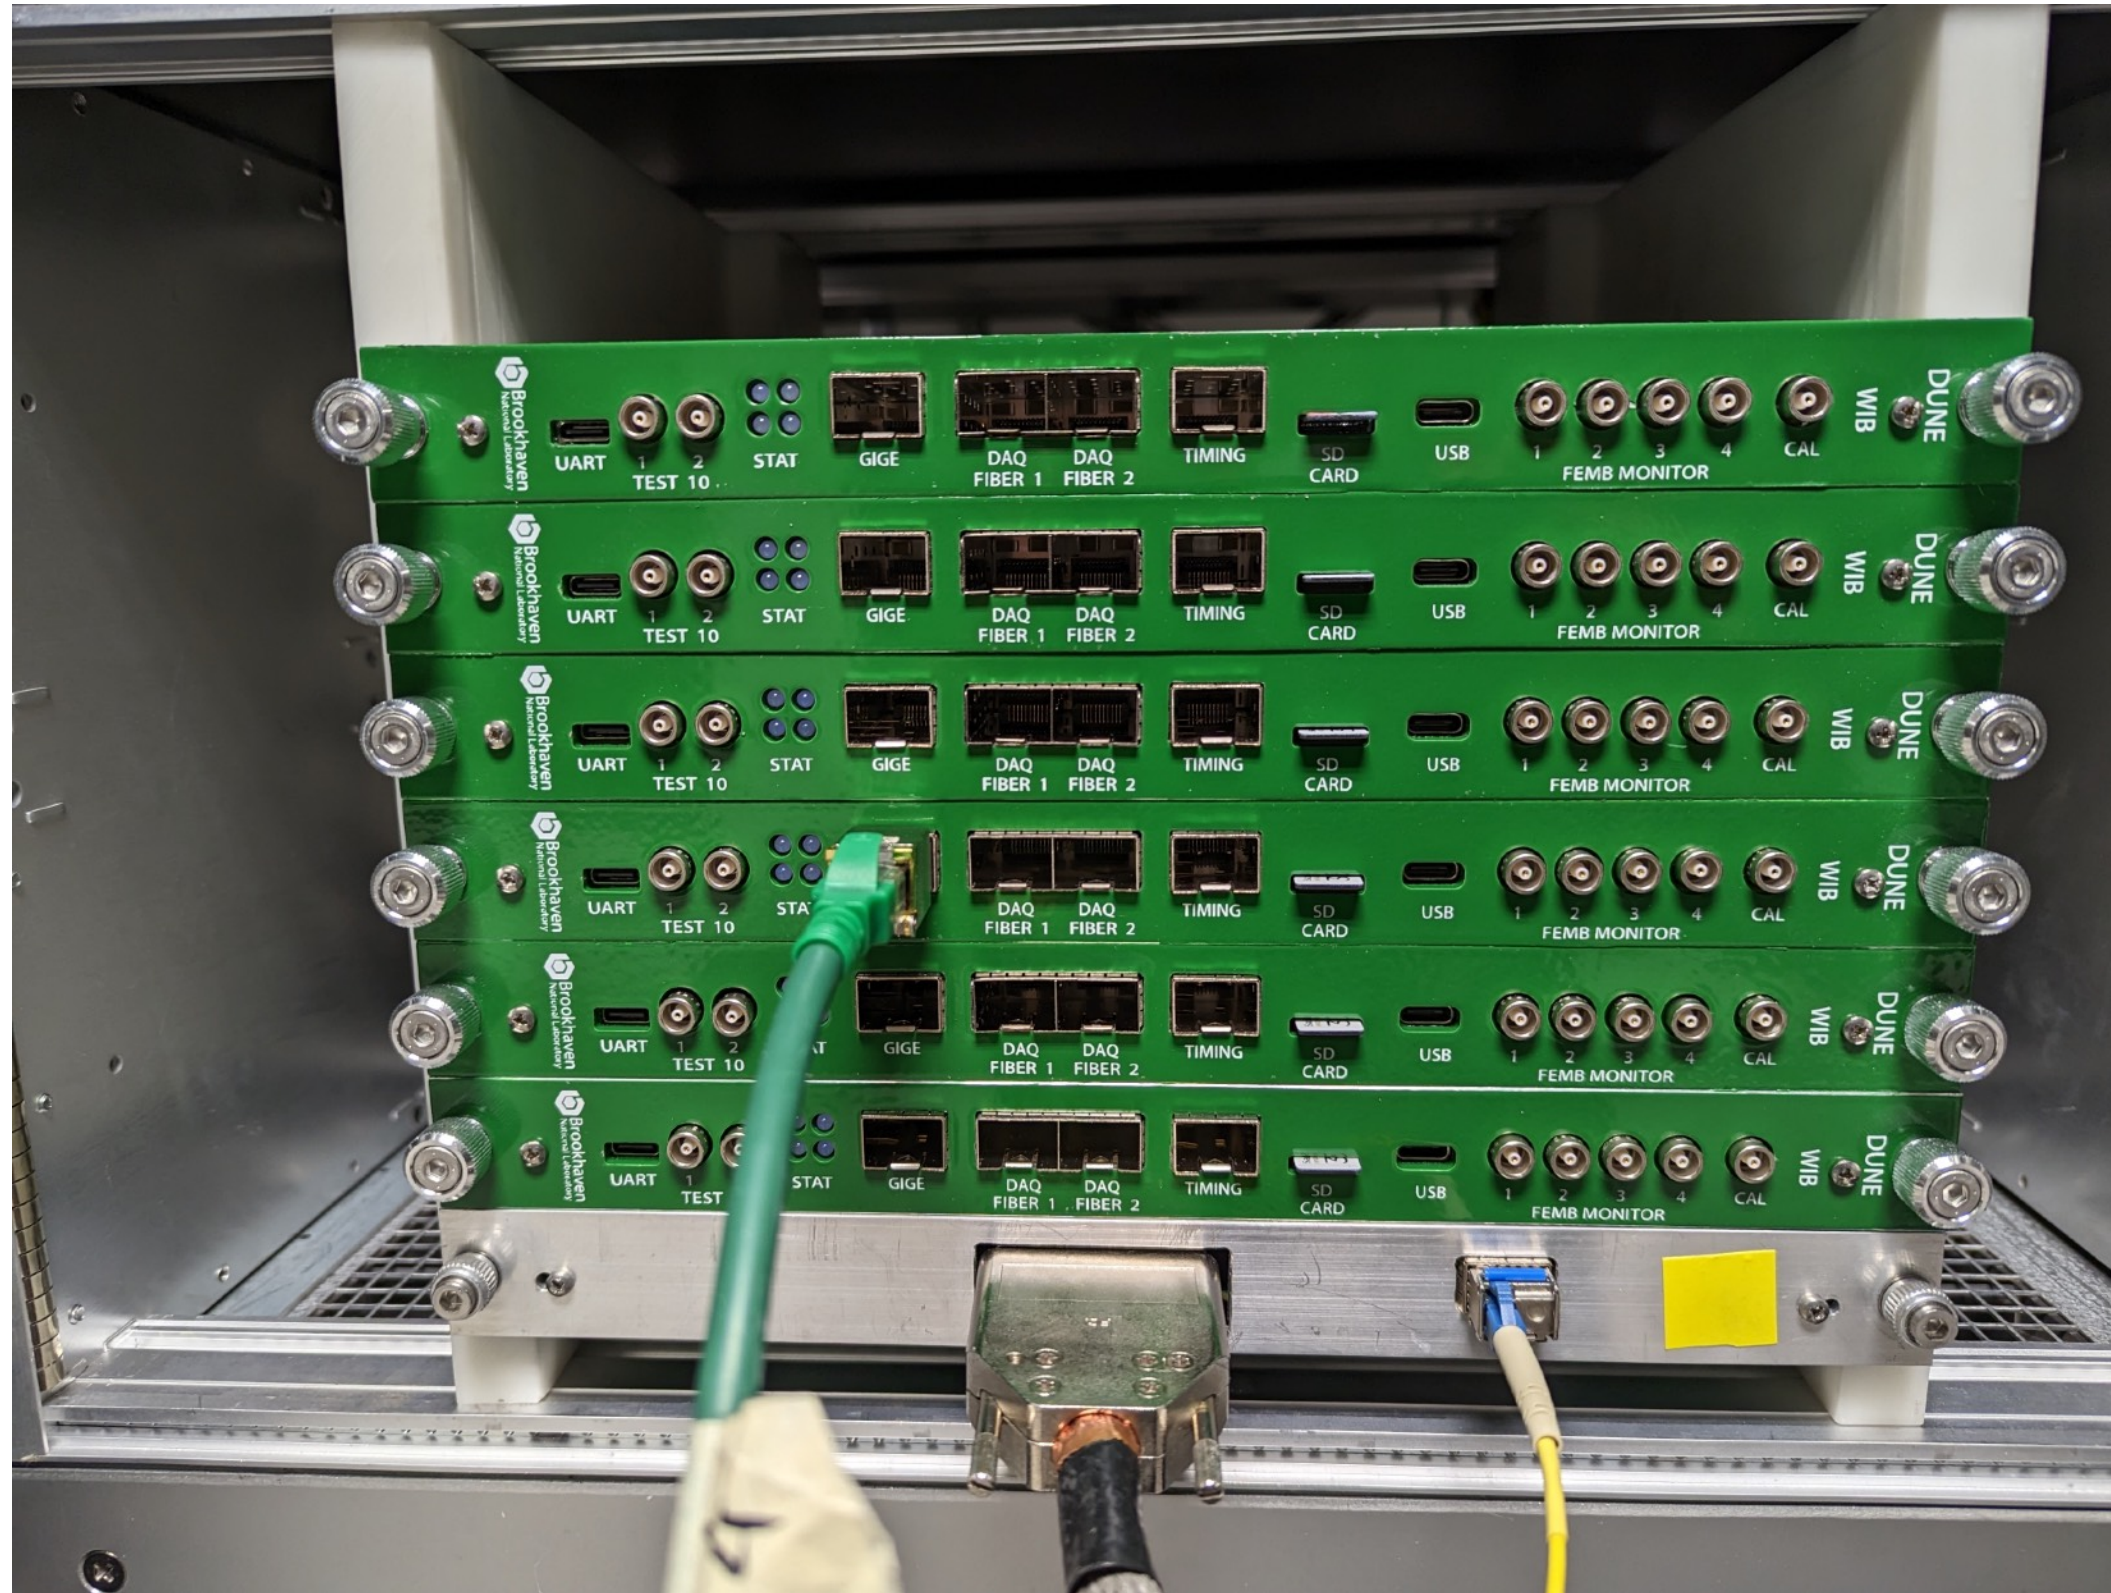
CRP5b WIBs

- 6 WIBs are installed at the VST test stand
- Loaded with the latest firmware and software
