Engineering Design and Fabrication Process of SSR1/2 SC Cavity

Myung Ook Hyun / SCL Development Team

2023.03.01.

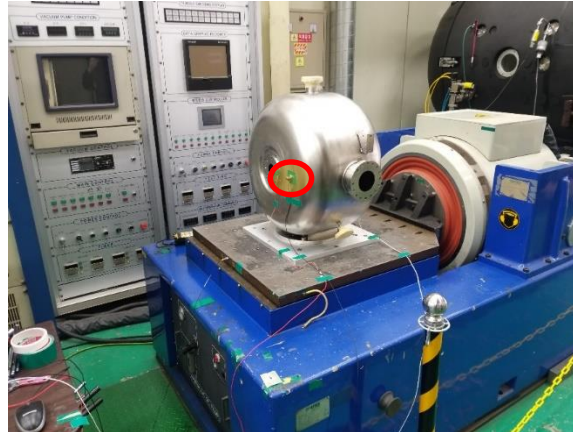
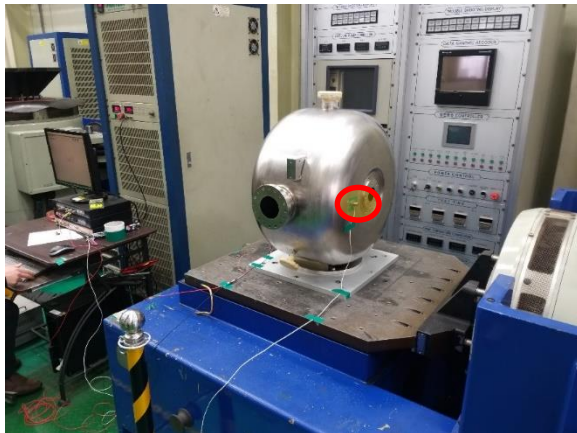
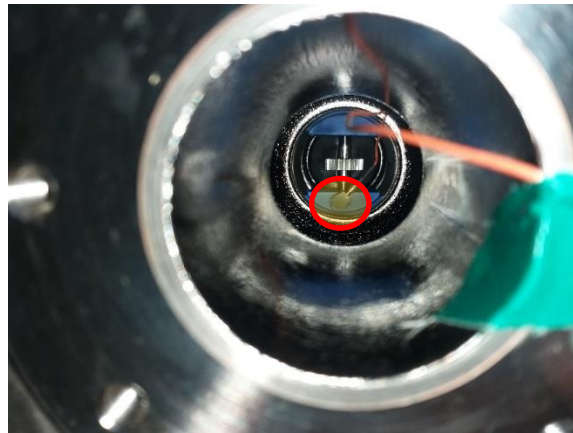
SSR1 TR#1 Vibration Test

Vibration Test (done by KIMM)

- Test Condition
 - .. 0.3G / 5 to 1000Hz Sweep
 - .. Sensor : Spoke Center/Covers
- Lateral Vibration Machine

Spoke Fixture for Sensor

- Clamping Fixture (Lower Left)
- Installed by left/right thread

Purpose of Vibration Test

- Check the resonance of SSR1 dressed Cavity (around 42/240Hz)
- Draw the resonance map

Test Results

- 1st Trial : Stopped due to high resonance @ 240Hz → Changed G-level from 0.5 to 0.3
- 2nd Trial : Done!
 - .. 1st Peak : 47.96Hz
 - .. 2nd Peak : 234.6Hz
 - .. 3rd Peak : 256.1Hz
 - .. 4th Peak : 349.2Hz
 - .. 5th Peak : 580.8Hz
 - .. 6th Peak : 737.3Hz

Consideration

- Main Peak : 1~4 peaks
- Need double-check : 5/6th peaks

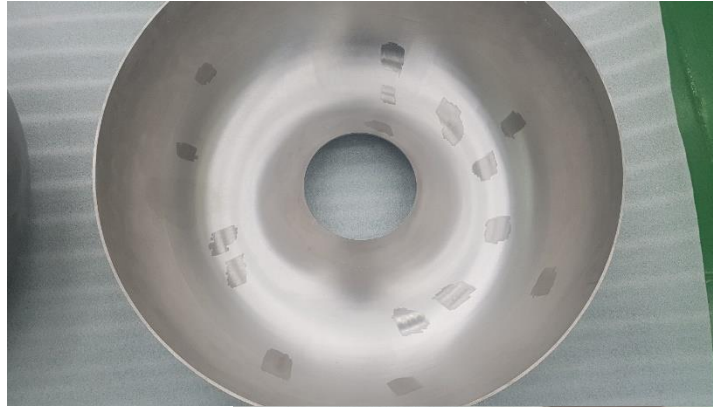
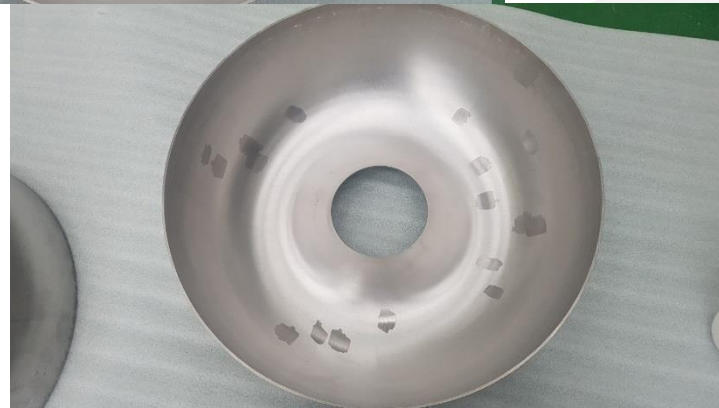
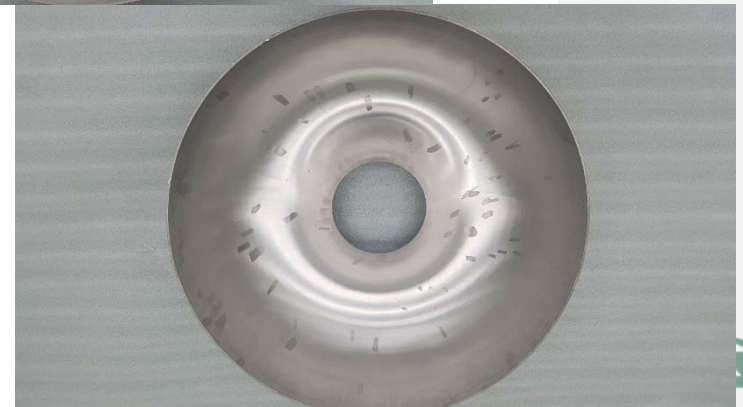
Salt Water Test (OTIC) (SSR1)

Condition : 10% salt water dipping, drying@class 100
→ rust appeared, removed!

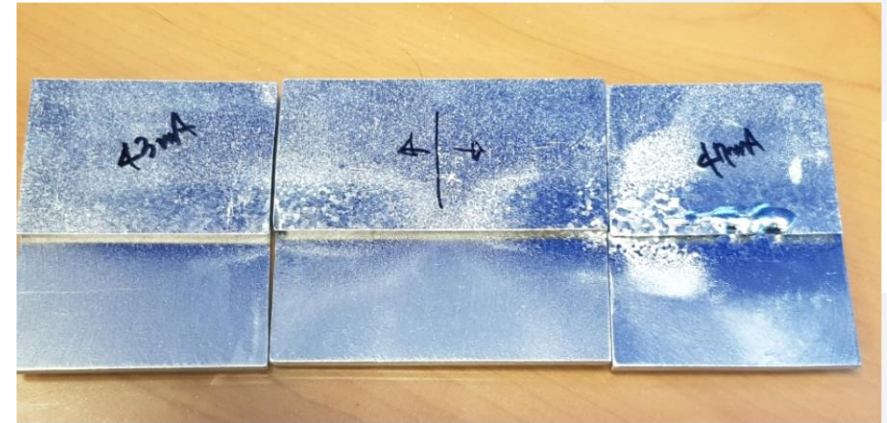
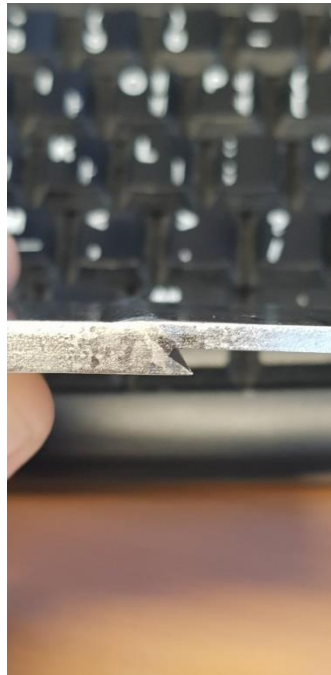
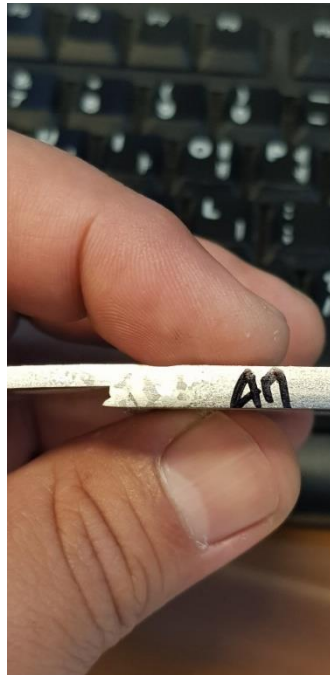
Half Shell EBW Specimen Test (SSR1)

* EBW Specimen Test

- Initial Conditions : Beam current(BC) 35/37/40mA
- 1st Test : 35mA (Penetration depth(PD) 50%/Bead width(BW) 6mm), 37mA (PD 60%/BW 6.5mm), 40mA (PD 70%/BW 8mm), all test are not satisfied for full penetration.
- 2nd Conditions : BC 43m/47mA
- 2nd Test : 43mA (PD 95%/BW 8.3mm), 47mA (PD 107%/BW 9.2mm), 47mA back bead shape is not uniform.
- Fixed BC 43mA as final EBW BC condition

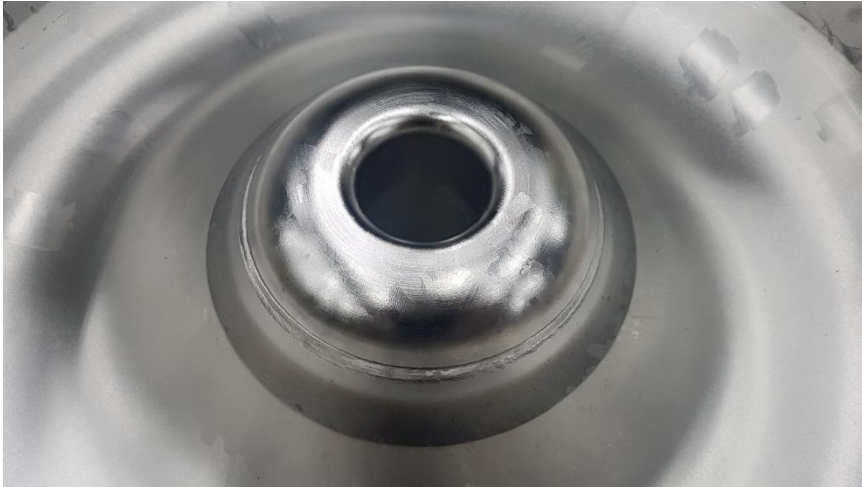
Half Shell + Beam Port EBW (SSR1)

#1 : HS#OTIC16, BP#3, BC 42.1mA

#2 : HS#OTIC17, BP#2, BC 42.1mA

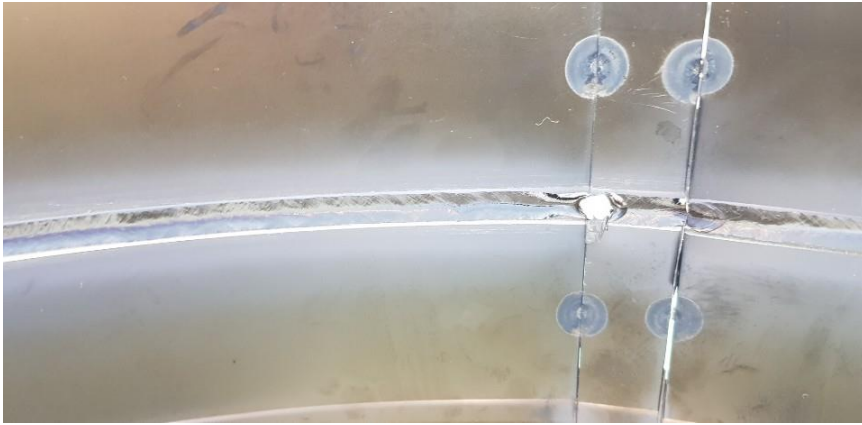
Shell-to-Shell EBW Test (SSR1)

2nd test for S-T-S EBW

- Conditions : BC 25.7~24.5mA
- Over-melted @ 2 points → Reduce beam current!

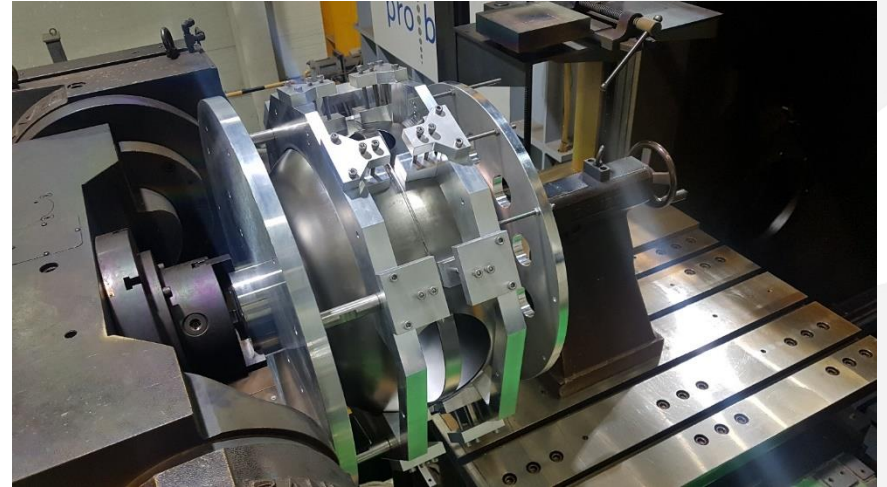
Shell-to-Shell EBW (SSR1)

S-T-S EBW : OK

- Hole around tacking → Removing Area!

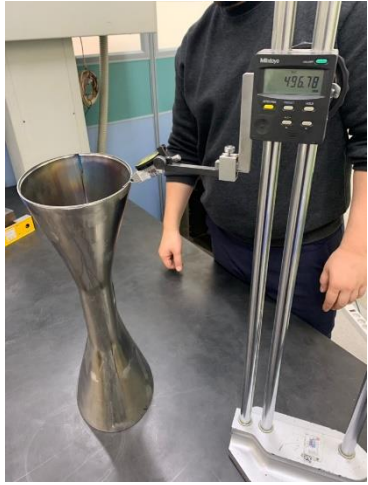
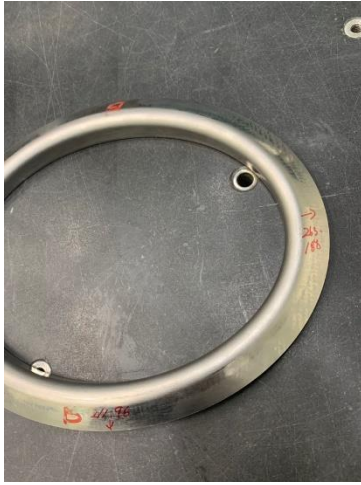
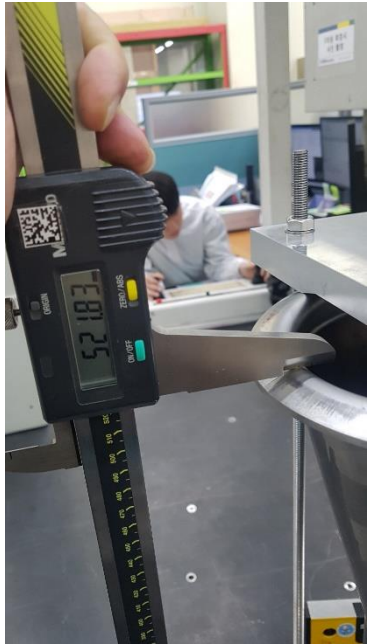
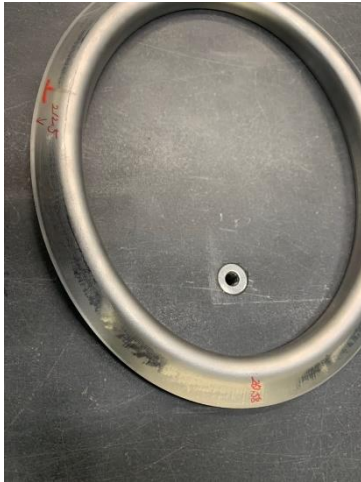
Spoke-to-Collar EBW (SSR1)

S-T-C EBW : OK

- Trimming, Measurement
- Upper EBW, Lower EBW
- BCs are varied corresponding to the curvature.
- Issues : tailstock is loosen during upper EBW → Fixed!
- Fully penetration is OK! → Buffing & Surface Finishing

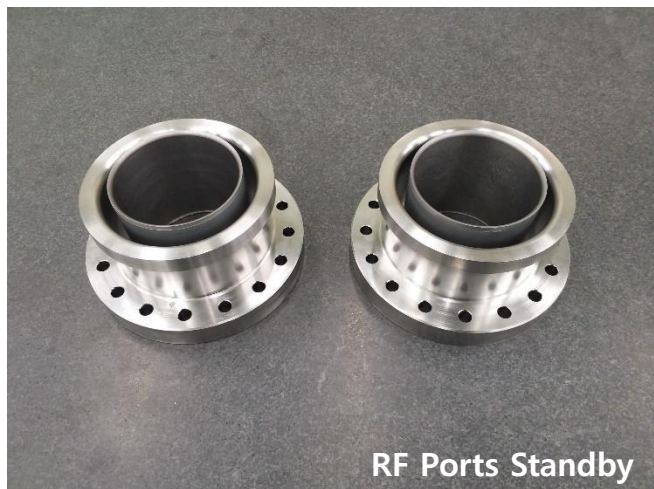
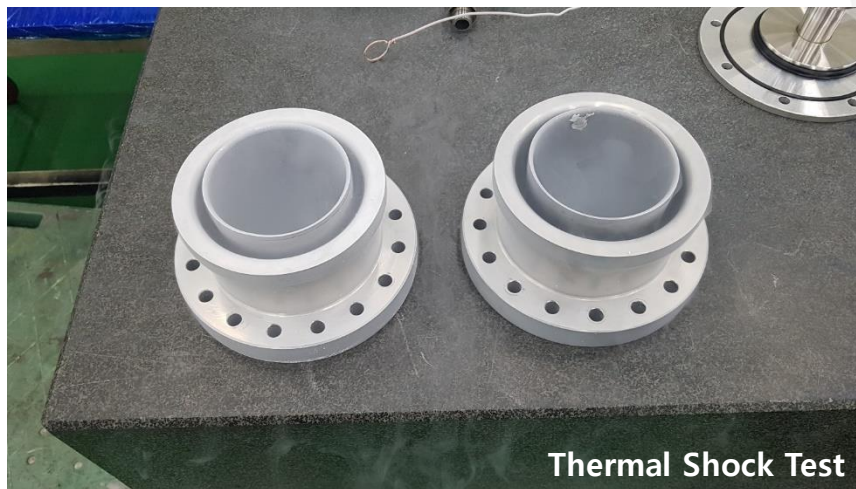
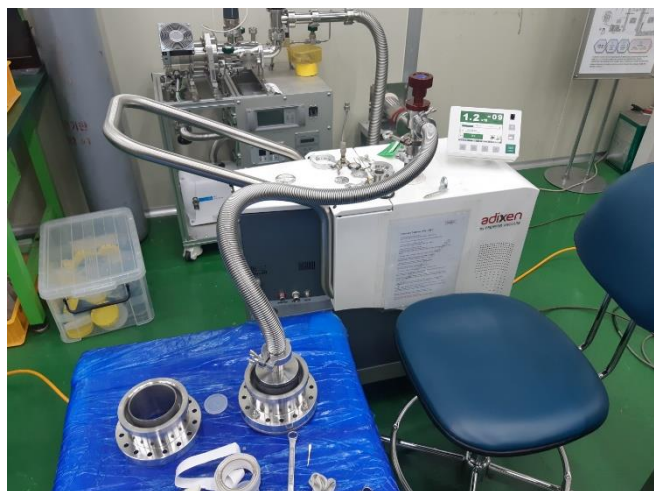
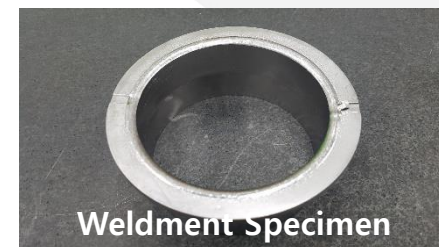
Shell-to-RF ports EBW (SSR1)

Shell-to-RF Port EBW

- EBW Specimen, RF Ports thermal shock test, Fixture Setup

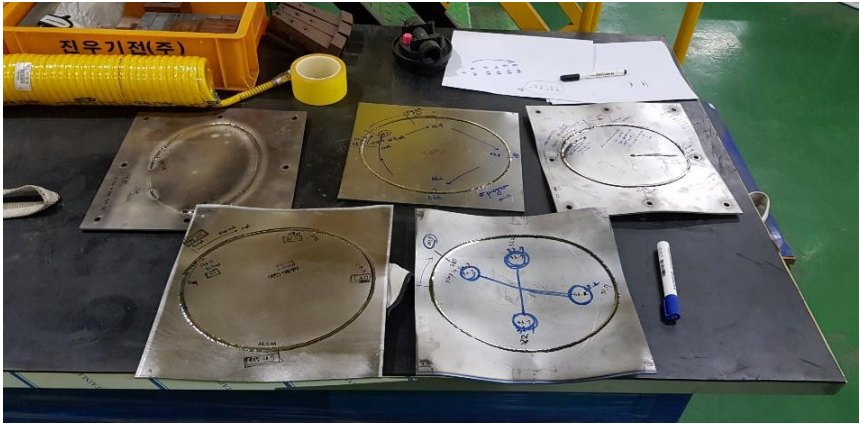
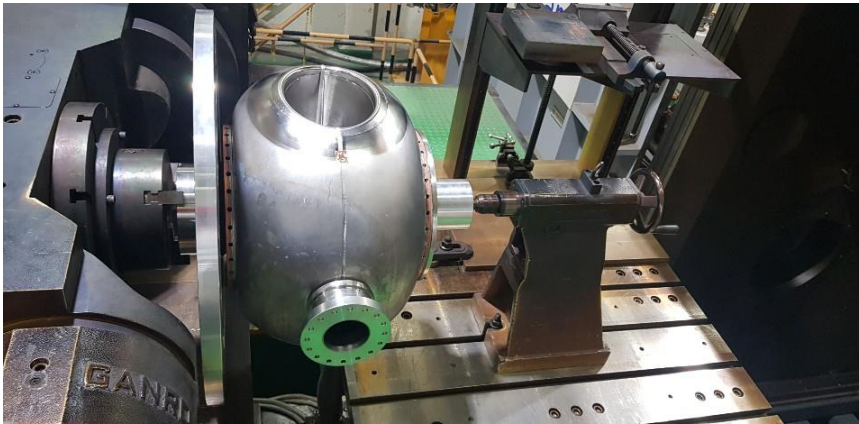
Shell-to-Spoke EBW Test (SSR1)

Shell-to-Spoke EBW

- Specimen Test : EBW Condition : 32.7 → 33.7 → 33.2 → 33.7 → 32.7mA
- Spoke Tacking : Point/Short-line EBW for posture fixing

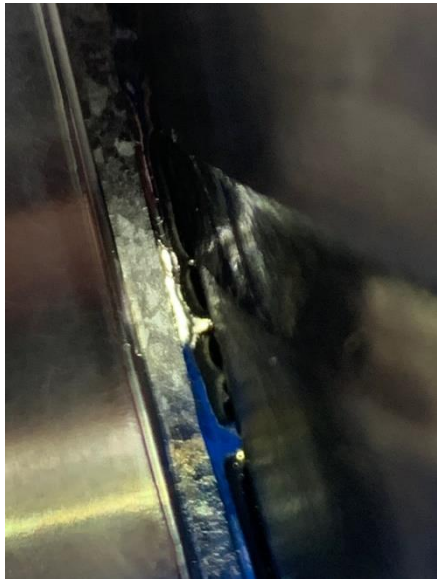
RF Port EBW Repair (SSR1)

- RF Port Leak : Re-EBW → Leak is not disappeared... → What's next?
