SBND Installation Status

SBN Oversight Board Meeting

June 9, 2023

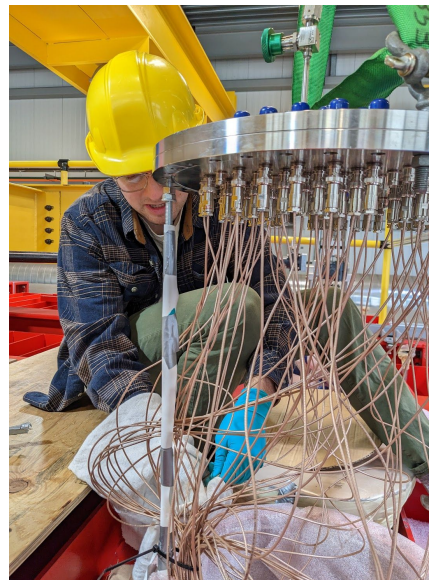
Installation of PMT feedthroughs

- Installed last part of optical fibers for the PDS calibration system
- Installed PMT flanges & PMT repeated QC
- X-ARAPUCA system pulled cables through the top cap and QC
- All CE FEMBs were re-tested after pulling CE cables through the top cap
- Wire bias system was checked out again, after solving problems with bad connectors between wire bias filter boards;
- Performed another test fit of the HV donut & installation practice

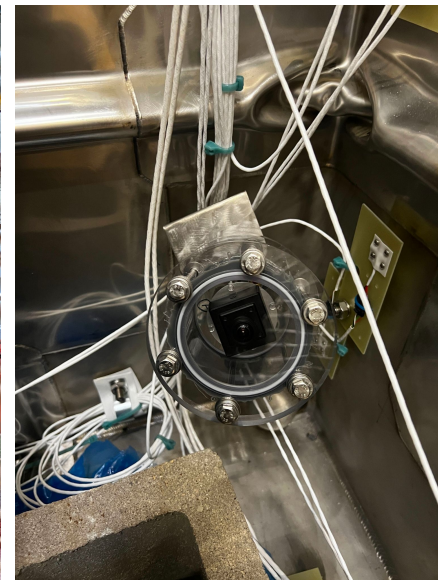
Camera and temperature probes inside the cryostat.

- 12 RTDs on the detector, 42 RTDs on the cryostat walls + underside of top caps
- 5 cameras (4 on the cryostat walls, 1 on the detector) & several LED strips for lighting
- 2 liquid level probes on the cryogenics top cap
- CERN team installed strain gauges

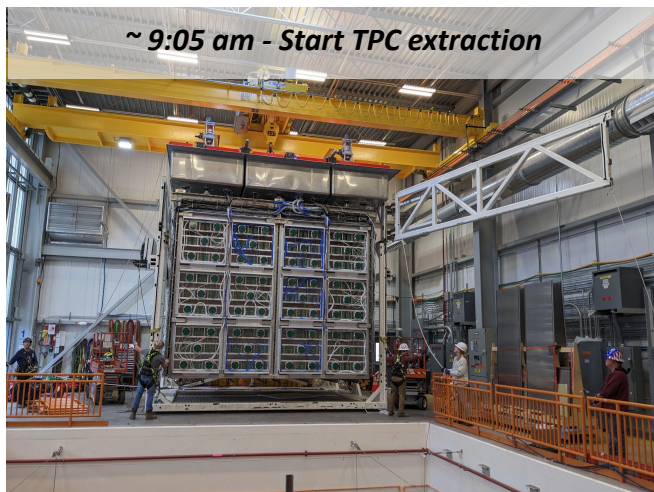
~ 9:05 am - Start TPC extraction

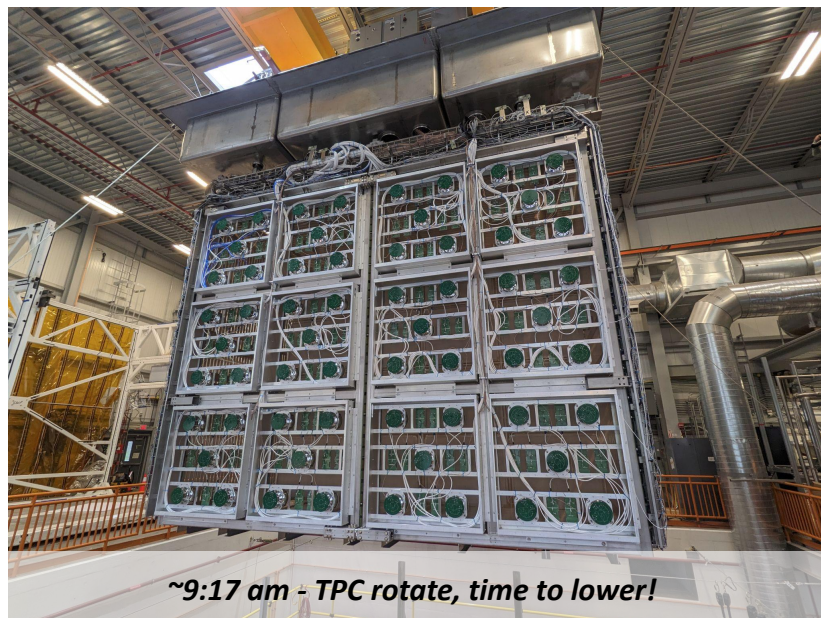
~9:17 am - TPC rotate, time to lower!

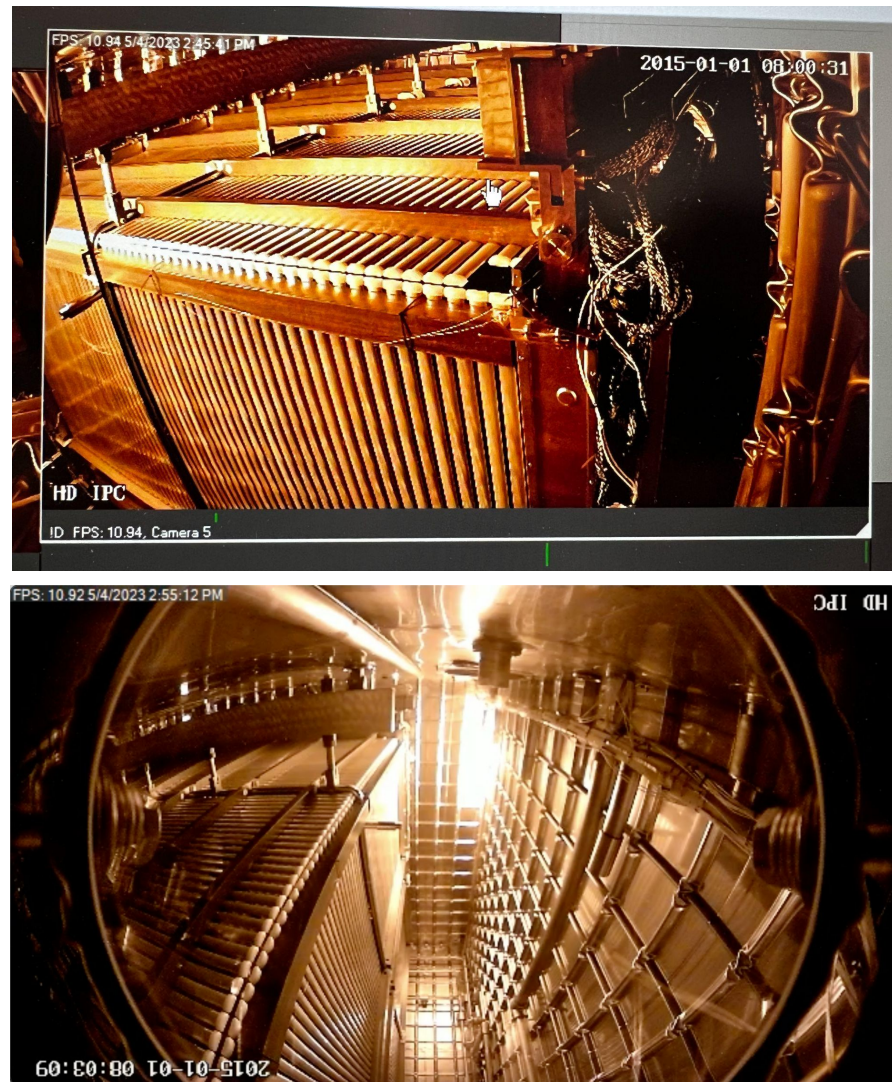
First images from inside the cryostat.

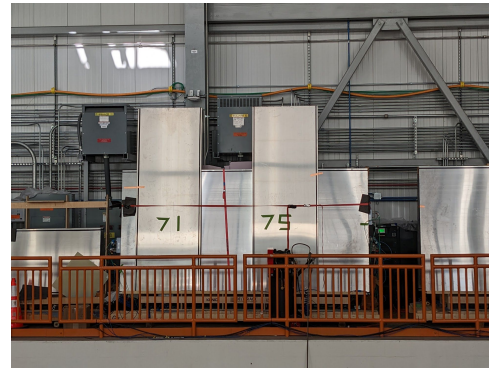
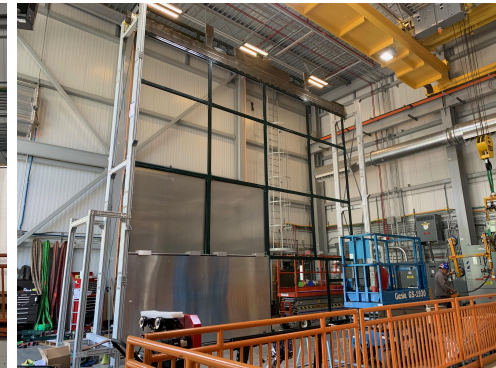
Modules being tested on A-frame & CRT wall module installation

- Installation of the CRT North Wall is complete
 - The North Wall has to be installed prior to finalizing cryogenics piping connecting to the cryostat; East, West and South Wall will be installed only after successful cryo operation is established, using same method
- 18 CRT modules have been tested & characterized on an A-frame setup to be installed on the North Wall
- The North wall was assembled as a whole on the loading deck prior to installation
- The entire wall was rigged into place and hung from the North Wall steel support posts

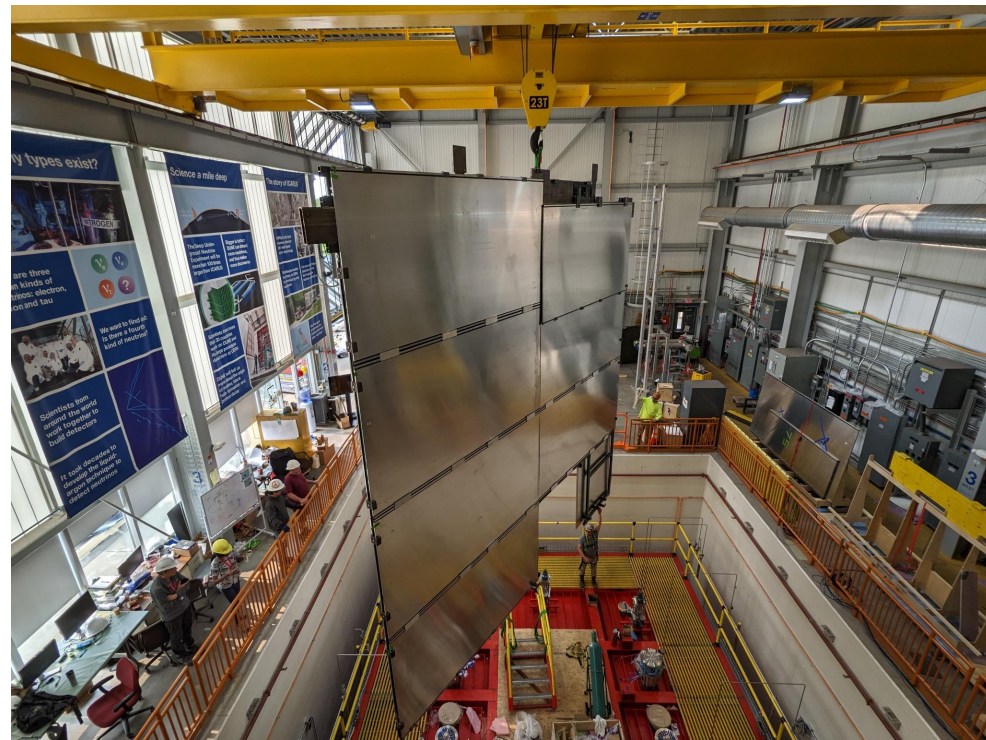
CRT Wall Rigging

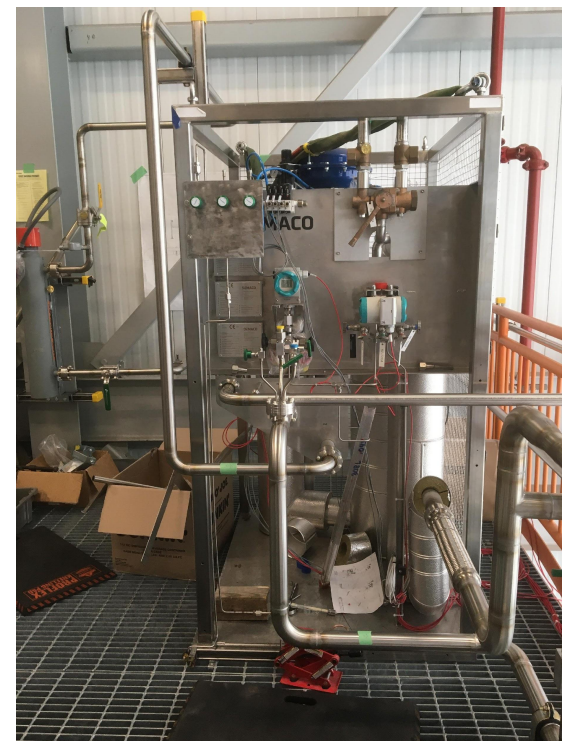
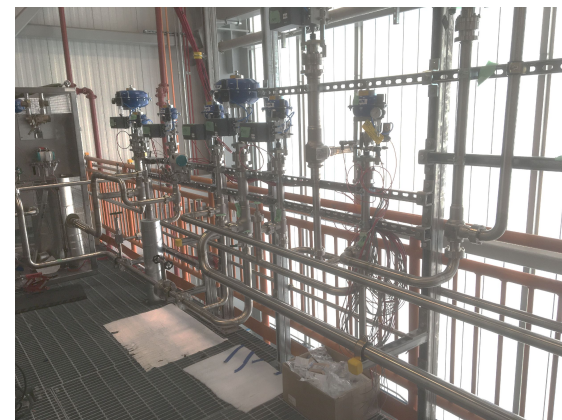
Warm GAr system

- Cryogenics Installation Progress
 - Gas analyzer system installation in progress
 - Warm GAr collection system installation complete
 - Only part remaining is connection to top of cryostat
 - Insulation Nitrogen purge system almost complete
 - In-line PrM line completed and vacuum jacket leak-checked
 - Vacuum jacketed transfer lines that connect the cryogenics system to cryostat are on critical path
 - delay in the delivery of bellows and ceramic isolators to TechniFab from supplier
 - Received a partial delivery of 21 of 36 parts in May; installation of these starting now
 - expected final delivery in August/early September
- Pressure test for Ar Dewar and connecting piping ongoing
- *LAr delivery contract placed with Air Products*
 - on schedule and under budget
 - same vendor as MicroBooNE and ICARUS fills

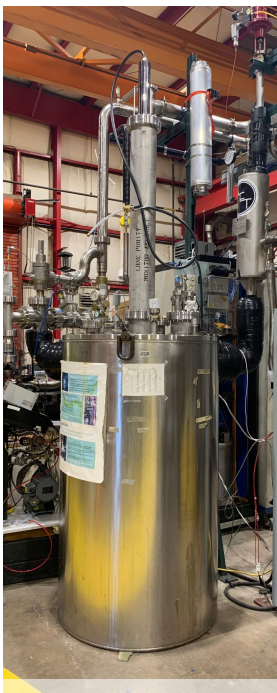
*HV FT Test Setup in
BLANCHE @NLTF*

- All parts for the TPC Calibration laser system have been received from Bern
 - installation of feedthroughs scheduled for next week
 - Laser testing (Class IV), rotation motor testing & electronics installation to happen in July/August
- HV Production Feedthrough testing ongoing at NLTF

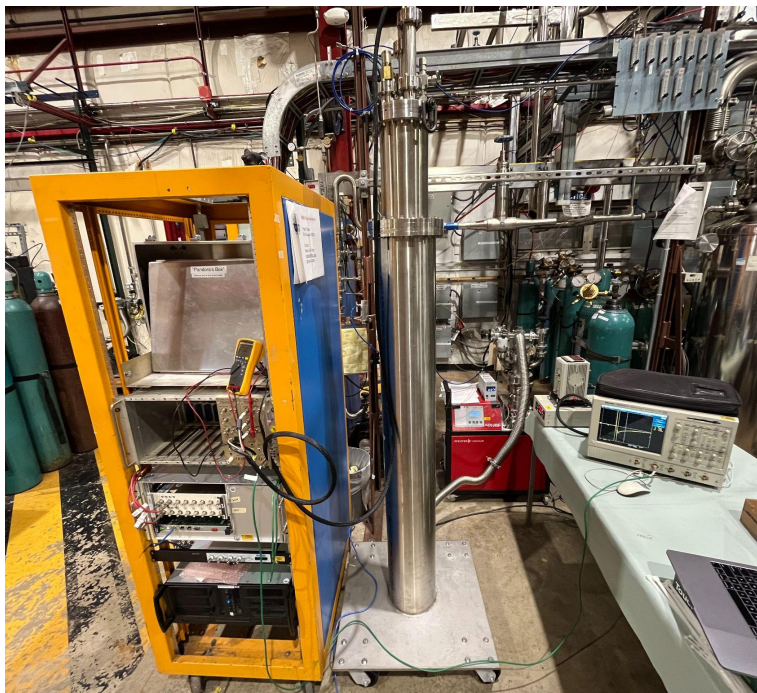
Purity Monitor Test Setup at NLTF

- Purity Monitors
 - inline and cryostat-internal purity monitors being tested at NLTF (fka PAB)

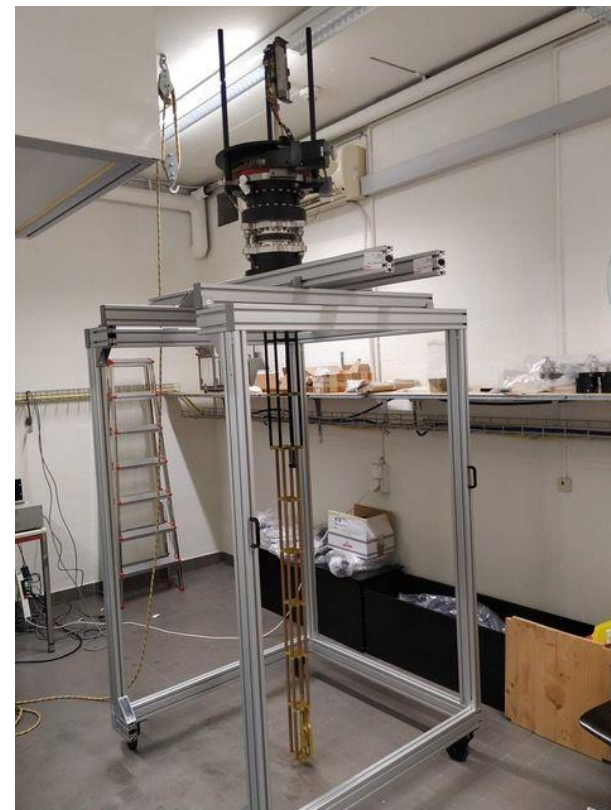
Laser Feedthrough Test Assembly @Bern
