ioLS Status Update

CALCI Consortium Meeting

April 13, 2023

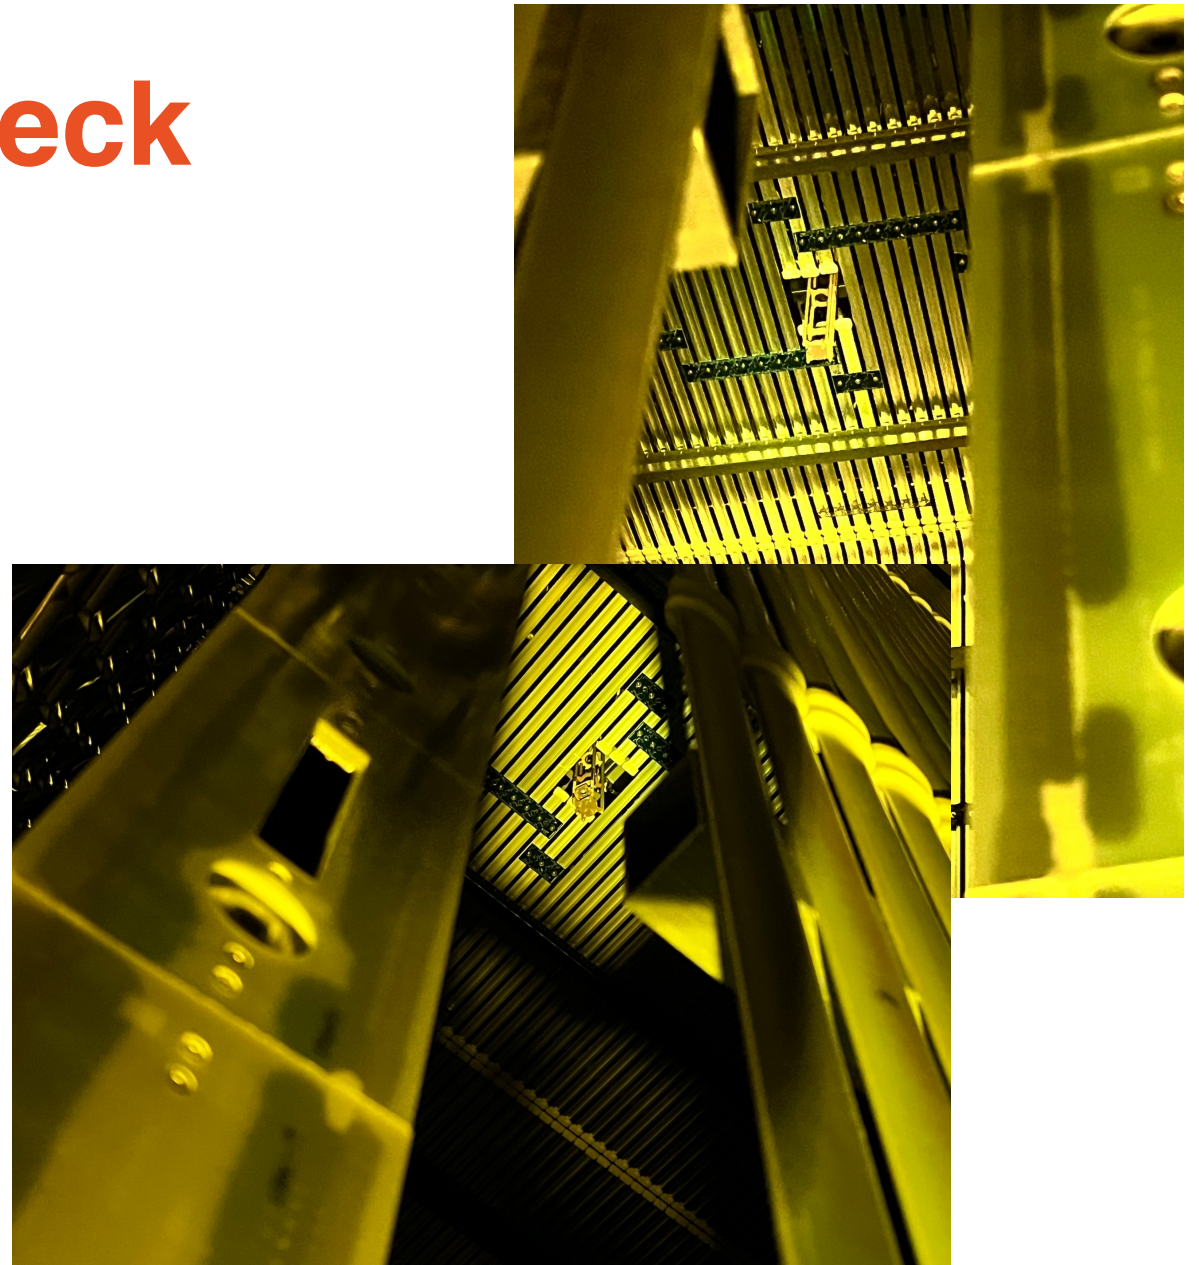
Rotary clearance check

- Rotated P1-RNN600, in the fully extended position, while monitoring from inside the cryostat to make sure that the periscope cleared the cutout
 - 360° rotation check
 - Had to keep an eye on the cables to make sure they didn't get stuck during the full rotation

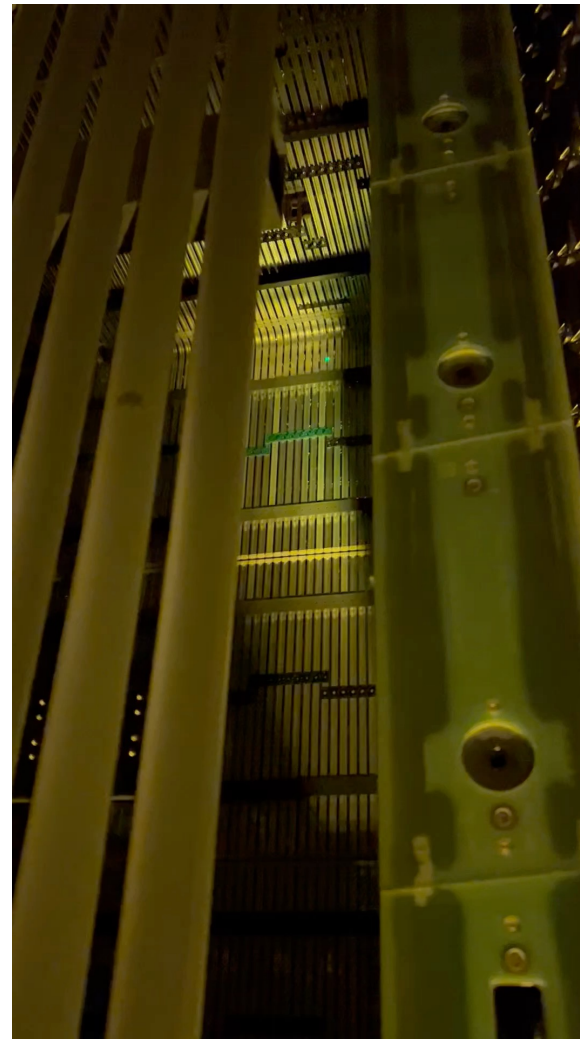
- Rotated RNN600 to roughly align the periscope w/ the +z axis of the detector (beam direction)
 - Rotated to the nearest field cage gap (FCG) to the left of this (when looking in the +z direction)
- Attempted to scan vertically up and down along the FCG
 - Observed a 0.6° tilt in the +x (detector) direction as the laser mirror tilts the spot down.
 - Used the port aligner to compensate for the 0.6° to check if this is a tilt of the flange relative to field cage

With top flange leveled.
Beam trajectory has -0.6° tilt
(from vertical)

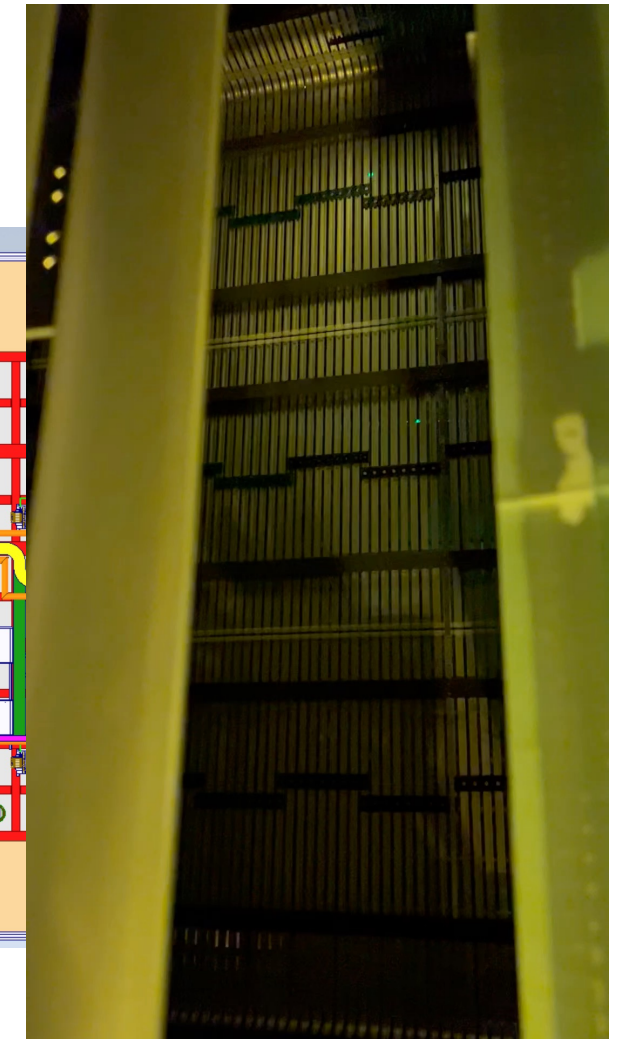
After introducing $+0.6^\circ$
tilt with port aligner to
compensate

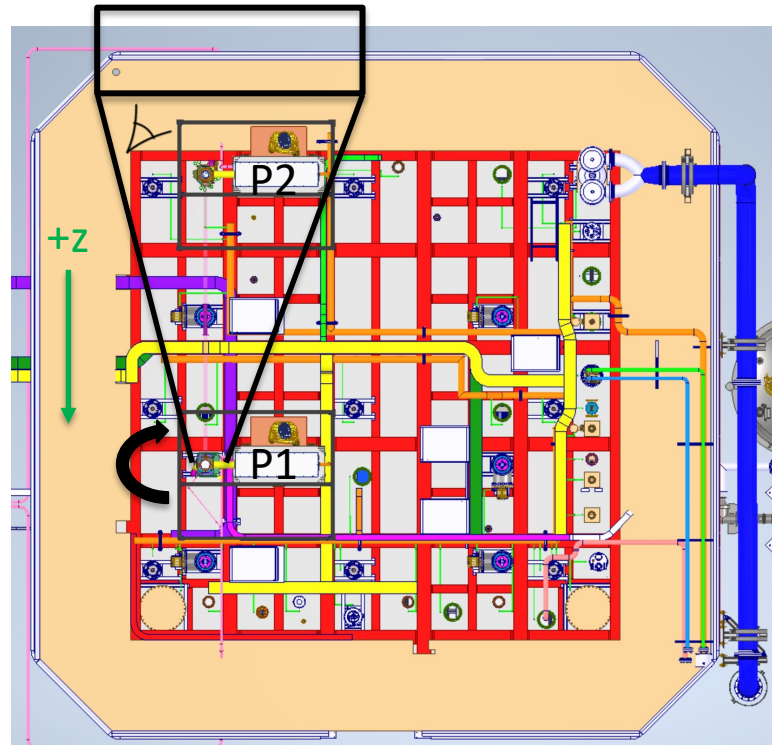
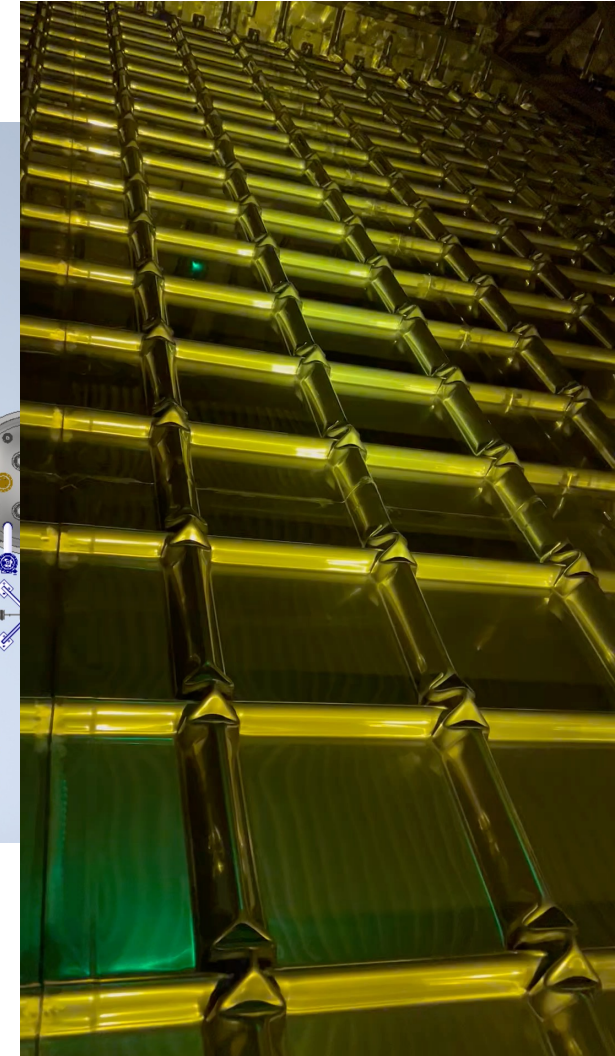
Continued...

- Rotated the RNN600 by 180° and measured the tilt of the beam on the opposite cryostat wall w/ the port aligner w/ the 0.6° compensation still in place
 - Cleared the cutout during the rotation with a *very small margin*
- The tilt on the opposite wall was roughly twice the tilt observed originally
 - ∴ the 0.6° tilt is on periscope and not between the flange and the field cage itself

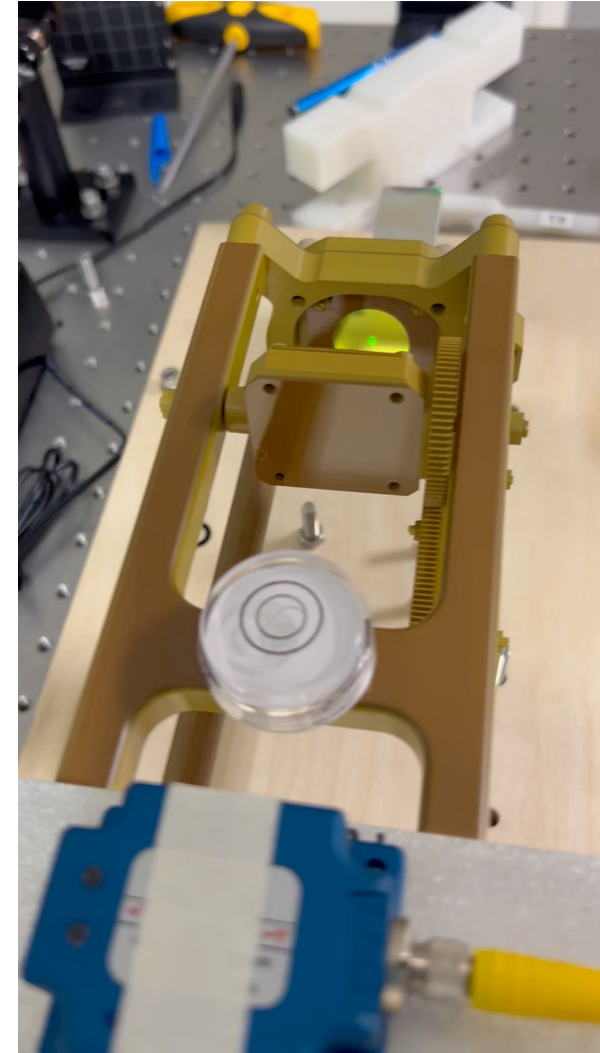
Twist compensation

- Managed to counter the angle observed on the horizontal setup by twisting the Torlon bottom in the opposite direction compared to the twist in the Torlon top
- Will check if the twists creep over time w/ P1 in the horizontal setup (next visit to CERN)
- How will this change in the cold?

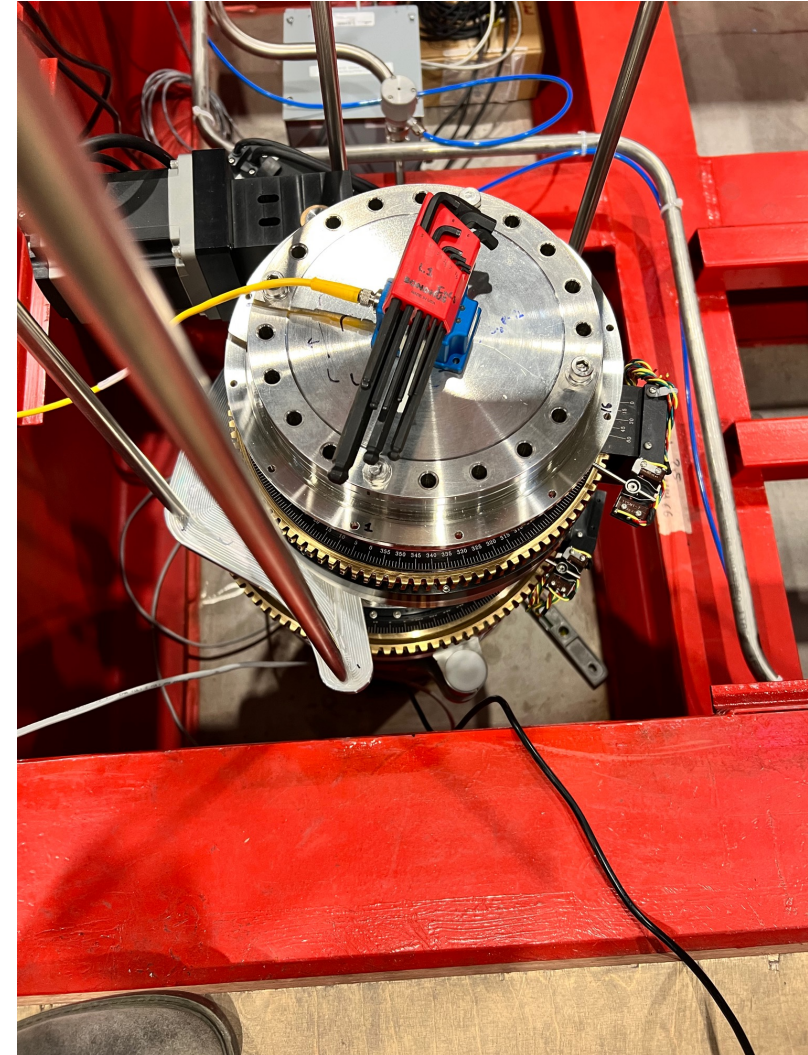
Flange tilt measurement

- Rotated the RNN600 until one tiltmeter axis was zeroed, $\theta_{yz} \cong 0^\circ$
- Check the direction and magnitude of the non-zero axis, $\theta_{xz} \cong 0.35^\circ$
- Should be able to orient all stages in the model to agree w/ what we have at ProtoDUNE
 - Can reconstruct the angle of the tilt using the measurements
- Exploring ways to mitigate this (software or w/ additional flange)

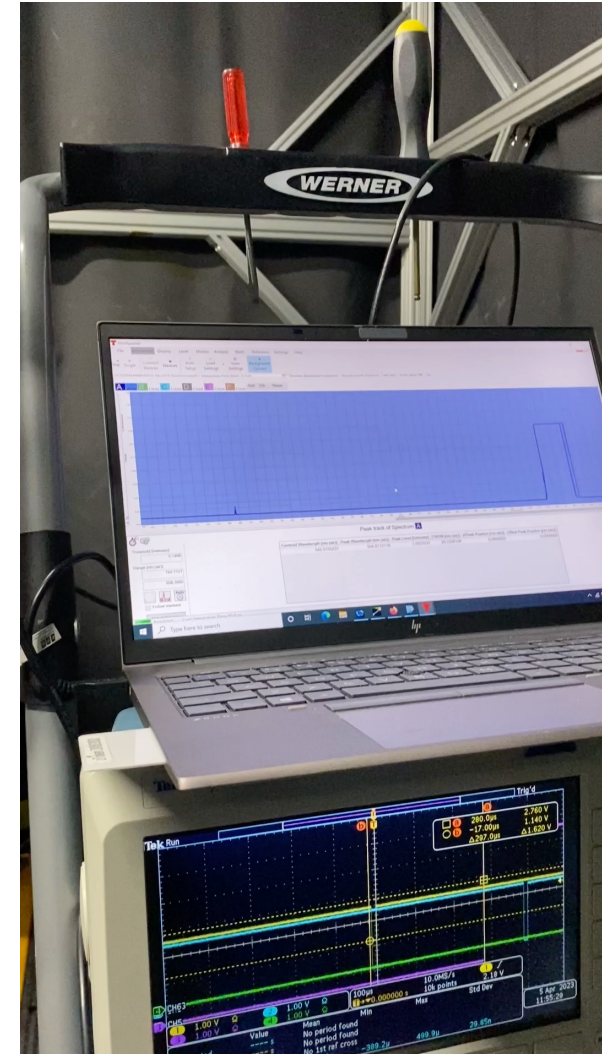
Next steps

- Fast shutter tests are ongoing:
 - Using the shutter to block the UV beam when desired
 - Currently driving the fast shutter using the signal derived from laser Flashlamp TTL pulse
- Also using the vertical setup and a spectrometer to sample the beam composition after the attenuator
- Ship lasers to CERN

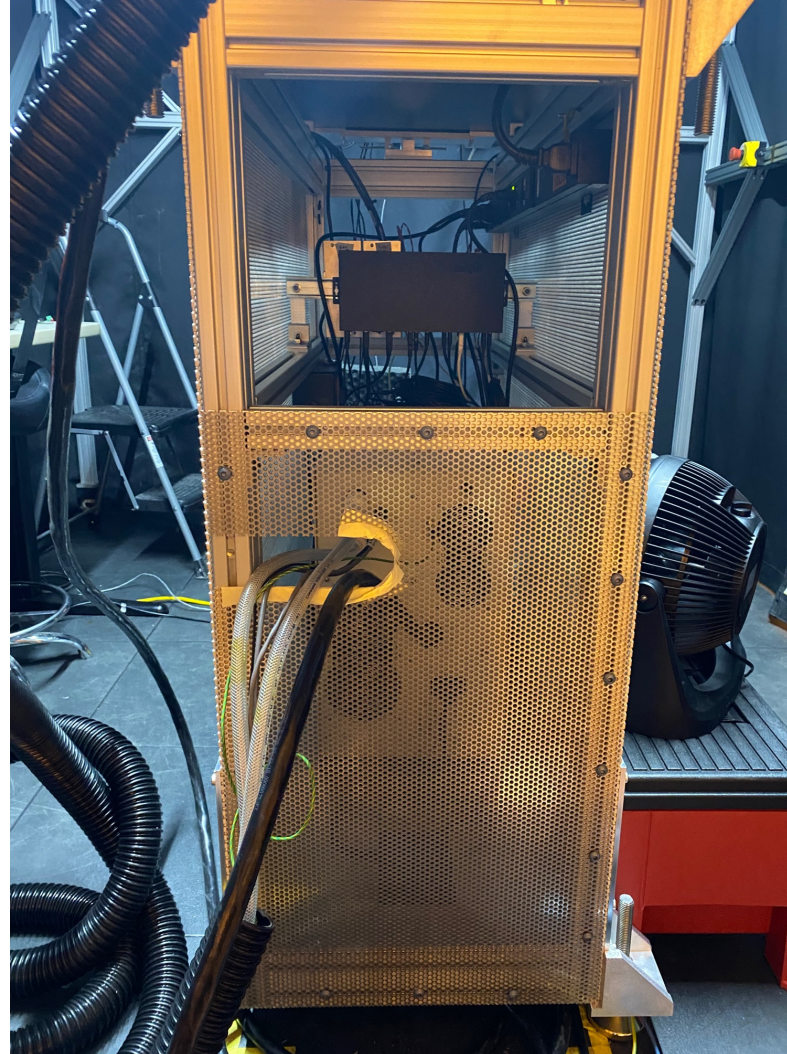
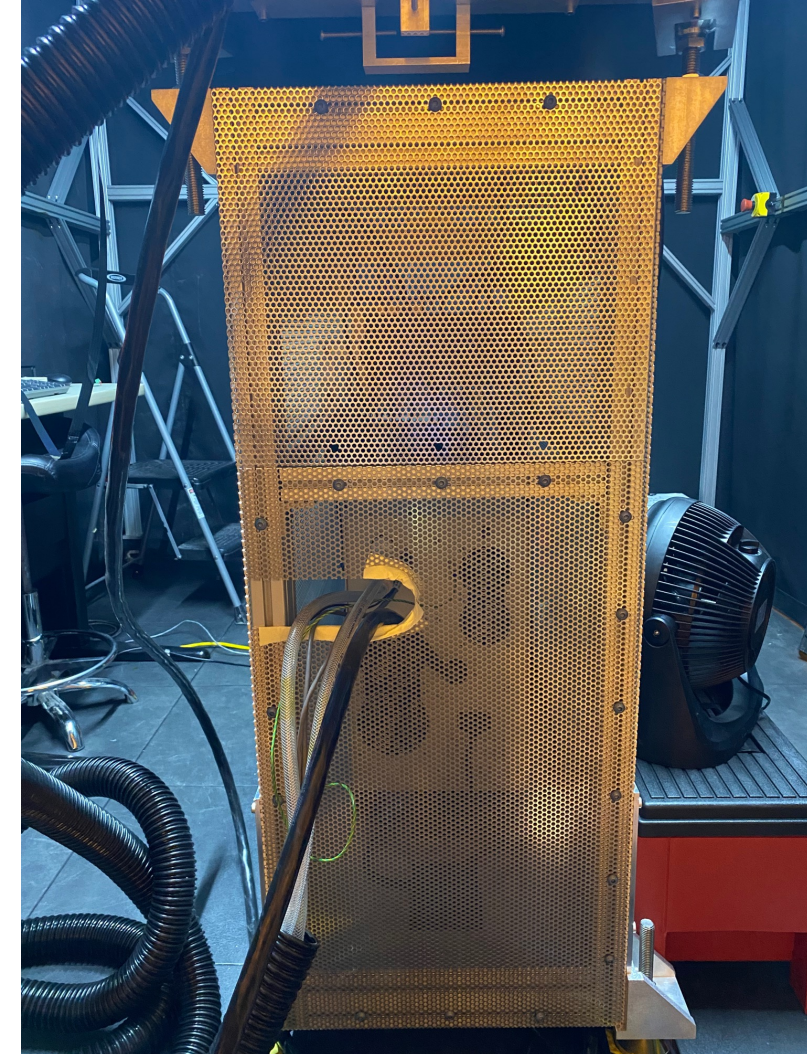
Laser stand

- Received the perforated panels for the laser stands back from the shop
 - Checked that they fit well
 - Checked the position of the cutout for the umbilical and HV cables on the PCU

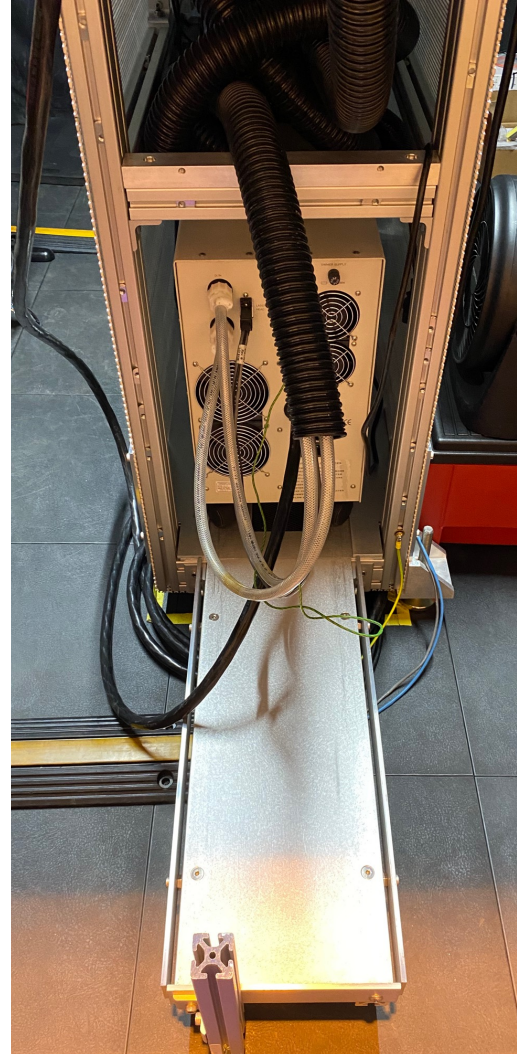
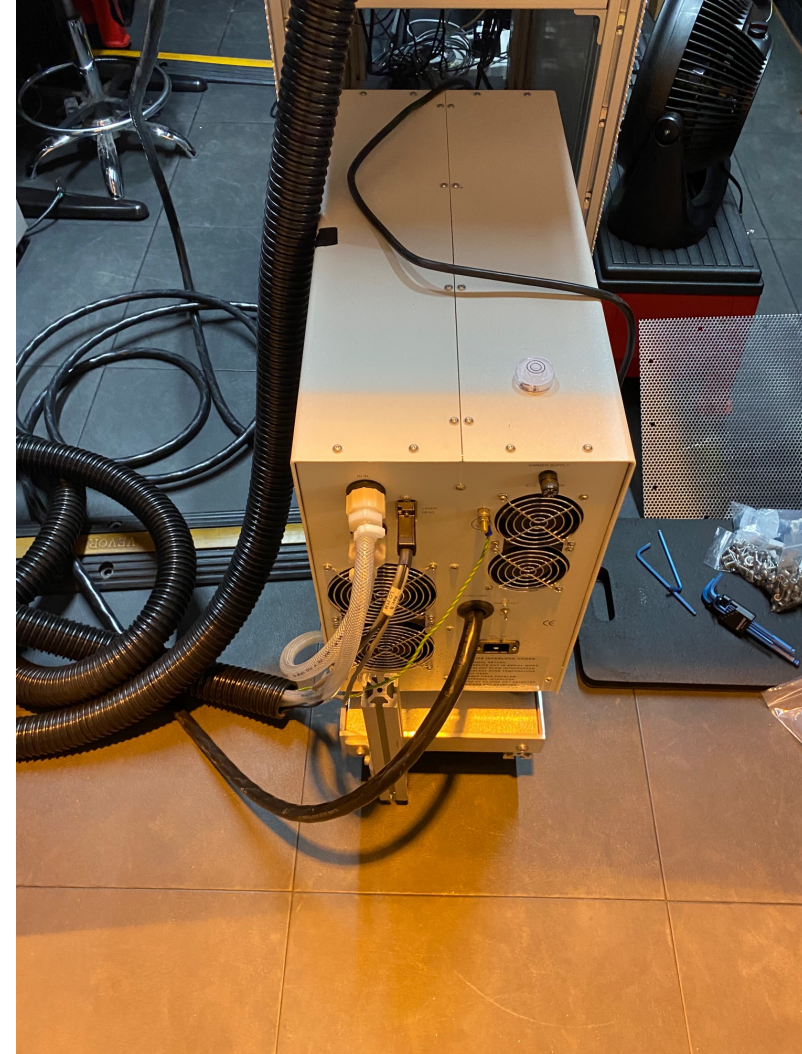
Continued...

- Platform used to roll out the laser Power and Cooling Unit when refilling water or replacing water filters
- Will ship after minor mods
