Contamination prevention measures when installing the SRILAC cryomodules to a 40-years-old dirty beam line

Kazunari Yamada, RIKEN Nishina Center

Overview of SRILAC

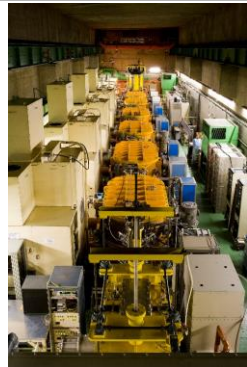
New installation of SRILAC cryomodules & beamline in 2019

RIKEN Heavy-Ion Linac (RILAC) Facility

HEBT used since 1981, rearranged in 2001

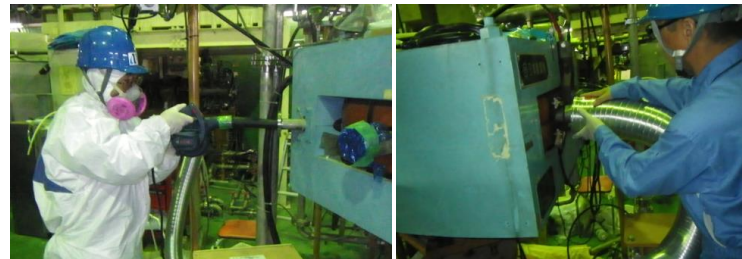
- Air blow – dust collector

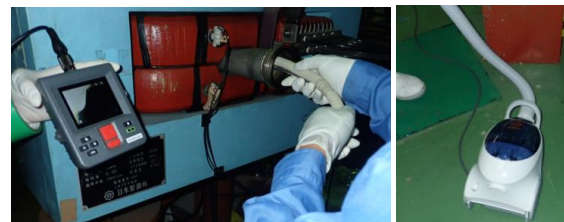
Visible dusts are carefully
removed one by one viewing
with fiber scope

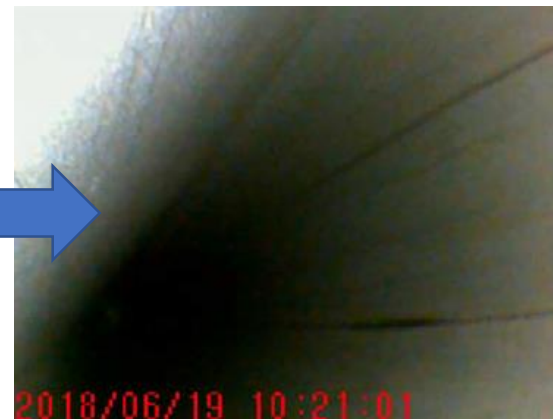
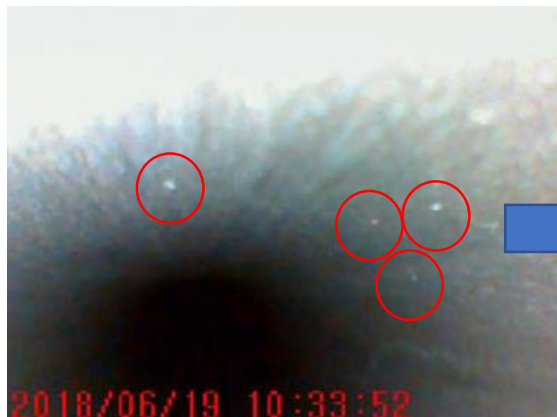
Example for dipole beam duct

Pictures of contaminant in HEBT

Before

After

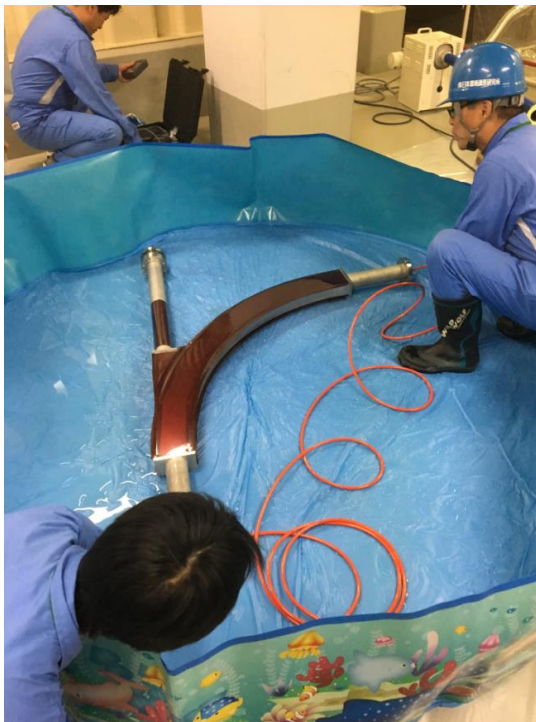
Cleaning for dipole magnets where the beam duct can be removed in other radiation controlled area at RIKEN

- High-pressure rinsing with ultra pure water
- Drying by hot air blower with HEPA filter

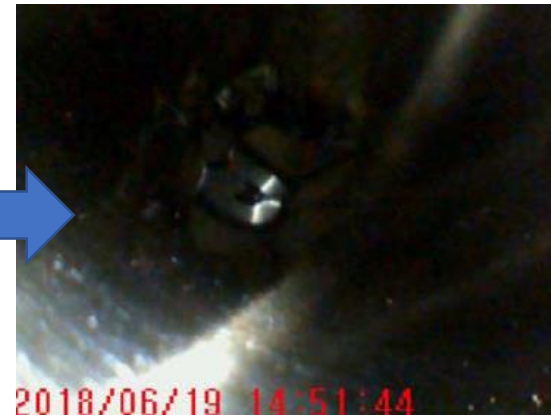
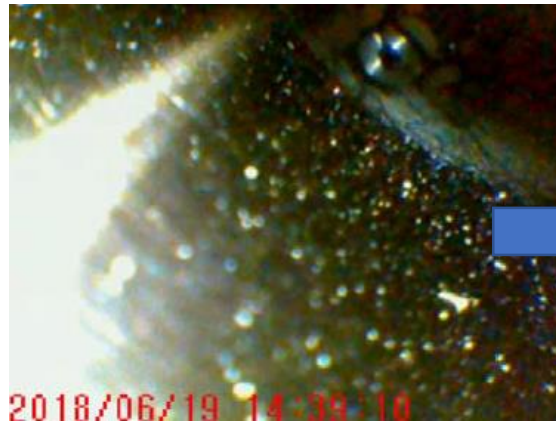
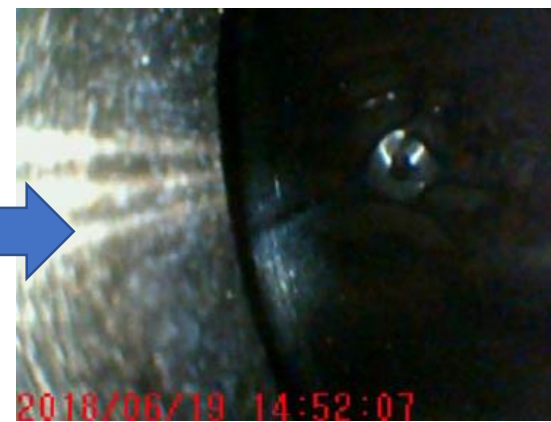
Example for dipole beam duct

Pictures of contaminant in HEBT

Before

After

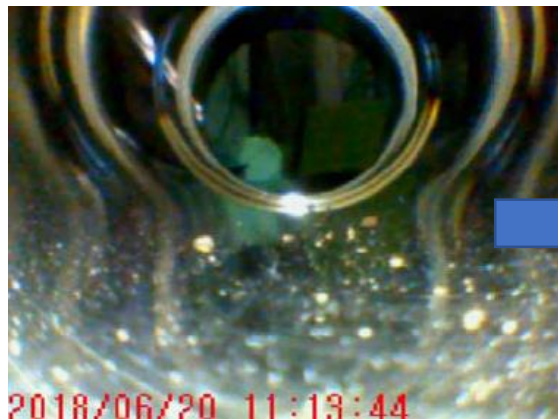
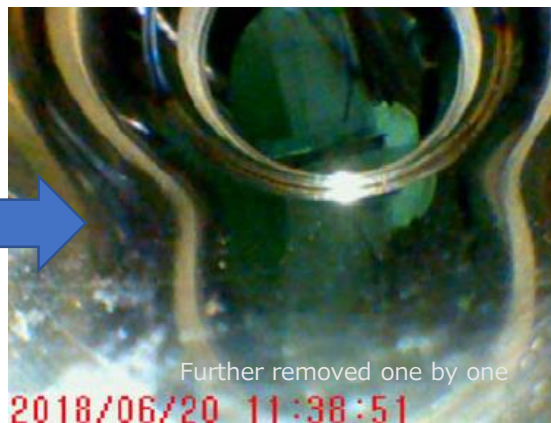
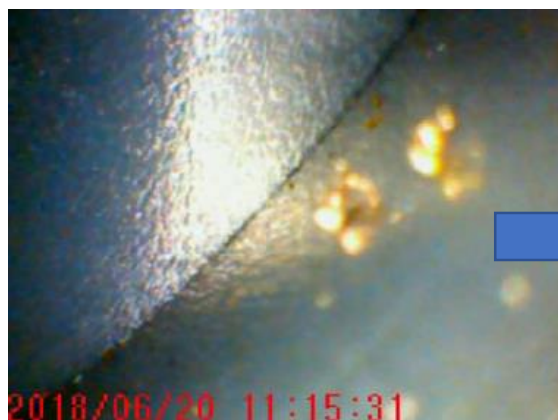
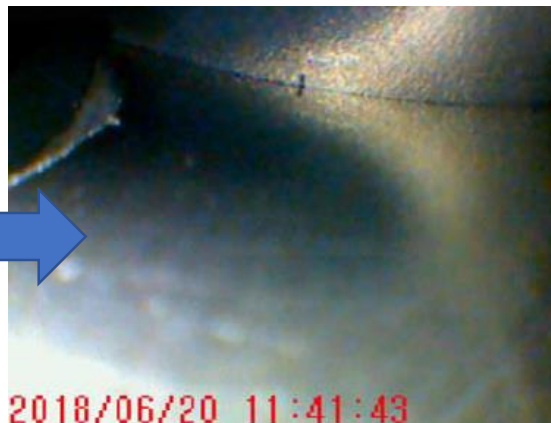
Example for diagnostic chamber

Pictures of contaminant in HEBT

Before

After

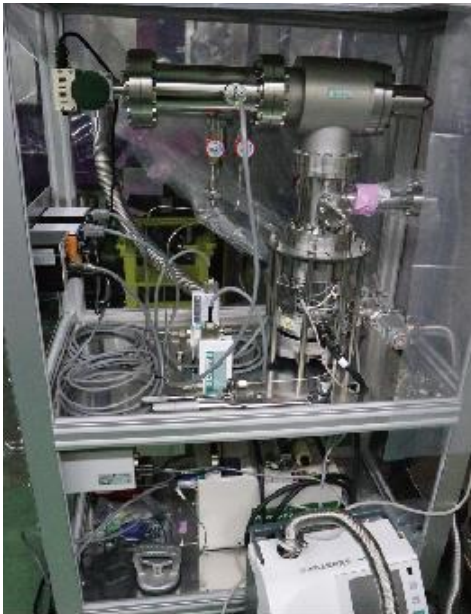
Slow leak and pumping system
using MFC & diffuser

→ Argon gas was used for pressurization

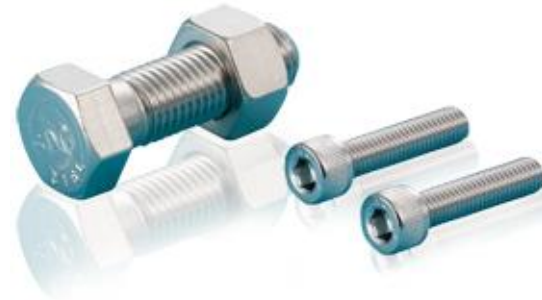
SDC clean bolt

(316L stainless steel + plasma surface hardening)

→ Low particle generation and anti-seizing

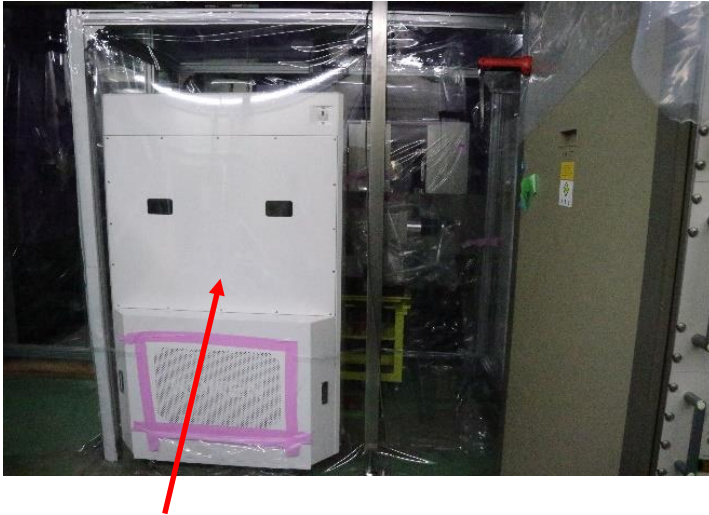
Enclosed each section by local clean booth with standard aluminum frames and antistatic-vinyl sheets

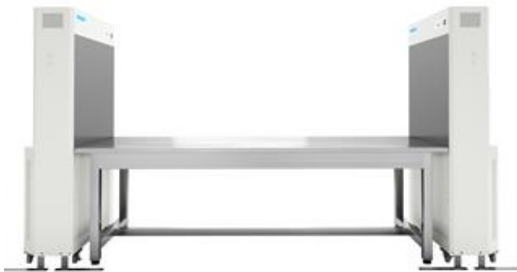
KOACH C900-F (Stand KOACH)

One side of Stand KOACH pair was used for FFU

Open clean system "KOACH"

ISO class 1 super clean area: W900 mm × H700 mm × L1800~2300 mm

→ One side of pair: L900~1800 mm

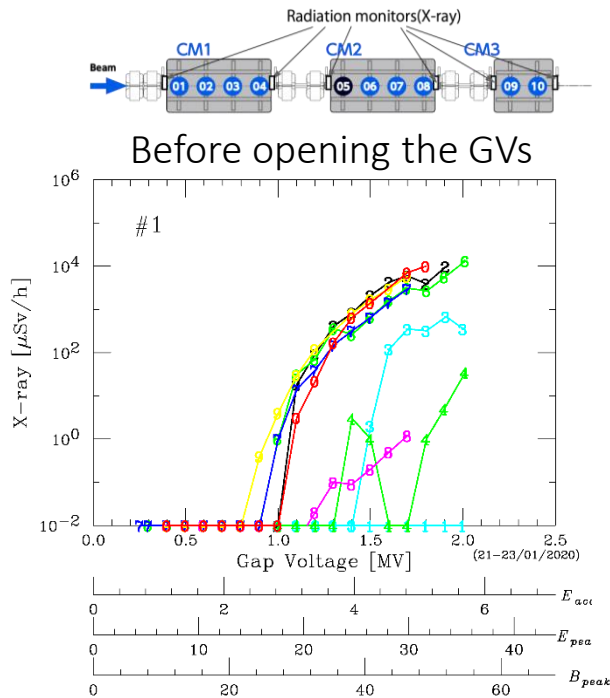
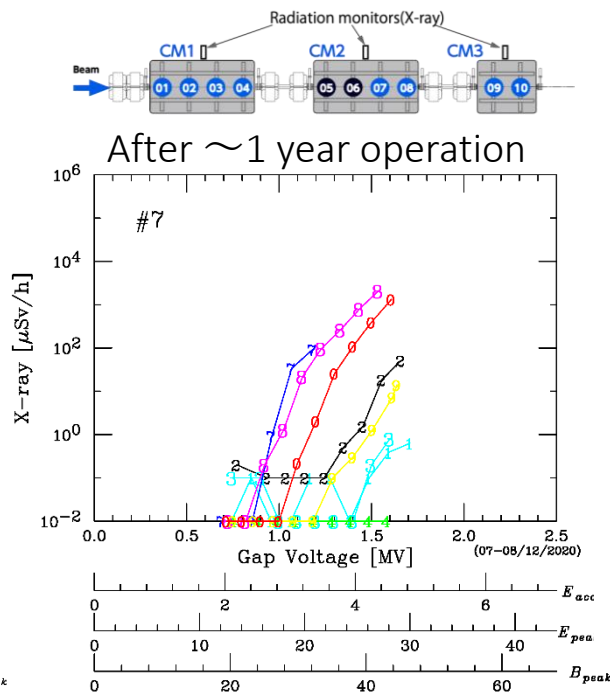
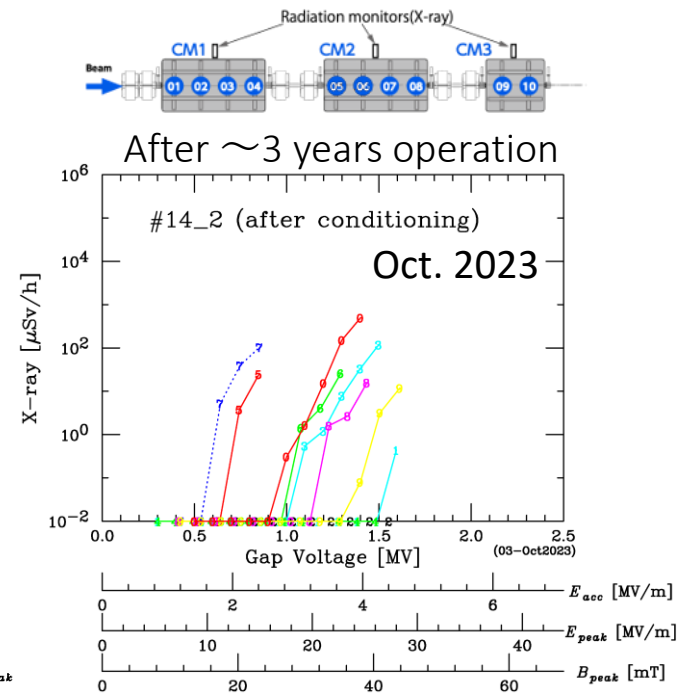
Degree of contamination

- Degradation of CM2 performance is mainly due to an impact of SC06 coupler-window-break
- No significant performance degradation of CM1 and CM3 was observed after the connection of warm sections
- X-ray emissions were gradually increasing in the CM1 and CM3 with operation, however, the performance degradation has been recovered by a pulse conditioning so far
- It seems to be preventing the contamination of metallic coarse particles from old beam line
